**COLORADO**Division of Reclamation,
Mining and Safety

MINERALS PROGRAM INSPECTION REPORT**PHONE: (303) 866-3567**

MINE NAME: Pueblo West Pit	MINE/PROSPECTING ID#: M-1977-573	MINERAL: Sand and gravel	COUNTY: Pueblo
INSPECTION TYPE: Monitoring	INSPECTOR(S): Patrick Lennberg	INSP. DATE: November 28, 2018	INSP. TIME: 10:00
OPERATOR: Continental Materials Corporation	OPERATOR REPRESENTATIVE: Brandon Heser, Bruce Humphries, and Bill Pope	TYPE OF OPERATION: 112c - Construction Regular Operation

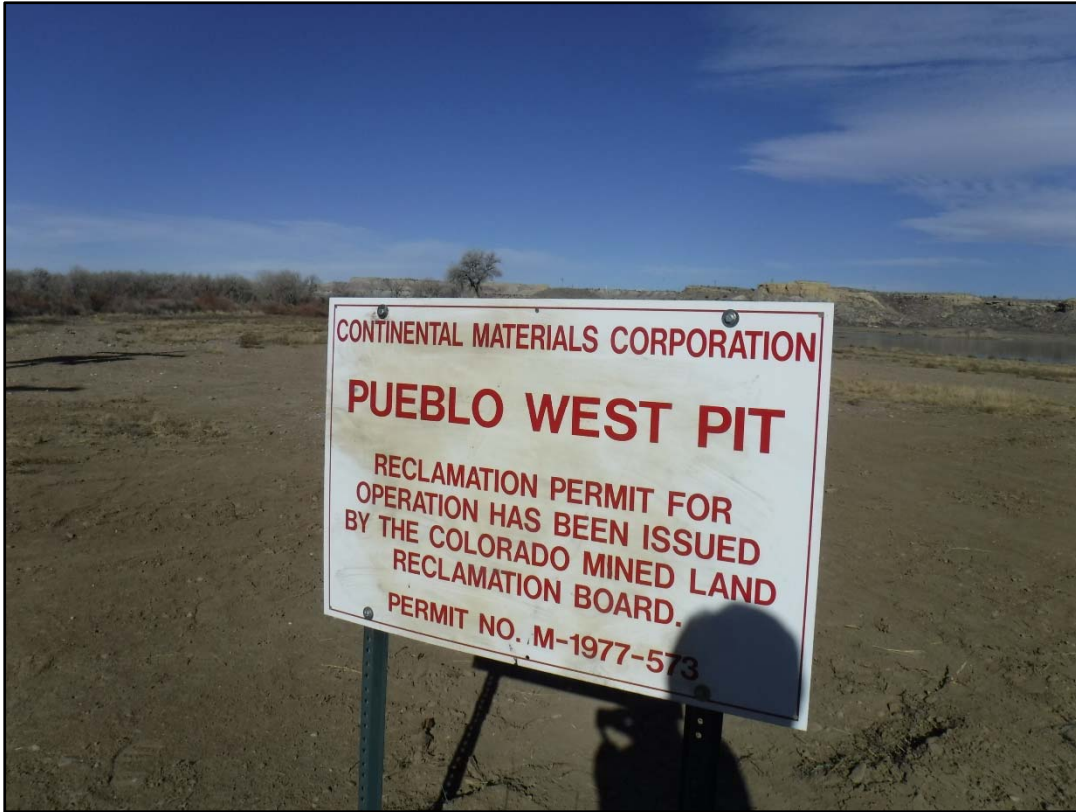
Photo 1: Mine permit sign

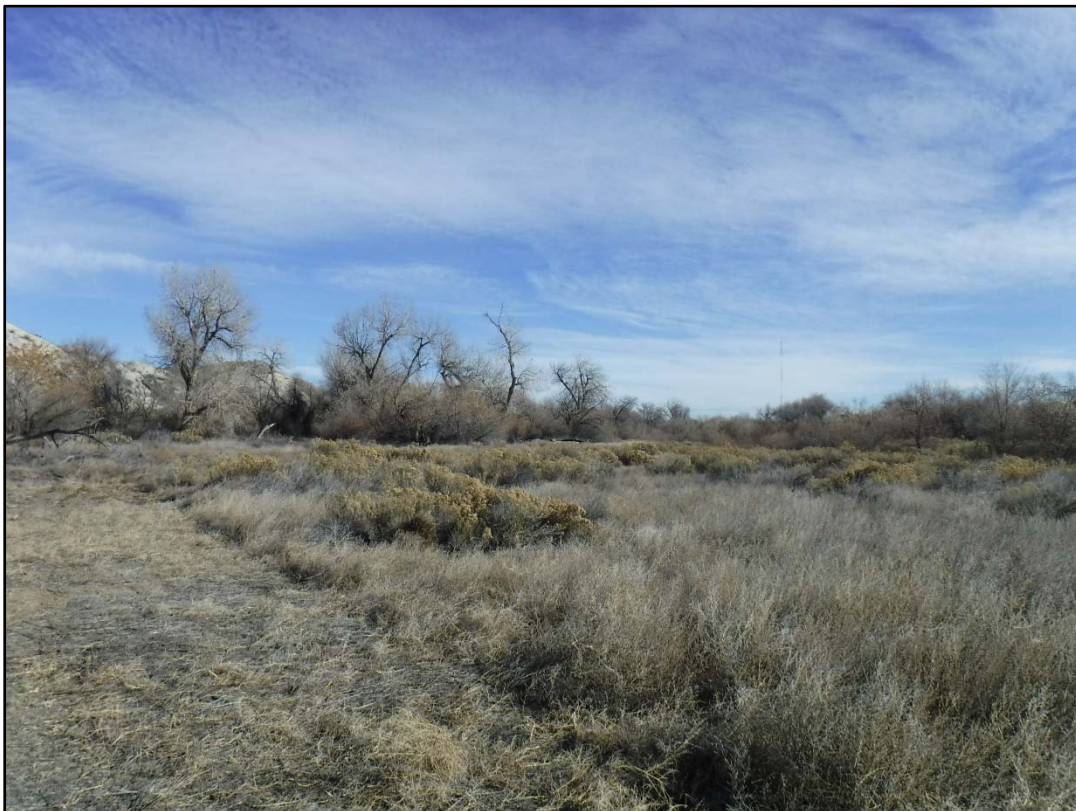
Photo 2: Finger lake area looking east, mowed area is approximate property line.

The Division recommends the Operator contact CPW to get their input on the reclamation efforts of the finger lake area. If CPW is satisfied with the reclamation efforts then the Operator can seek release of the area. The Operator will be required to complete the acreage release process, pursuant to Rule 4.17.

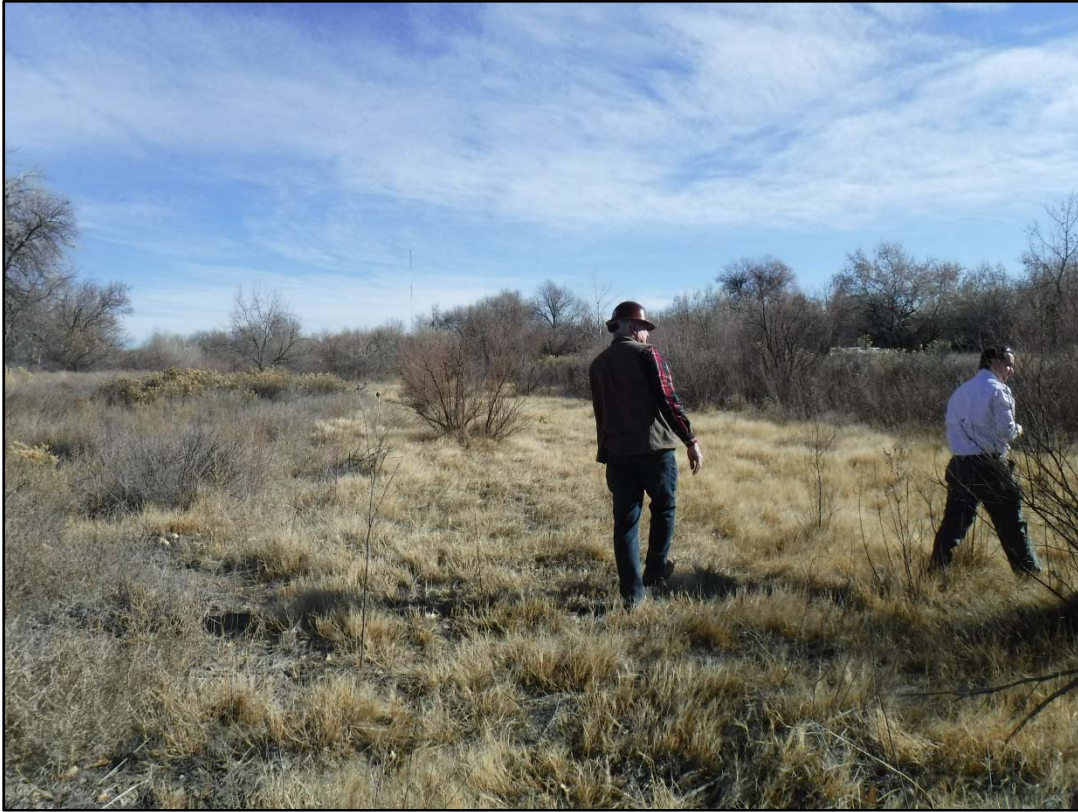
The finger lake area is approximately 10 acres in size and was mined and backfilled in the late 1990's and early 2000's. During mining they were required to maintain a minimum of a 50 foot buffer to the property line which resulted in approximately 4.4 acres of disturbance. The area was backfilled to allow it to become an emergent wetland (Annual Report March 22, 2001). Since that time vegetative cover has consisted of annual weeds and some native volunteer species. There are many Russian olive trees and tamarisk trees throughout the area. These are List B Noxious Weeds Species by the Colorado Department of Agriculture which requires suppression not eradication. The area maybe acting as a localized sink as its vegetation closely mimics vegetation that is found outside the mined area. Evidence of wildlife was very common through this area, there were numerous well-travelled paths that animals use as a travel corridor paralleling the river.

Photo 3: Low area that was mined and backfilled

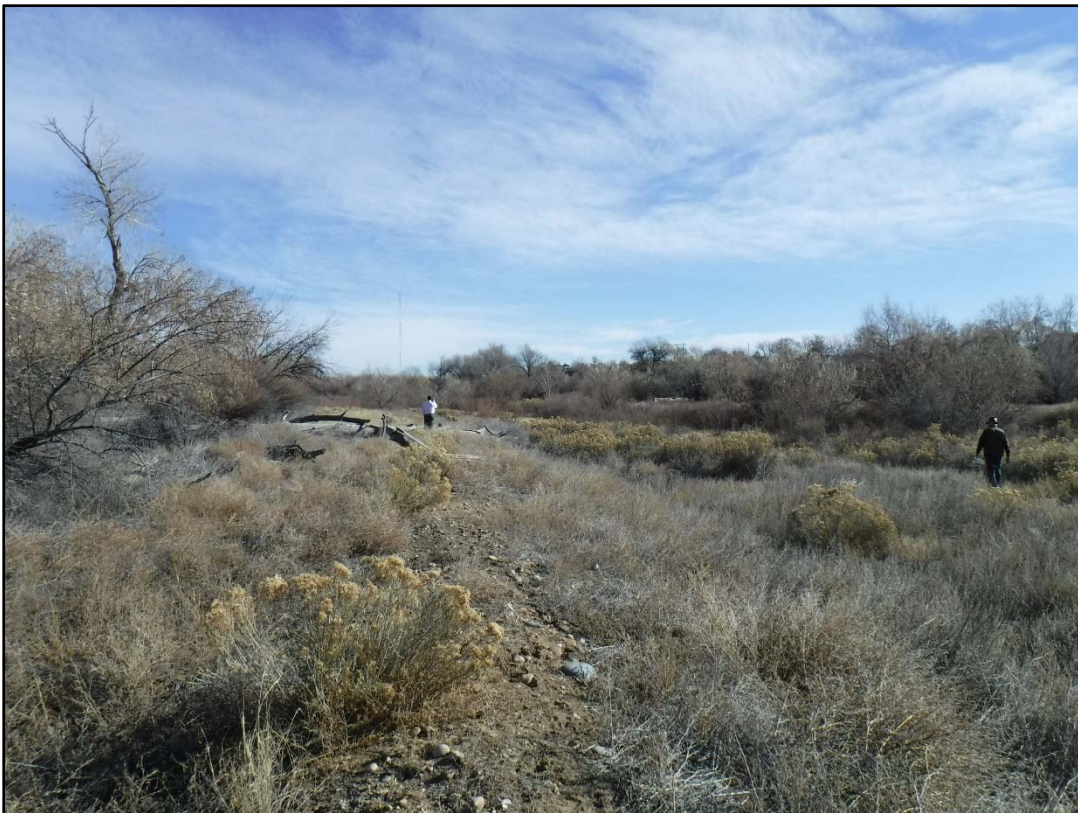
Photo 4: Bermed and area to the left is 50' buffer and to the right is the lower mined area.

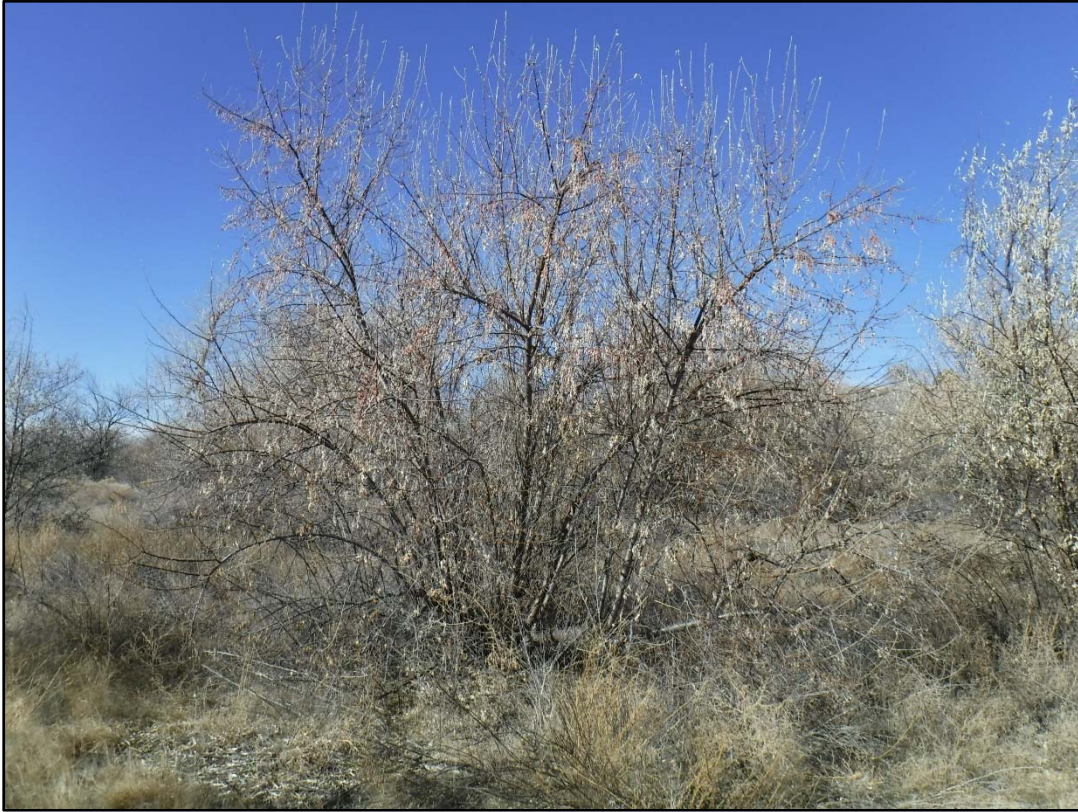
Photo5: Russian olive tree established in mined area

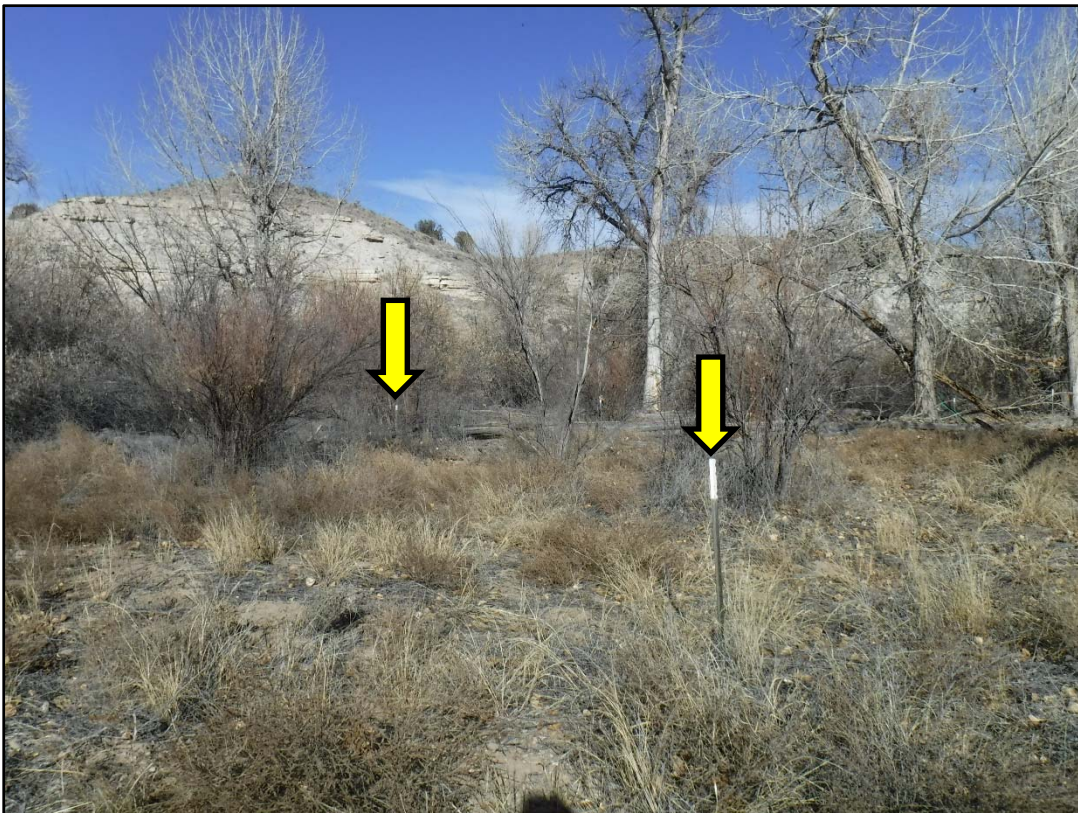
Photo 6: T-posts marking property boundary and 50' buffer

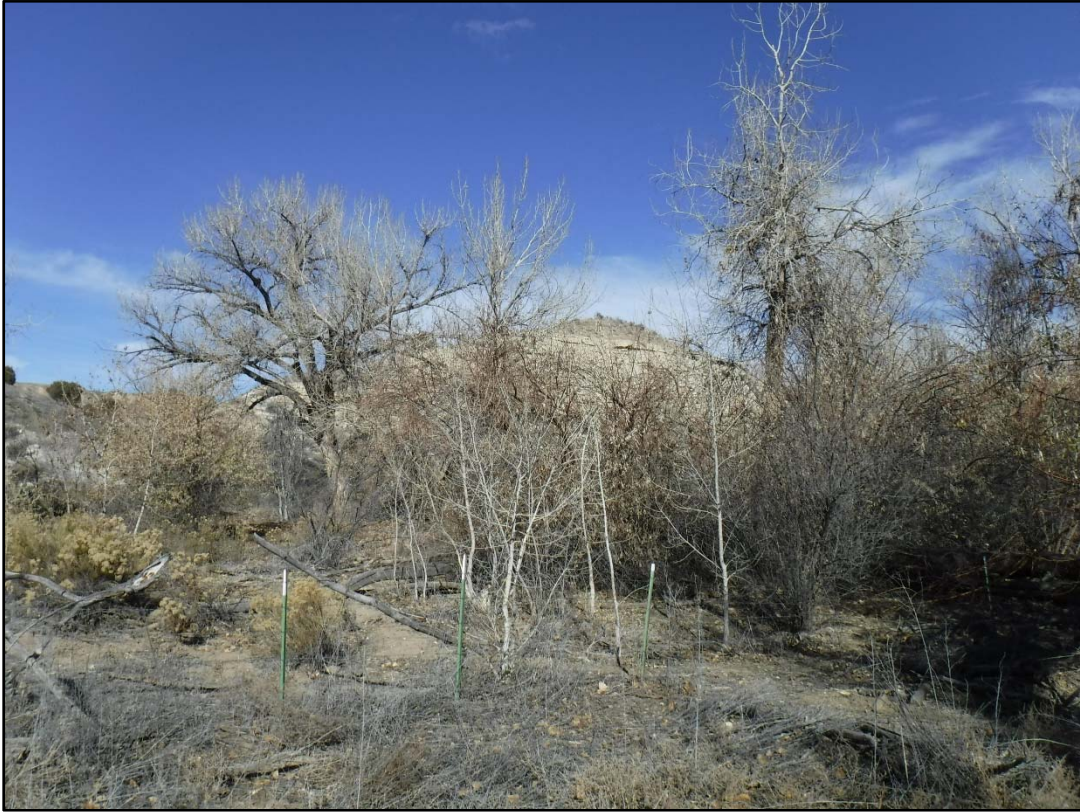
Photo 7: Vegetation conditions outside the property boundary adjacent to finger lake area to the north

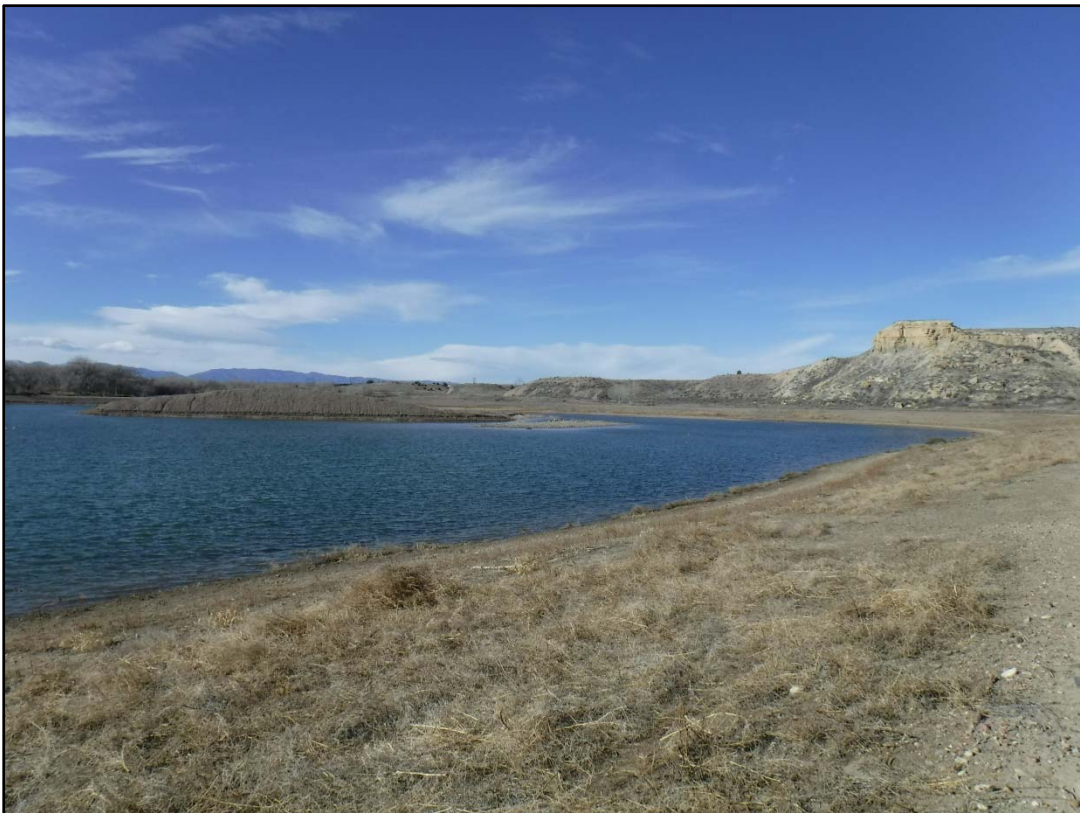
The reservoir was first filled to capacity in June of this year. Within the reservoir there is an island of topsoil that has not been seeded or had any vegetation established to date. The current reclamation plan map for the site does not indicate an island in the reservoir and is being cited as a problem in this inspection report. The Operator will need to revise the reclamation plan map to reflect existing conditions by submitting a Technical Revision. The lack of vegetation has resulted in some erosional rills on the topsoil pile. The Operator stated that they are planning on getting a hand crew and/or a rototiller on the island to begin revegetation.

Additionally, on the east side of the island the slope is near a 1H:1V grade and at the waterline water erosion has created a vertical slope. There was abundant wildlife seen using the lake especially on and around the island where the island provides some shelter and where the water gets shallower on the west side of the island.

Photo 8: Topsoil island showing erosion on the east side

INSPECTION TOPIC: Gen. Compliance With Mine Plan**PROBLEM/POSSIBLE VIOLATION:** Problem: Failure to follow approved reclamation plan, or current reclamation plan needs to be updated and clarified pursuant to C.R.S. 34-32.5-116 (1). The operator must follow approved reclamation plan or provide sufficient information to describe or identify how the operator intends to conduct reclamation.**CORRECTIVE ACTIONS:** The operator shall submit a Technical Revision, with the required \$216 revision fee, to update and clarify the current approved reclamation plan to reflect existing and proposed activities by the corrective action date.**CORRECTIVE ACTION DUE DATE:** 1/10/19

With the difficulty getting vegetation to grow at the site the Division wonders if the topsoil island could be better used in getting vegetation established for final reclamation.

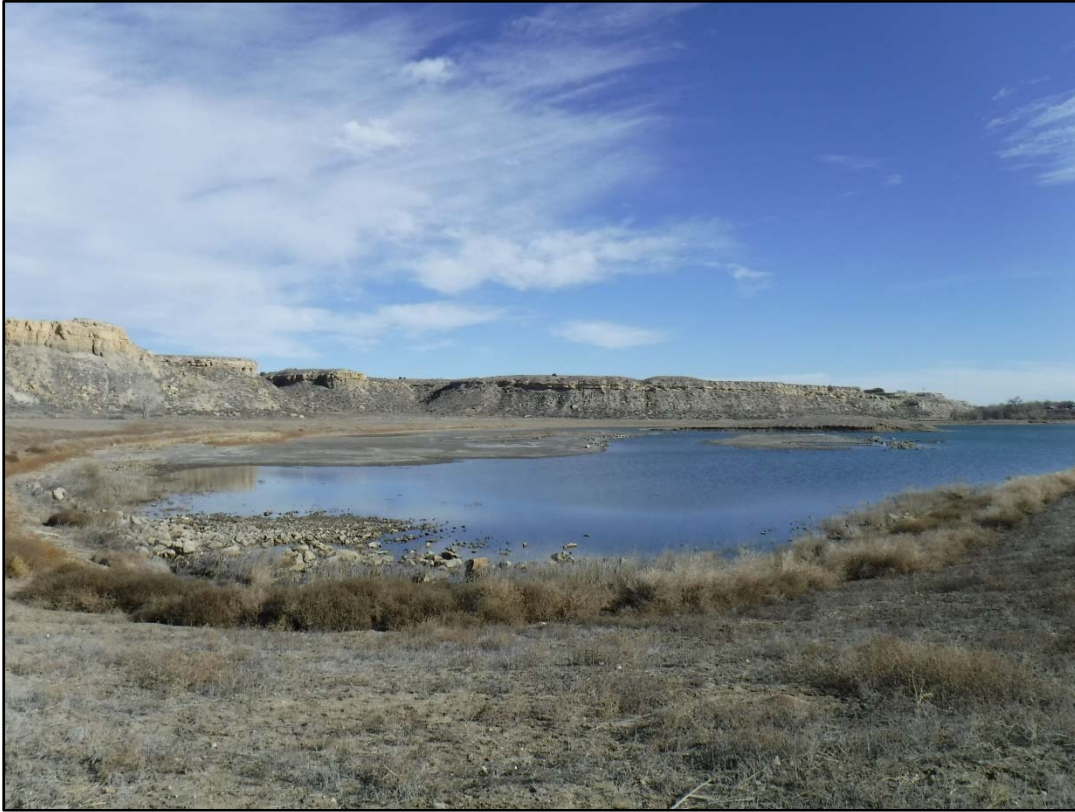
Photo 9: West side area of topsoil island that is shallow and contain abundant water fowl

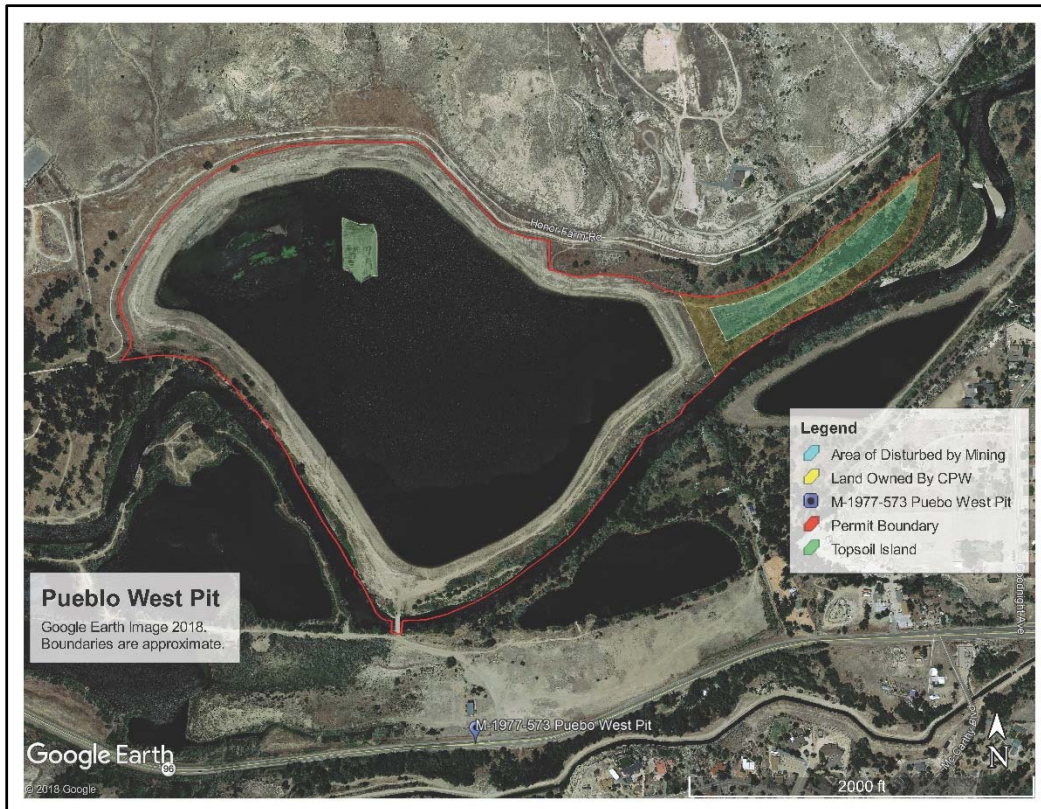
Photo 10: Overview of Pueblo West Pit
