MINERALS PROGRAM INSPECTION REPORT
PHONE: (303) 866-3567

MINE NAME: Norwood Pit	MINE/PROSPECTING ID#: M-1981-154	MINERAL: Sand and gravel	COUNTY: San Miguel
INSPECTION TYPE: Monitoring	INSPECTOR(S): Lucas J. West	INSP. DATE: October 23, 2018	INSP. TIME: 13:30
OPERATOR: San Miguel County	OPERATOR REPRESENTATIVE: Ryan Righetti, Alan Hatfield	TYPE OF OPERATION: 112c - Construction Regular Operation	
REASON FOR INSPECTION: Normal I&E Program	BOND CALCULATION TYPE: None	BOND AMOUNT: \$0.00	
DATE OF COMPLAINT: NA	POST INSP. CONTACTS: None	JOINT INSP. AGENCY: None	
WEATHER: Raining	INSPECTOR'S SIGNATURE:

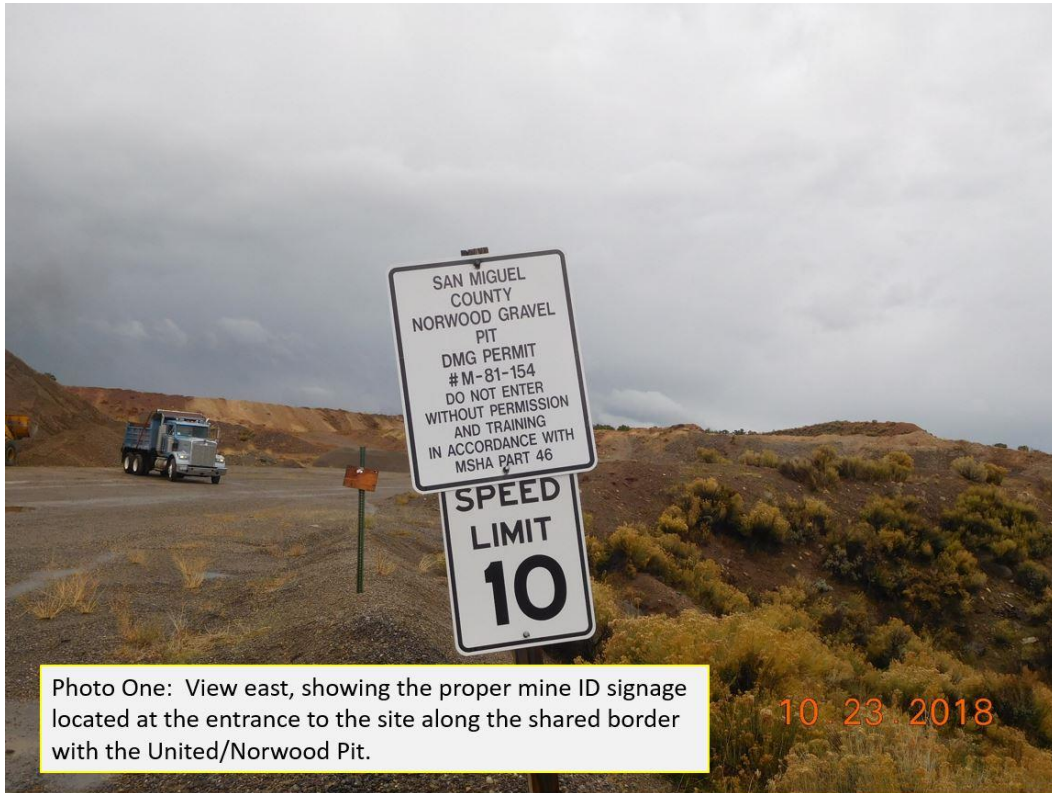
Photo One: View east, showing the proper mine ID signage located at the entrance to the site along the shared border with the United/Norwood Pit.

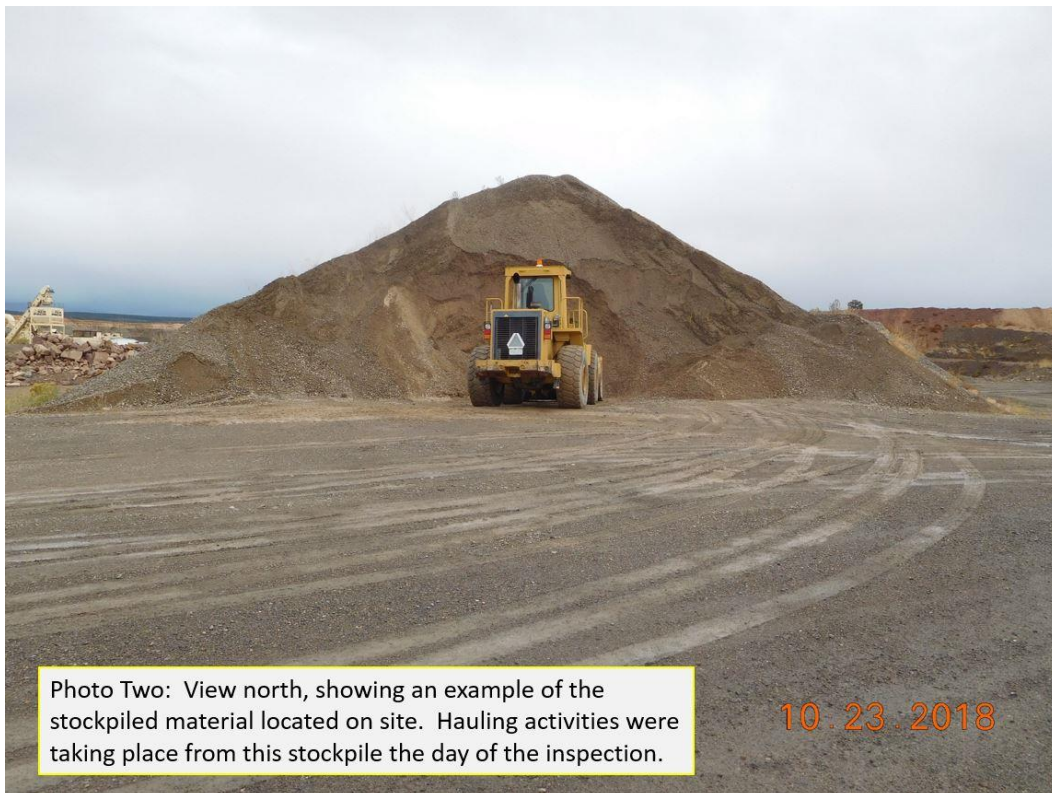
Photo Two: View north, showing an example of the stockpiled material located on site. Hauling activities were taking place from this stockpile the day of the inspection.

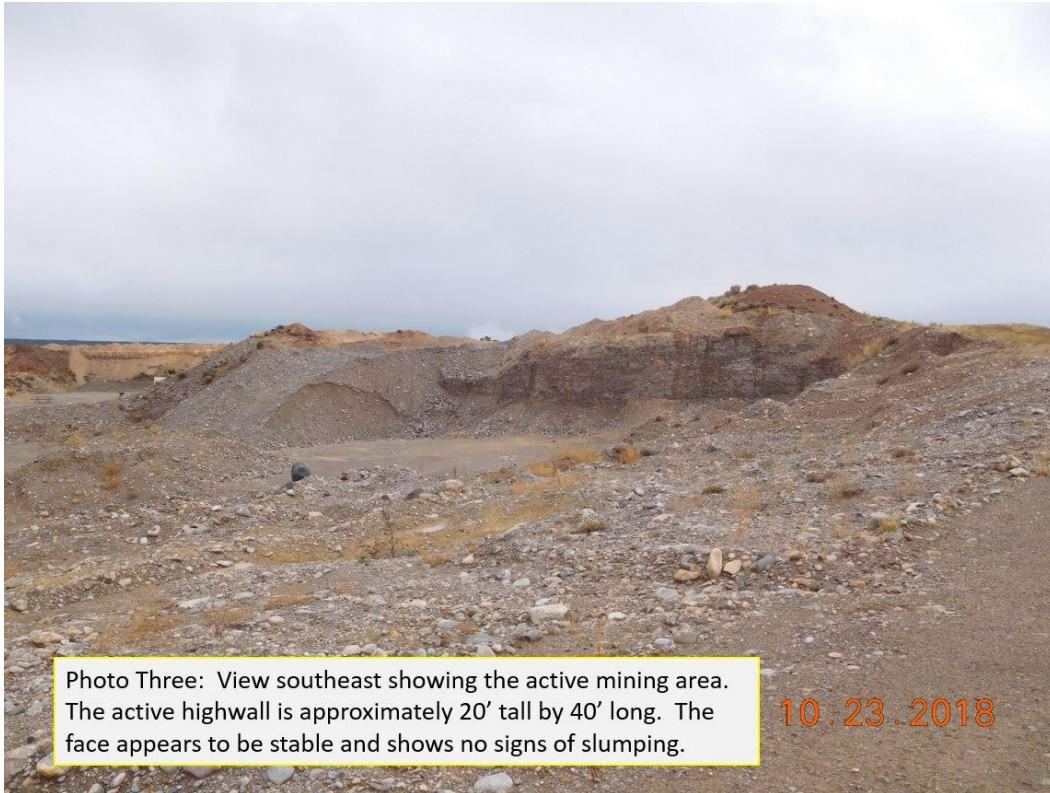
The proper mine identification signage was posted at the entrance to the site and can be seen in Photo One. The permit boundaries were well marked on the East, South and West sides with T-posts and signs that were observed. The site shares a permit boundary with the United Companies United/Norwood pit along the northern edge of the permitted area. Various stockpiles were observed on site and appeared to be stable. Hauling and processing of materials takes place on an as needed basis and is in compliance with Rule 1.13. Active hauling operations from the stockpiles were taking place the day of the inspection. Examples of the stockpiles can be seen in Photo Two. The active mining area consists of a small highwall approximately 20 feet tall spanning around 40 Linear Feet. The mining area is in good condition and appears to be stable, the highwall can be seen in Photo Three.

Photo Three: View southeast showing the active mining area. The active highwall is approximately 20' tall by 40' long. The face appears to be stable and shows no signs of slumping.

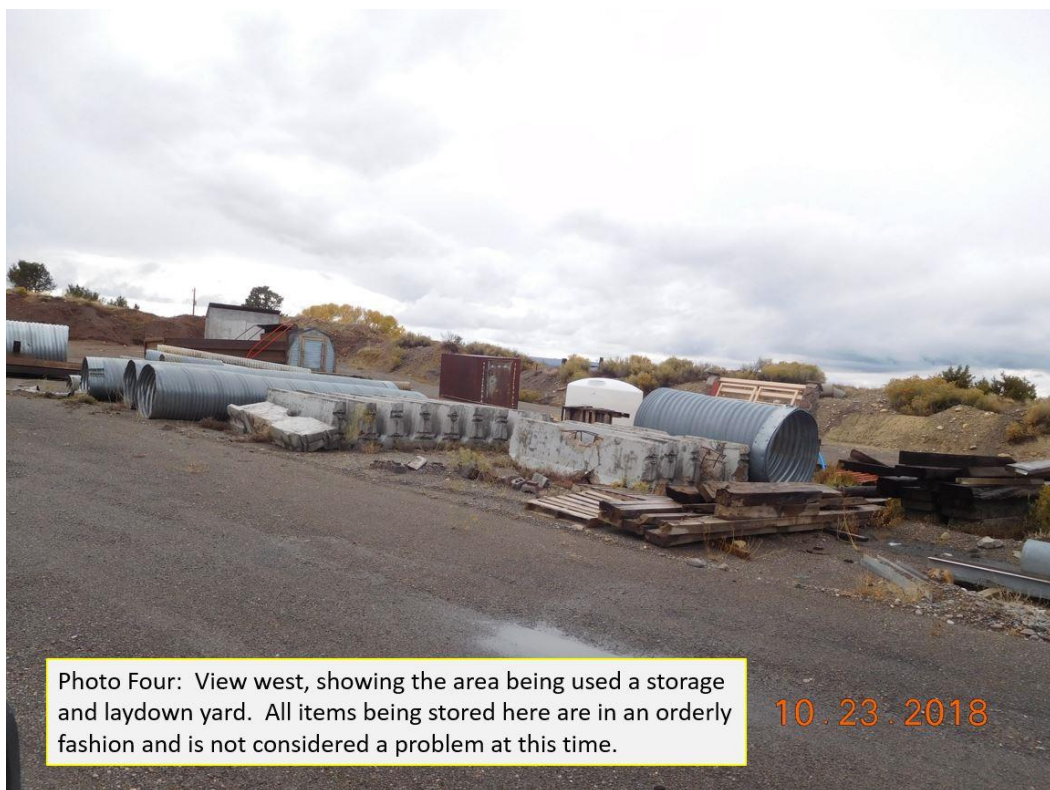
Most slopes on the site appear to be no steeper than 3H: 1V, while the slopes are not in the final configuration, they are well vegetated with volunteer species and otherwise appear stable. The eastern boundary of the highwall is being backfilled with materials to establish the required 3: 1V slopes, materials were noted as being clean fill material. Located in the Southwestern corner of the permitted area is the overburden and topsoil stockpiles that are also in good condition. The stockpiles are well vegetated with native grasses and shrubs. No Noxious weeds were observed on site, and the Operator identified the weed management plan is active and ongoing. A small area is being used as a storage / laydown area, all items in the area are stored in a neat and orderly fashion. The storage area can be seen in Photo Four.

Photo Four: View west, showing the area being used as a storage and laydown yard. All items being stored here are in an orderly fashion and is not considered a problem at this time.
