MINERALS PROGRAM INSPECTION REPORT**PHONE: (303) 866-3567**

MINE NAME: Zadra Pit	MINE/PROSPECTING ID#: M-1989-030	MINERAL: Gravel	COUNTY: San Miguel
INSPECTION TYPE: Monitoring	INSPECTOR(S): Lucas J. West	INSP. DATE: October 23, 2018	INSP. TIME: 14:45
OPERATOR: San Miguel County	OPERATOR REPRESENTATIVE: Ryan Righetti, Alan Hatfield	TYPE OF OPERATION: 112c - Construction Regular Operation	
REASON FOR INSPECTION: Normal I&E Program	BOND CALCULATION TYPE: None	BOND AMOUNT: \$0.00	
DATE OF COMPLAINT: NA	POST INSP. CONTACTS: None	JOINT INSP. AGENCY: None	
WEATHER: Cloudy	INSPECTOR'S SIGNATURE:

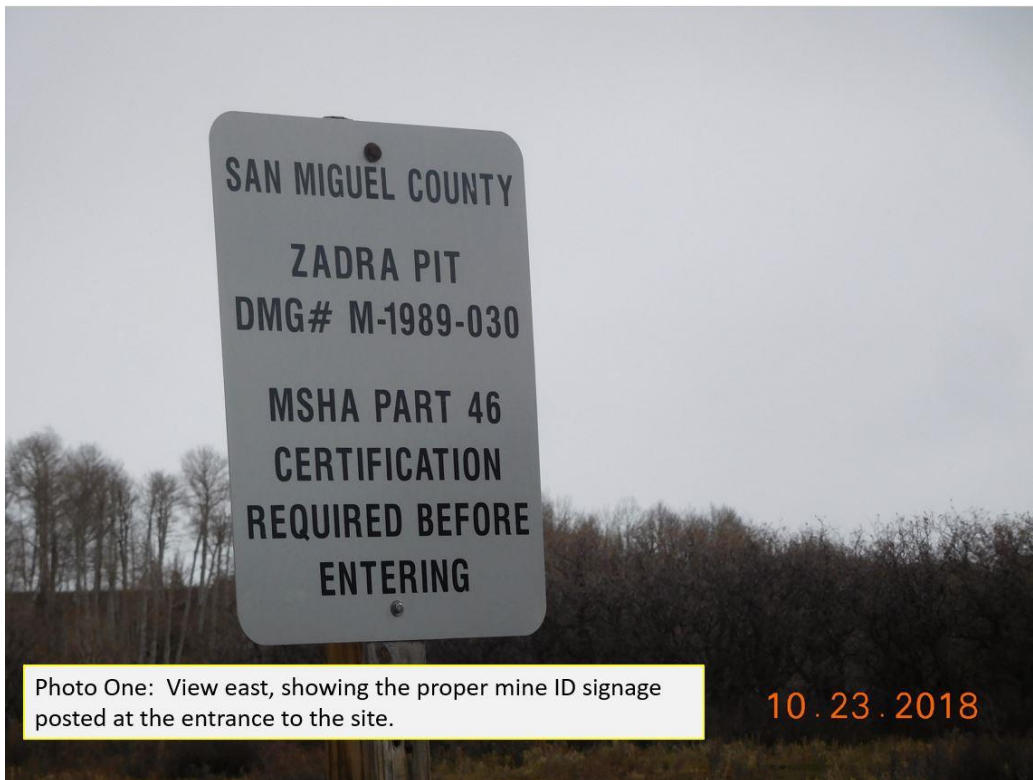
The proper mine identification signage was posted at the entrance to the site as seen in Photo One, and the permit boundaries were clearly marked. The site was not active during the inspection however mining related equipment as well as a crusher and it's support equipment were on site. All fuel and hazardous materials used in support of the crushing operations was verified to be in secondary containment Photos Two and Three show the equipment being utilized. The site crushes intermittently with a mobile crushing unit, stockpiling material for periodic use in the area. One large stockpile is located adjacent to the crusher, and can be seen in Photo Four. The stockpile appears to be in good condition and stable.

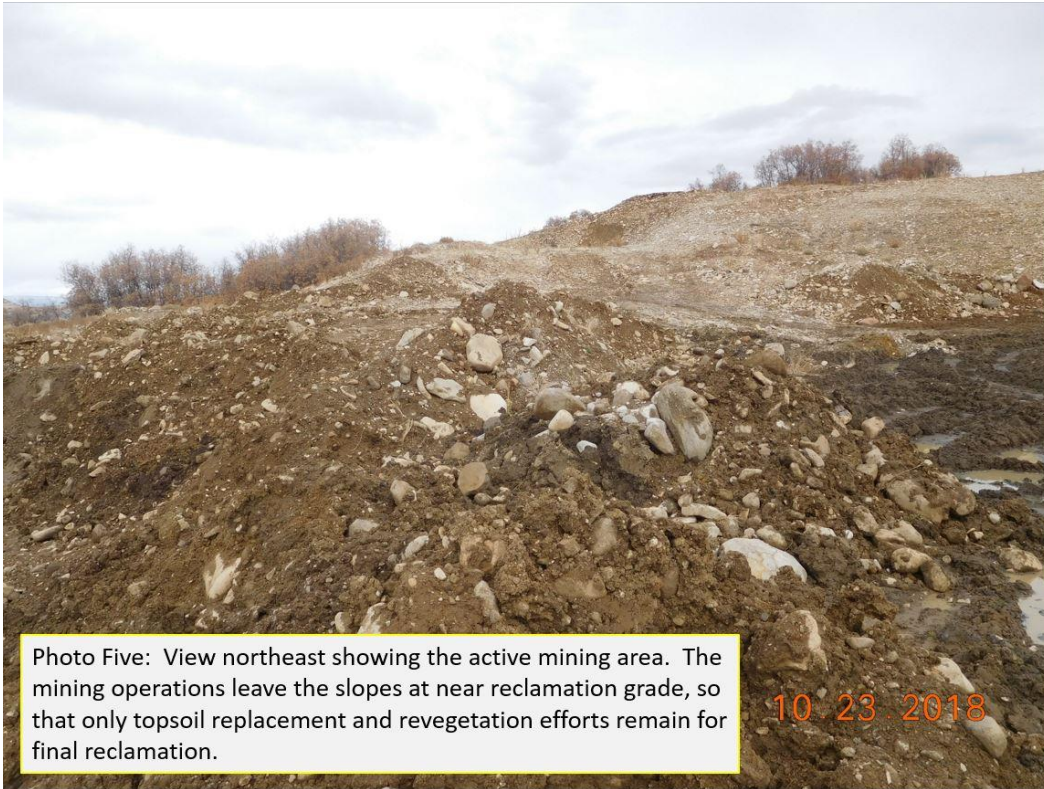
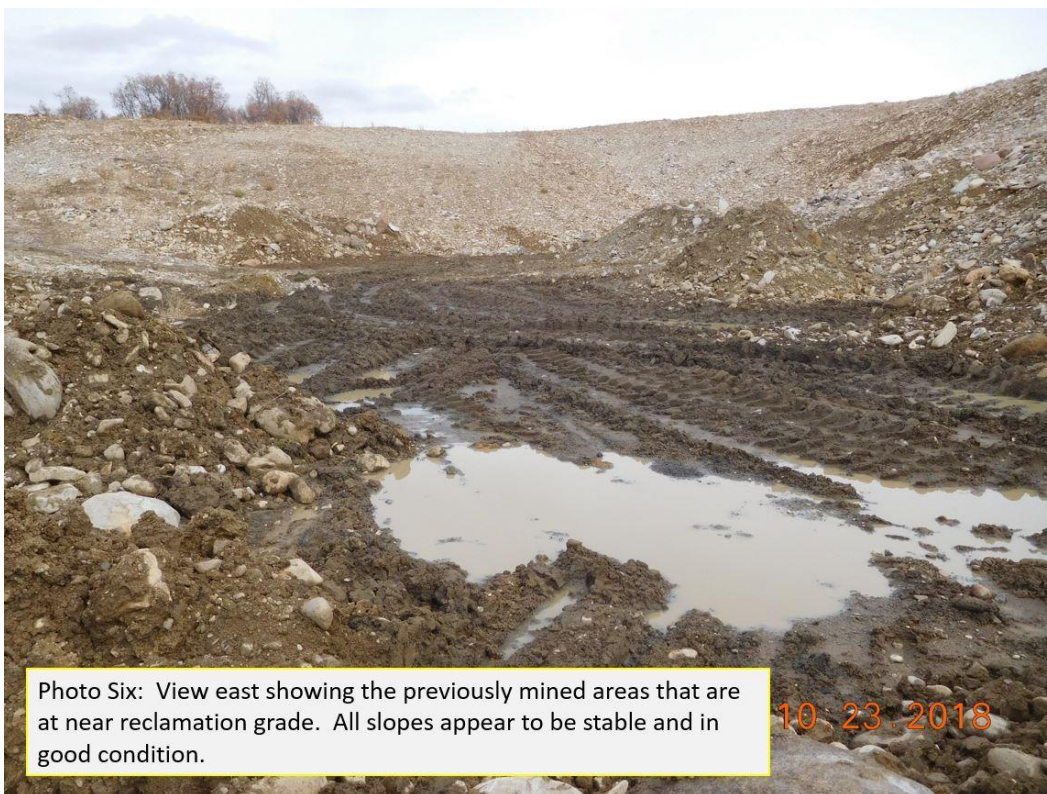
The active mining operations are being done in a manner that leaves the mined areas at near reclamation grade. All mined slopes, including the active mining area were observed and appear to be stable and in good condition. Photos Five and Six show the active mining area as well as an example of the previously mined areas that are nearly at final grade.
