COLORADO
Division of Reclamation,
Mining and Safety
Department of Natural Resources

Permit Number: C-1981-012 Mine Name: New Elk Mine Operator: New Elk Coal Company, LLC Operator Address: Mr. Louis Head 12250 Highway 12 Weston, CO 81091	County: Las Animas Operation Type: Underground Permit Status: Active Ownership: Private
	Operator Representative Present: Vince Massarotti
Operator Representative Signature: (Field Issuance Only)

Inspection Start Date: December 11, 2018 Inspection Start Time: 14:00 Inspection End Date: December 12, 2018 Inspection End Time: 08:30		Inspection Type: Coal Partial Inspection Inspection Reason: Normal I&E Program Weather: Clear	
Joint Inspection Agency: None		Joint Inspection Contacts: 	
Post Inspection Agency: None		Post Inspection Contacts: 	
Inspector(s): Robert D. Zuber, P.E.	Inspector's Signature:

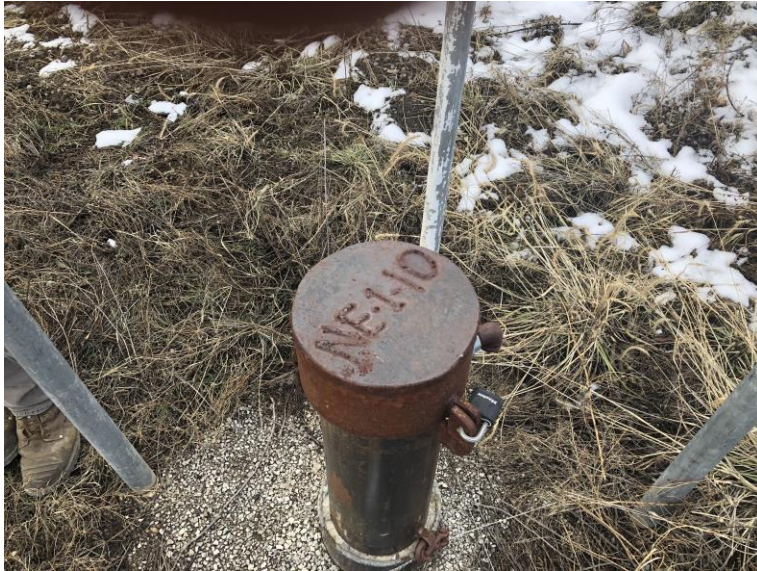
The surface casing of well NE-1-10 was inspected, and no problems were identified. The well was locked shut. No problems were seen with PAW-9 either.

Casing for Well NE-1-10

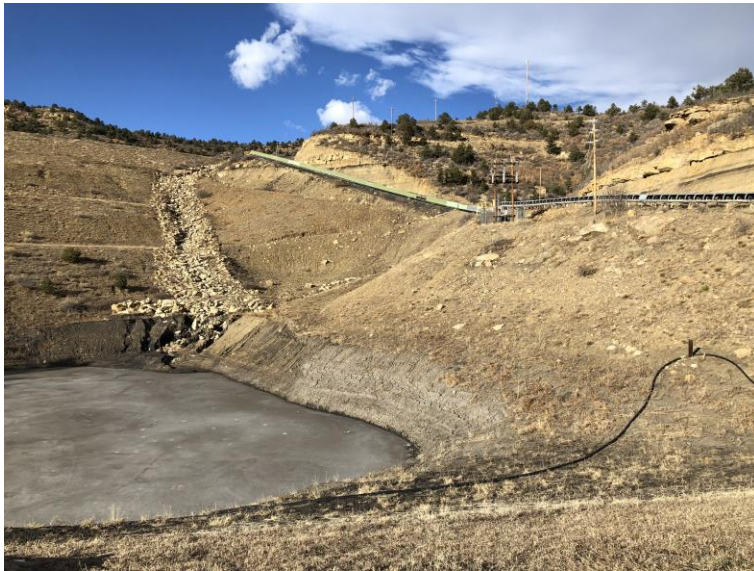
- None of them were discharging, but all held at least a small amount of water/snow/ice.
- The impounded water in Pond 08 was measured to be 20 feet below the emergency spillway.
- The impounded water in Pond 007A was measured to be 3.5 feet below the lowest weep hole of the primary spillway.
- No water was seen flowing through the pipe and pump systems on site. Vince Massarotti indicated that there was ice in the hose between Pond 08 and the other ponds.
- The Pond 001A liner was partially visible, and no tears or other problems were seen.
- No significant issues were seen with the embankments or spillways of any ponds, although the top of the Pond 08 dam lacks vegetation.

Portion of Pond 08 and hillside above it

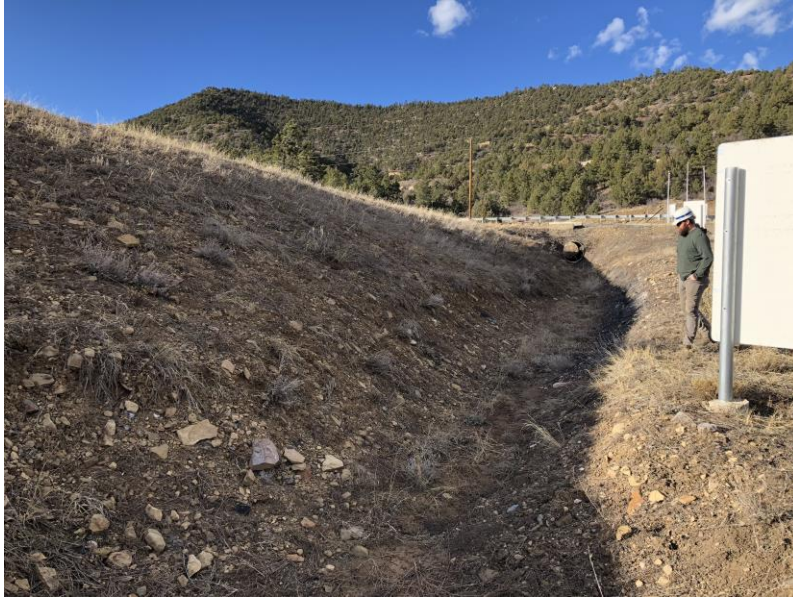
- Ditches D10 and D10A were in good shape.
- Culvert C6 was clear.
- Culvert C41 is clear at the upper end. (The lower end was not inspected.)
- The hillside above Ditch C26 (below the water tanks) appeared stable.

Ditch D10 and portion of SAE

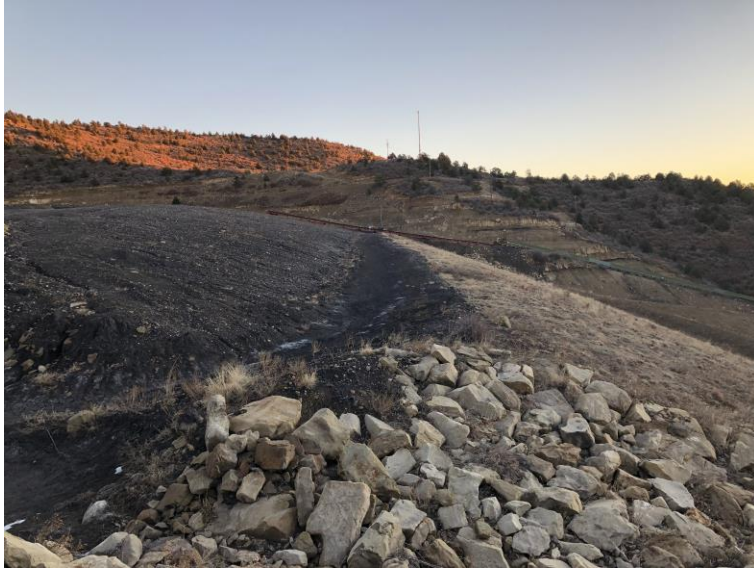
No erosion was seen on the reclaimed portion of the RDA. The ditch between the upper and lower portions of the RDA is in good shape. No ponding, erosion, or other problems with the upper portion of the RDA were seen (although NECC still needs to spread some piles of material). No signs of blowouts below the clear water ditches were seen.

RDA – ditch between reclaimed area and upper area (left side of photo)

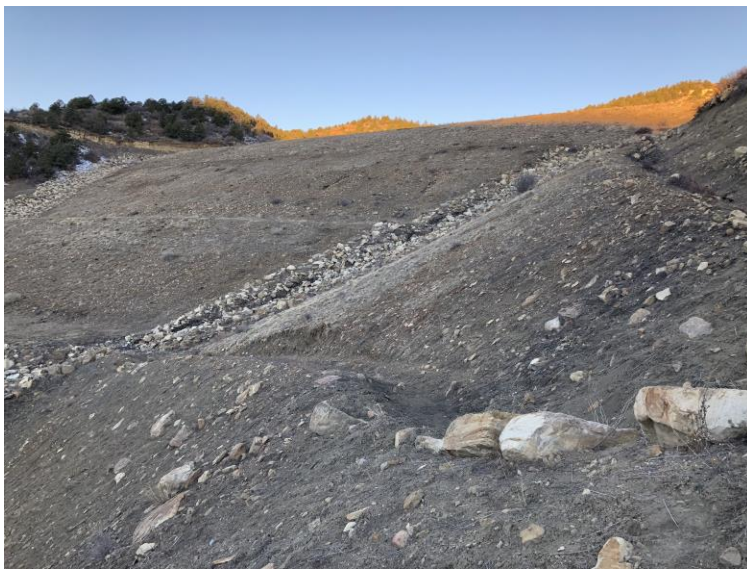
Lower (reclaimed) portion of RDA

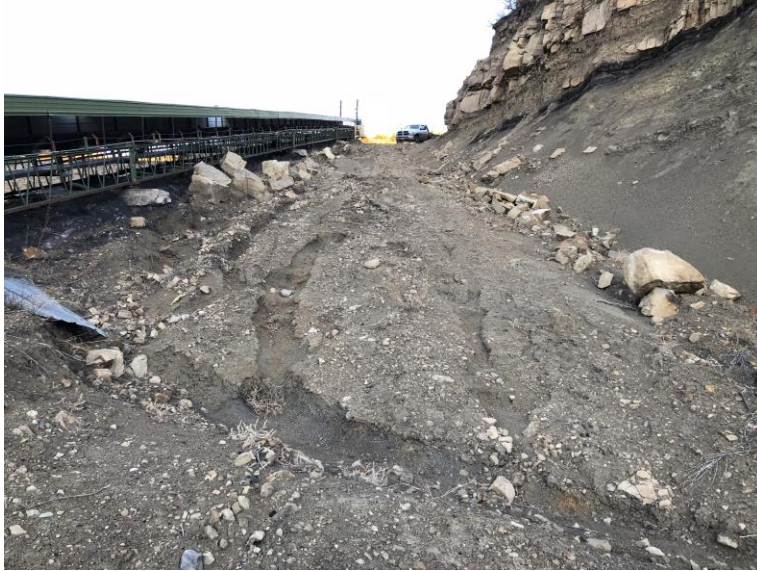
The road beside the conveyor to the RDA requires significant maintenance. There are very large rills in it, and the former sump near the bottom is totally full of sediment.

Eroding road next to conveyor

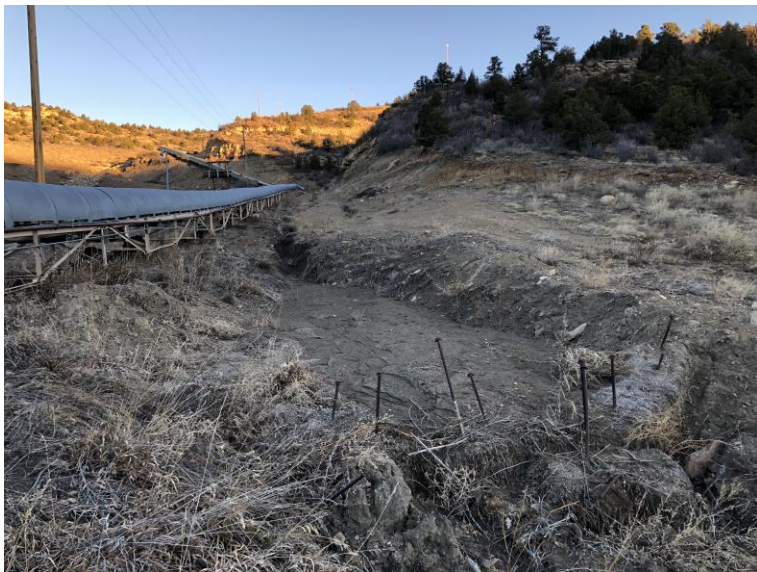
Eroding road next to conveyor with non-functioning sediment trap

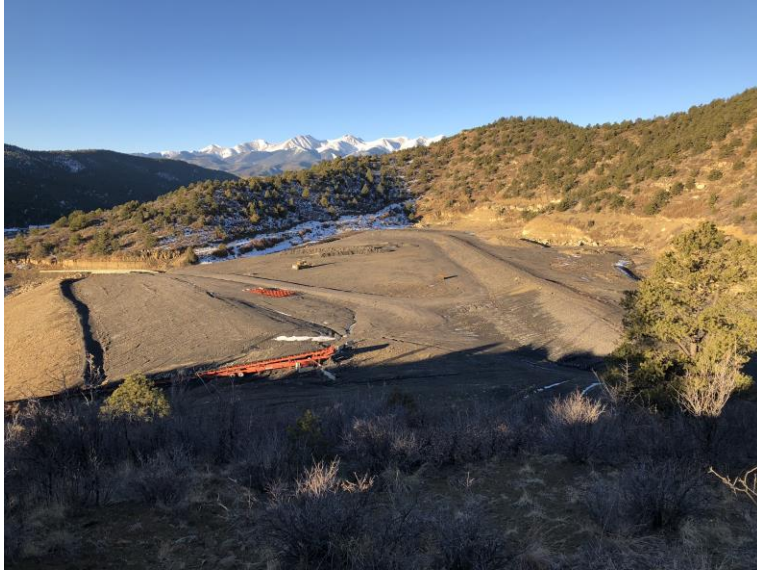
RDA – upper portion

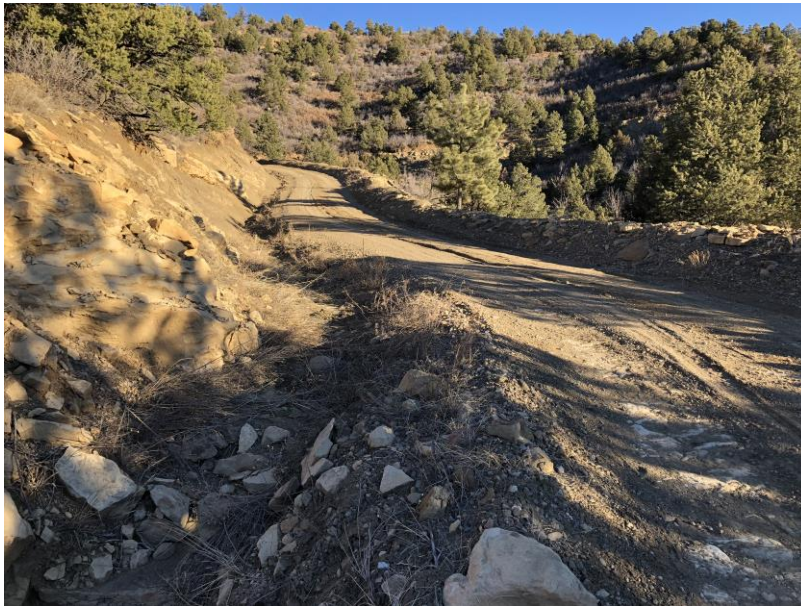
The fill slope below the road to the RDA appears to be alright in terms of limited sediment loading to undisturbed area below; however, it is lacking in vegetation and requires frequent monitoring (as noted previously).

Road to RDA
