MINERALS PROGRAM INSPECTION REPORT
PHONE: (303) 866-3567

MINE NAME: Fork Horn Mesa Subdivision	MINE/PROSPECTING ID#: M-2008-044	MINERAL: Gravel	COUNTY: La Plata
INSPECTION TYPE: Monitoring	INSPECTOR(S): Lucas J. West	INSP. DATE: October 24, 2018	INSP. TIME: 12:01
OPERATOR: Palmer Pipe & Construction, LLC	OPERATOR REPRESENTATIVE: None	TYPE OF OPERATION: 110c - Construction Limited Impact	
REASON FOR INSPECTION: Normal I&E Program	BOND CALCULATION TYPE: Complete Bond	BOND AMOUNT: \$3,523.00	
DATE OF COMPLAINT: NA	POST INSP. CONTACTS: None	JOINT INSP. AGENCY: None	
WEATHER: Clear	INSPECTOR'S SIGNATURE:

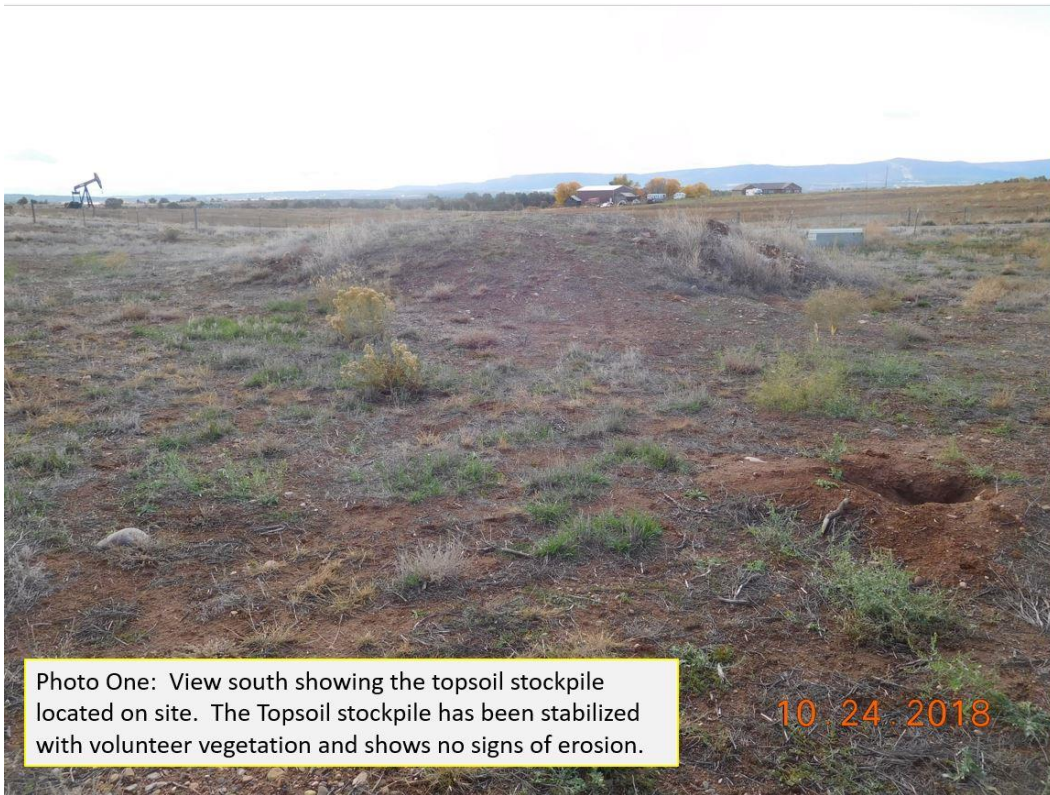
No mining or reclamation equipment was present on site. This area was not the actual site of excavation, the material was generated when an oil and gas well pad was constructed nearby. The material was stockpiled on site to be processed, used and sold. The affected lands consist of a small topsoil stockpile that was scraped back to create a location for the material to be stockpiled. The topsoil stockpile is small, nearly knee high, and appears to be stable. It has been vegetated with volunteer species and shows no signs or significant erosion. The topsoil stockpile can be seen in Photo One.

Photo One: View south showing the topsoil stockpile located on site. The Topsoil stockpile has been stabilized with volunteer vegetation and shows no signs of erosion.

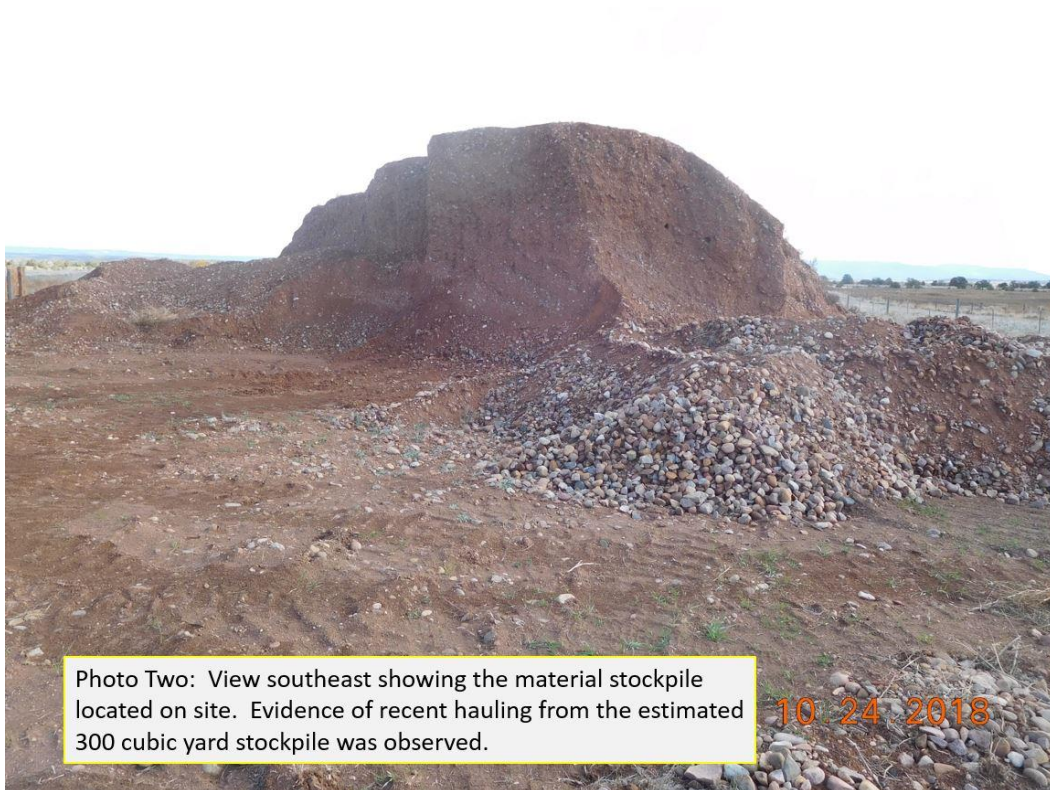
The material stockpile is one consolidated stockpile estimated at approximately 300 cubic yards. The stockpile appears to be stable and in good condition. No signs of settling, slumping or erosion was observed. Some of the faces of the pile are near vertical as left from hauling activity. Evidence of recent hauling activity was observed. Photo Two shows the stockpiled material. All areas around the stockpiles are well vegetated with volunteer species. There is however, a large population of Russian thistle within the permitted area. This is not considered a problem at this time but it should be watched and potentially treated in the spring.

Photo Two: View southeast showing the material stockpile located on site. Evidence of recent hauling from the estimated 300 cubic yard stockpile was observed.
