MINERALS PROGRAM INSPECTION REPORT
PHONE: (303) 866-3567

MINE NAME: Forest Lakes Pit #1	MINE/PROSPECTING ID#: M-1981-158	MINERAL: Sand and gravel	COUNTY: La Plata
INSPECTION TYPE: Monitoring	INSPECTOR(S): Lucas J. West	INSP. DATE: October 24, 2018	INSP. TIME: 12:42
OPERATOR: Forest Lakes Metro District	OPERATOR REPRESENTATIVE: None	TYPE OF OPERATION: 110c - Construction Limited Impact	
REASON FOR INSPECTION: Normal I&E Program	BOND CALCULATION TYPE: Complete Bond	BOND AMOUNT: \$12,623.00	
DATE OF COMPLAINT: NA	POST INSP. CONTACTS: None	JOINT INSP. AGENCY: None	
WEATHER: Clear	INSPECTOR'S SIGNATURE:

SIGNATURE DATE: December 21, 2018

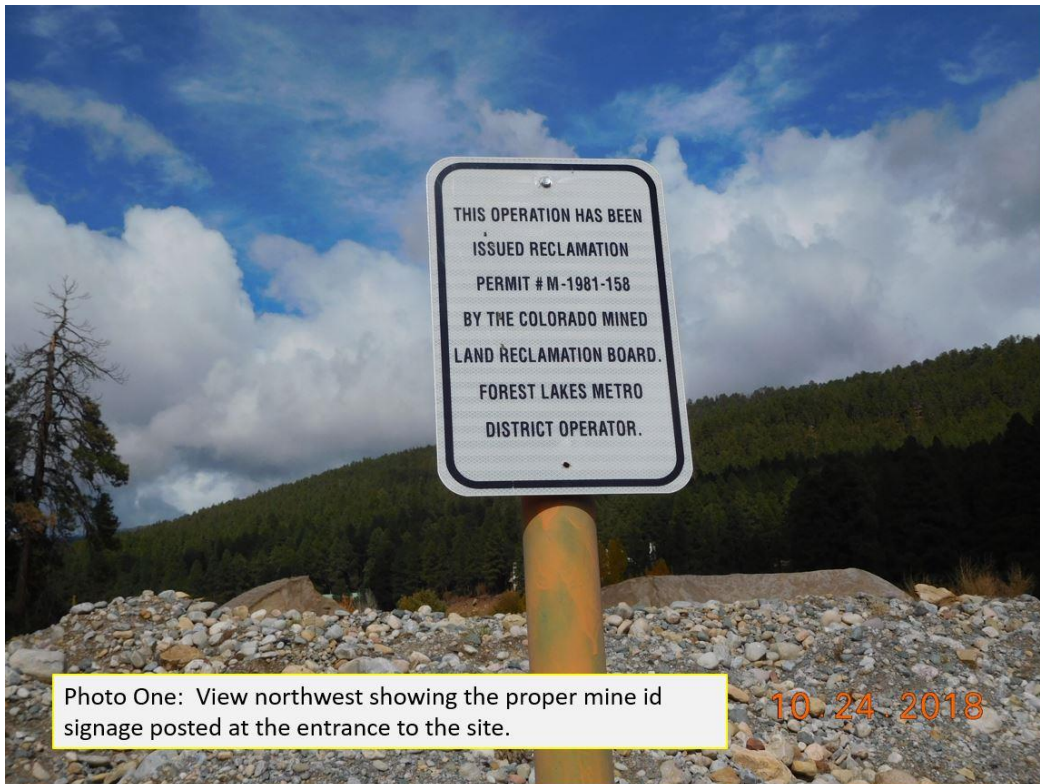
The proper mine identification signage was posted at the entrance to the site and can be seen in Photo One. The permit boundaries were also clearly marked with a series of T-Posts and fence lines. The site was not active at the time of the inspection, but stockpiles of excavated materials were observed on site. The pit area serves only the Metro District for road base, and bedding materials for new utility lines within the district. Operations at the pit consist of periodic crushing and stockpiling of materials for prolonged use on projects within the district. The stockpile area consists of various stockpiles of various sized material from fill dirt, to road base and large cobble. All stockpiles observed in the stockpile area appear to be stable and in good condition. None of the stockpiles or surrounding area show signs of settling, slumping or erosion. Examples of the stockpiles located in the area can be seen in Photos Two and Three.

Photo One: View northwest showing the proper mine id signage posted at the entrance to the site.

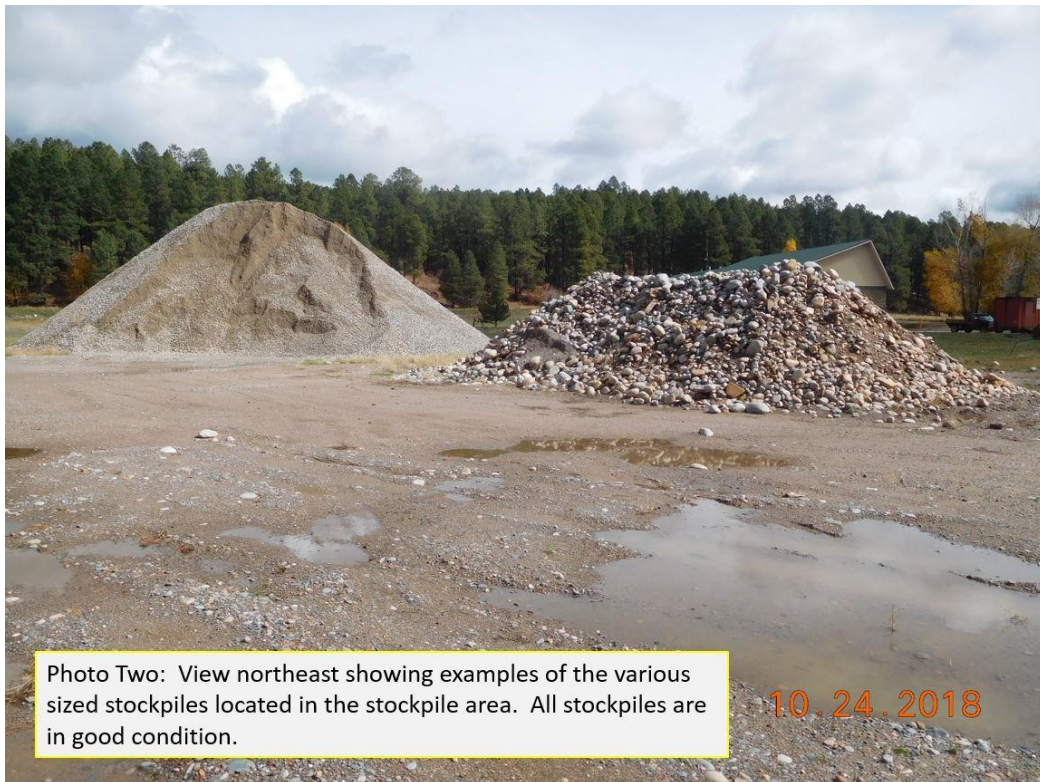
Photo Two: View northeast showing examples of the various sized stockpiles located in the stockpile area. All stockpiles are in good condition.

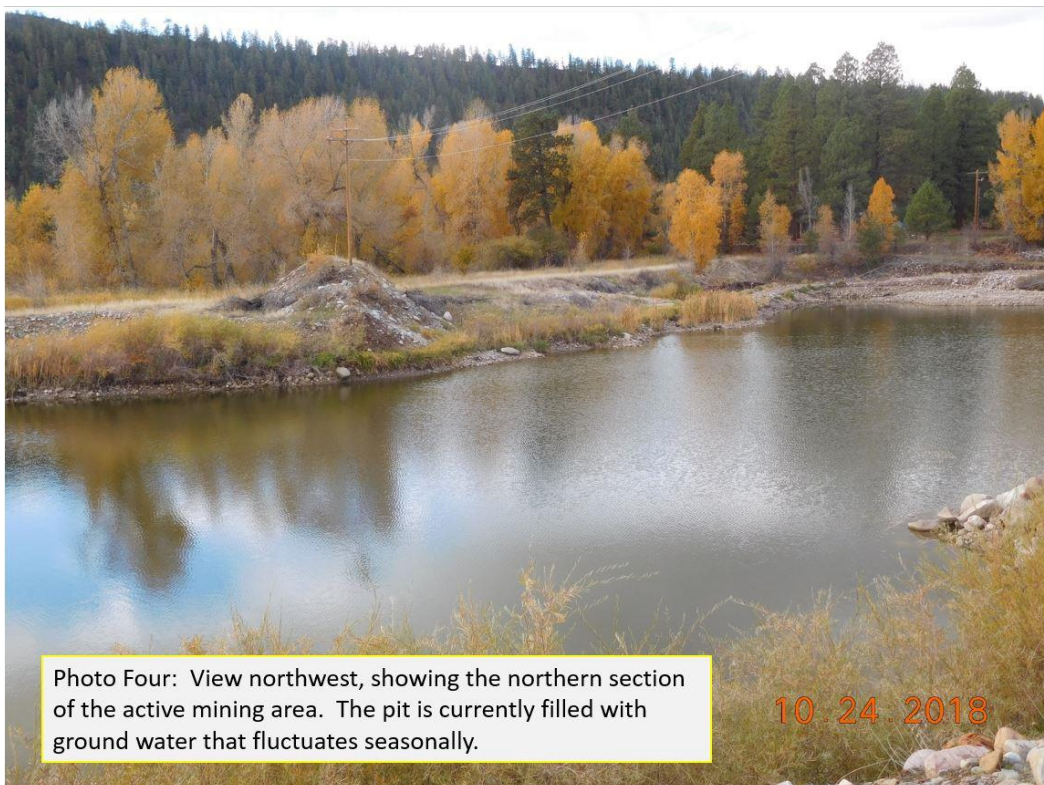
The active mining area is confined to the pit on the western end of the permit area. All active mining faces appear to be stable, in good condition. The pit can be seen in Photos Four and Five. The site currently employs contemporaneous reclamation in filling of the pit from the south as excavation takes place on the Northern end of the pit. The pit is currently filled with water, and is subject to seasonal filling as explained by the operator. The appropriate water augmentation plan is in place to account for the exposed water.

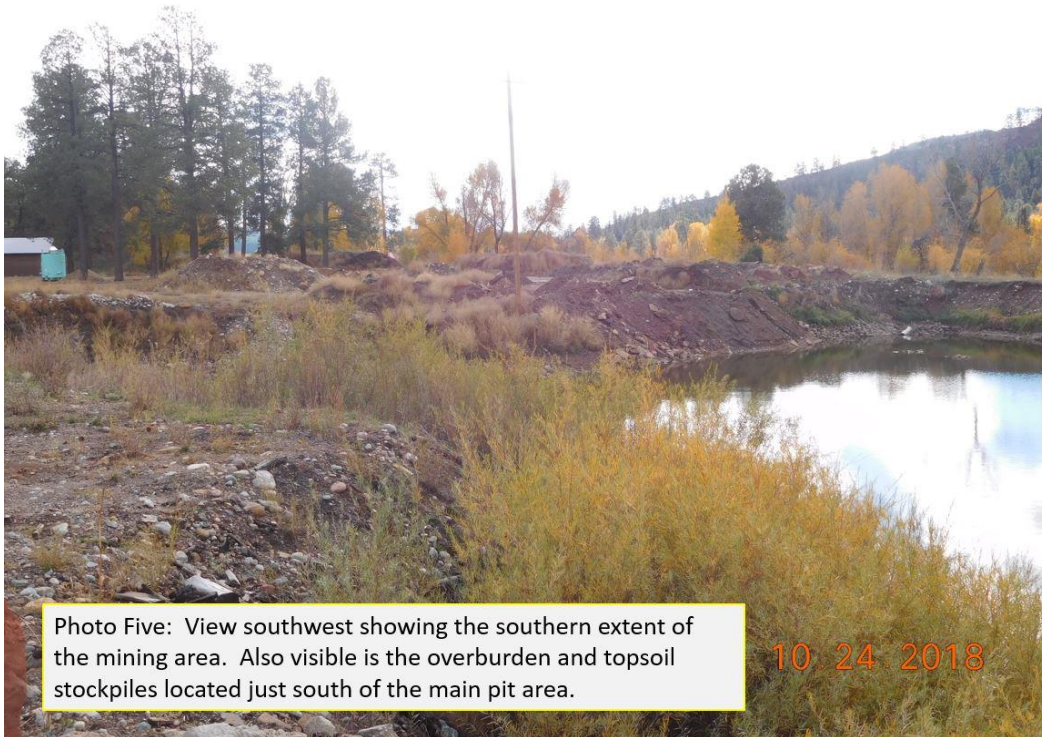
Photo Five: View southwest showing the southern extent of the mining area. Also visible is the overburden and topsoil stockpiles located just south of the main pit area.
