MINERALS PROGRAM INSPECTION REPORT**PHONE: (303) 866-3567**

MINE NAME: Luke the Duke Gravel Pit	MINE/PROSPECTING ID#: M-2013-036	MINERAL: Gravel	COUNTY: La Plata
INSPECTION TYPE: Monitoring	INSPECTOR(S): Lucas J. West	INSP. DATE: October 24, 2018	INSP. TIME: 15:56
OPERATOR: Luke The Duke, LLC	OPERATOR REPRESENTATIVE: John Avery	TYPE OF OPERATION: 110c - Construction Limited Impact	
REASON FOR INSPECTION: Normal I&E Program	BOND CALCULATION TYPE: Complete Bond	BOND AMOUNT: \$14,631.48	
DATE OF COMPLAINT: NA	POST INSP. CONTACTS: None	JOINT INSP. AGENCY: None	
WEATHER: Clear	INSPECTOR'S SIGNATURE:

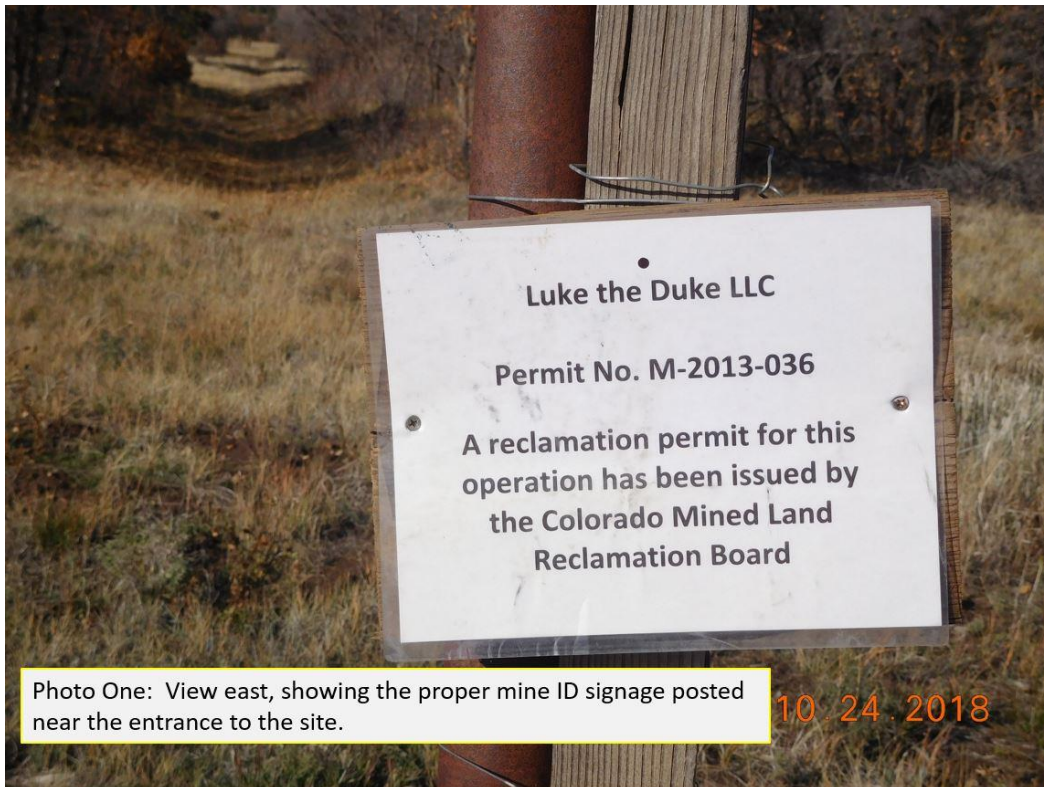
The proper mine identification signage is posted near the entrance to the site and can be seen in Photo One. The permit boundaries are clearly marked with agricultural tape hot fence stretched around the permit area. This permit was issued as a result of enforcement action in 2014. The permit issuance documents indicate that it is a reclamation only permit and no further excavation of the area can take place. The Operator is however allowed to remove any materials that have already been stockpiled on site. Consequently the condition of the site is similar to that when the original permit was issued. No further excavation of material has taken place in accordance with the Board Order and no reclamation activities have been conducted yet. The areas that were excavated were concentrated to two main areas that will be reclaimed to ponds. These areas can be seen in Photos Two and Three. The two ponds have near vertical walls that are on average approximately 10 feet tall. The walls all appear to be stable and in good condition and show no signs of settling, slumping or erosion. Several stockpiles are located on site including topsoil, overburden and excavated materials stockpiles. Examples of these stockpiles can be seen in Photos Four and Five. The stockpiles all appear to be stable and in good condition and free from erosion or sedimentation.

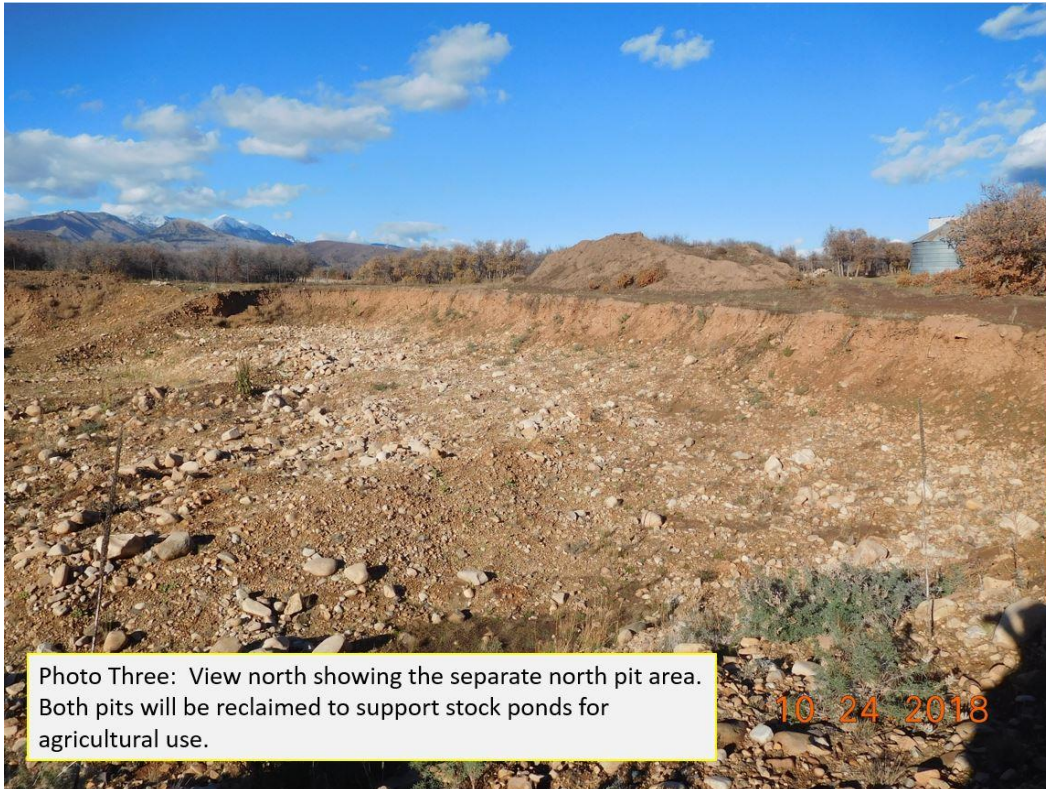
Photo Three: View north showing the separate north pit area. Both pits will be reclaimed to support stock ponds for agricultural use.

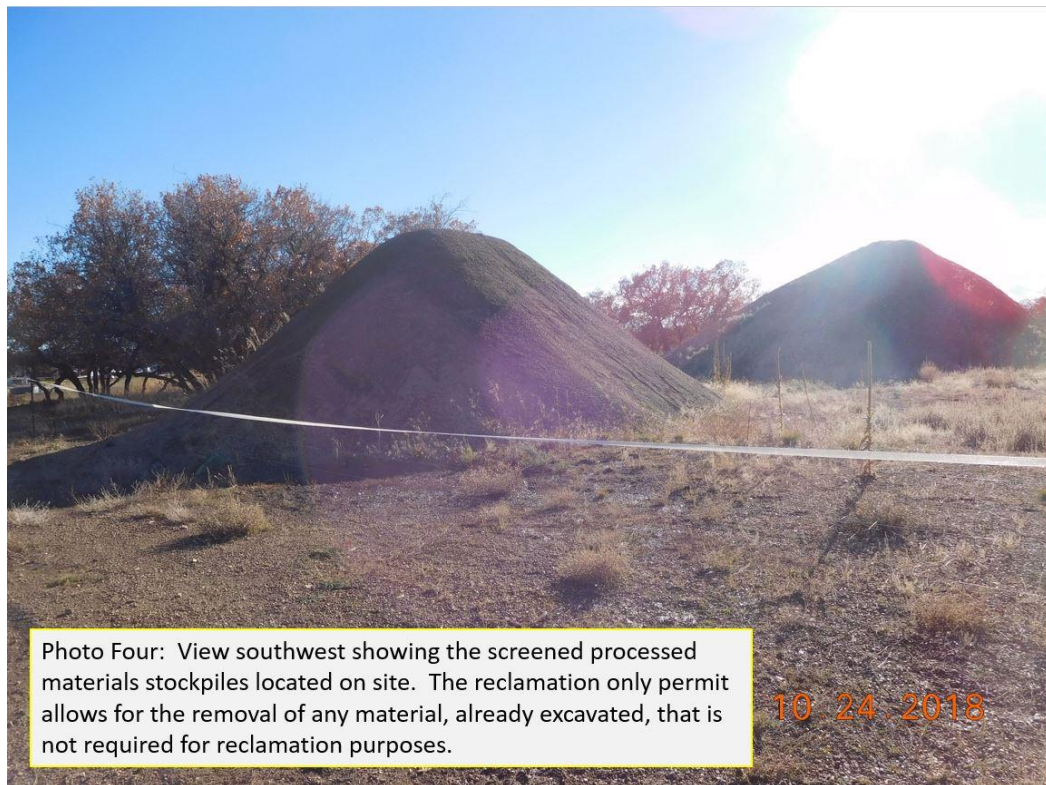
Photo Four: View southwest showing the screened processed materials stockpiles located on site. The reclamation only permit allows for the removal of any material, already excavated, that is not required for reclamation purposes.

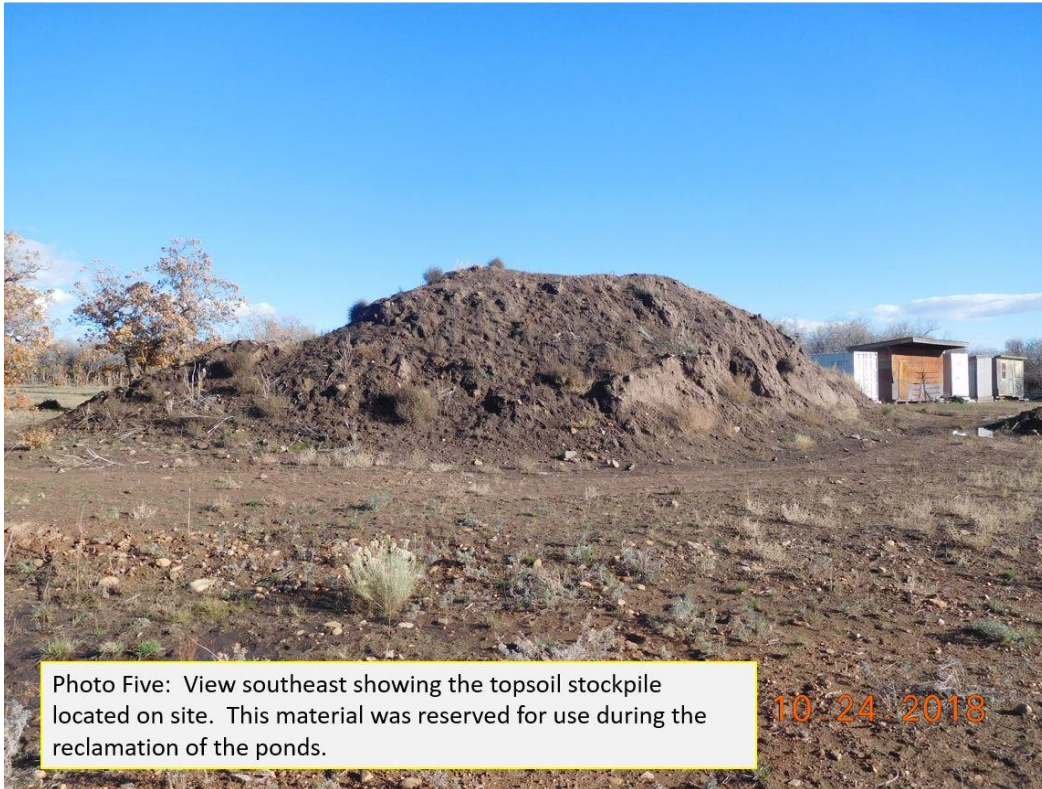
Photo Five: View southeast showing the topsoil stockpile located on site. This material was reserved for use during the reclamation of the ponds.
