**MINERALS PROGRAM INSPECTION REPORT**  
**PHONE: (303) 866-3567**

| <b>MINE NAME:</b><br>Cresson Project | <b>MINE/PROSPECTING ID#:</b><br>M-1980-244 | <b>MINERAL:</b><br>Gold | <b>COUNTY:</b><br>Teller |
| <b>INSPECTION TYPE:</b><br>Monitoring | <b>INSPECTOR(S):</b><br>Timothy A. Cazier | <b>INSP. DATE:</b><br>September 27, 2018 | <b>INSP. TIME:</b><br>09:45 |
| <b>OPERATOR:</b><br>Cripple Creek & Victor Gold Mining Company | <b>OPERATOR REPRESENTATIVE:</b><br>Justin Bills, Katie Blake | <b>TYPE OF OPERATION:</b><br>112d-3 - Designated Mining Operation | |

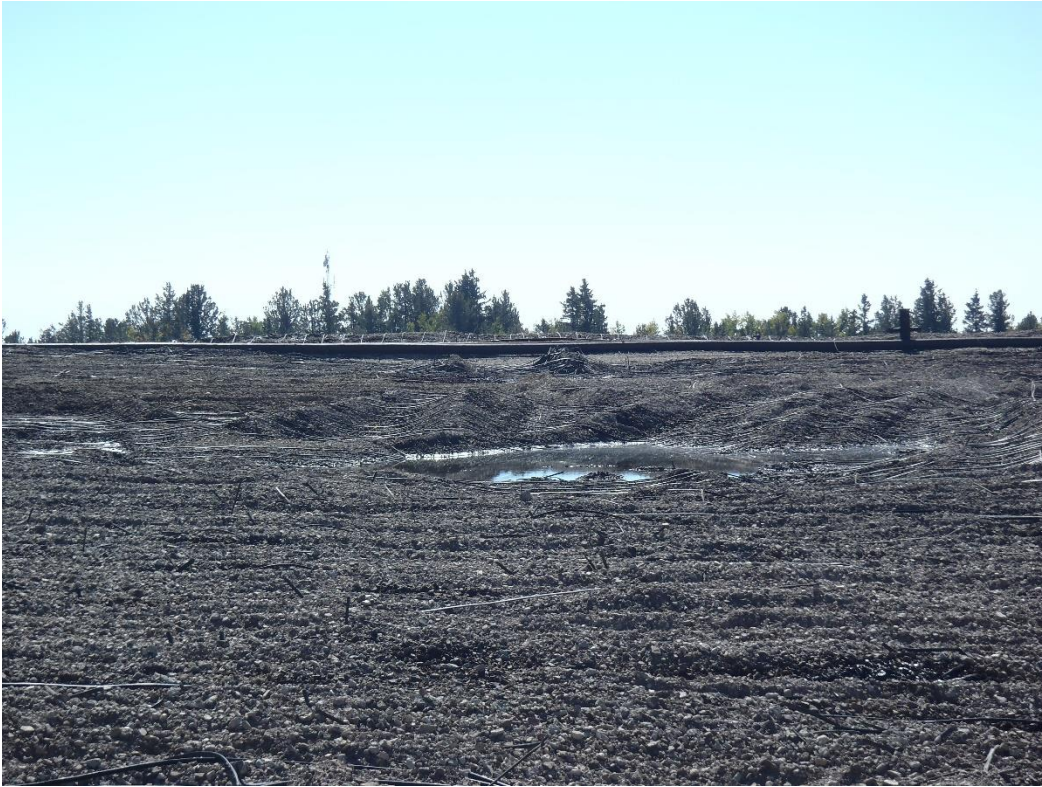
Arequa Gulch Valley Leach Facility (VLF1): Messrs. Laurin Colby and Dylan Noble accompanied the DRMS, Ms. Blake and Mr. Bills on the VLF1 tour. Active leaching areas were observed, primarily elevation 10,200 and 10,400. **The amount of ponded solution observed (see Photos 1 -2) on the surface was significantly less than observed during the July inspection, but still exceeded the three foot by three foot limit allowed by the approved wildlife protection plan and cited as a Problem.** Site personnel were contacted by Mr. Colby during the inspection to begin remedying the situation. It took some time to correct this problem, but it appeared to be resolved by the time the DRMS's October inspection. The problem with solution ponding has continued to be an intermittent problem. The **DRMS continues to emphasize the importance of adhering to the three foot by three foot limit for ponded solution as directed in the approved wildlife protection plan.** As of the writing of this inspection report, the ponded solution problem observed during the September inspection is considered abated.

Photo 1. Ponded solution on VLF1 (10,400 level).

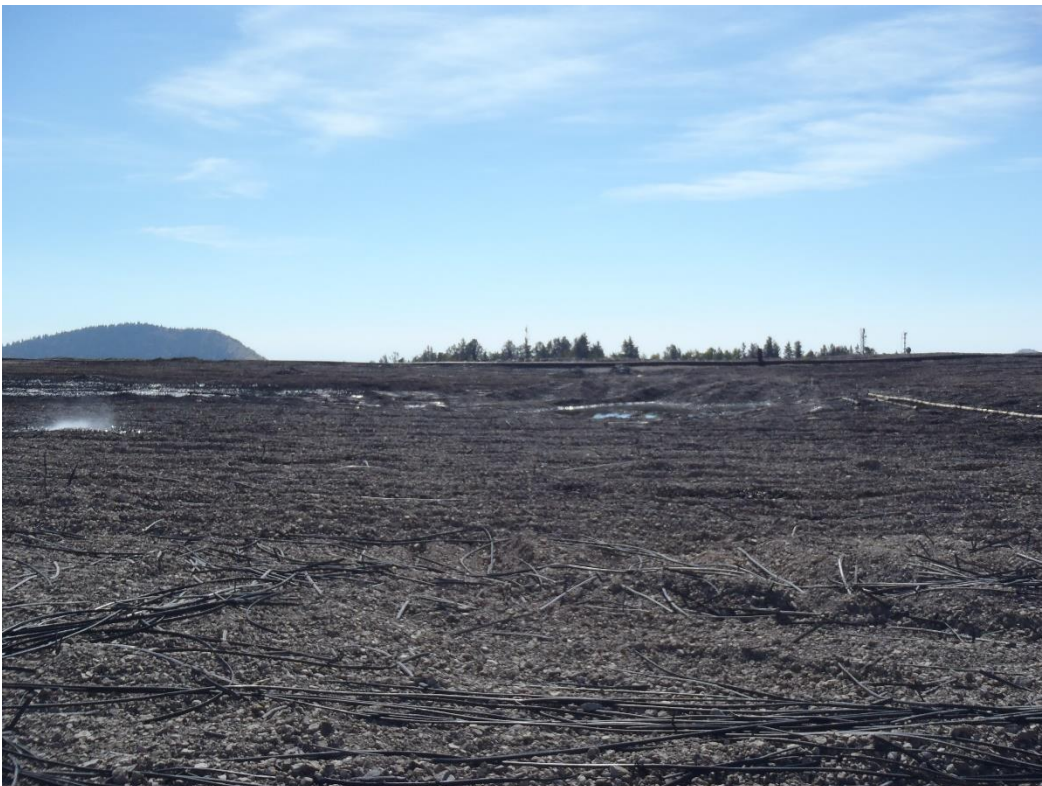
Photo 2. Ponded solution on VLF1 (10,400 level).

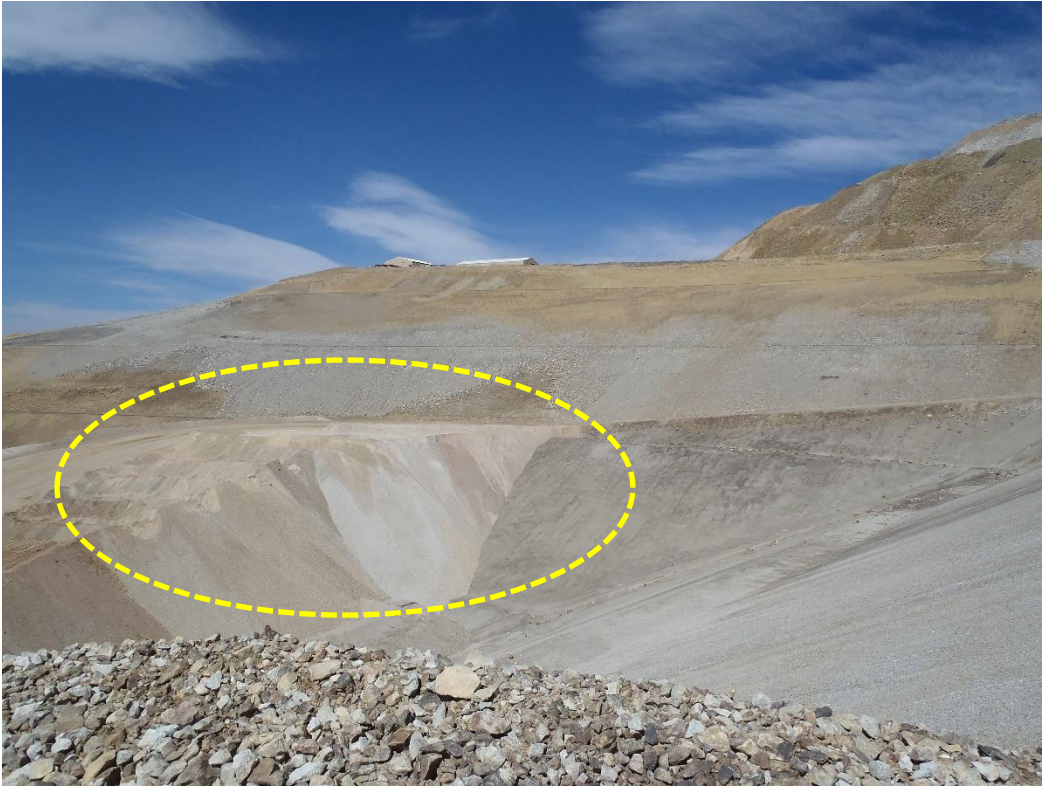
Squaw Gulch Valley Leach Facility (VLF 2 ) & Liner Repair Area: Messrs. Colby and Bills accompanied the DRMS to the east side of VLF2 where the new access ramp (see **Photo 3**) to the 9950 elevation was identified by CC&V has not having been constructed in accordance with the revised ore stacking plan approved by the DRMS with TR-103. CC&V explained their investigation to assess liner damage. The DRMS is satisfied with their investigative approach.

Photo 3. New access ramp to the VLF2 9950 elevation.

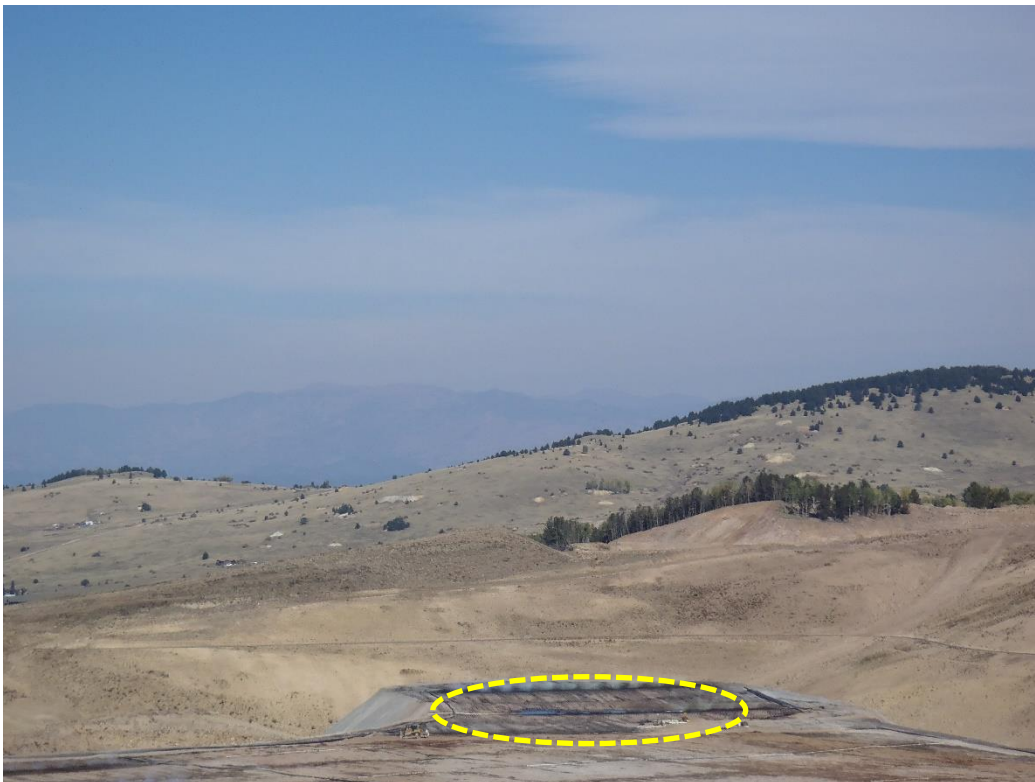
Messrs. Colby and Noble accompanied the DRMS, Ms. Blake and Mr. Bills on the VLF2 tour. Active leaching areas were also observed on VLF 2. Some ponded solution was observed using binoculars on the northwest side of the pad at the 9850 elevation (see **Photo 4**). **The observed ponded solution on VLF2 was cited as a problem.** The problem was resolved by the DRMS's October inspection.

Photo 4. Ponded solution observed using binoculars on northwest side of VLF2 at the 9850 elevation.

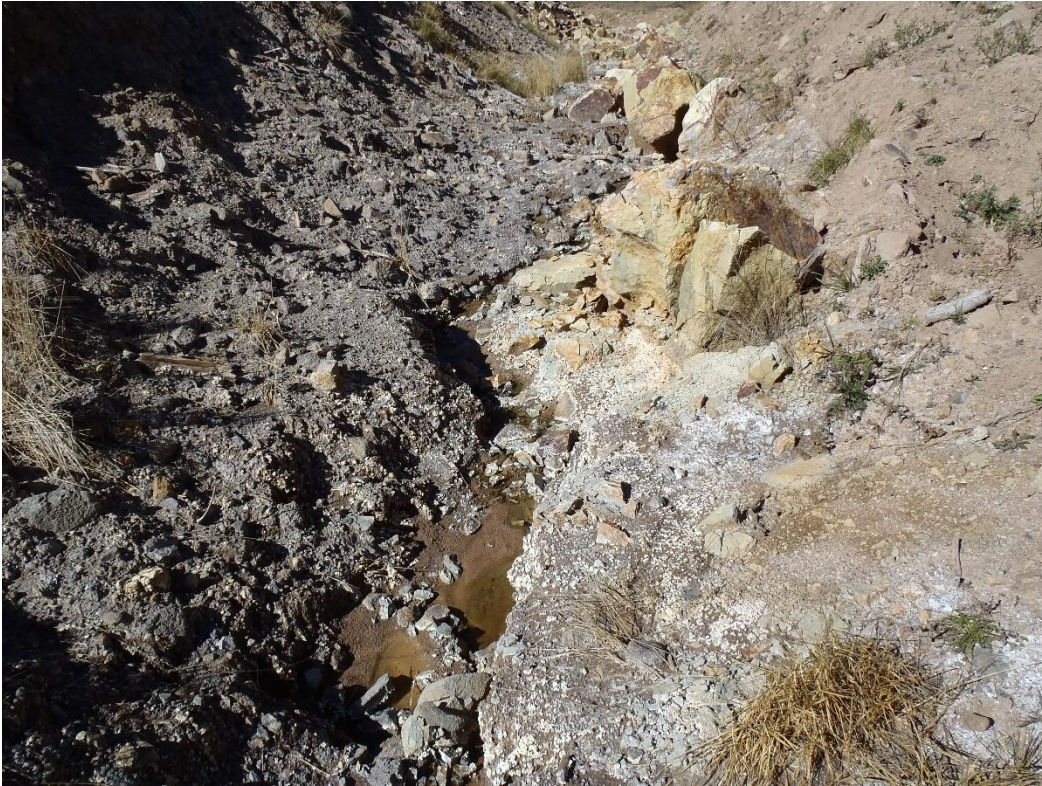
East Cresson Overburden Storage Area (ECOSA) Seep: The DRMS was accompanied by CC&V personnel to ECOSA seep area. The seepage area appeared wet with near zero flow (see **Photo 5**) was observed.

Photo 5. ECOSA seep area appeared wet with near zero flow.

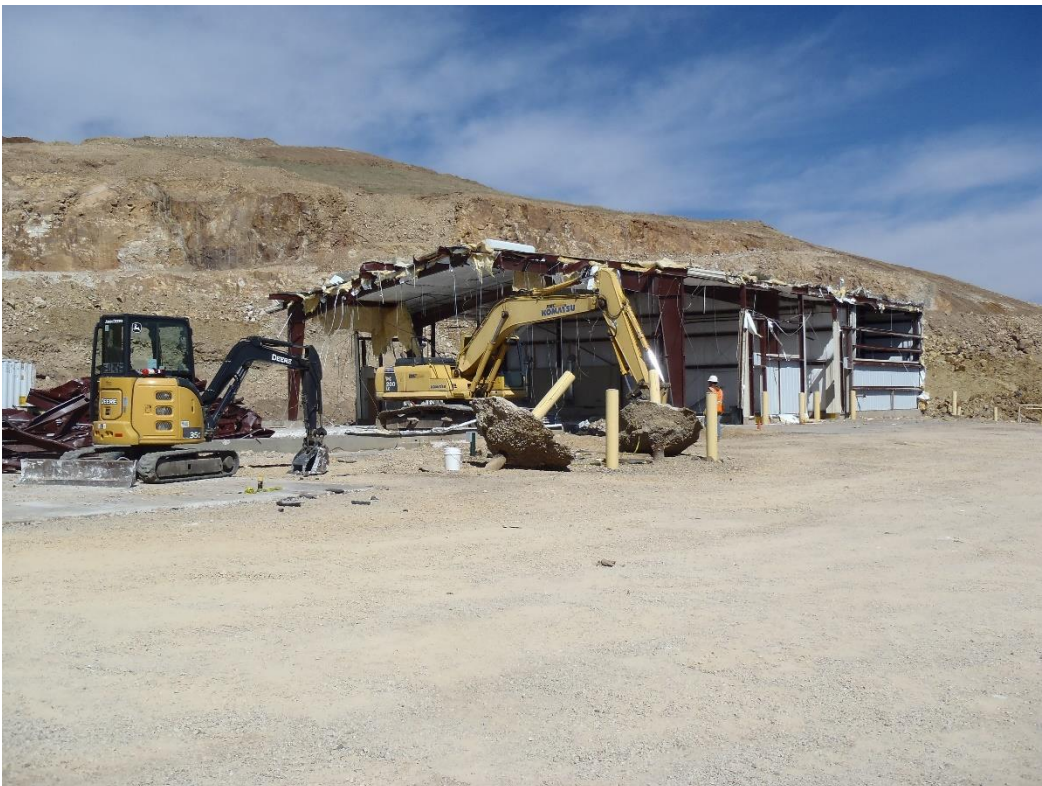
South Cresson Pit area: The purpose of the visit to the South Cresson pit was to help the DRMS clarify whether or not a revision is necessary with respect to the planned extent of the fully developed South Cresson pit. CC&V was in the process of demolishing the Ajax Building (see **Photo 6**), previously used to store drill core. The pit limit was staked with survey lathe (see **Photo 7**). Subsequent to the inspection, the DRMS determined the marked extent of the South Cresson pit does NOT require a revision to the mine reclamation permit.

Photo 6. Demolishing the Ajax Building.

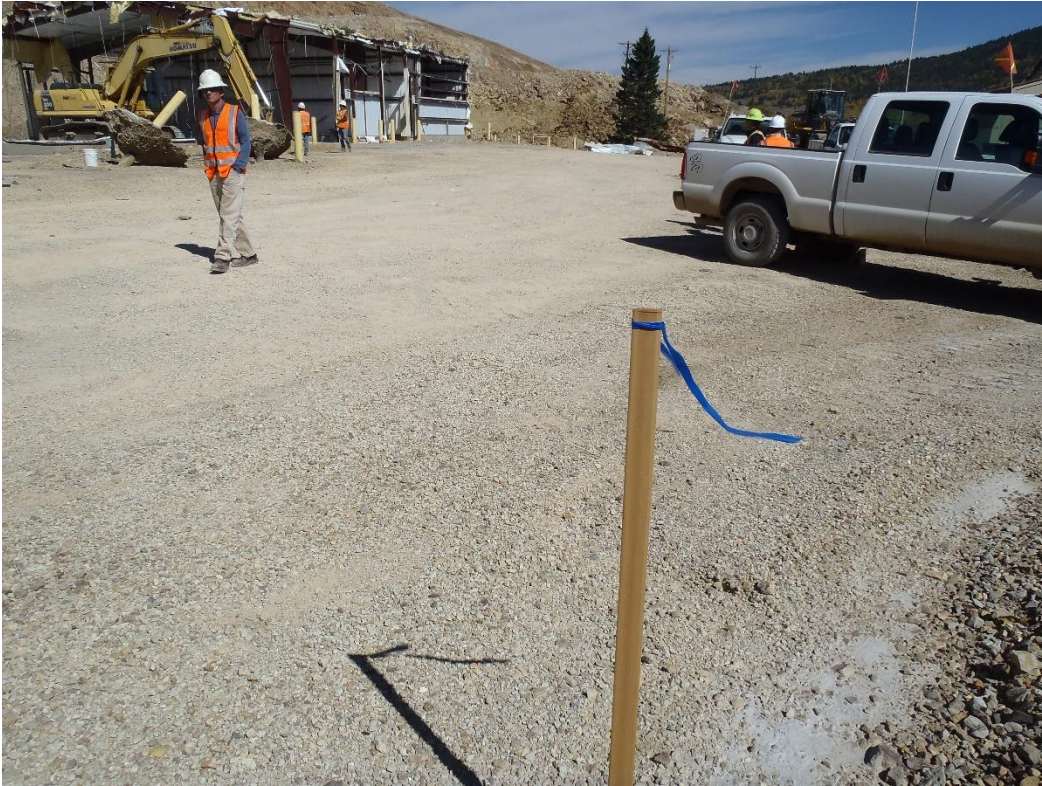
Photo 7. South Cresson pit limit staked with survey lathe.

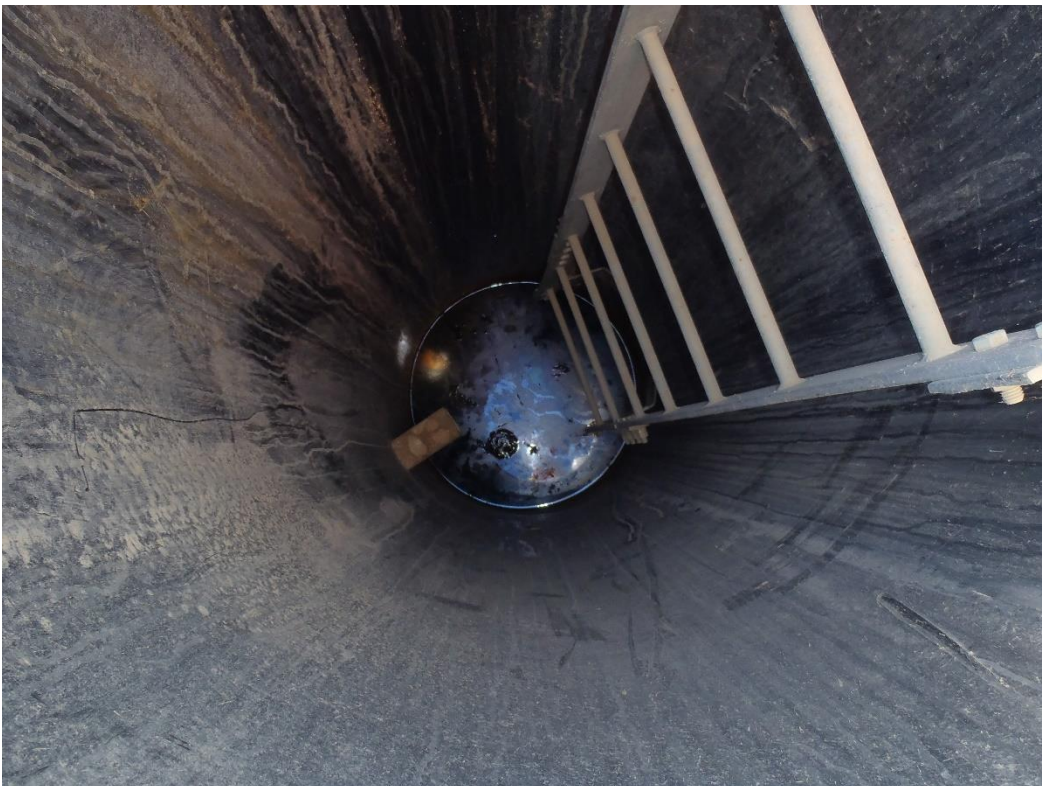
| LDS Sump ID | Water Observed | Other Observations |
|---|---|---|
| LDS 1 | Yes (see <b>Photo 8</b> ) <sup>‡</sup> | Needs a raise or barrier to prevent debris and meteoric water inflow (see <b>Photo 9</b> ) |

Photo 8. Water observed in VLF1 LDS1 sump.

| LDS Sump ID | Water Observed | Other Observations |
|---|---|---|
| <a href="#">‡ LDS sumps must be sampled and characterized when they contain water. Water should be removed afterwards so it can be determined if water continues to enter the sump.</a> | | |

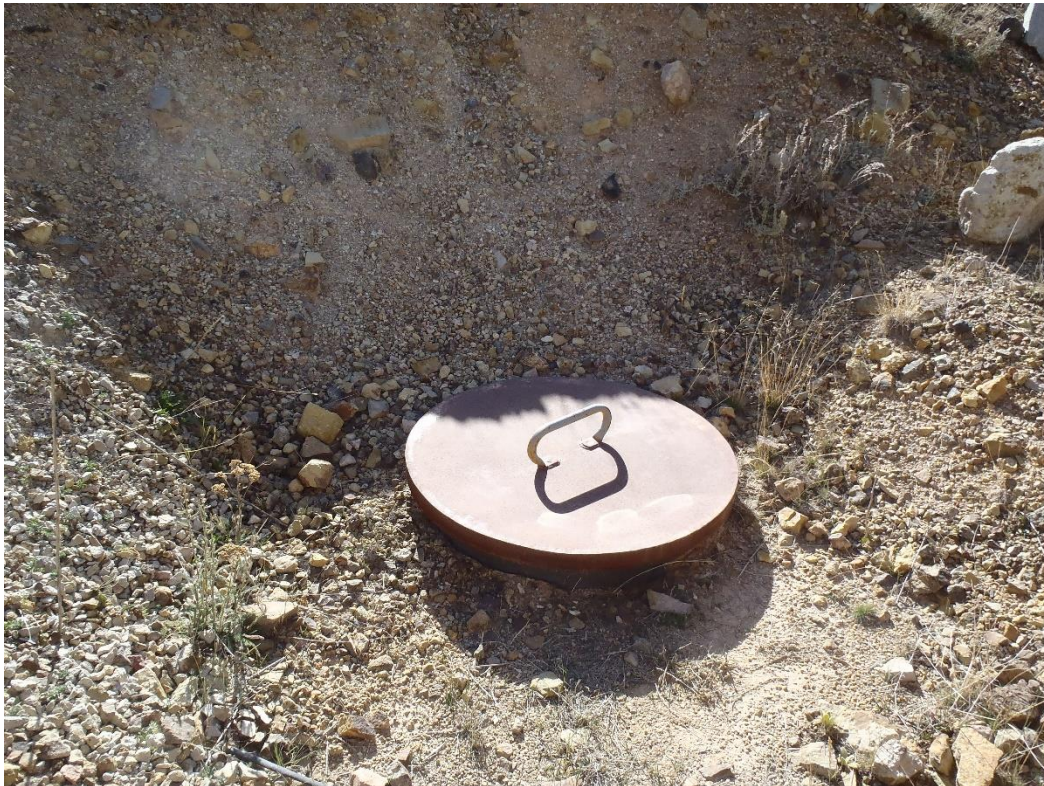
Photo 9. VLF1 LDS1 low profile requires a raise or barrier to prevent debris and meteoric water inflow.

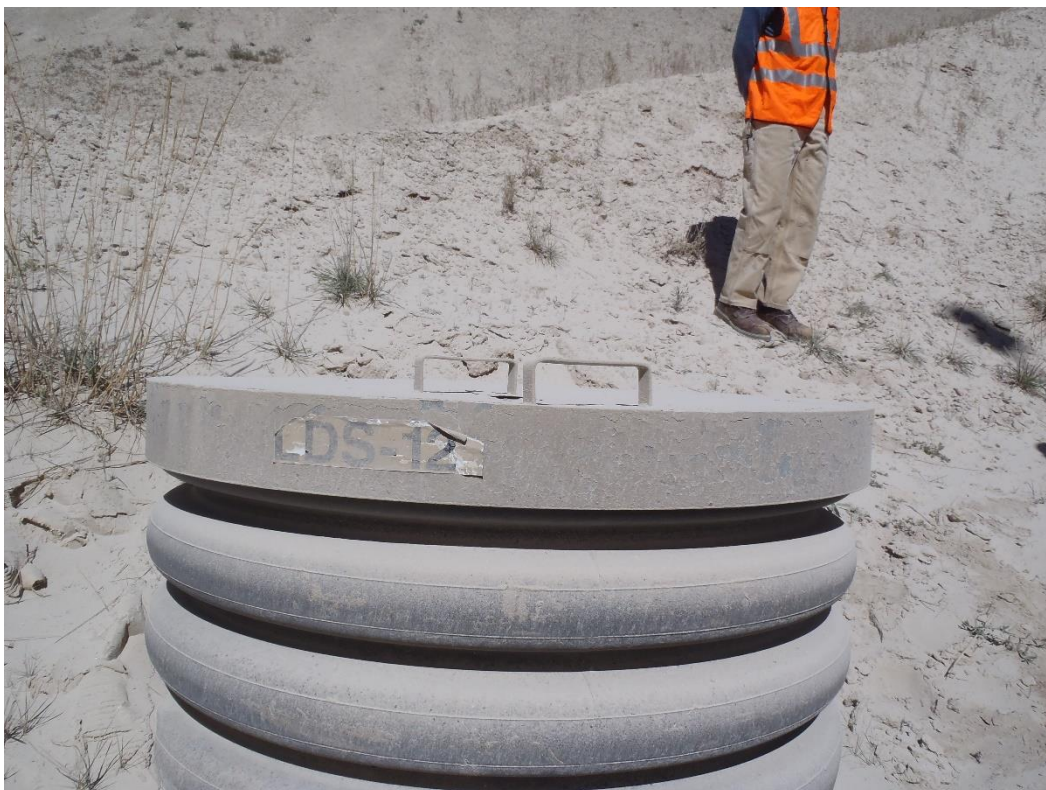
| LDS Sump ID | Water Observed | Other Observations |
|---|---|---|
| LDS 12 | Dry | Ground at surface is well below the top of sump (see <b>Photo 10</b> ). |

Photo 10. VLF1 LDS12 with adequate profile to prevent debris and meteoric water inflow.

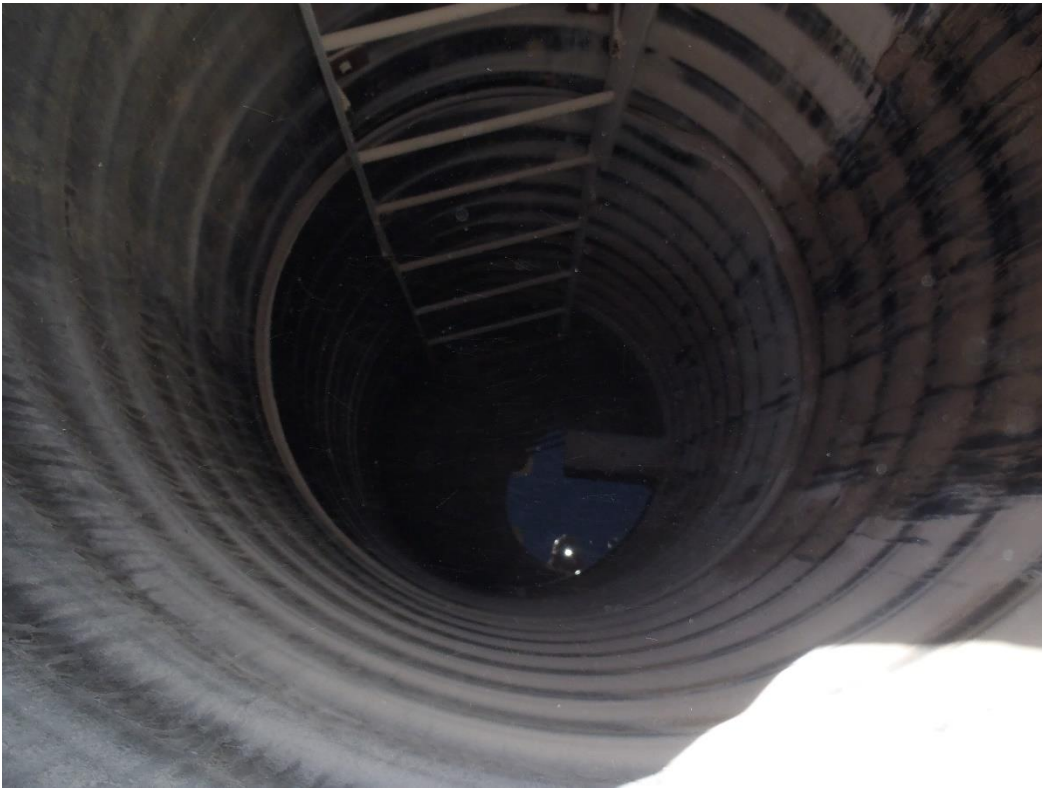
| LDS Sump ID | Water Observed | Other Observations |
|---|---|---|
| LDS 13 | Yes (see <b>Photo 11</b> ) <sup>‡</sup> | Needs a raise or barrier to prevent debris and meteoric water inflow (see <b>Photo 12</b> ) |

Photo 11. Water observed in VLF1 LDS13 sump.

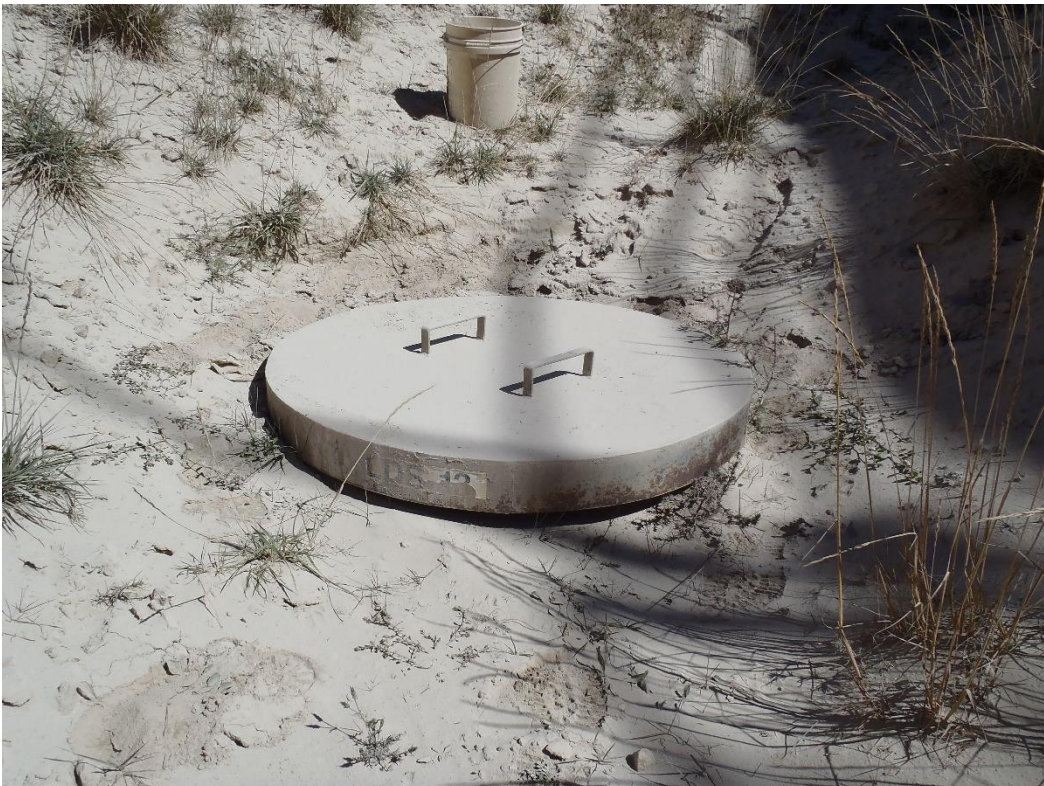
Photo 12. VLF1 LDS13 low profile requires a raise or barrier to prevent debris and meteoric water inflow.

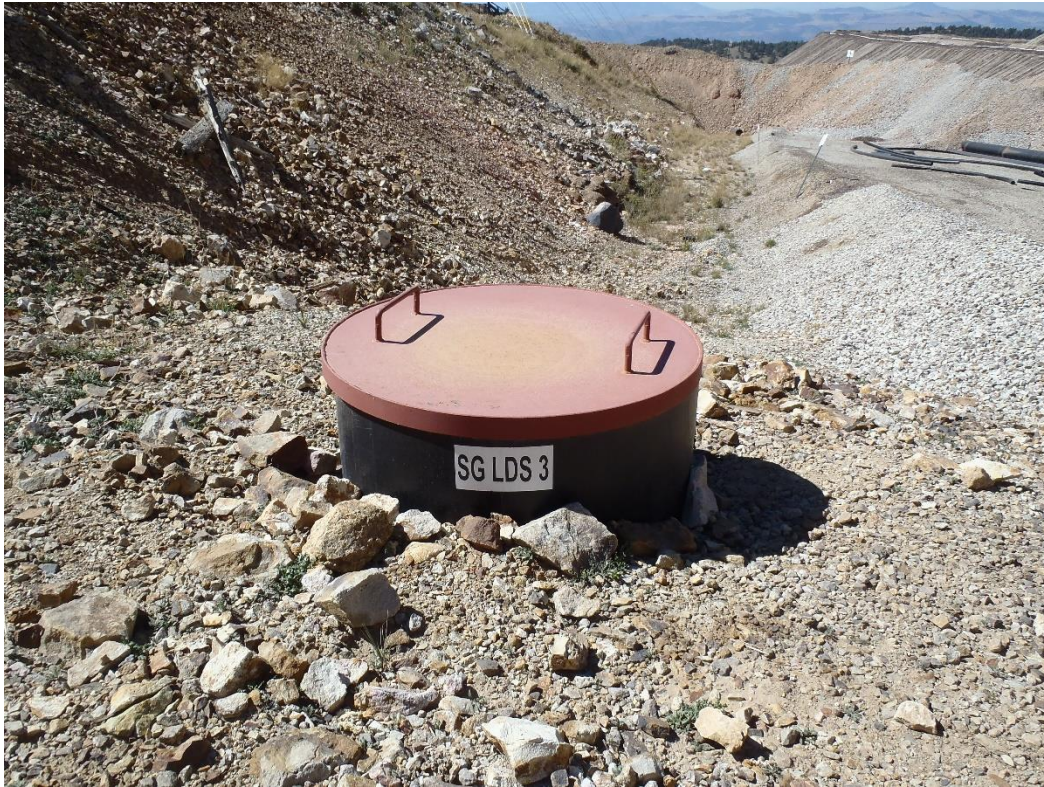
| LDS Sump ID | Water Observed | Other Observations |
|---|---|---|
| SG LDS 3 | Dry | Ground at surface is well below the top of sump (see <b>Photo 13</b> ). |

Photo 13. VLF2 LDS3 with adequate profile to prevent debris and meteoric water inflow.
