**COLORADO**Division of Reclamation,  
Mining and Safety

**MINERALS PROGRAM INSPECTION REPORT****PHONE: (303) 866-3567**

<b>MINE NAME:</b> Tierra Piedra Gravel Pit	<b>MINE/PROSPECTING ID#:</b> M-2009-081	<b>MINERAL:</b> Sand and gravel	<b>COUNTY:</b> Archuleta
<b>INSPECTION TYPE:</b> Monitoring	<b>INSPECTOR(S):</b> Lucas J. West	<b>INSP. DATE:</b> October 25, 2018	<b>INSP. TIME:</b> 12:15
<b>OPERATOR:</b> Tierra Piedra Ranch LLC	<b>OPERATOR REPRESENTATIVE:</b> None	<b>TYPE OF OPERATION:</b> 110c - Construction Limited Impact	
<b>REASON FOR INSPECTION:</b> Normal I&E Program	<b>BOND CALCULATION TYPE:</b> Complete Bond	<b>BOND AMOUNT:</b> \$5,952.00	
<b>DATE OF COMPLAINT:</b> NA	<b>POST INSP. CONTACTS:</b> None	<b>JOINT INSP. AGENCY:</b> None	
<b>WEATHER:</b> Clear	<b>INSPECTOR'S SIGNATURE:</b>

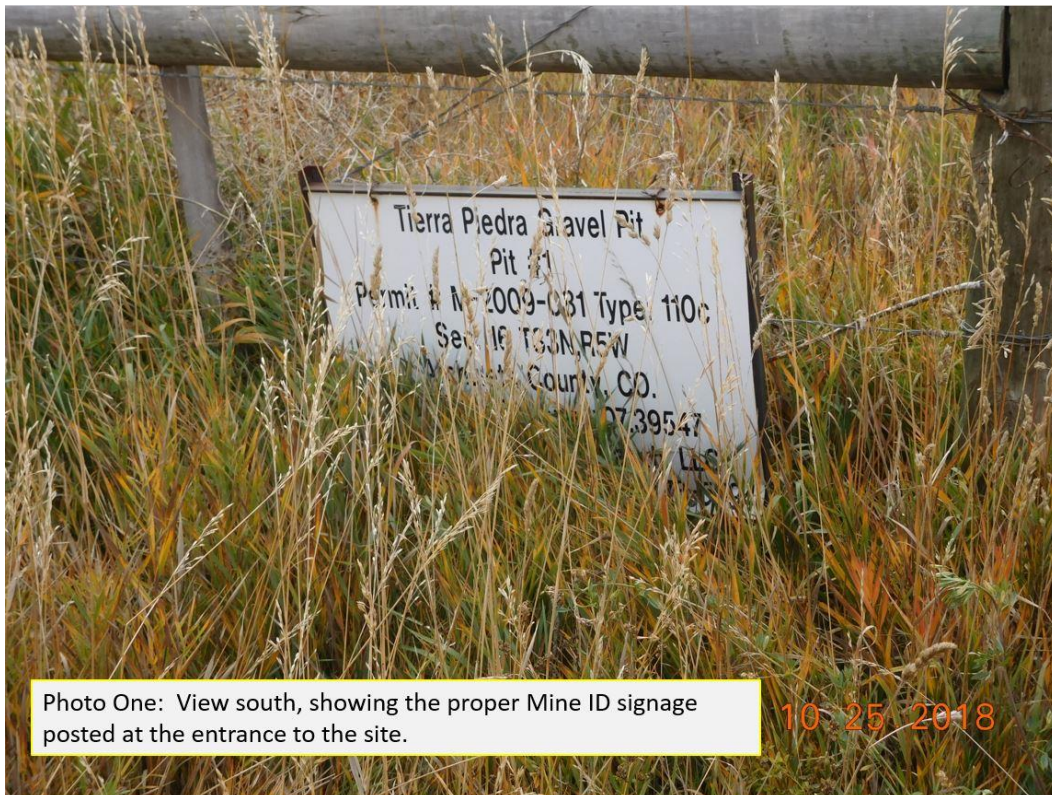
The proper mine identification signage was posted at the entrance to the site and can be seen in Photo One. The permit boundaries are delineated by a fence line on the east, tree line on the south and west and the Piedra River to the north. The site was not active during the inspection and no Operator representative was present. No mining or reclamation equipment was observed on site during the inspection. The active mining area consists of a pond on the south end of the permit area. During mining operations the water is pumped down to allow for the excavation of material. The active mining operations expands the pond banks during excavation, and is left in a stable, near 3H: 1V configuration. The pond area can be seen in Photos Two and Three. The material is then processed and stockpiled in the processing area. Other stockpiles of materials including topsoil and crusher fines are also stockpiled in this area. All stockpiles that were observed appear to be stable and in good condition. The stockpiled material can be seen in Photo Four.

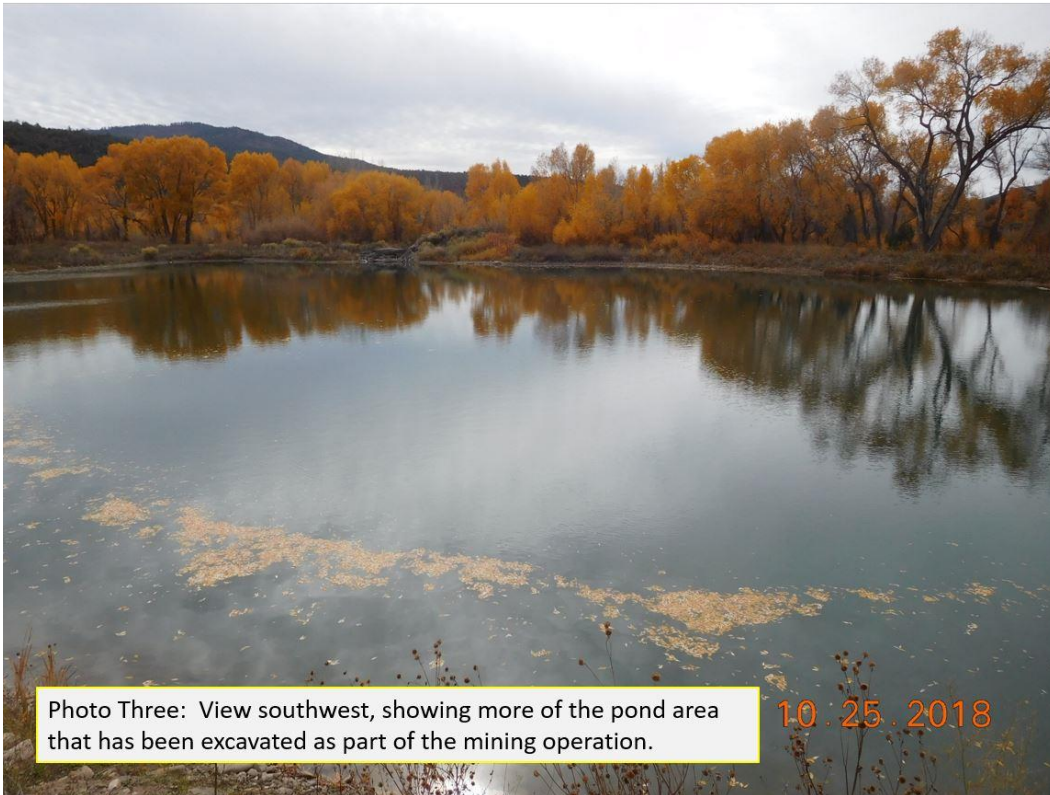
Photo Three: View southwest, showing more of the pond area that has been excavated as part of the mining operation.

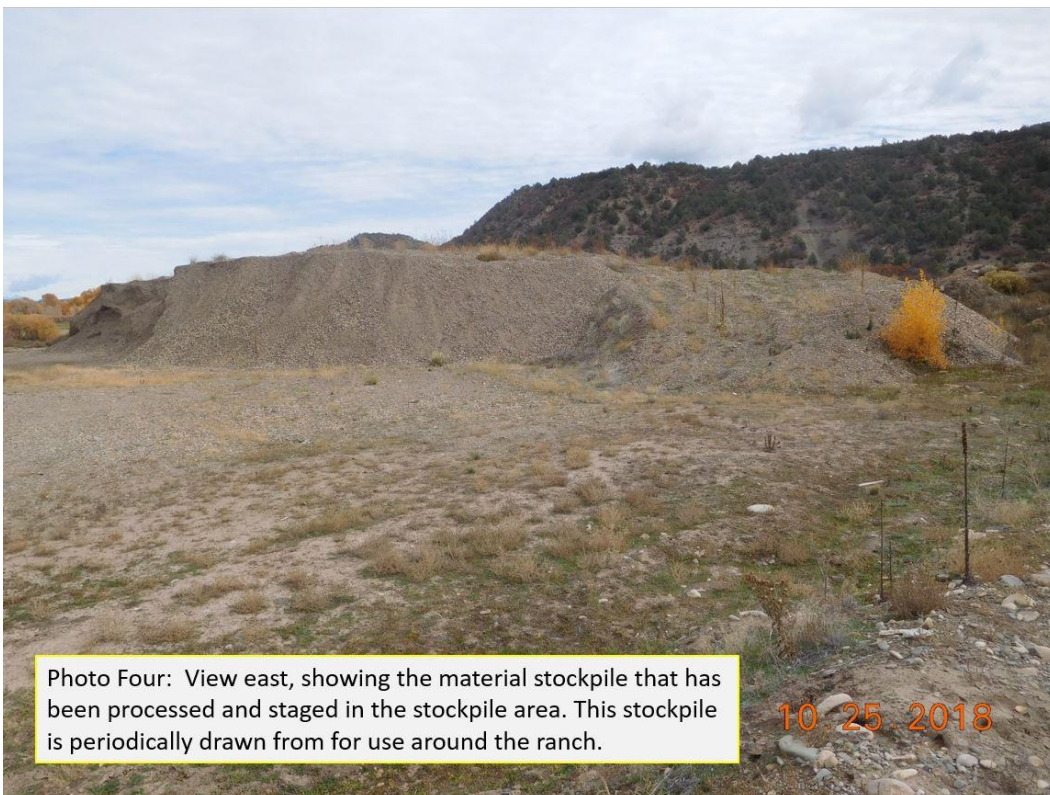
Photo Four: View east, showing the material stockpile that has been processed and staged in the stockpile area. This stockpile is periodically drawn from for use around the ranch.

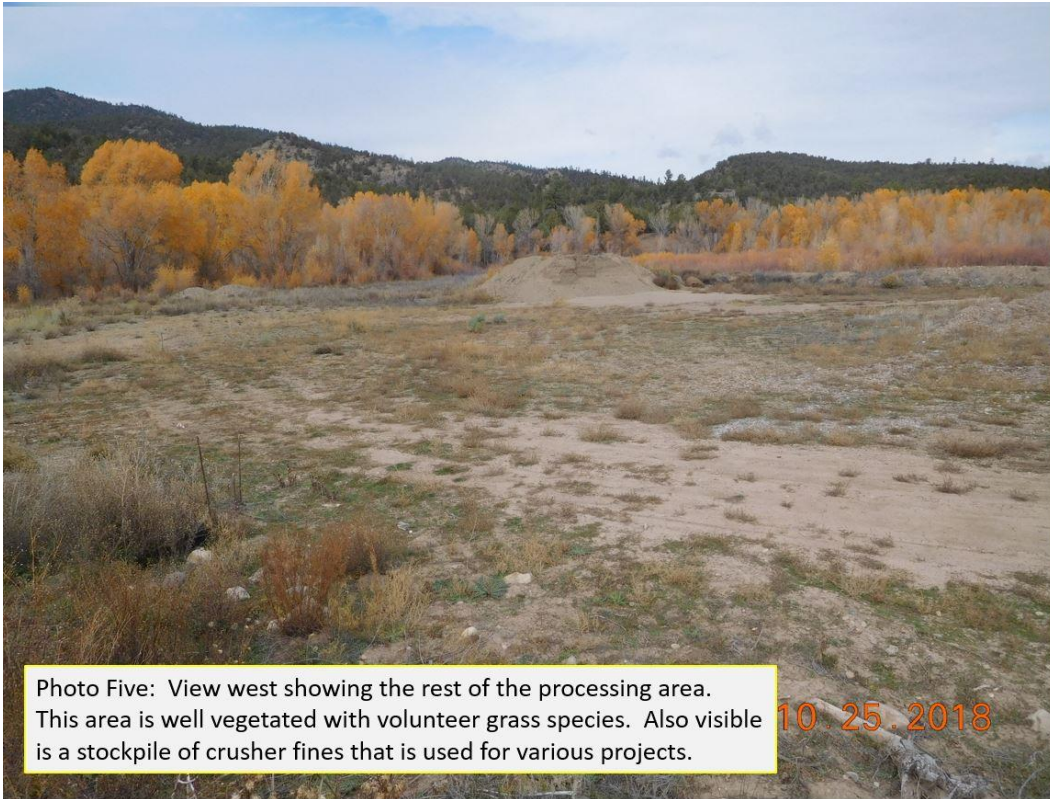
The processing and stockpile area has been partially revegetated with volunteer species. The vegetation in the undisturbed areas of the permitted boundaries is dense and diverse. Evidence of chemical treatment of weed species was observed and no new growth was noted during the inspection. Photo Five shows the processing and stockpiling area as well as a small stockpile of crusher fines located in that area.

Photo Five: View west showing the rest of the processing area. This area is well vegetated with volunteer grass species. Also visible is a stockpile of crusher fines that is used for various projects.
