**MINERALS PROGRAM INSPECTION REPORT**  
**PHONE: (303) 866-3567**

<b>MINE NAME:</b> Roberts Quarry	<b>MINE/PROSPECTING ID#:</b> M-1977-301	<b>MINERAL:</b> Limestone (general)	<b>COUNTY:</b> Larimer
<b>INSPECTION TYPE:</b> Surety Release Inspection	<b>INSPECTOR(S):</b> Jared L. Ebert	<b>INSP. DATE:</b> December 19, 2018	<b>INSP. TIME:</b> 10:20
<b>OPERATOR:</b> Pete Lien & Sons, Inc.	<b>OPERATOR REPRESENTATIVE:</b> Rob Kisner	<b>TYPE OF OPERATION:</b> 112c - Construction Regular Operation	
<b>REASON FOR INSPECTION:</b> Surety Release Requested	<b>BOND CALCULATION TYPE:</b> Complete Bond	<b>BOND AMOUNT:</b> \$308,500.00	
<b>DATE OF COMPLAINT:</b> NA	<b>POST INSP. CONTACTS:</b> None	<b>JOINT INSP. AGENCY:</b> None	
<b>WEATHER:</b> Windy	<b>INSPECTOR'S SIGNATURE:</b>

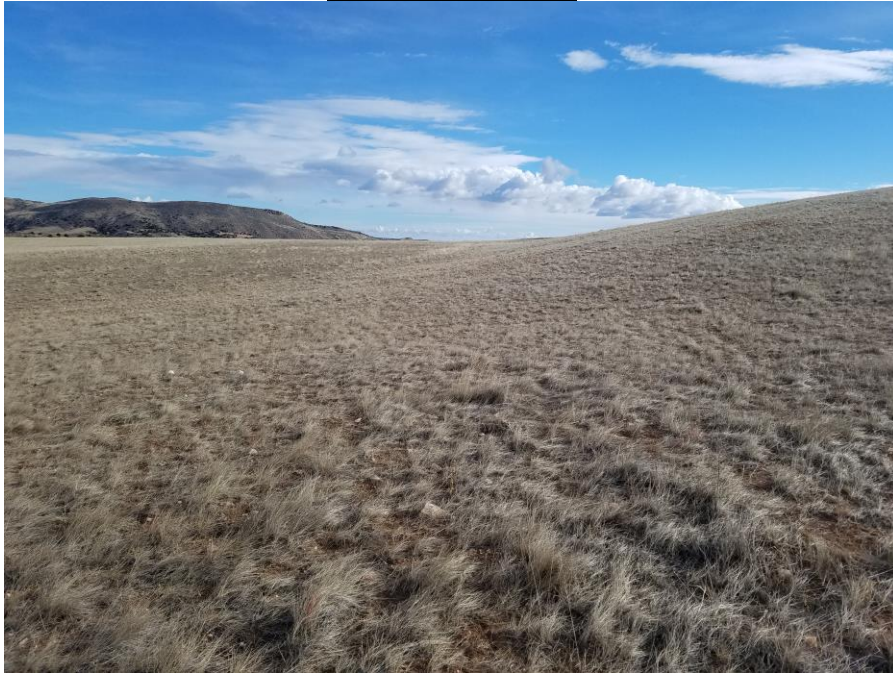
The 80 acre AR01 bond release area is located on the west side of the permit area. The affected land within the AR01 area is estimated to be about 15 acres and consisted of former Phase III and II mining areas. The affected land has been backfilled and graded to blend is very well with the adjacent un-affected land. The

graded slopes varied but were overall less than the required 2H:1V ratio. The graded area was stable and well vegetated with a diverse array of native grasses primarily. The landowner appears to have allowed cattle to utilize the area for grazing in 2018 but overall the reclaimed vegetation was dense and well established. It appears the approved post-mining land use as been implemented. Given this, the Division will approve the AR01 application. The Division's decision date will coincide with the date this report is sent. DRMS is required to wait 30 days for an appeal period before the final decision on the acreage reduction will be issued. Approval of the AR01 application will be addressed under a separate cover letter.

Figure 1. From the west end of the AR01 affected land looking east.

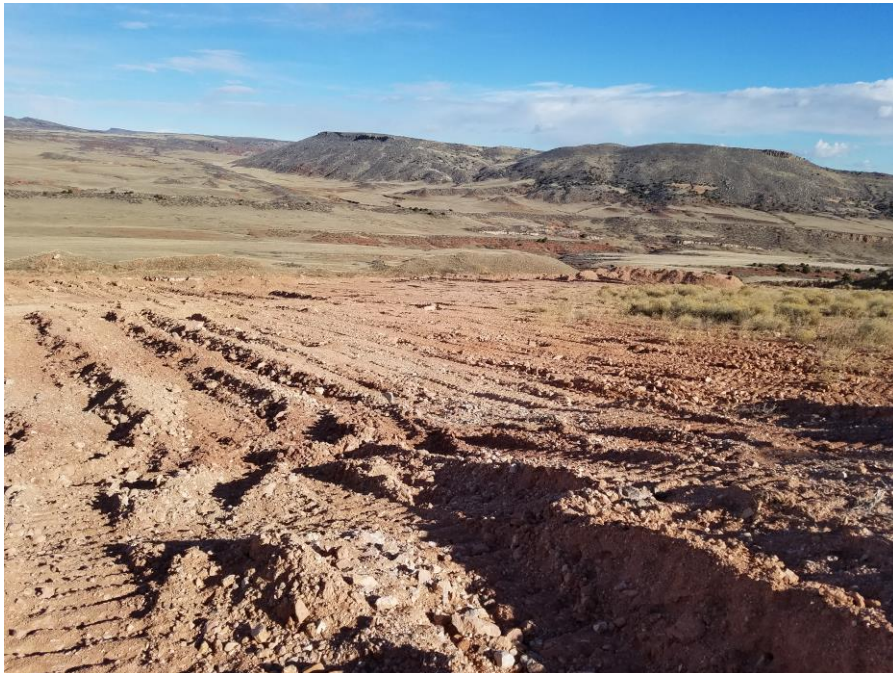
The Operator has recently backfilled and graded a portion of the active mine area located within the Phase IV area on the western side of the site. Evidence of recent slot dozing was observed.

Figure 2. Recently backfilled portion of the western most Phase IV/Phase I pit. Looking north.

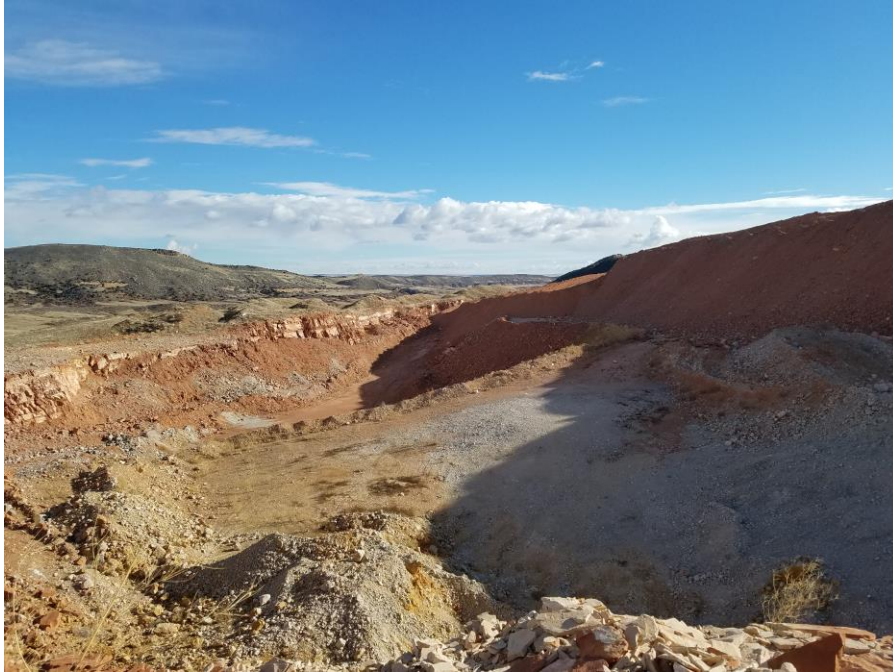
Overall, mining appears to be occurring in accordance with the approved mine plan. The Operator is actively mining in the Phase I, IV and V mining areas as approved with Technical Revision No. 5 (TR05). The majority of the affected land is located in a large pit area located in the western most Phase IV area and Phase I area. A large amount of overburden is piled on the south side of the pit in two distinct mine benches. The upper bench appears to be 50 to 75 feet in height on average and the bottom, northern most bench is about 25 feet in height. A highwall daylights to the south in this area.

Figure 3. Near the center of the Phase IV/V western most pit looking east.

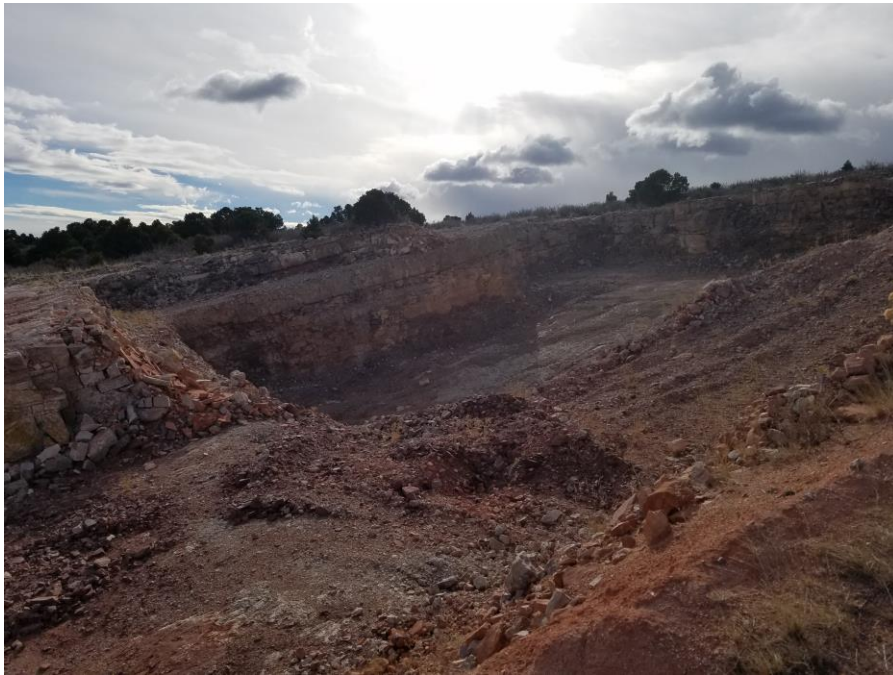
Two smaller pit excavations are located in what appears to be a portion of the eastern most Phase IV mining area and Phase V mining area. One pit is located on the south side of the access road that consists of a pit with a northern aspect with a near-vertical to vertical 20 to 25 foot highwall that daylights to the north and west. The second pit is located on the north side of the access road in the Phase V area. This is a small pit depression with 1H:1V ratio side slopes that is about 25 feet deep.

Figure 4. Eastern Phase IV and Phase V pit on the south side of the access road looking south east.

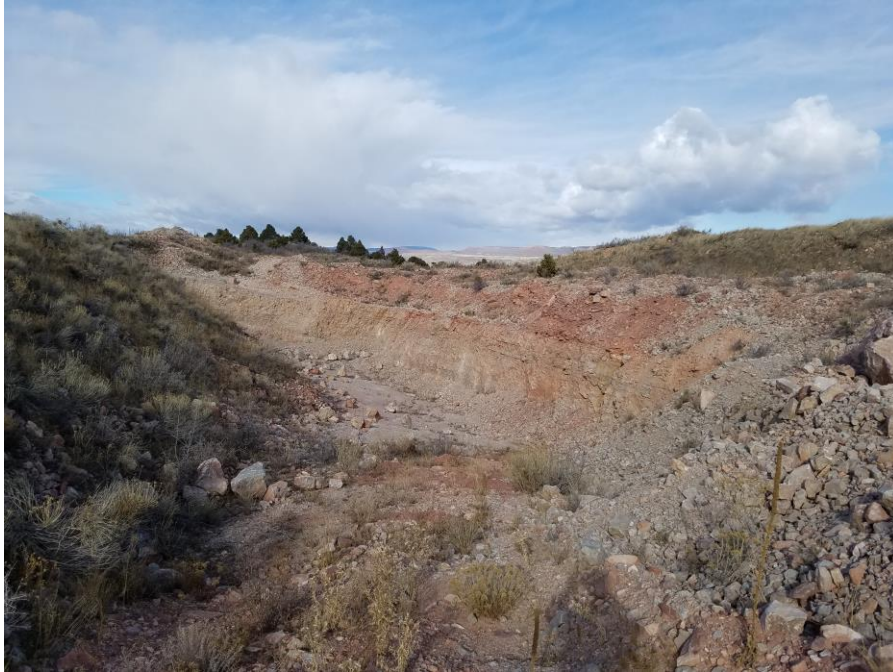
Figure 5. Small pit excavation on the north side of the access road looking northwest.
