MINERALS PROGRAM INSPECTION REPORT
PHONE: (303) 866-3567

MINE NAME: Cresson Project	MINE/PROSPECTING ID#: M-1980-244	MINERAL: Gold	COUNTY: Teller
INSPECTION TYPE: Monitoring	INSPECTOR(S): Timothy A. Cazier	INSP. DATE: November 29, 2018	INSP. TIME: 09:55
OPERATOR: Cripple Creek & Victor Gold Mining Company	OPERATOR REPRESENTATIVE: Justin Bills, Katie Blake	TYPE OF OPERATION: 112d-3 - Designated Mining Operation	
REASON FOR INSPECTION: Normal I&E Program	BOND CALCULATION TYPE: None	BOND AMOUNT: \$208,491,188.00	
DATE OF COMPLAINT: NA	POST INSP. CONTACTS: None	JOINT INSP. AGENCY: None	
WEATHER: Clear	INSPECTOR'S SIGNATURE:

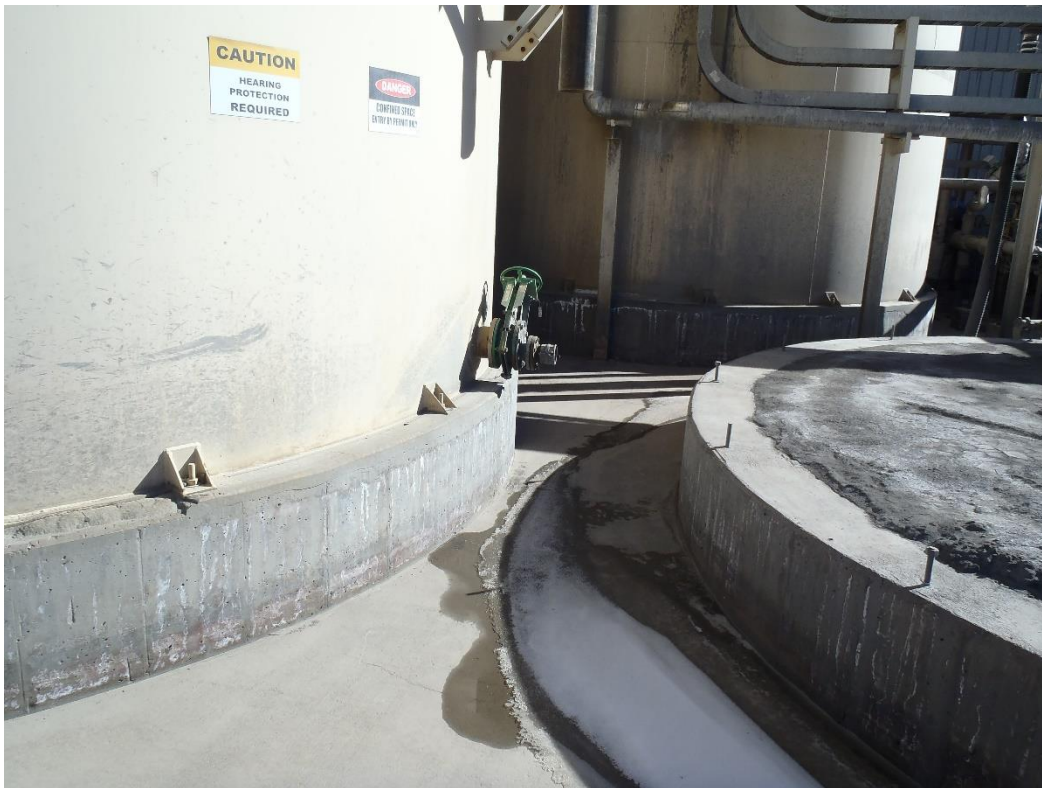
High Grade Mill: Messrs. Laurin Colby and Charles Bissue accompanied the DRMS, Mr. Bills and Ms. Blake on the mill exterior walk-around inspection. The purpose was to perform a visual inspection for leaks, spills and secondary containment problems. Both the east and west sides of the mill exterior were inspected, as well as the area around the concentrate storage facility (Con Barn). No problems were observed. The vat leach circuit on the west side of the HGM (See **Photo 1**) continued to be offline (since around February 18, 2018).

Photo 1. Vat leach circuit on the west side of the HGM.

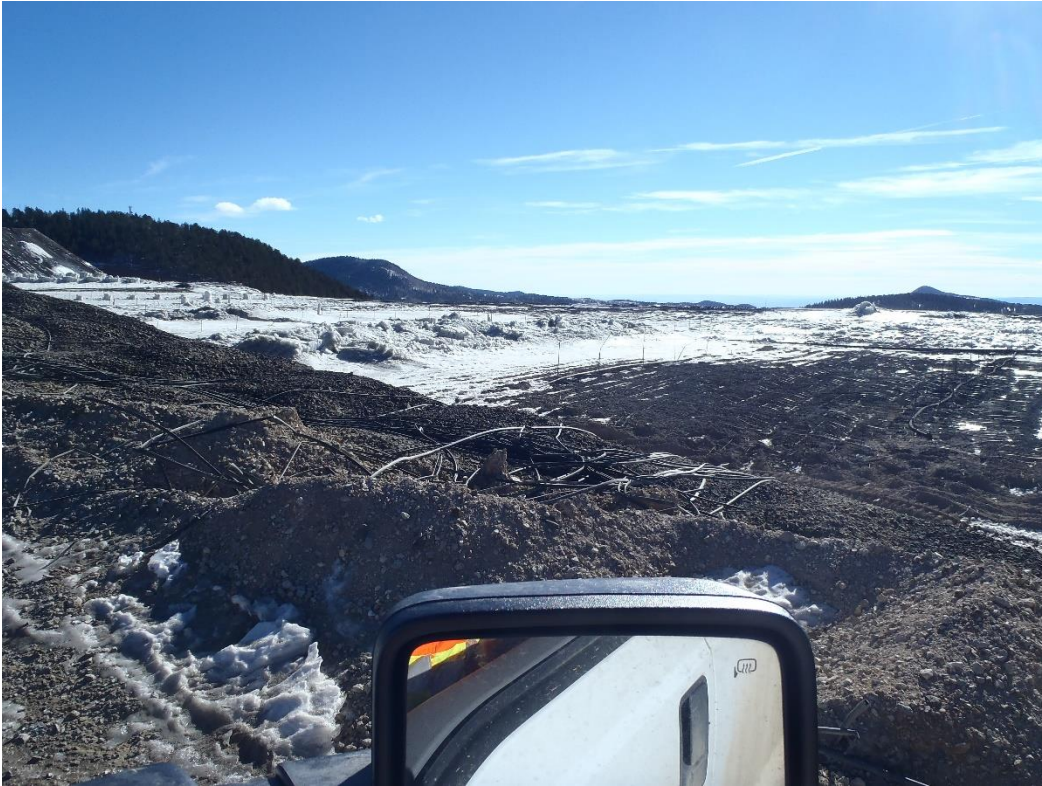
Arequa Gulch Valley Leach Facility (VLF1): Messrs. Colby and Bissue accompanied the DRMS, Mr. Bills and Ms. Blake on the VLF1 tour. Active leaching areas were observed, primarily elevation 10,200 and 10,400. No significant ponding was observed. However, due to the cold temperatures, lots of ice (most of it process solution) was observed (See **Photos 2, 3 and 4**). Discussions with Messrs. Colby and Bissue indicated the mines does not expect to experience process solution ponding problems when the observed ice begins to melt. They were confident they could manage the solution at the anticipated melting rates.

Photo 2. VLF 1 ice (elevation 10,200, phase I/II).

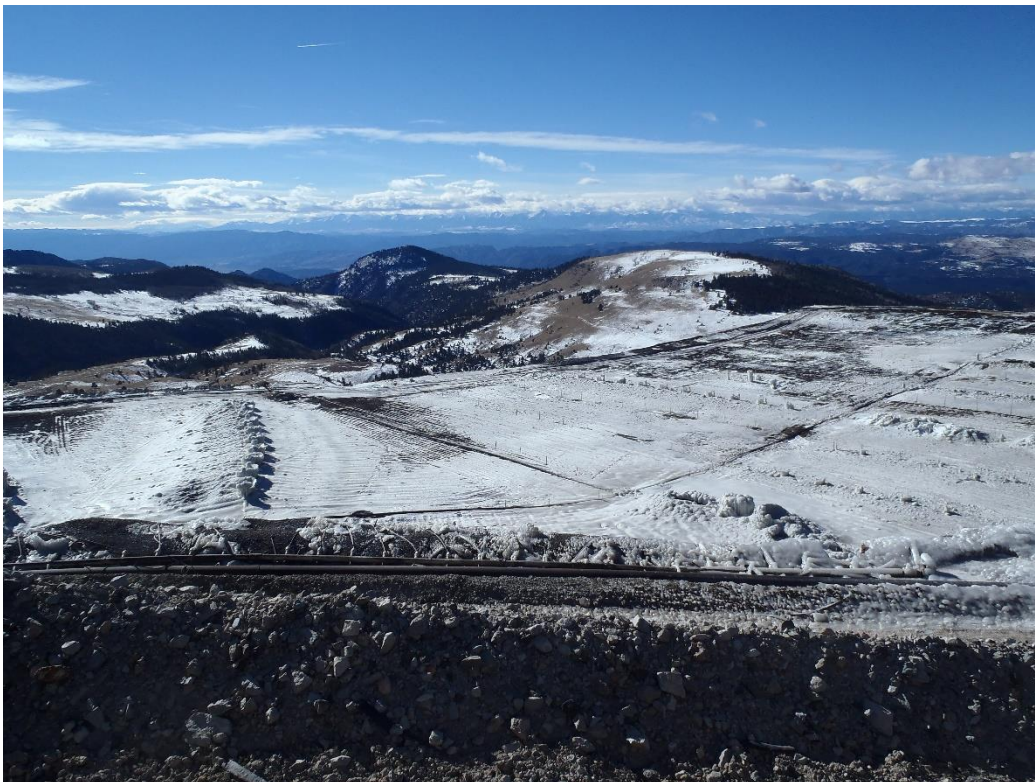
Photo 3. VLF 1 ice (elevation 10,200, phase I/II).

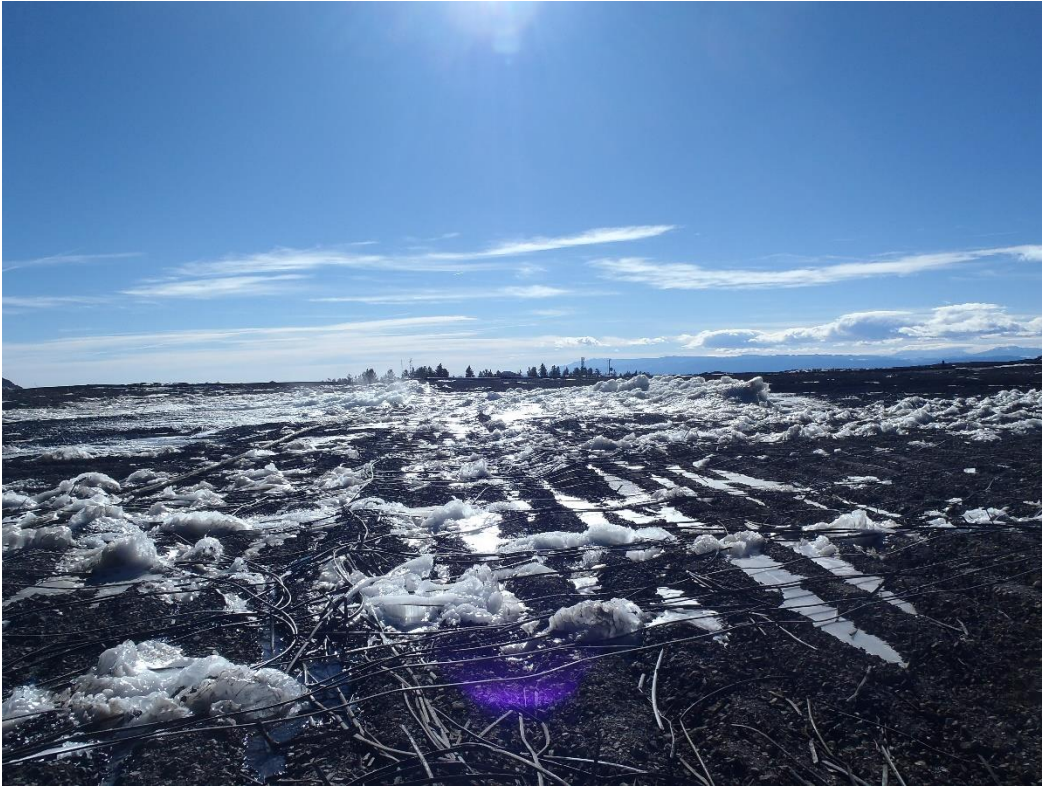
Photo 4. VLF 1 ice (elevation 10,400, phase V).

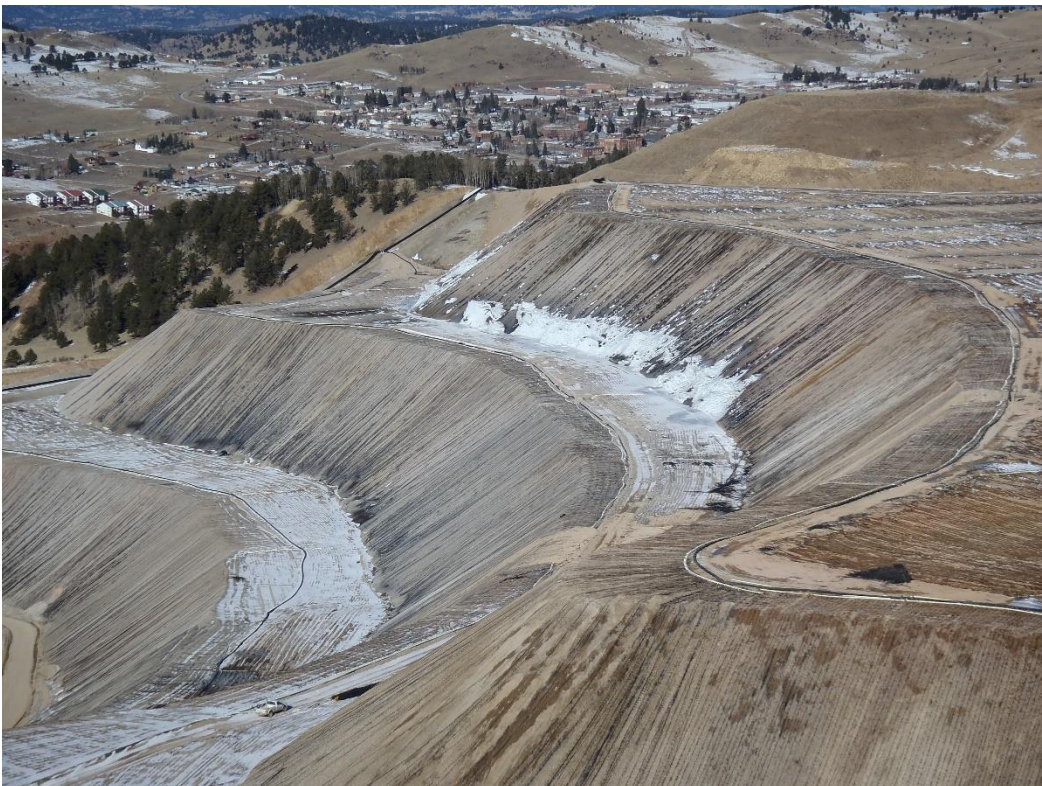
Squaw Gulch Valley Leach Facility (VLF 2) & Liner Repair Area: Messrs. Colby and Bissue accompanied the DRMS, Mr. Bills and Ms. Blake to the VLF 2. Frozen process solution was observed on the on the slope from the 9650 bench (See **Photo 5**).

Photo 5. VLF 2 ice 9650 and 9750 benches.

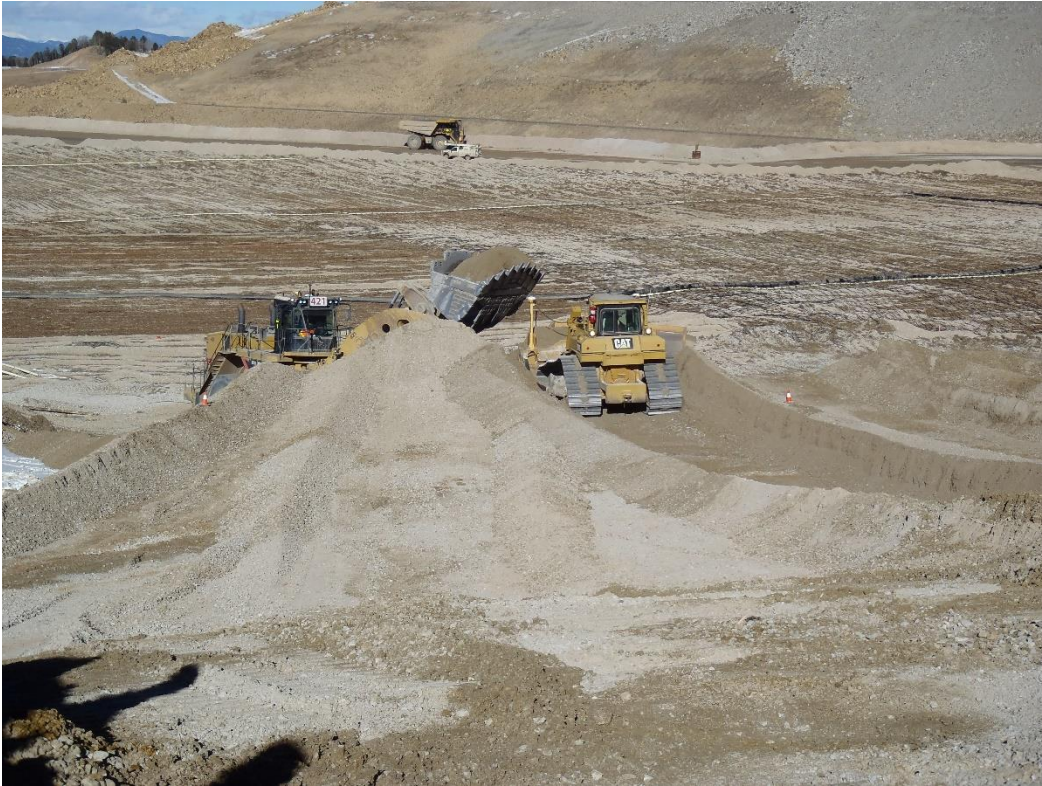
We observed the removal of the mill reject stockpile identified during the DRMS February as a potential problem related to liner integrity. A dozer with GPS elevation controls (See **Photo 6**) was observed pushing the reject material down to an area where a wheel loader was filling haul trucks with the scraped material to transport to elsewhere on VLF2. The mine intends to use a similar potholing approach to detect liner damage as with the previous investigation.

Photo 6. Dozer with GPS elevation controls removing reject pile south of VLF 2.

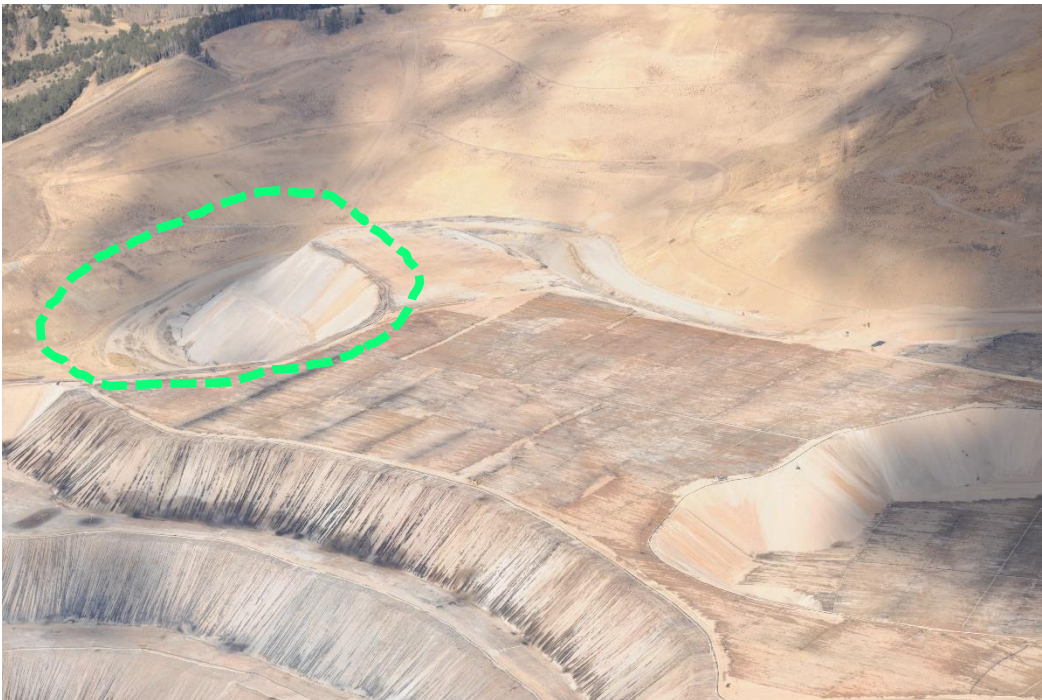
During the October 25, 2018 aerial inspection, the DRMS noted the north side of VLF2 had completed two 100-foot lifts above the haul road (See **Photo 7**) and expressed concerns with how ore stacking would proceed while adhering to the guidelines approved in TR-103 designed to reduce the potential damage to the VLF liner. While on the north side, Messrs. Colby and Bissue explained the mine's planned approach to loading this side of VLF2 after completion of Phase 2 liner construction (anticipated to occur during the 2019 construction season). The DRMS agreed the approach to push down some material to level the area near the Phase 2 liner tie-in (See

Photo 7. October 25, 2018 aerial showing two 100-ft lifts above Phase II liner tie-in (looking north).

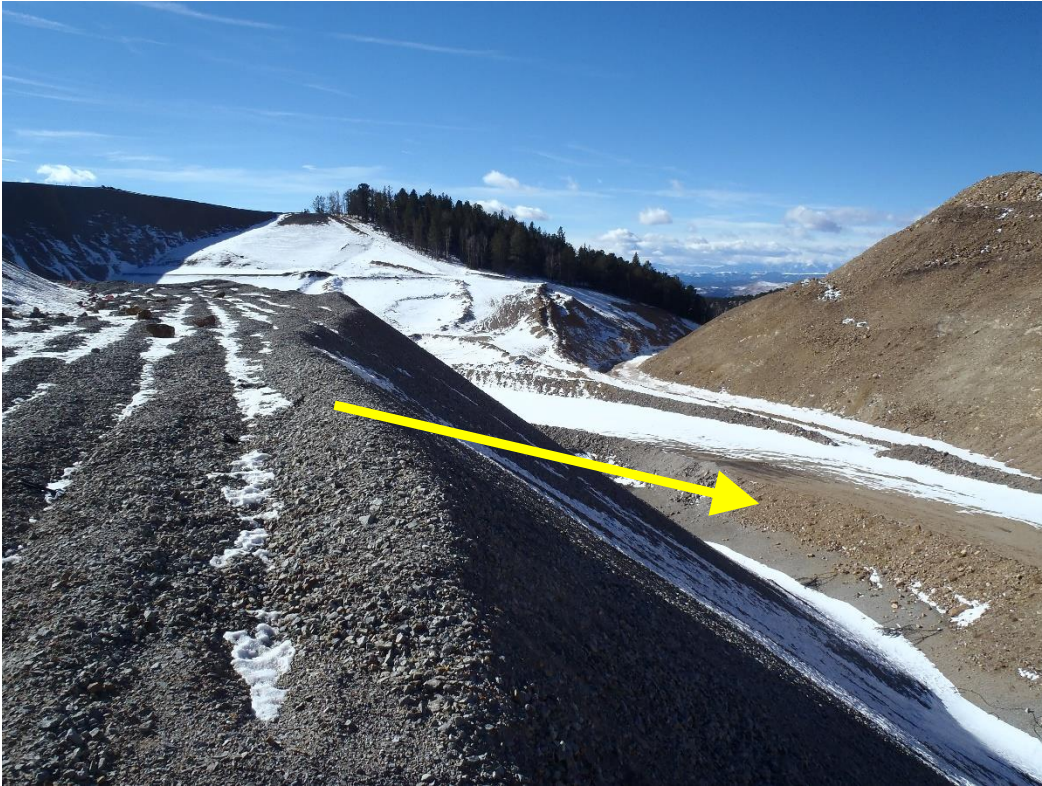
Photo 8. North VLF2 area & direction material will be pushed down to level area near the Phase 2 liner tie-in.

Photo 8) and build some up from the bottom on the west side (See **Photo 9)** would likely be able to achieve satisfactory results, but would require frequent and detailed coordination between mine planners and equipment operators. The DRMS emphasized this will be a critical effort to avoid potential costly damage to the liner during the transition to loading the Phase 2 liner.

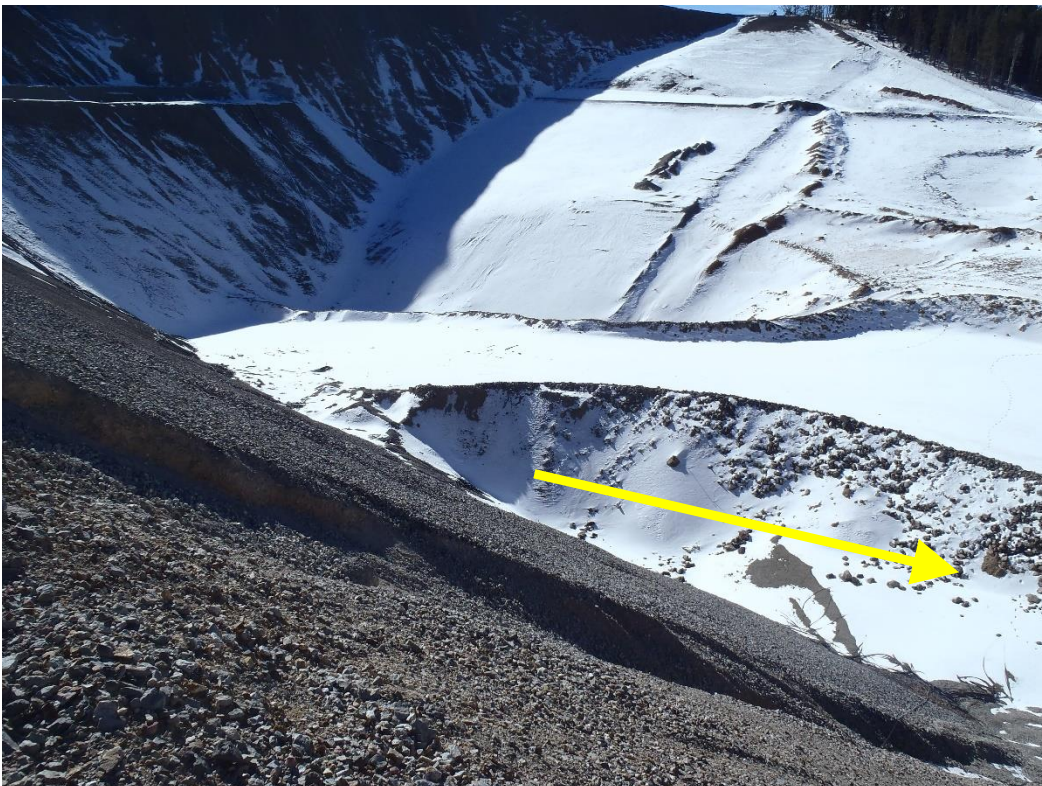
Photo 9. NW VLF2 Area & direction material will be pushed up to facilitate the Phase 2 liner tie-in.

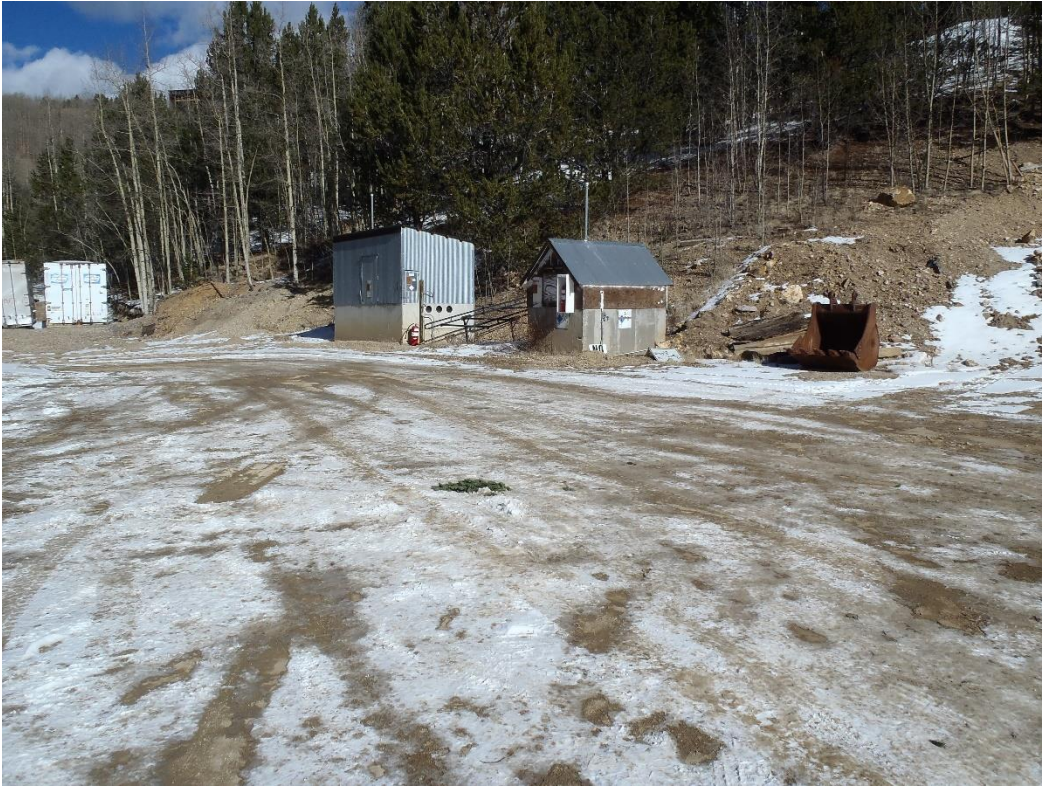
Photo 10. Chicago Tunnel area (looking NE from portal).

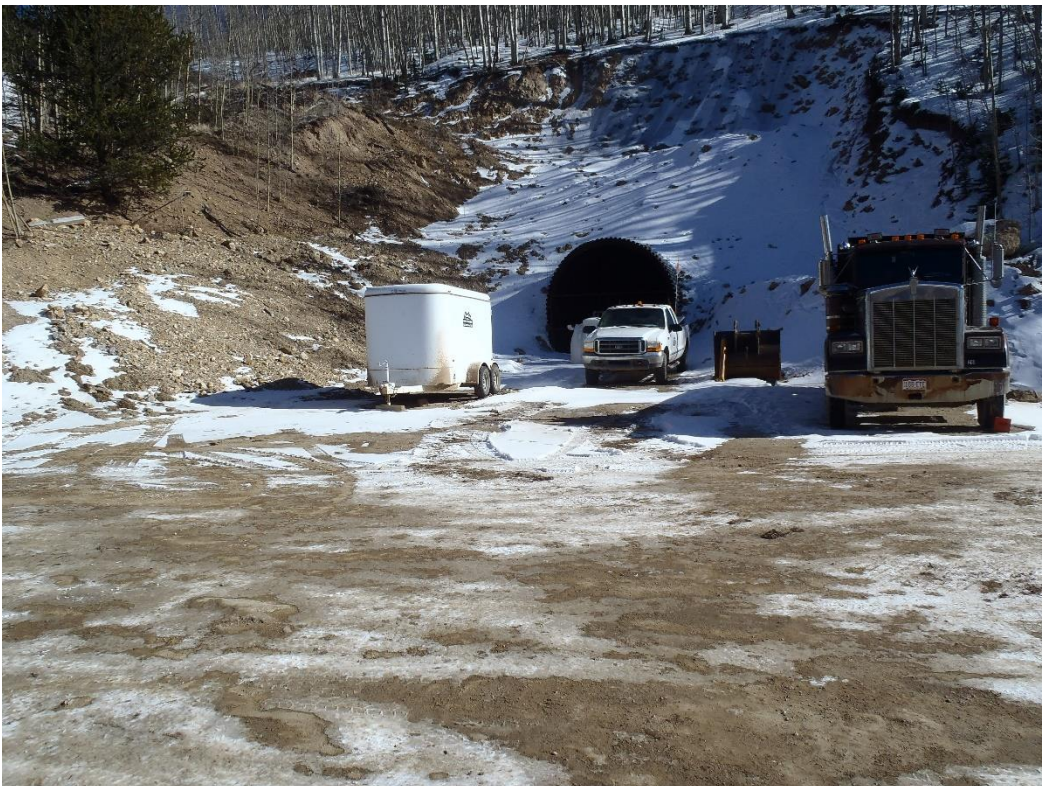
Photo 11. Chicago Tunnel portal.

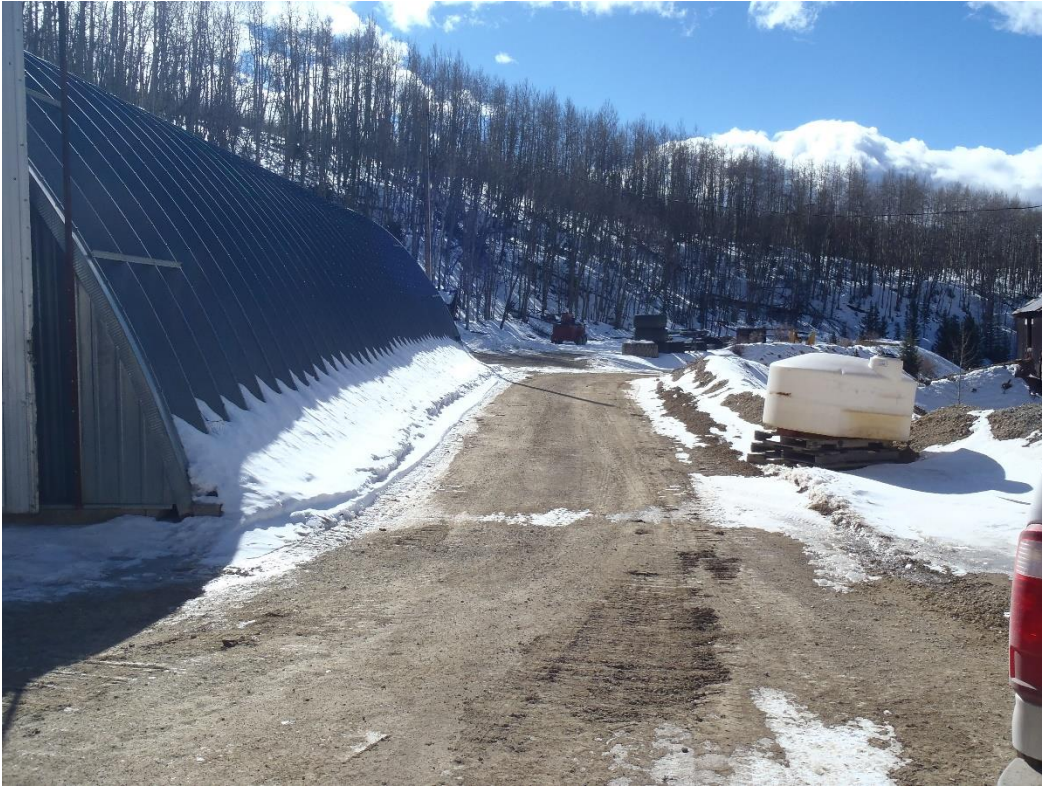
Chicago Tunnel area: Mr. Bills, Ms. Blake and the DRMS drove to the Chicago Tunnel area, recently incorporated into the Cresson Project. This area was formerly regulated under a separate mine reclamation permit (M-1988-026). The Chicago Tunnel area disturbance was incorporated into the Cresson Project with the approvals of amendments 11 and 12 (AM-11 & AM-12). However, the release request for the former Chicago Tunnel was submitted and approved only recently (September 5, 2018). The Chicago Tunnel is still regulated by the DRMS, but now under this permit (M-1980-244). CC&V representatives indicated very little activity has occurred in the Chicago Tunnel area and confirmed no underground activity had occurred since Newmont began operating the mine. The DRMS observed no signs of underground activity or other activity directly related to the mining operation (See **Photos 10, 11 and 12**). It should be noted one of the mine contractors uses this area to store and maintain his equipment.

Photo 12. Chicago Tunnel area (looking SW from portal).
