**MINERALS PROGRAM INSPECTION REPORT**  
**PHONE: (303) 866-3567**

<b>MINE NAME:</b> Cresson Project	<b>MINE/PROSPECTING ID#:</b> M-1980-244	<b>MINERAL:</b> Gold	<b>COUNTY:</b> Teller
<b>INSPECTION TYPE:</b> Aerial Inspection	<b>INSPECTOR(S):</b> Timothy A. Cazier	<b>INSP. DATE:</b> July 26, 2018	<b>INSP. TIME:</b> 14:08
<b>OPERATOR:</b> Cripple Creek & Victor Gold Mining Company	<b>OPERATOR REPRESENTATIVE:</b> N/A	<b>TYPE OF OPERATION:</b> 112d-3 - Designated Mining Operation	
<b>REASON FOR INSPECTION:</b> Normal I&E Program	<b>BOND CALCULATION TYPE:</b> None	<b>BOND AMOUNT:</b> \$208,491,188.00	
<b>DATE OF COMPLAINT:</b> NA	<b>POST INSP. CONTACTS:</b> None	<b>JOINT INSP. AGENCY:</b> None	
<b>WEATHER:</b> Clear	<b>INSPECTOR'S SIGNATURE:</b>

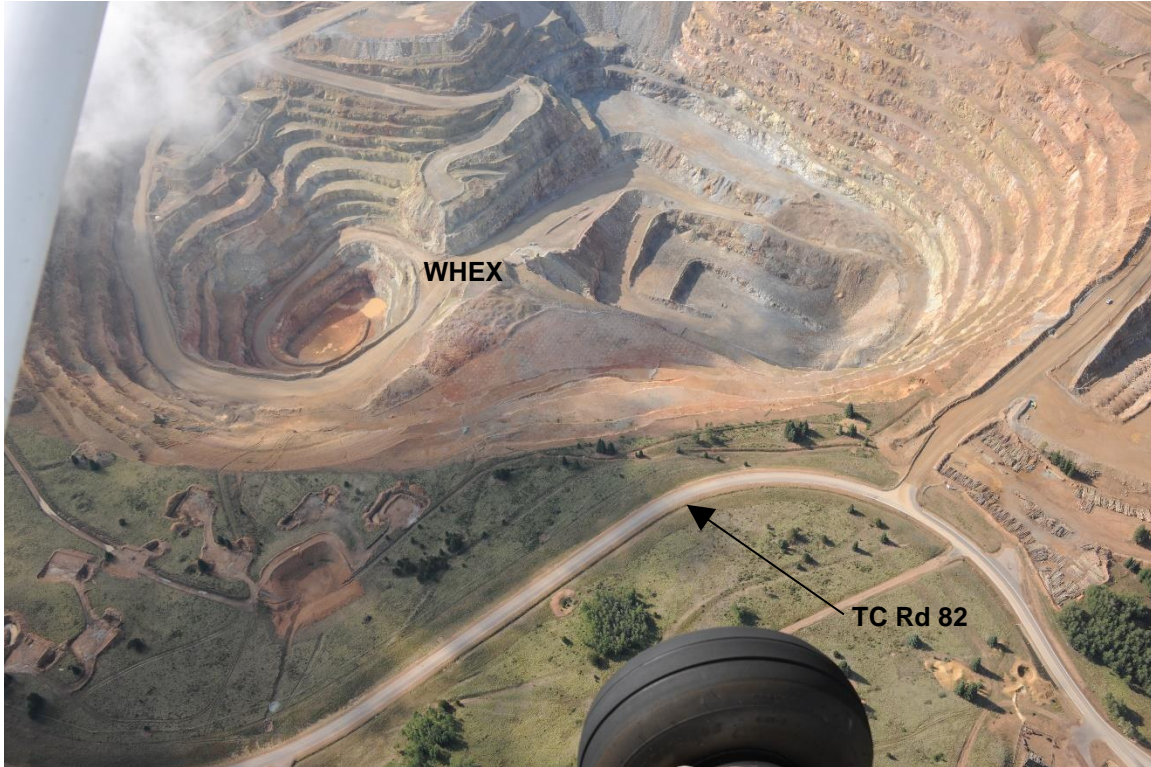
Photo 1. Wildhorse Extension Pit (Looking south).

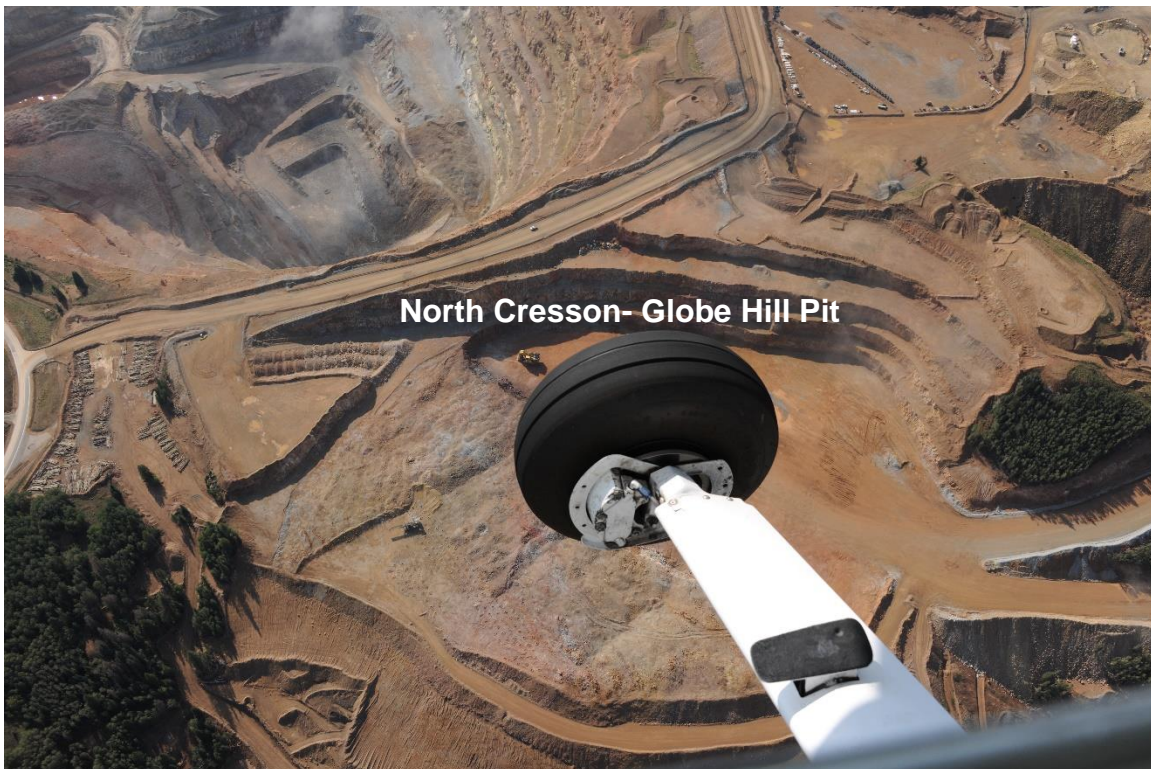
Photo 2. North Cresson (looking SE).

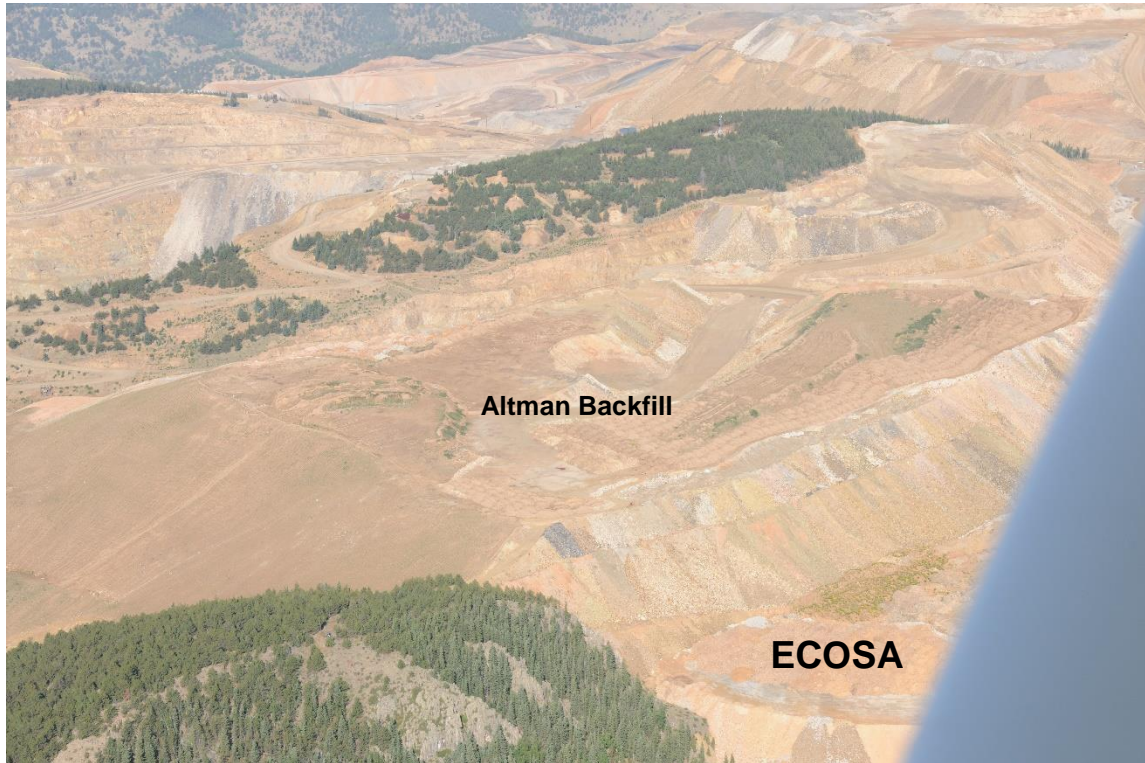
Photo 3. East Cresson OSA (looking west).

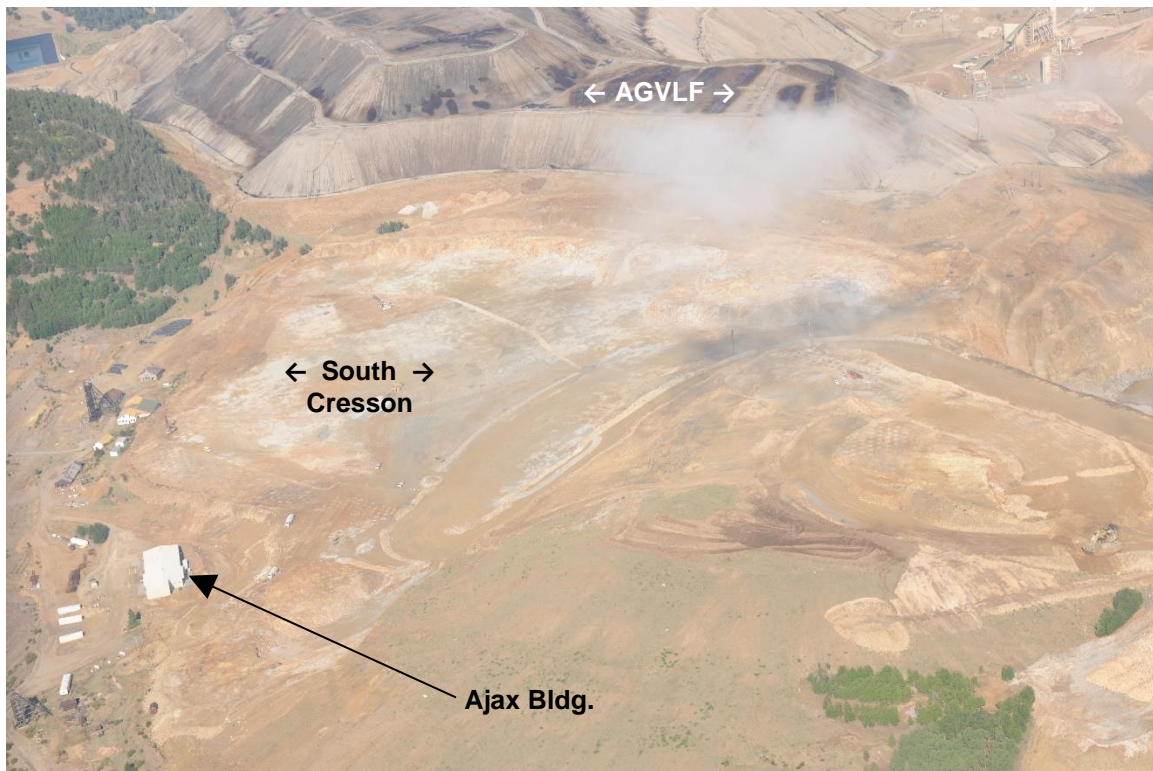
Photo 4. South Cresson (looking WSW).

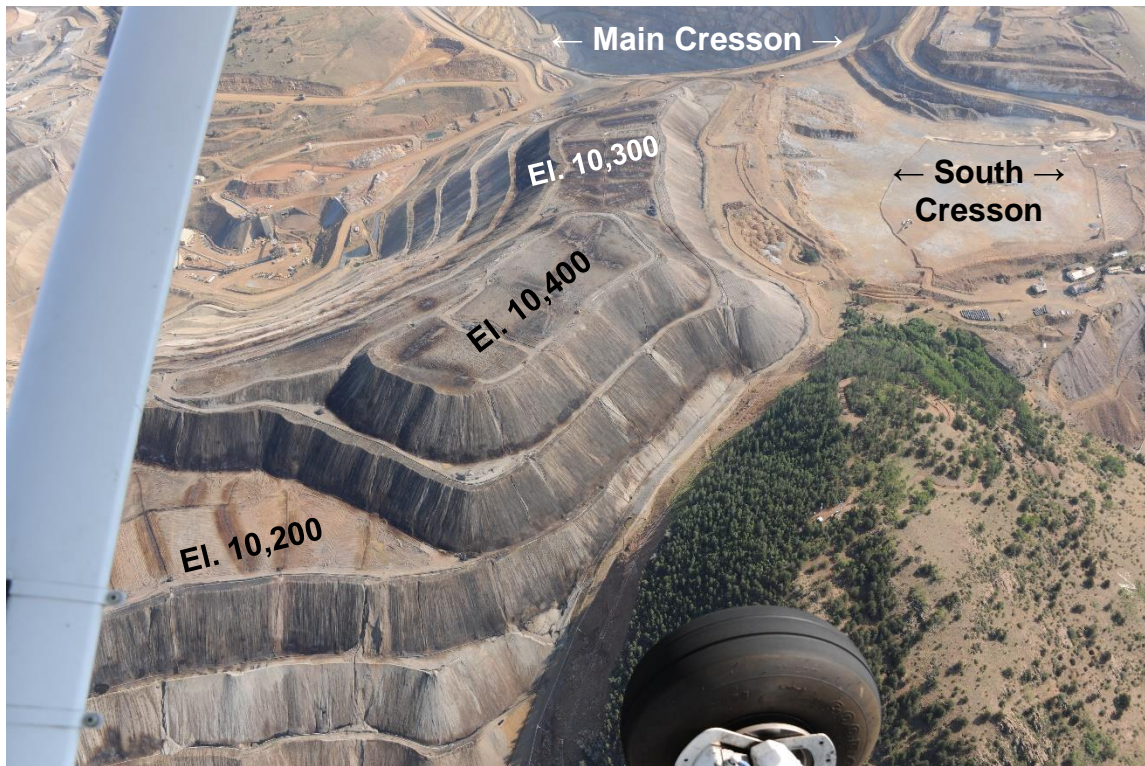
Photo 5. Main Cresson Pit (looking north).

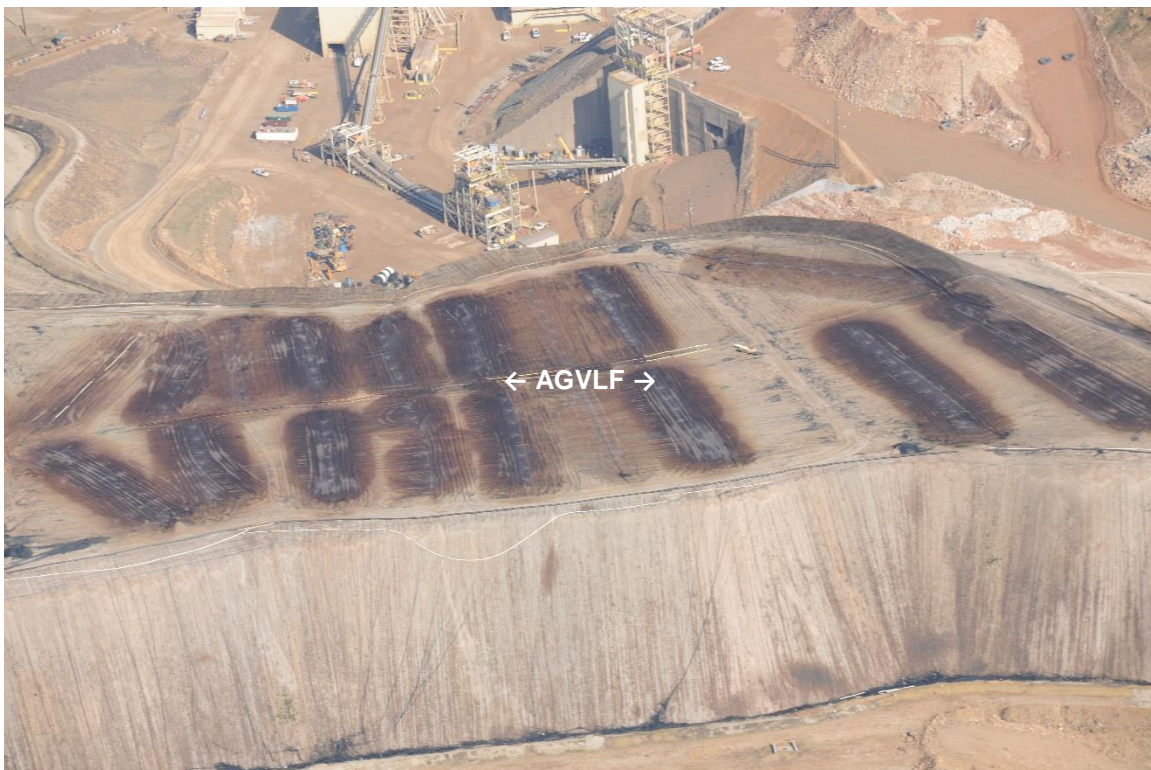
Observed problems were VLF solution ponding which were cited in the July 31, 2018 regular monthly inspection.

Photo 6. Solution ponding on AGVLF (VLF 1), El. 10,300 (looking NW).

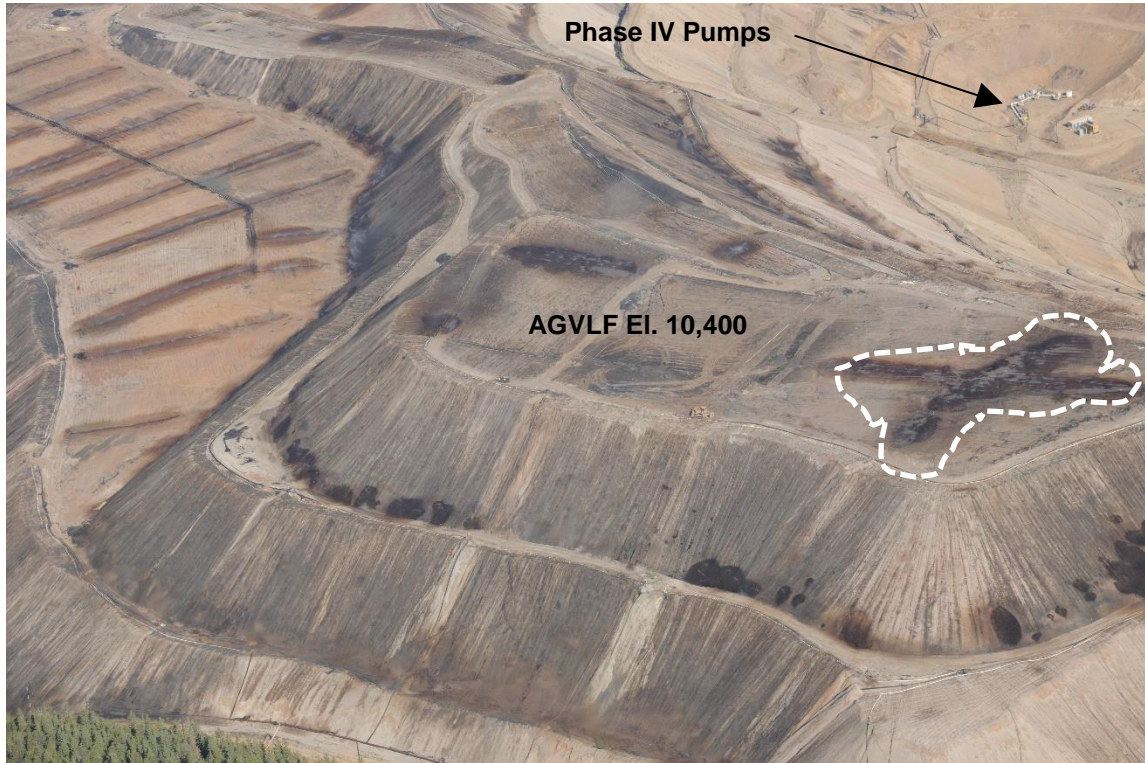
Photo 7. Arequa Gulch VLF El. 10,400 solution ponding (looking WNW).

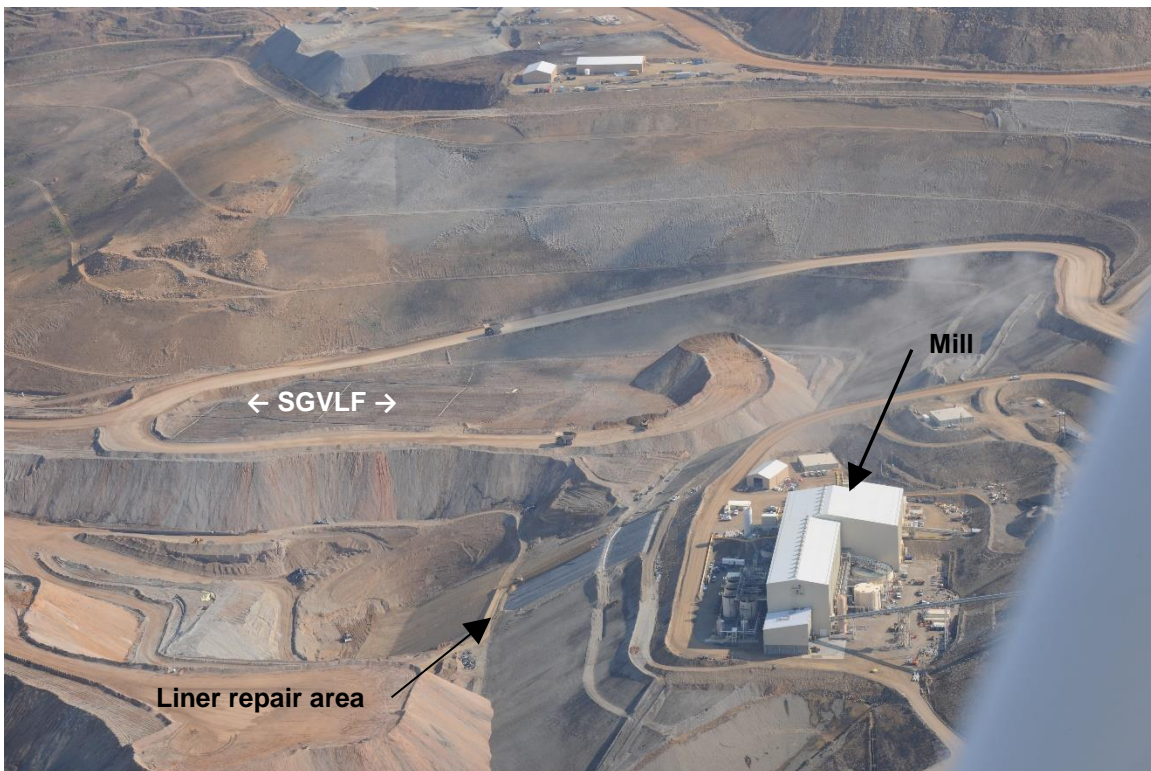
Photo 8. High Grade Mill building (Looking NE).

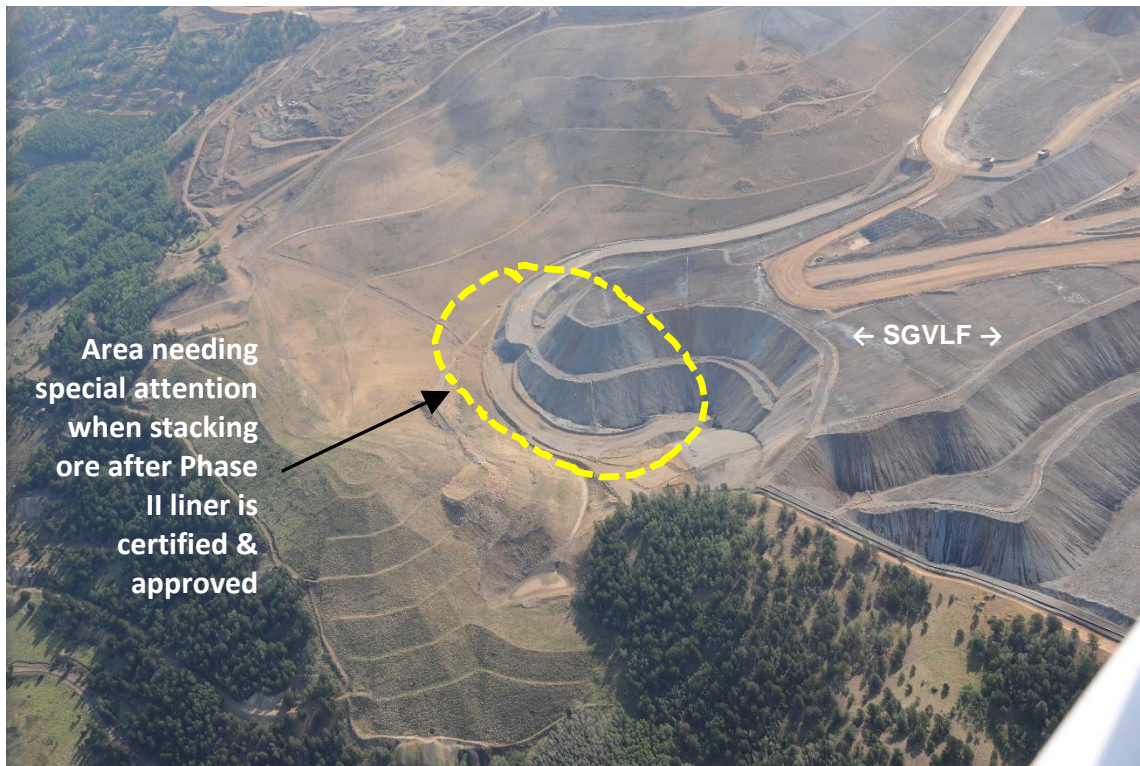
Photo ID	Mine Facility	Perspective	Notes
Photo 1	Wildhorse Extension Pit (WHEX)	Looking south	Teller County Road 82 in foreground
Photo 2	North Cresson pit (Globe Hill)	Looking SE	WHEX in upper left
Photo 3	East Cresson OSA (ECOSA) and Altman backfill	Looking west	Altman backfill in center
Photo 4	South Cresson	Looking WSW	Arequa Gulch VLF beyond (note Ajax Bldg to be removed)
Photo 5	Main Cresson Pit, South Cresson Pit & Phase V VLF 1	Looking NE	VLF 1 elevations 10,200; 10,300 & 10,400 visible
Photo 6	Arequa Gulch VLF (VLF 1) 1 of 2	Looking NW	Note solution ponding on 10,300 elevation
Photo 7	Arequa Gulch VLF (VLF 1) 2 of 2	Looking WNW	Note solution ponding on 10,400 elevation
Photo 8	High Grade Mill building	Looking NE	SGVLF on left (note liner repair efforts immediately left of HGM)
Photo 9	Squaw Gulch VLF (VLF 2) – north end	Looking NE	Highlights area needing special attention when stacking ore after Phase II liner is certified & approved

Photo 9. North end of Squaw Gulch VLF (Looking NE).

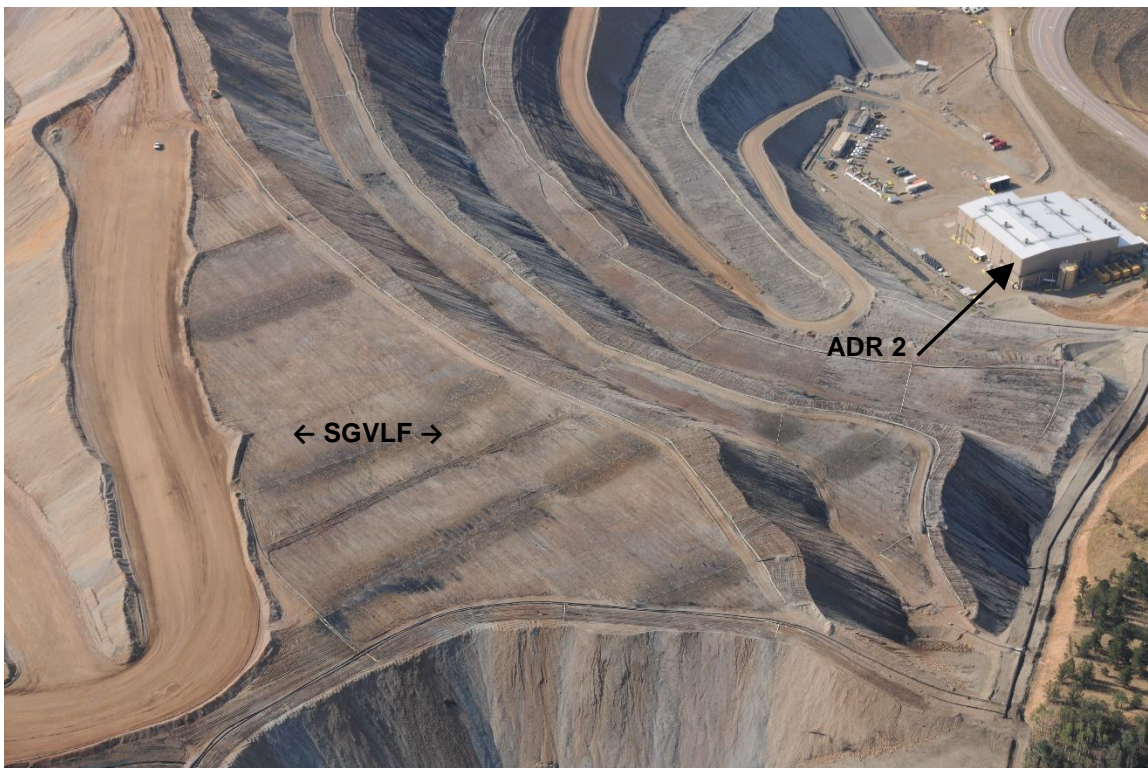
Photo 10	ADR 2	Looking south	Squaw Gulch VLF on left
<u>Acronyms:</u>		PSSA – Pregnant Solution Storage Area	
ADR – Adsorption/desorption Recovery		OSA – overburden storage area	
PSES – Process Solution Enhancement System		VLF – valley leach facility

Photo 10. ADR 2 (looking south).
