MINERALS PROGRAM INSPECTION REPORT
PHONE: (303) 866-3567

MINE NAME: Climax Mine	MINE/PROSPECTING ID#: M-1977-493	MINERAL: Molybdenum	COUNTY: Summit
INSPECTION TYPE: Monitoring	INSPECTOR(S): Lucas J. West	INSP. DATE: December 12, 2018	INSP. TIME: 10:05
OPERATOR: Climax Molybdenum Company	OPERATOR REPRESENTATIVE: Diana Kelts	TYPE OF OPERATION: 112d-3 - Designated Mining Operation	
REASON FOR INSPECTION: Normal I&E Program	BOND CALCULATION TYPE: None	BOND AMOUNT: \$78,246,088.00	
DATE OF COMPLAINT: NA	POST INSP. CONTACTS: None	JOINT INSP. AGENCY: None	
WEATHER: Clear	INSPECTOR'S SIGNATURE:

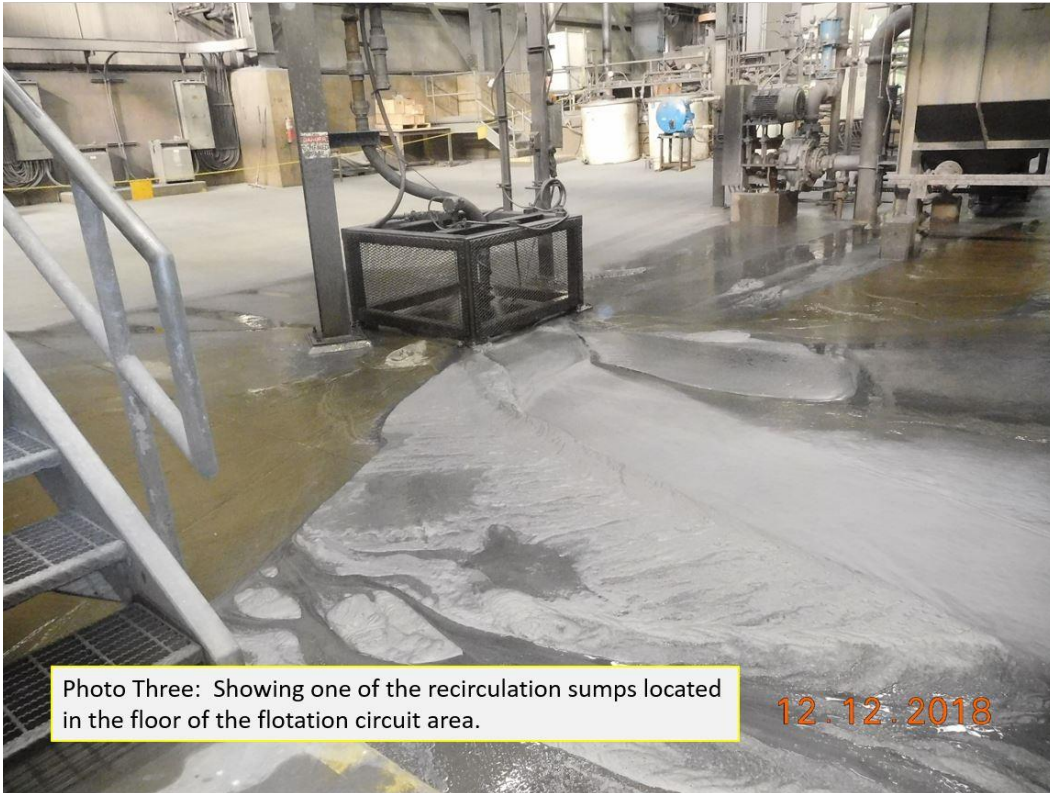
The next area that was observed was the area around the Rougher Flotation Circuit, Cleaner Flotation Circuit, drying area and thickener. Similar to the mill area the entire floor acts as secondary containment. The floor within the circuit area is sloped towards a series of recirculation sumps that return material into the process. An example of the sloped floor and sump is seen in Photo Three. The Thickener is the first step in tailings being prepped to be sent to one of the various Tailing Storage Facilities. The thickener exists within a separate concrete apron equipped with blind sumps that do not recirculate material but capture it to prevent a loss of containment.

Photo Three: Showing one of the recirculation sumps located in the floor of the flotation circuit area.

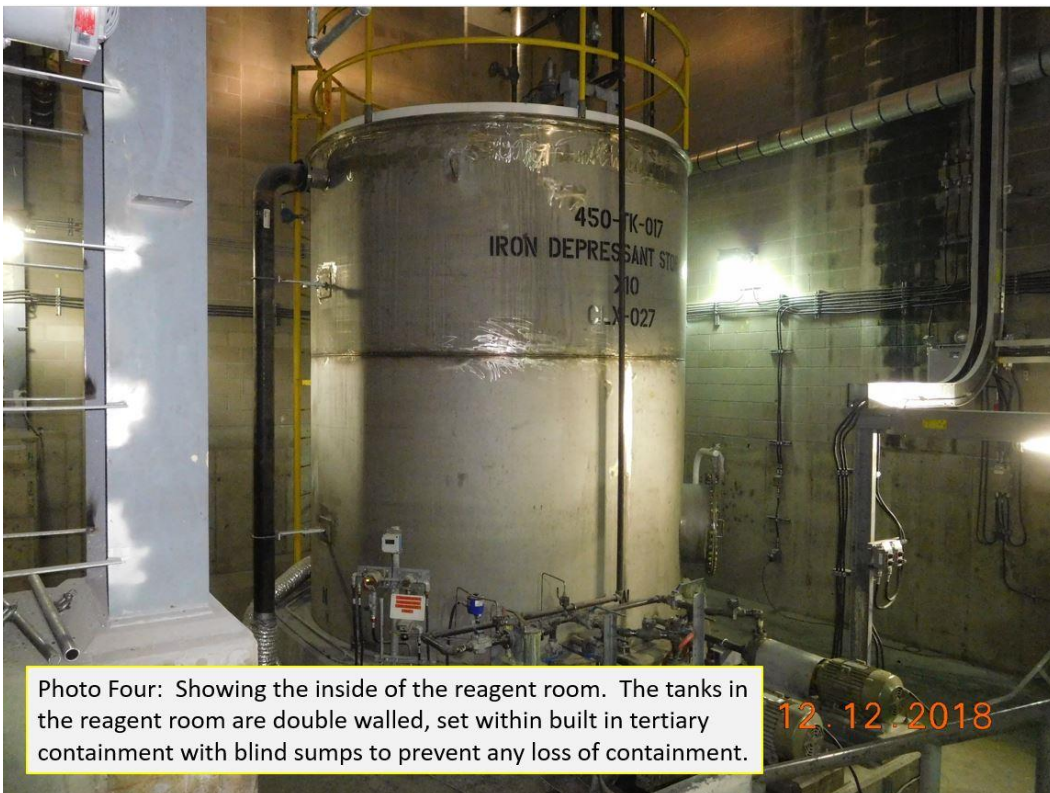
The Warehouse Lube Room and Reagent room were also observed. Similar to the Mill Building Lube Room the door is equipped with water tight seals as well as blind sumps to contain any spillage. Adjacent to the Lube Room is the Reagent Storage Room. This room has a separate containment structure that is completely isolated from other systems. The tanks in the reagent room are double walled as secondary containment and the room itself is designed as tertiary containment that also contains blind sumps. An example of the double walled tanks can be seen in Photo Four.

Photo Four: Showing the inside of the reagent room. The tanks in the reagent room are double walled, set within built in tertiary containment with blind sumps to prevent any loss of containment.

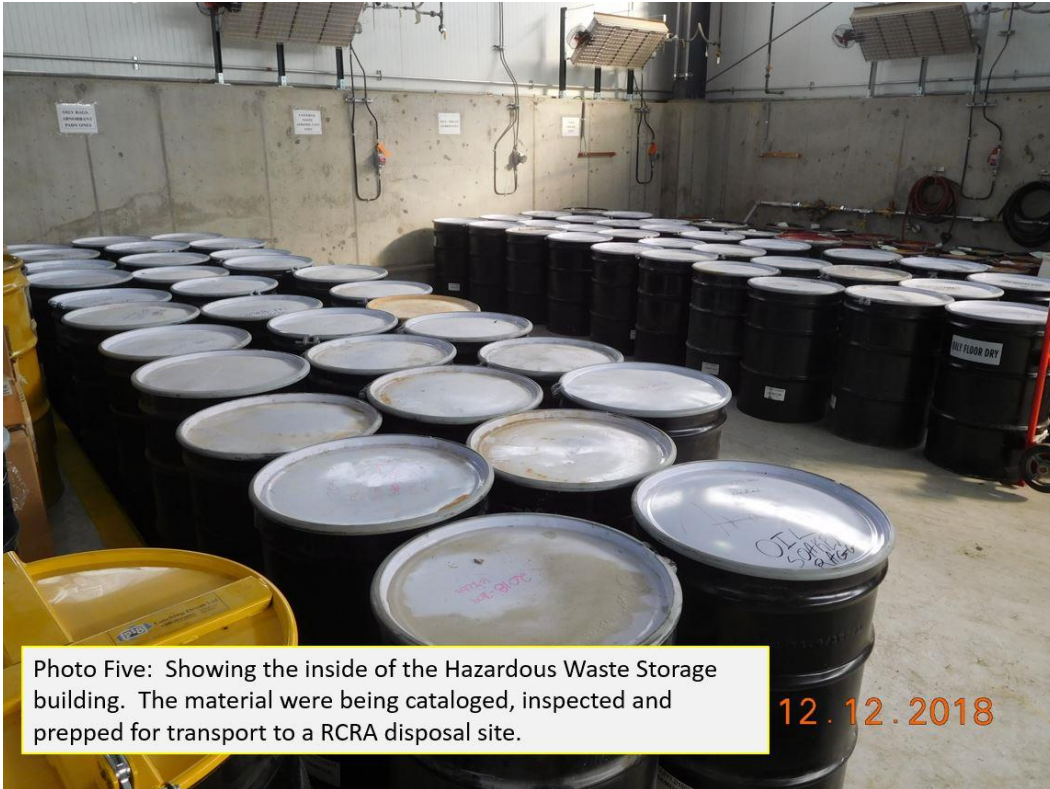
The Climax Mine facility is registered as a small quantity generator in compliance with all rules and regulations under the Resource Conservation and Recovery Act (RCRA). All hazardous waste that is generated by the site is stored in the Hazardous Waste Storage Building. During this inspection an active shipment of material was taking place. The material was being cataloged, sealed and loaded for transport to an appropriate hazardous waste disposal facility. Similar to the other buildings on site, the floor and apron of the building are designed as secondary containment. Most of the materials stored in the building are dry, however some liquids are stored. Some of the material being staged for transport can be seen in Photo Five.
