Re: Bowie Resources, LLC, Bowie No. 2 Mine
Coal Mine Waste Banks & Instrumentation Monitoring
Pond Quarterly Inspections
Permit C-1996-083

Coal Mine Waste Bank Nos. 1, 2, & 3 Inspections –4th Quarter 2018

Subject: Summary of Instrumentation Monitoring
4th Quarter 2018
Bowie Coal Waste Disposal Area No. 2
Paonia, Colorado

Subject: Summary of Instrumentation Monitoring
4th Quarter 2018
Bowie Coal Waste Disposal Area No. 3
Paonia, Colorado

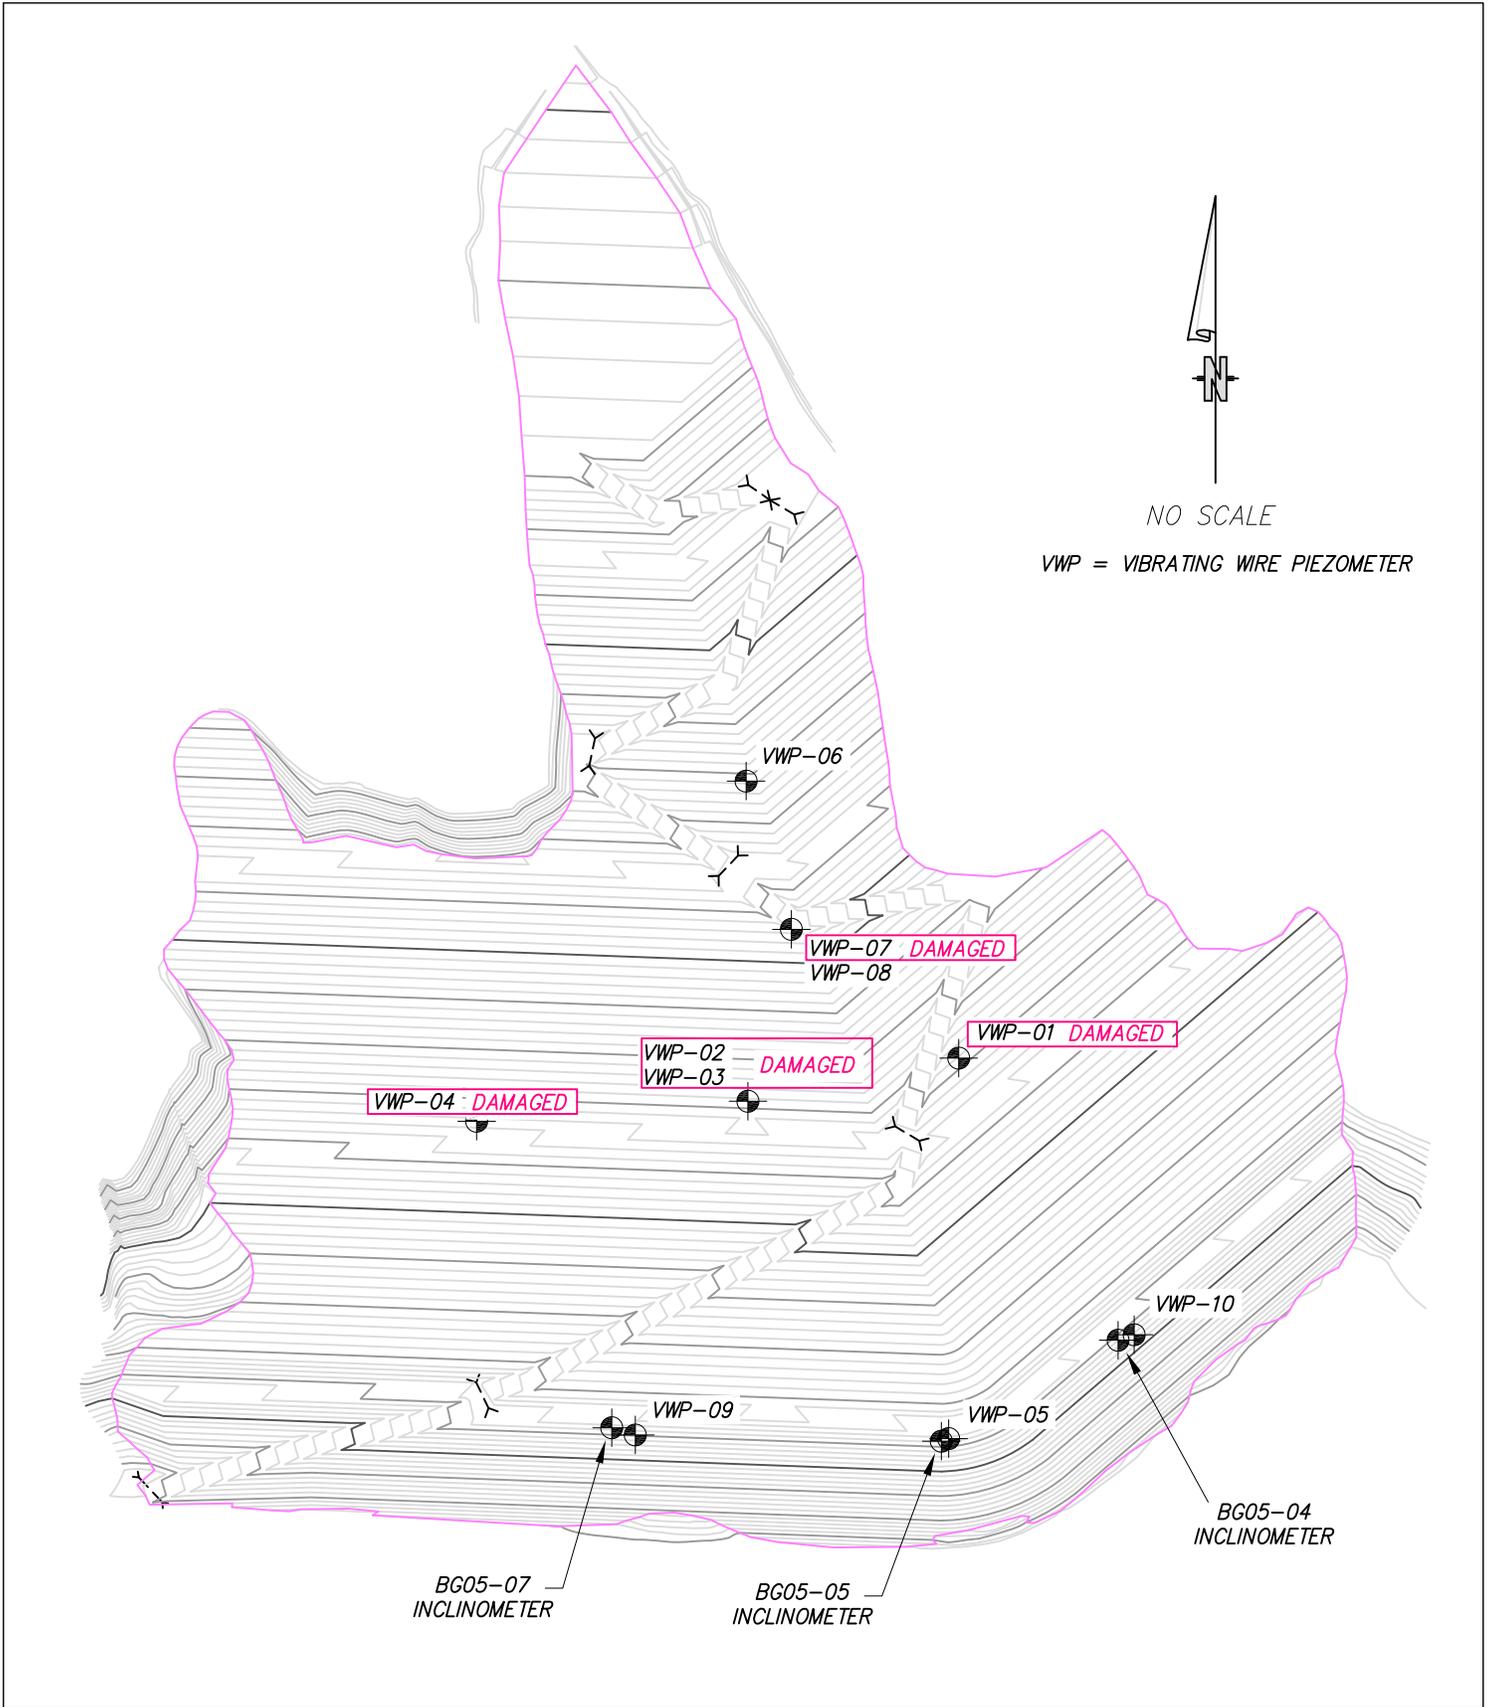
Map 1 OF 1		Huddleston-Berry BOWIE #2 GOB PILE DELTA COUNTY, COLORADO

The physical locations of the piezometers are shown on the attached Instrumentation Site Plan (Map 1). As seen on this map, five of the original VWP's were damaged and some were replaced. Currently, there are five active VWP's and three of them are adjacent to the three inclinometers. The graph of historical data from 5/16/05 through 5/21/14 is presented for reference as Figure 1. A graph of measured pore pressures of active piezometers is presented on the attached Figure 2 and is presented numerically in Table 1 below.

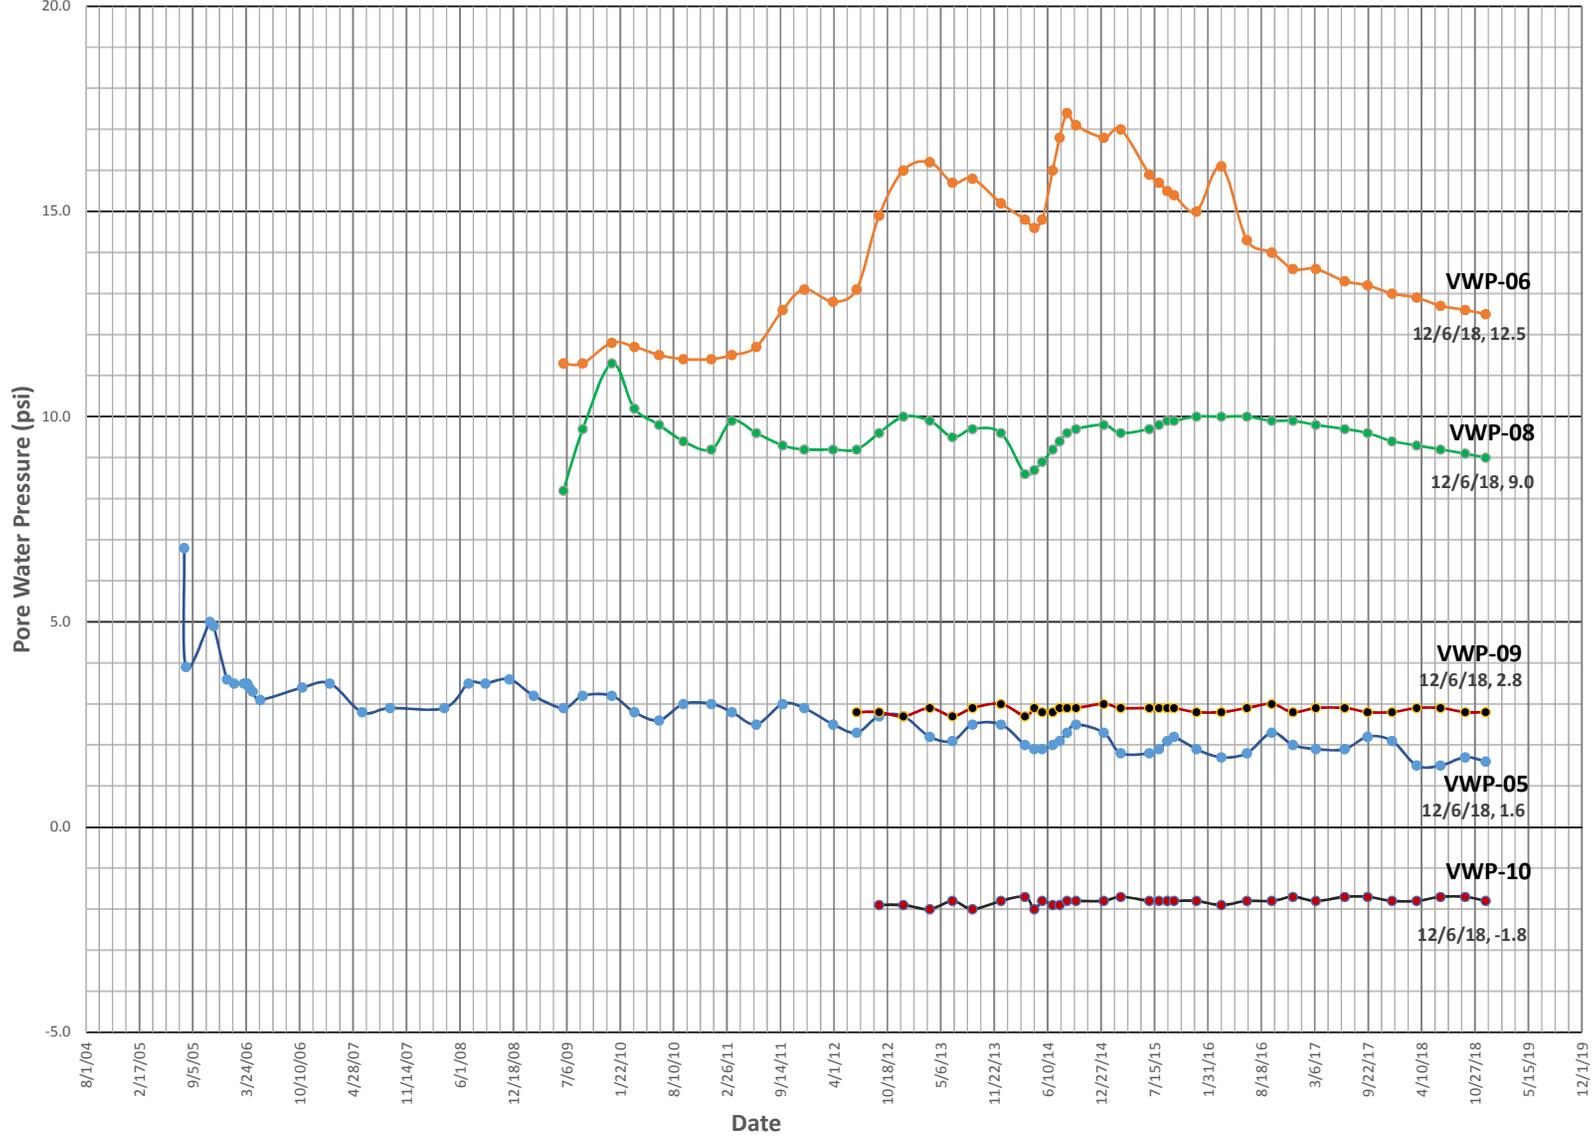
Figure 2 - Bowie Mine #2 - CWDA #2
Active Vibrating Wire Piezometer Data

VWP-05 was installed on August 3, 2005 near the toe of CWDA No. 2 adjacent to the access road/bench. The pore pressures recorded at VWP-05 have shown some seasonal fluctuations; however, the range of pore pressure changes is fairly small. In general, HBET does not believe that the pore pressures in VWP-05 are cause for concern regarding stability of the gob pile.

VWP-06 was installed on June 5, 2009 near the existing top of CWDA No. 2. The pore pressures recorded at VWP-06 have fluctuated since installation. In general, the fluctuations have been seasonal and reflect the level of coal mine waste placement activity on top of CWDA No. 2. In general, HBET does not believe that the measured pore pressures are an indication of any instability in CWDA No. 2.

VWP-08 was installed on June 5, 2009 at a slightly lower elevation than VWP-06. The pore pressures recorded at VWP-08 have fluctuated since installation. However, the fluctuations have generally been within a narrow range of values. The measured pore pressures are generally consistent with the level of coal mine waste placement activity at CWDA No. 2.

As indicated in the referenced *Stability Evaluation* report, the stability of CWDA No. 2 is sensitive to increases in pore pressures in VWP-08. An increase in the pore pressure of 7 psi in VWP-08 would result in a reduction of the Factor of Safety to below 1.5.

The current pore pressure reflects a piezometric surface elevation of approximately 6097 feet which is much less than the critical elevation of 6113 feet. As a result, HBET does not believe that the measured pore pressures in VWP-08 are any indication of instability in CWDA No. 2.

VWP-09 was installed on May 18, 2012 near the toe of CWDA No. 2. The pore pressures recorded at VWP-09 have been fairly steady since installation. This suggests that dewatering of the gob in this area is likely nearly complete. It is anticipated that the pore pressures at VWP-09 will remain fairly steady over time.

VWP-10 was installed on May 18, 2014 near the toe of CWDA No. 2. The pore pressures recorded at VWP-10 have been fairly steady since installation. This suggests that dewatering of the gob in this area is likely nearly complete. It is anticipated that the pore pressures at VWP-10 will remain fairly steady over time.

In general, based upon the results of the recent VWP and inclinometer monitoring data, HBET does not believe that there is any reduction in the stability of CWDA No. 2. Due to the limited activity at the mine, HBET recommends that the monitoring frequency be reduced to semi-annually.

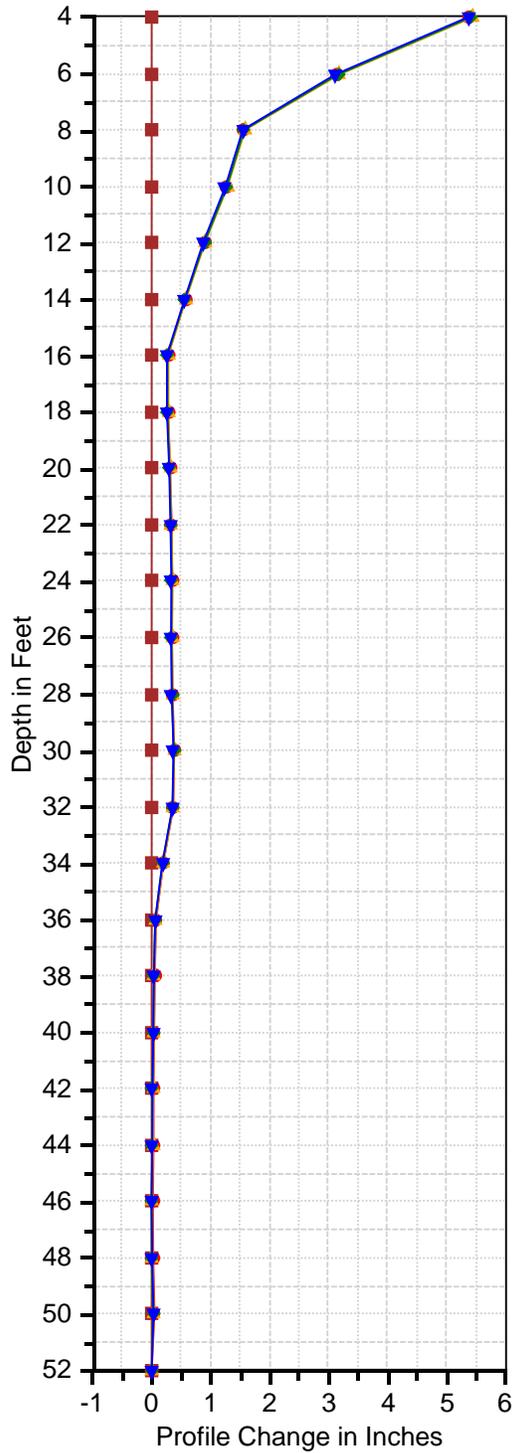
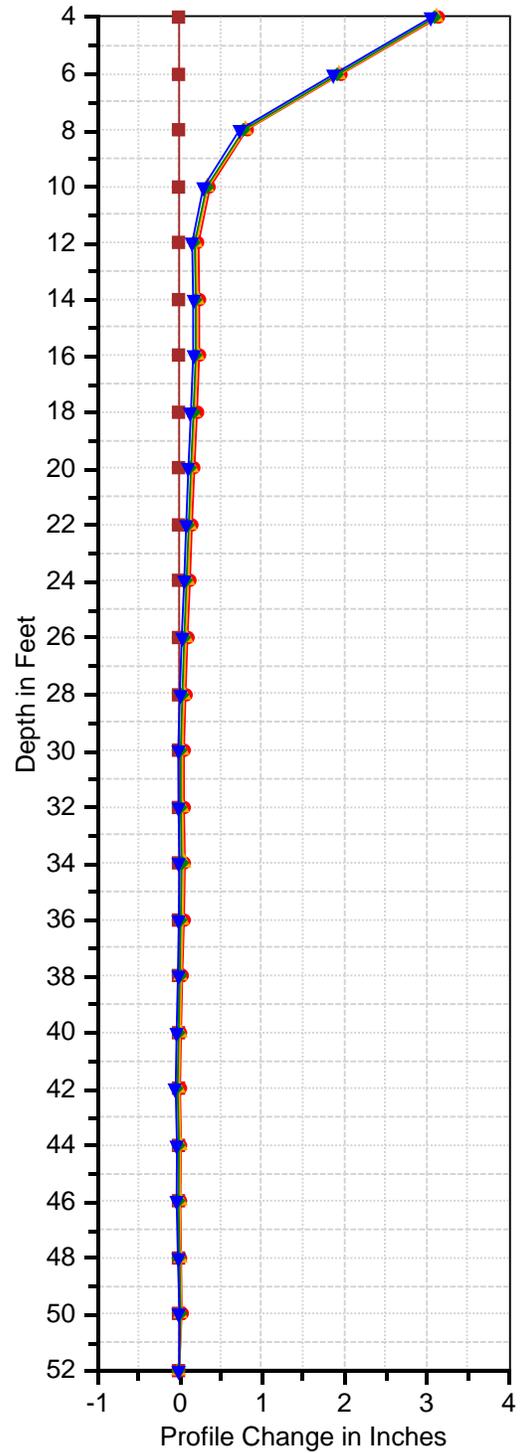
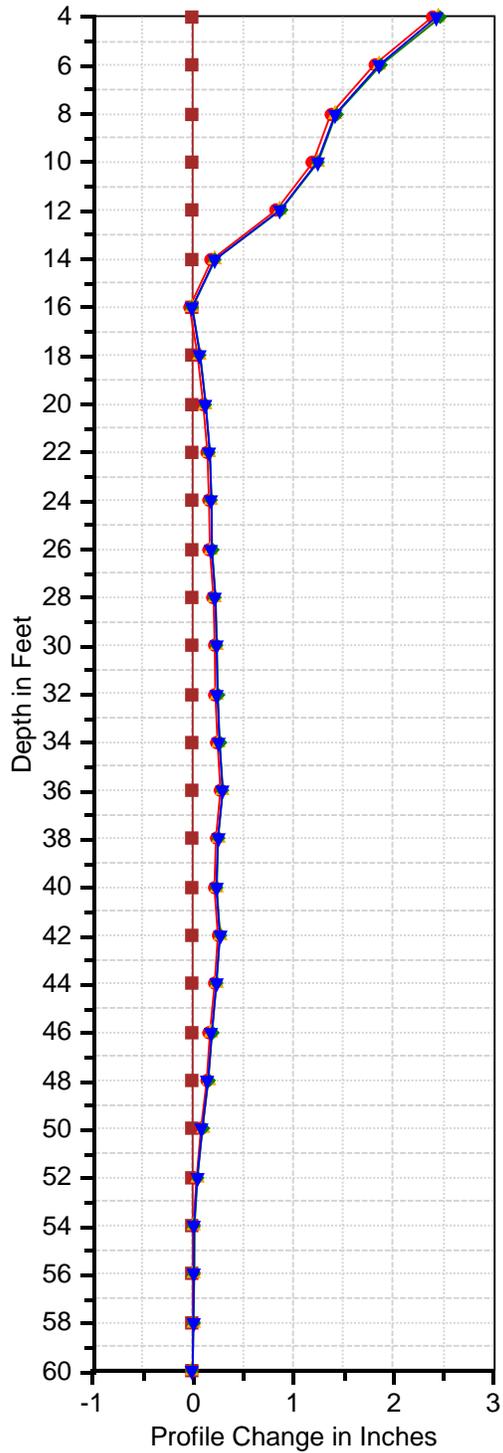
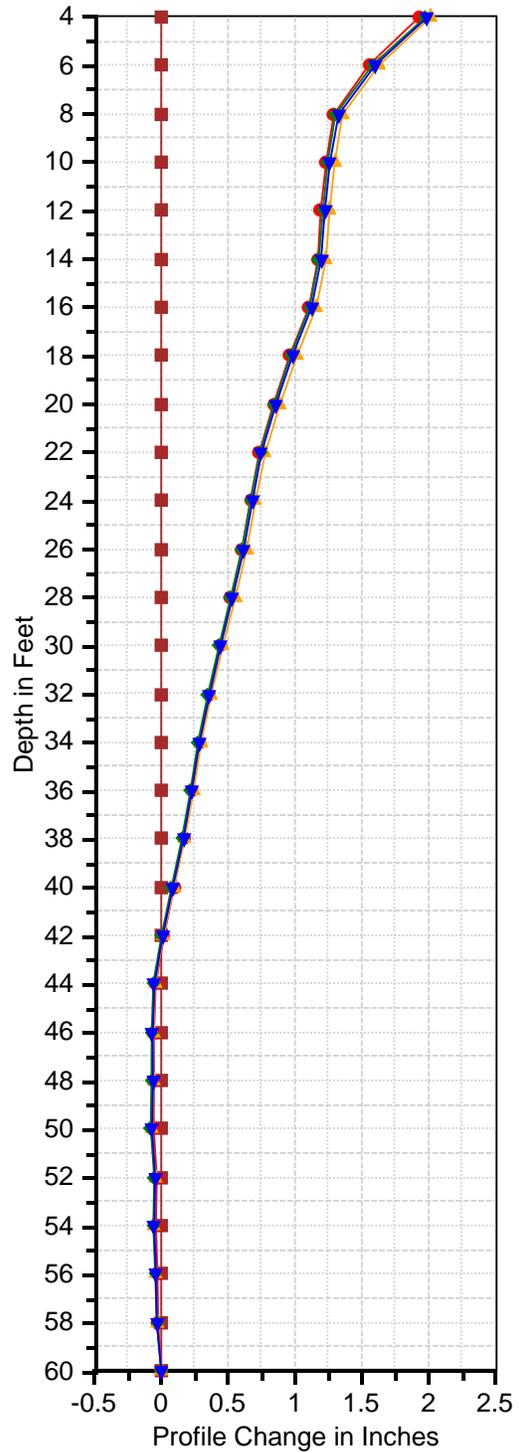
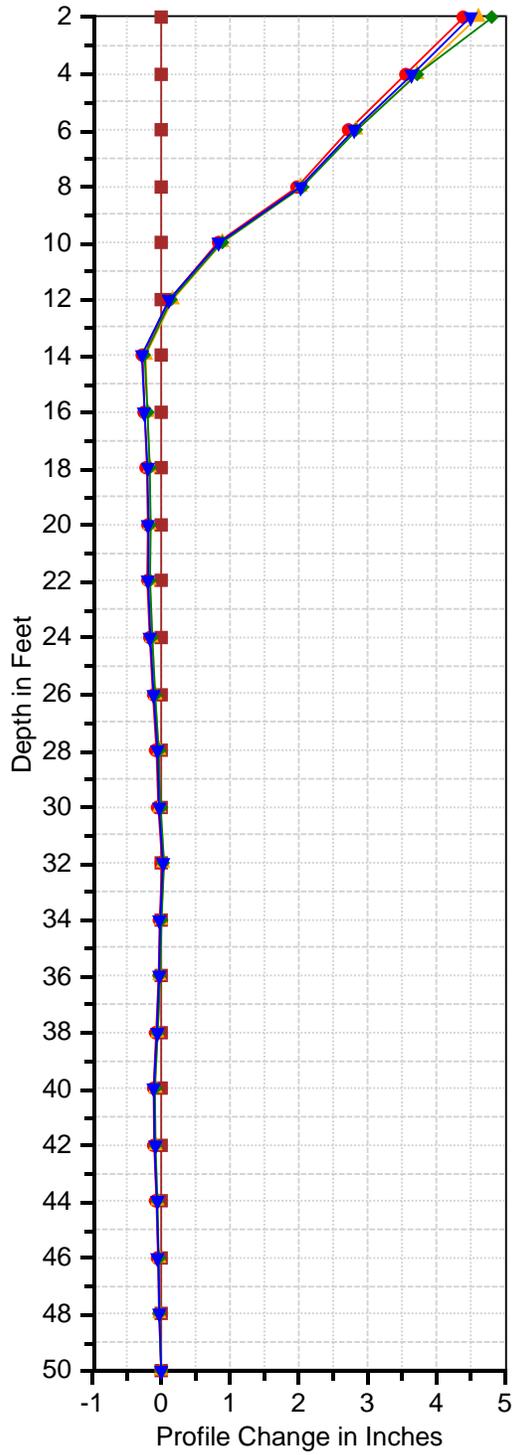
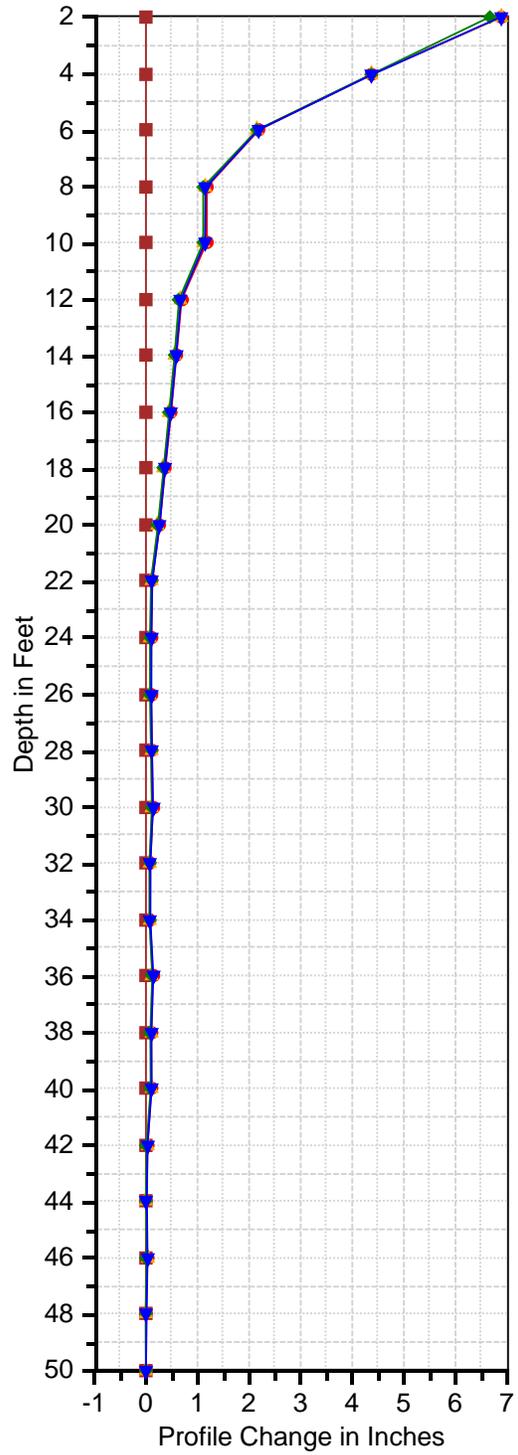
Figure 3. Displacement Curves for Inclinometers
4th Quarter 2018

The latest inclinometer readings indicate no major movements since the last quarterly reading. In general, the 4th Quarter 2018 monitoring data does not provide any indication of instability in CWDA No. 2.

As described in previous reports, we believe historic displacements indicated on the plots for the approximate upper ten feet of the inclinometers are likely due to placement of cover soil on the face of the waste bank during normal operations for maintenance and revegetation. Recent readings are generally consistent with previous readings.

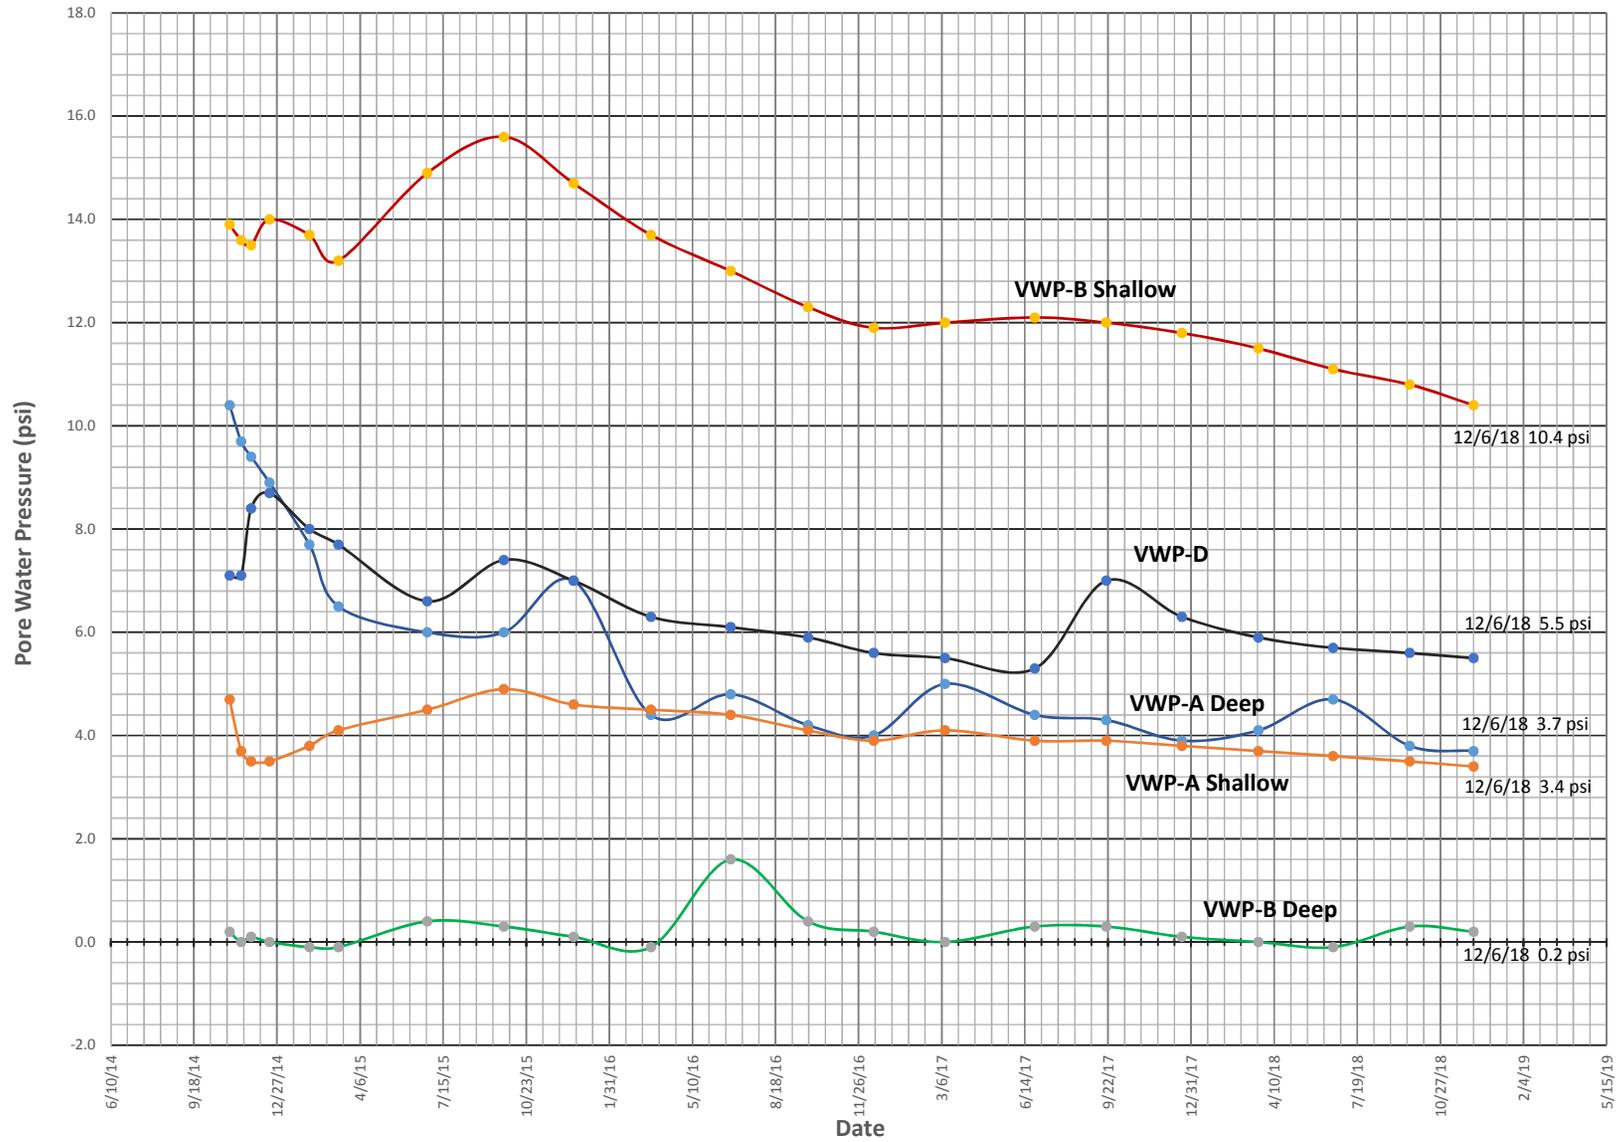
Figure 1 - Bowie Mine #2 - CWDA #3
Vibrating Wire Piezometer Data

VWP-A Deep was installed on October 6, 2014 near the northern edge of CWDA No. 3. VWP-A Deep was installed in the foundation soil approximately eight feet below the bottom of the gob. The pore pressures recorded at VWP-A Deep generally decreased since installation until September 2015. After that, the pore pressures have fluctuated within a narrow range. In general, HBET does not believe that the pore pressure changes in VWP-A Deep are cause for concern regarding stability of the gob pile.

VWP-A Shallow was installed on October 6, 2014 near the northern edge of CWDA No. 3. VWP-A Shallow was installed approximately ten feet above the base of the gob. After installation, the pore pressures dropped until November 2014. Between November 2014 and September 2015, increases in the pore pressures were recorded at VWP-A Shallow. However, between September 2015 and December 2016, the pore pressures decreased. Since then, the data have fluctuated within a narrow range with a general downward trend. In general, HBET does not believe that the pore pressure changes in VWP-A Shallow are an indication of instability in CWDA No. 3.

VWP-B Deep was installed on October 6, 2014 in the west-central portion of CWDA No. 3. VWP-B Deep was installed in the foundation soil approximately ten feet below the bottom of the gob. Since installation, the pore pressures recorded at VWP-B Deep have fluctuated within a narrow range. In general, HBET does not believe that the pore pressure changes in VWP-B Deep are an indication of instability in CWDA No. 3.

VWP-B Shallow was installed on October 6, 2014 in the west-central portion of CWDA No. 3. VWP-B Shallow was installed approximately ten feet above the base of the gob. Since installation, the pore pressures recorded at VWP-B Shallow have fluctuated with periods of slight increase and slight decrease. However, the last several readings have shown a general downward trend. In general, HBET does not believe that the pore pressure changes in VWP-B Shallow are an indication of instability in CWDA No. 3.

VWP-D was installed on October 7, 2014 in the east-central portion of CWDA No. 3. VWP-D was installed approximately ten feet above the base of the gob. Since installation, the pore pressures recorded at VWP-D have fluctuated. The pore pressures increase slightly during the 3rd Quarter of 2017. However, this likely reflects the activity at CWDA No. 3 during the monitoring period and the pore pressures have decreased since September 2017. In general, HBET does not believe that the pore pressure changes in VWP-D are an indication of instability in CWDA No. 3.

As seen on Figure 1, the readings are either consistent with previous historic readings or show a trend of generally decreasing pore pressure. If you have any questions regarding this letter or the instrumentation monitoring at CWDA #3, please contact me at (907) 562-2000 or jholland@dowl.com.

Based upon the results of the most recent VWP monitoring data, HBET does not believe that there is any reduction in the stability of CWDA No. 3. Due to the limited activity at the mine, HBET recommends that the monitoring frequency be reduced to semi-annually.
