MINERALS PROGRAM INSPECTION REPORT
PHONE: (303) 866-3567

MINE NAME: Cherokee Clay Mine	MINE/PROSPECTING ID#: M-1977-325	MINERAL: Clay (general)	COUNTY: Fremont
INSPECTION TYPE: Monitoring	INSPECTOR(S): Timothy A. Cazier	INSP. DATE: August 1, 2018	INSP. TIME: 13:15
OPERATOR: The Summit Pressed Brick and Tile Company	OPERATOR REPRESENTATIVE: Mike Leidich & Mark Jesik	TYPE OF OPERATION: 110c - Construction Limited Impact	
REASON FOR INSPECTION: Normal I&E Program	BOND CALCULATION TYPE: Partial Bond	BOND AMOUNT: \$18,500.00	
DATE OF COMPLAINT: NA	POST INSP. CONTACTS: None	JOINT INSP. AGENCY: None	
WEATHER: Cloudy	INSPECTOR'S SIGNATURE:

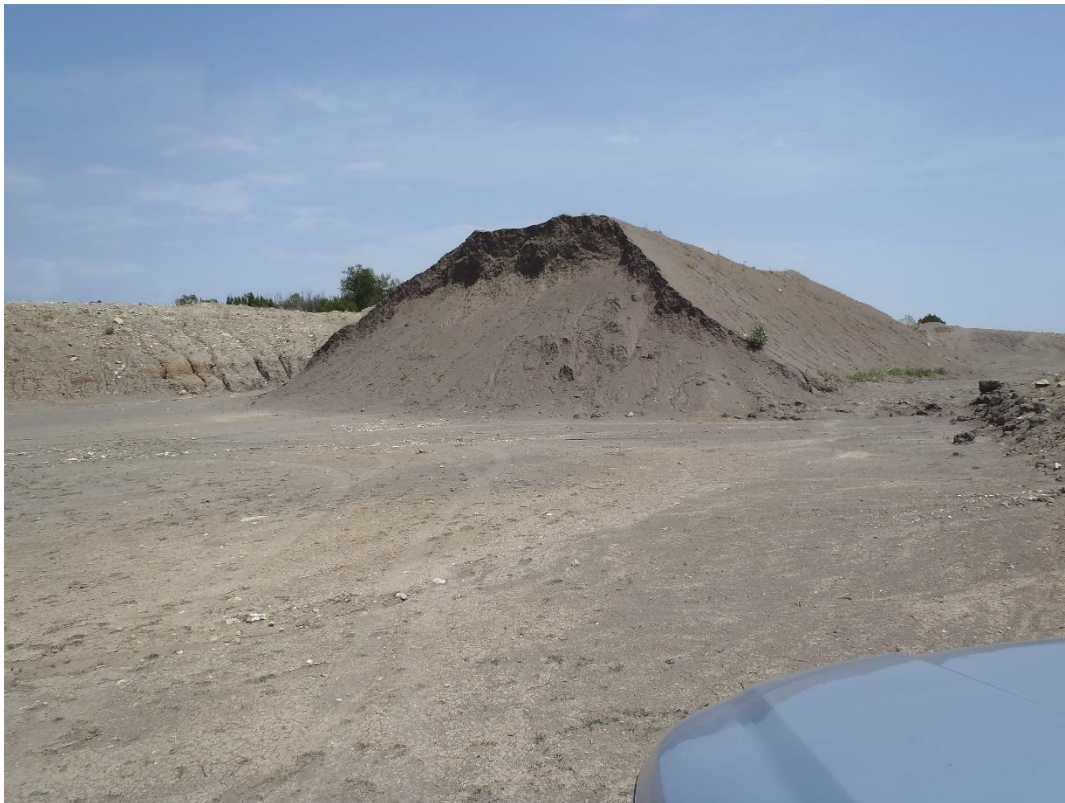
Gen. Compliance with Mine Plan: The operation appeared to be in compliance with the approved mine plan. Stockpiled material showing evidence of recent material removal was observed in the center of the site, near the west end (see **Photo 1**). Google Earth was used to measure the disturbed area, which was estimated to be approximately 4 acres, based on 2016 imagery. Highwalls were estimated to vary between 10 and 12 feet in height, sloped at roughly 2H:1V, and appeared stable (see **Photo 2**).

Photo 1. Stockpiled material showing evidence of recent material removal (looking east).

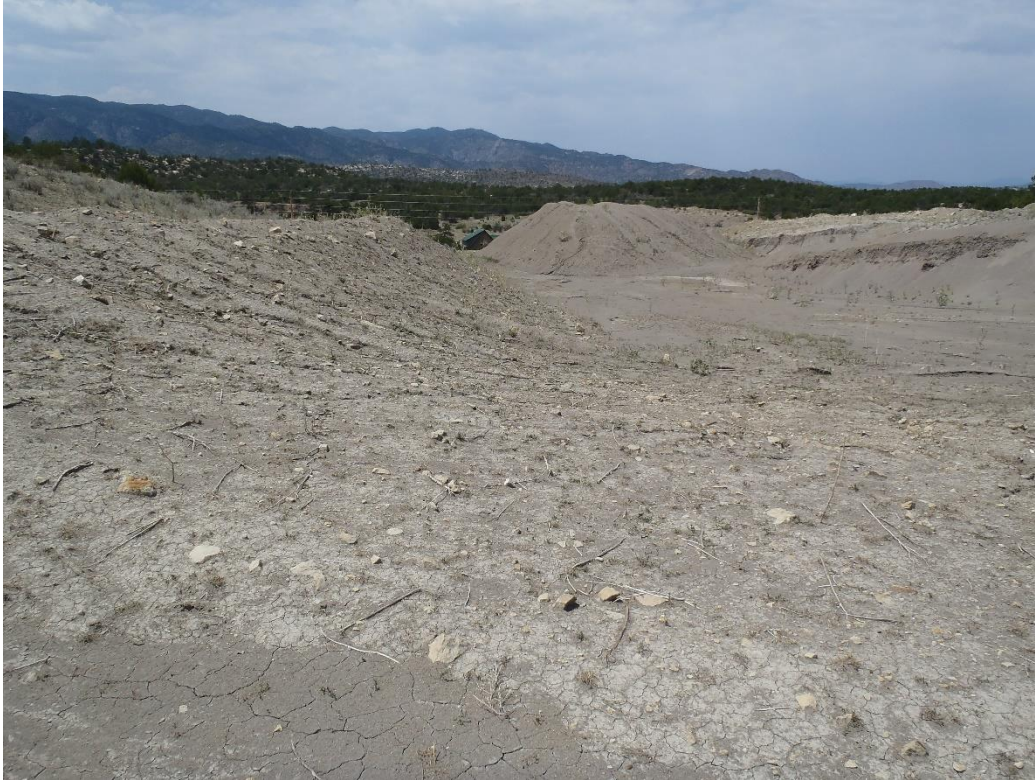
Photo 2. South side highwalls sloped between 2H:1V and 3H:1V (looking NW).

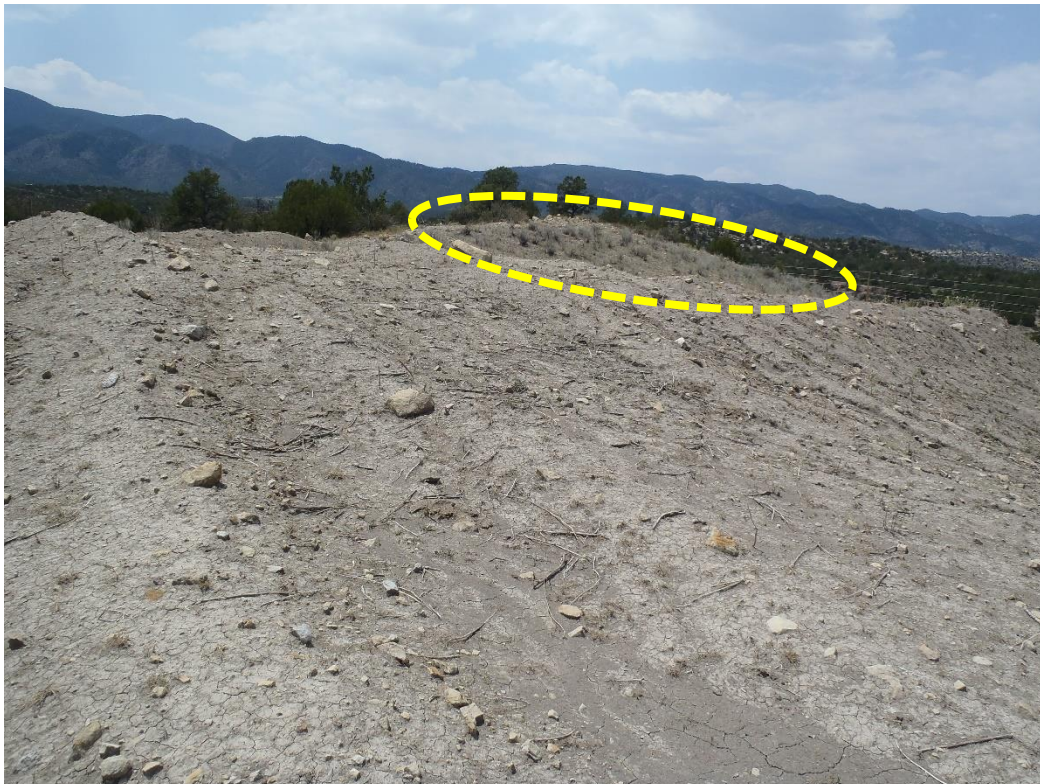
Revegetation: Some revegetation has been initiated on the south side of the site (see **Photo 3**). No noxious weeds were observed.

Photo 3. Some revegetation initiated on the south side of the site (looking west from east end).

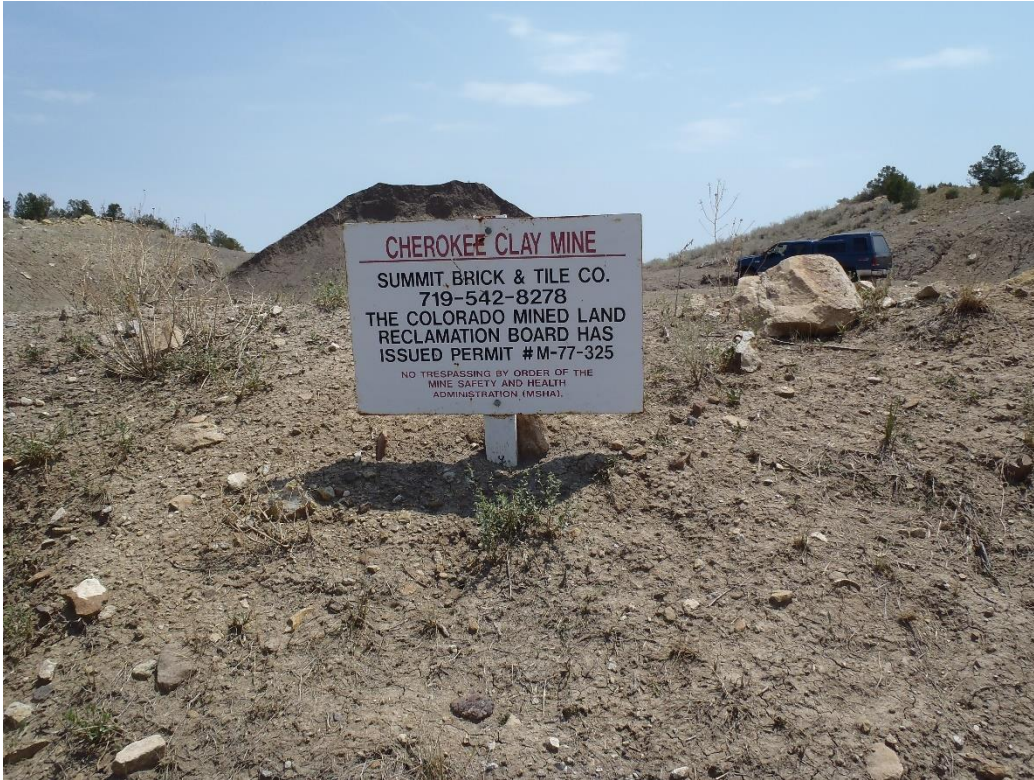
Signs and Markers: The permit sign was properly posted (see **Photo 4**). The southeast boundary marker was observed, delineating that corner of the permit boundary. The northern boundary markers were not located as mining has not progressed near the northern extents of the permit area. Mine personnel should verify these markers are in place prior to disturbing any area to the north.

Photo 4. Permit sign.
