MINERALS PROGRAM INSPECTION REPORT
PHONE: (303) 866-3567

MINE NAME: Caldwell-Nesselhuf Pit No. 1	MINE/PROSPECTING ID#: M-1997-071	MINERAL: Sand and gravel	COUNTY: Crowley
INSPECTION TYPE: Monitoring	INSPECTOR(S): Patrick Lennberg and Michael Cunningham	INSP. DATE: December 20, 2018	INSP. TIME: 10:40
OPERATOR: William & Beverly Caldwell and Albert & Lola Nesselhuf	OPERATOR REPRESENTATIVE: Gail and Charles Zimmerman, Frank Nusselhuf	TYPE OF OPERATION: 112c - Construction Regular Operation

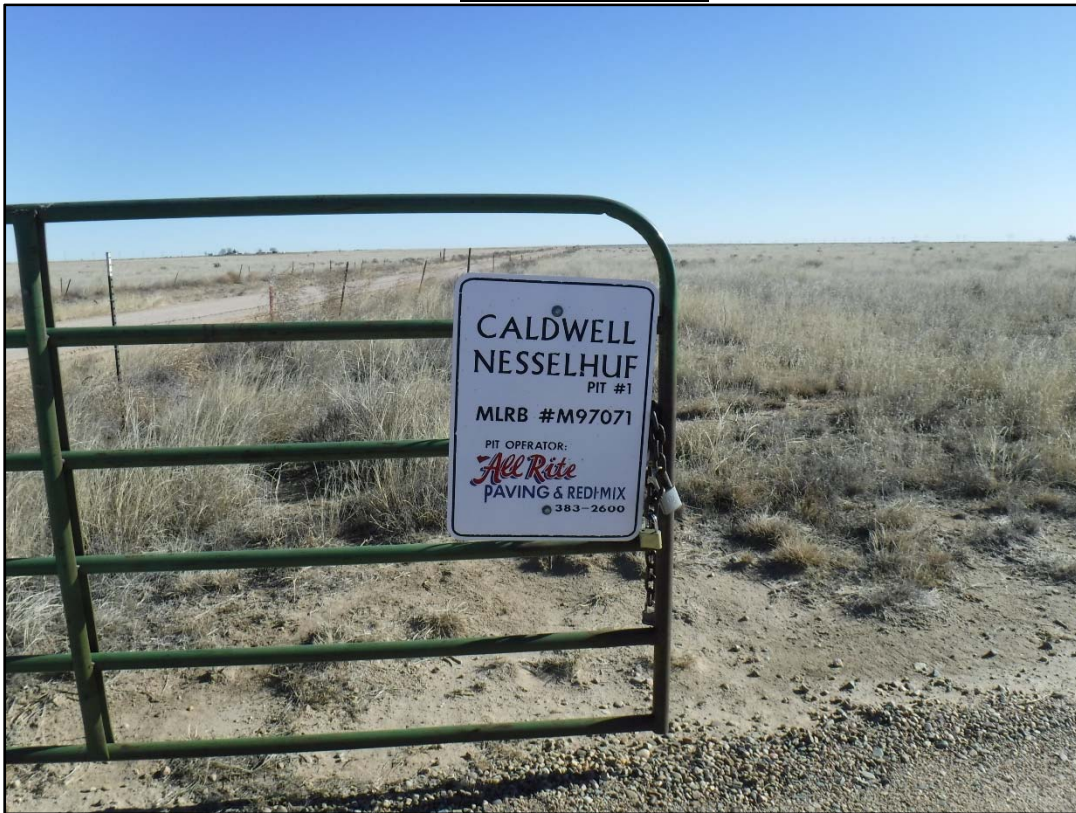
Photo 1: Mine sign at entrance off of County Road A 5/10

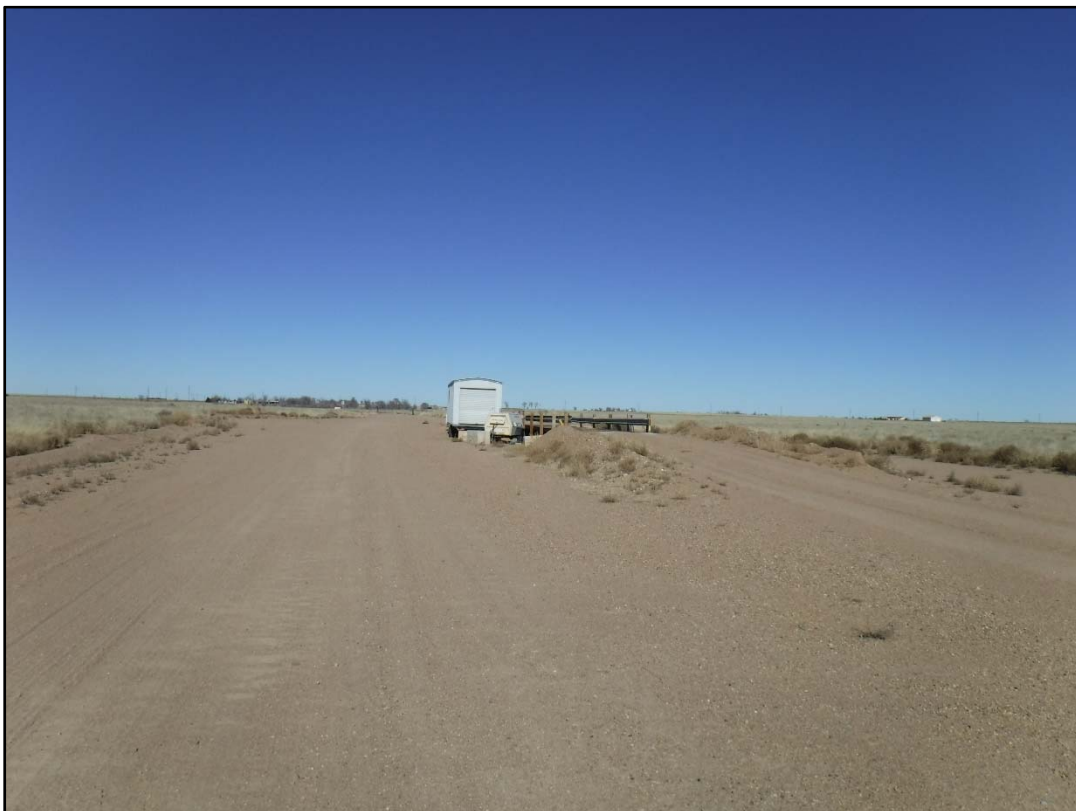
Additionally, in the original permit application a scale house was not identified as being part of the mine operations. The scale house was installed by All-Rite between late 2014 and 2015. The haul road has been substantially improved from the prevailing conditions that existed during the operation's limited use in the past. The land affected outside of the permit boundary, approximately 1.4 acres, is being cited as a Possible Violation pursuant to C.R.S. 34-32.5-116(4)(i) for failure to protect areas outside of the affected land from damages occurring during the mining operation. New or improved roads must be included as part of the permitted acreage. The upgraded haul road and scale house may require additional financial warranty for reclamation costs.

Photo 2: Looking north at the scale house.

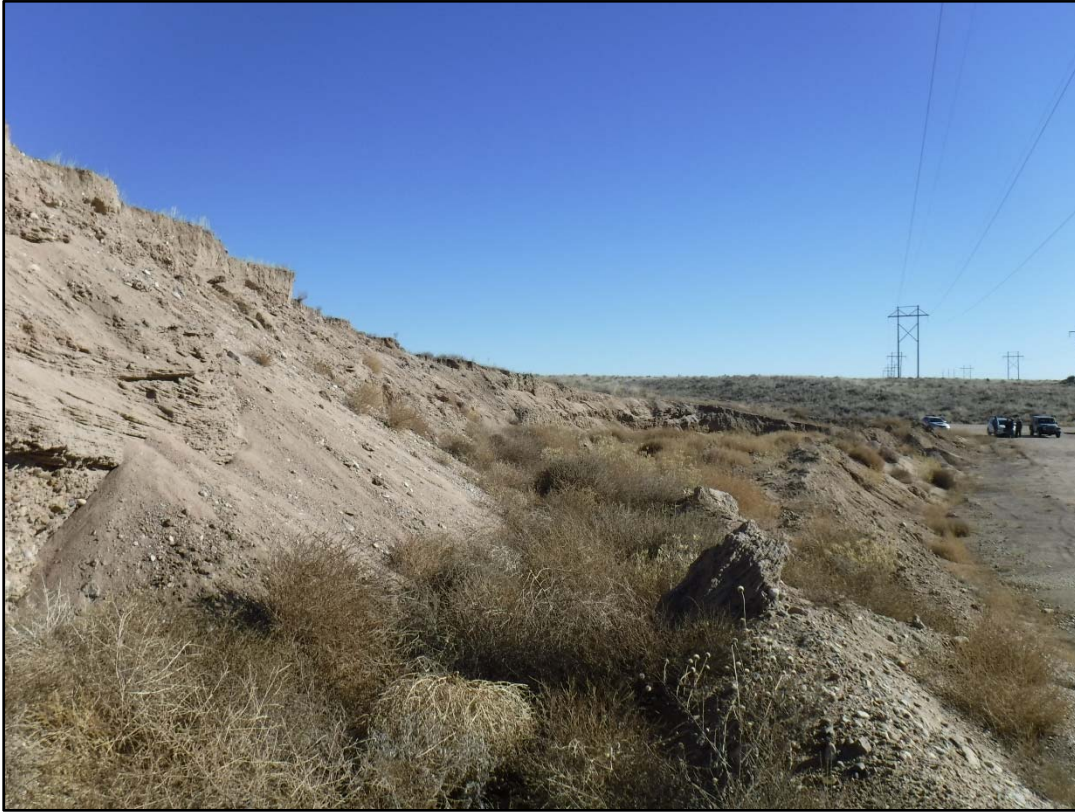
During the inspection there were a few highwalls that were steeper than the 2H:1V and this is being cited as a

Problem pursuant to C.R.S. 34-32.5-112 (1)(c)(VI) as the current mining plan does not allow for mining highwalls at a steeper grade than 2H:1V. The pit floor is flat and water entering the pit does not flow out.

Photo 3: Typical mining face along the northern edge of affected land.

CORRECTIVE ACTIONS: The operator will grade all high walls to approved 2H:1V or shallower. Proof of compliance may be in the form of detailed photographs.

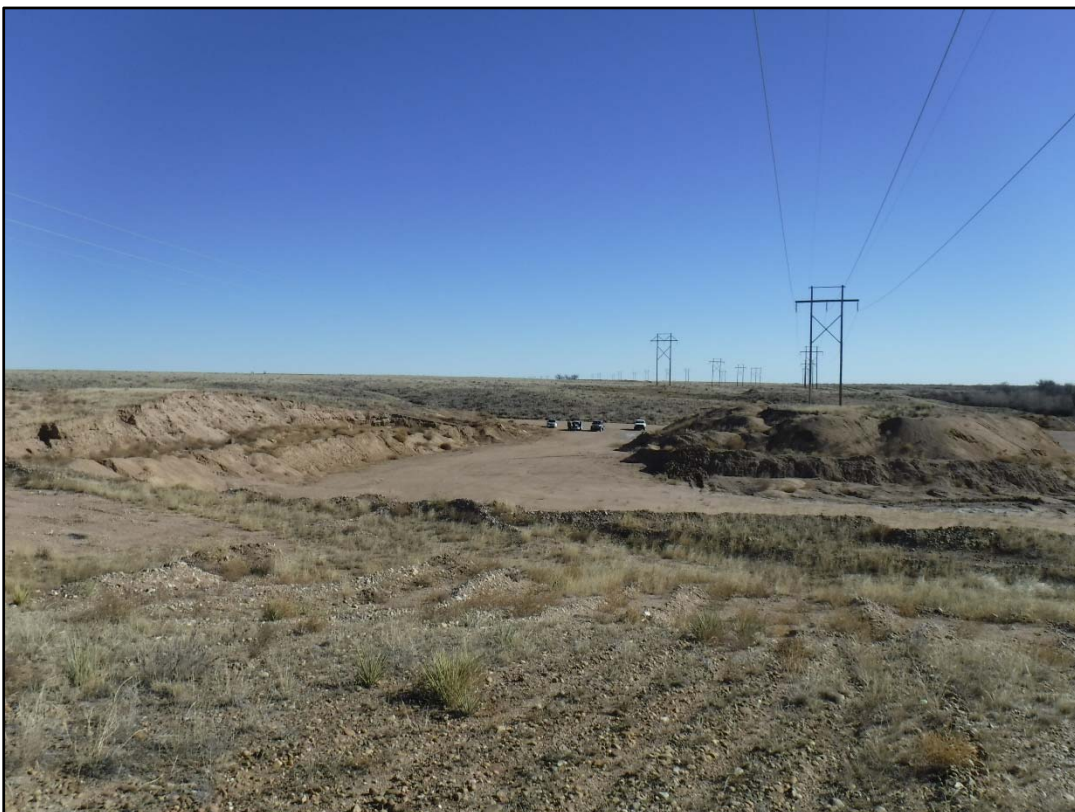
A review of the permit file after the inspection showed that there is only one power line operator, Tri-State Power, which has given permission for mining around power poles. There are additional power lines that are within 200 feet of affected lands. Not having sufficient structure agreements is being cited as a Problem pursuant to C.R.S. 34-32.5-115 (4)(e) and Rule 6.4.19. Currently, the operator does not have structure agreements for the power lines that are to the north of the Tri-State lines and the power poles that run along the southern boundary near the river. The operator will have to obtain new and/or updated agreements with the power line owners.

Photo 4: Looking east across the pit, note the power lines that cross the permit area.

CORRECTIVE ACTIONS: The operator must submit a notarized letter or agreement in accordance with Rule 6.4.19 addressing the potential for damage to the powerlines. If an agreement cannot be reached the operator can provide an engineering evaluation that the structures shall not be damaged by activities occurring at the mining operation.

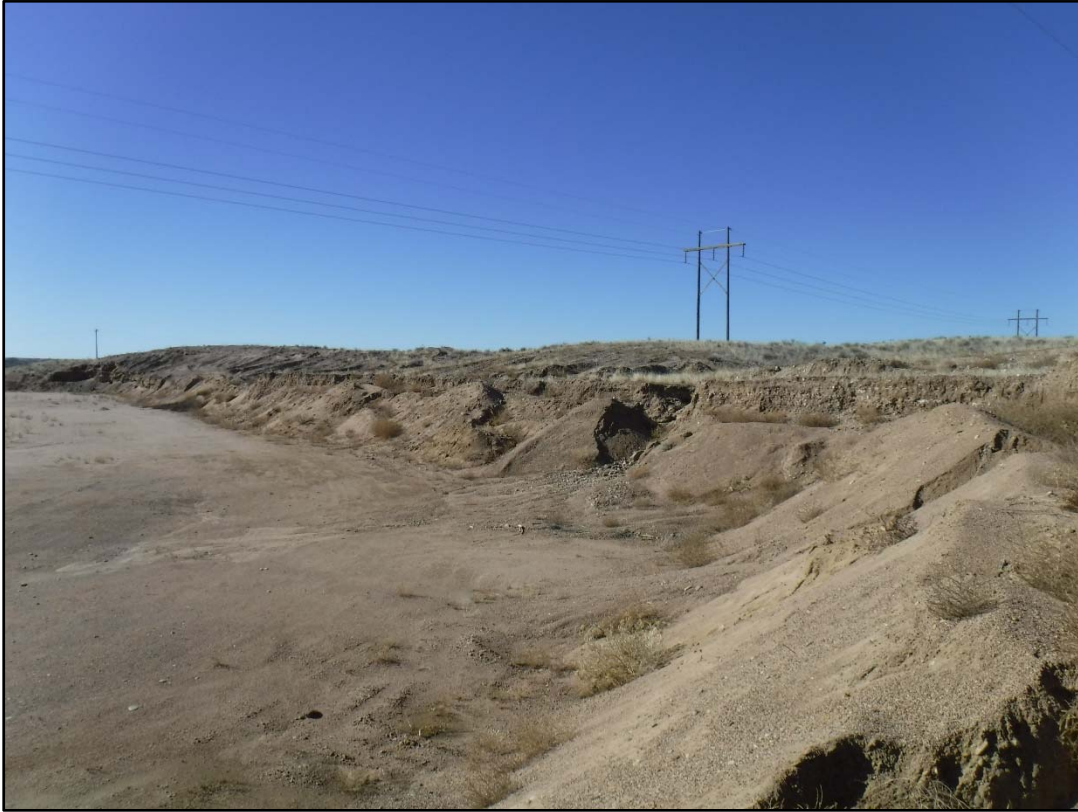
Photo 5: Looking southwest at the mining face that makes up the western edge of the pit.

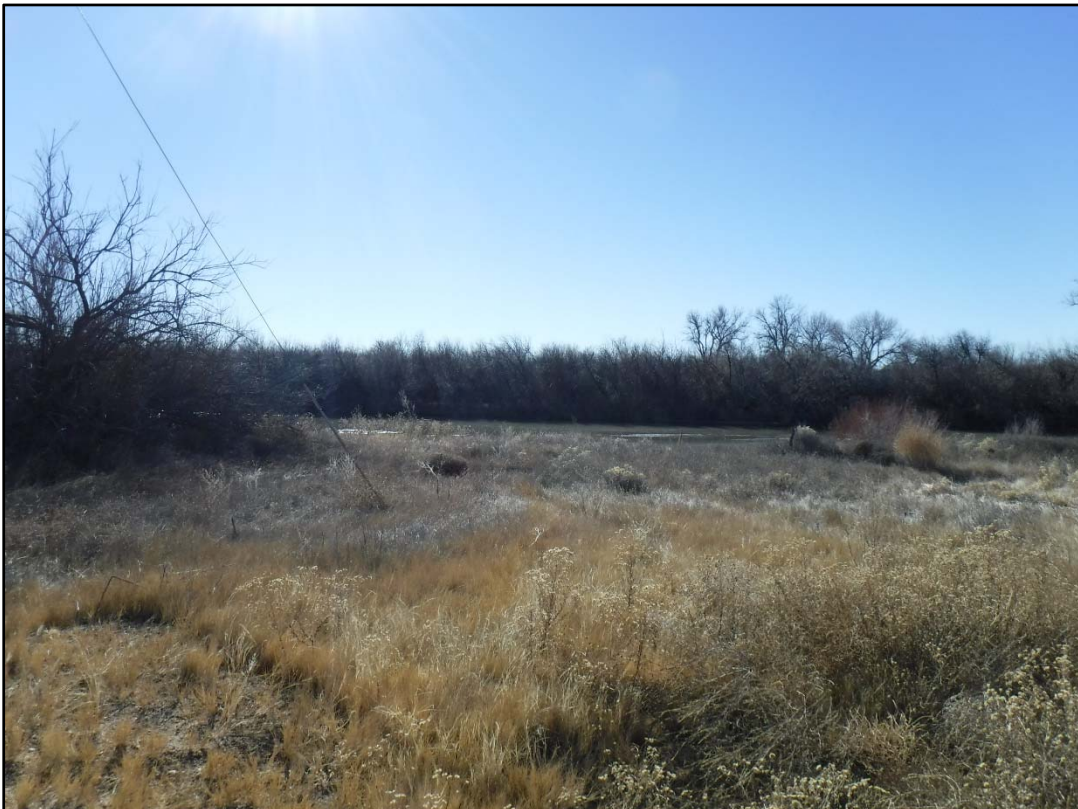
PROBLEM/POSSIBLE VIOLATION: Problem: During the inspection it was discovered that the operator allowed affected lands to come within 75 feet of the Arkansas River. This is a problem pursuant to C.R.S. 34-32.5-112 (1)(c)(VI) for failure to follow the approved mine plan.

Photo 6: Looking south from the edge of affected land towards the Arkansas River, 75 feet to river bank.

CORRECTIVE ACTIONS: The operator will reestablish the 200 foot buffer along the river, reclaim all affected land, and clearly identify and mark the 200 foot buffer zone. Proof of compliance may be in the form of detailed photographs.

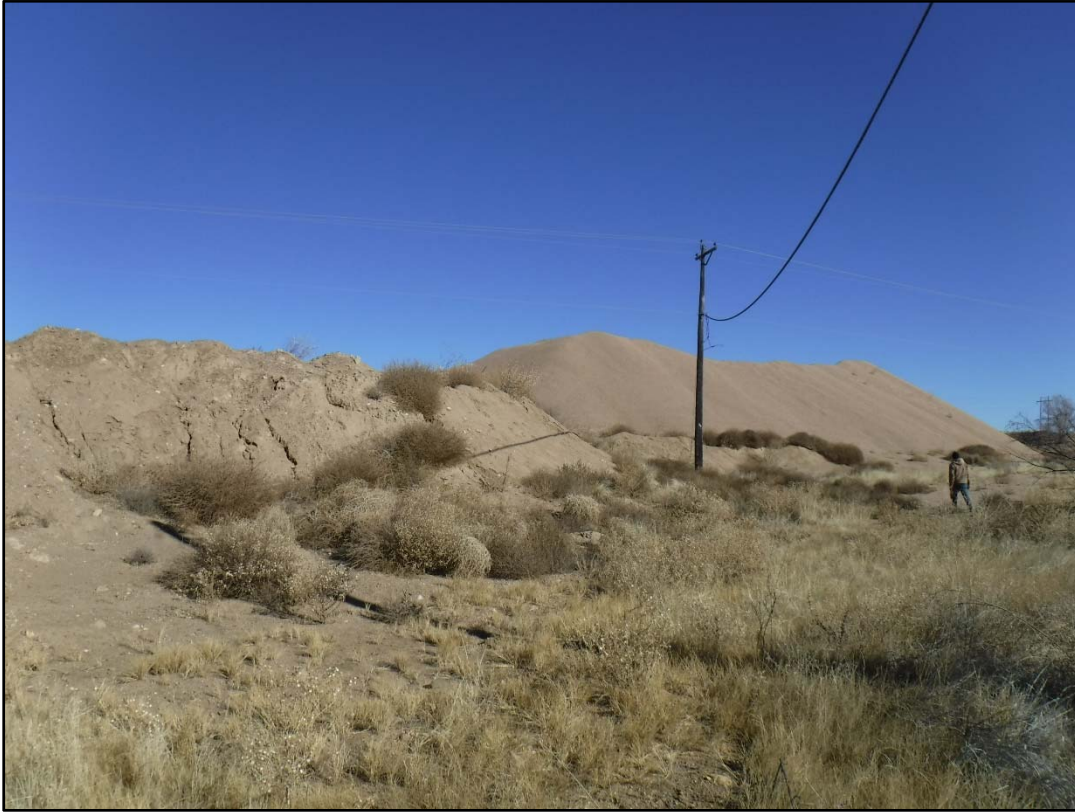
In the original permit application, the Operator agreed to keep a 200 foot buffer between affected land and the Arkansas River, as well as a 25 foot radius around all power poles that are within the permit boundary. During the inspection it was noted that mining had encroached to within 17 feet of the power pole that is located in the northern section of the currently mined area. However, material had been replaced to buttress the pole and currently the off-set measures 35 feet from the pole. During the inspection, the Division used a measuring tape to determine the product stockpiles in the southern portion of the mine have encroached to within 75 feet of the Arkansas River. This matter is being cited as a Problem in this report pursuant to C.R.S. 34-32.5-112 (1)(c)(VI) for failure to conduct mining as described in the mining plan.

Photo 7: Looking north from the southern edge of affected land towards stockpiles, note proximity of stockpiles to power pole.

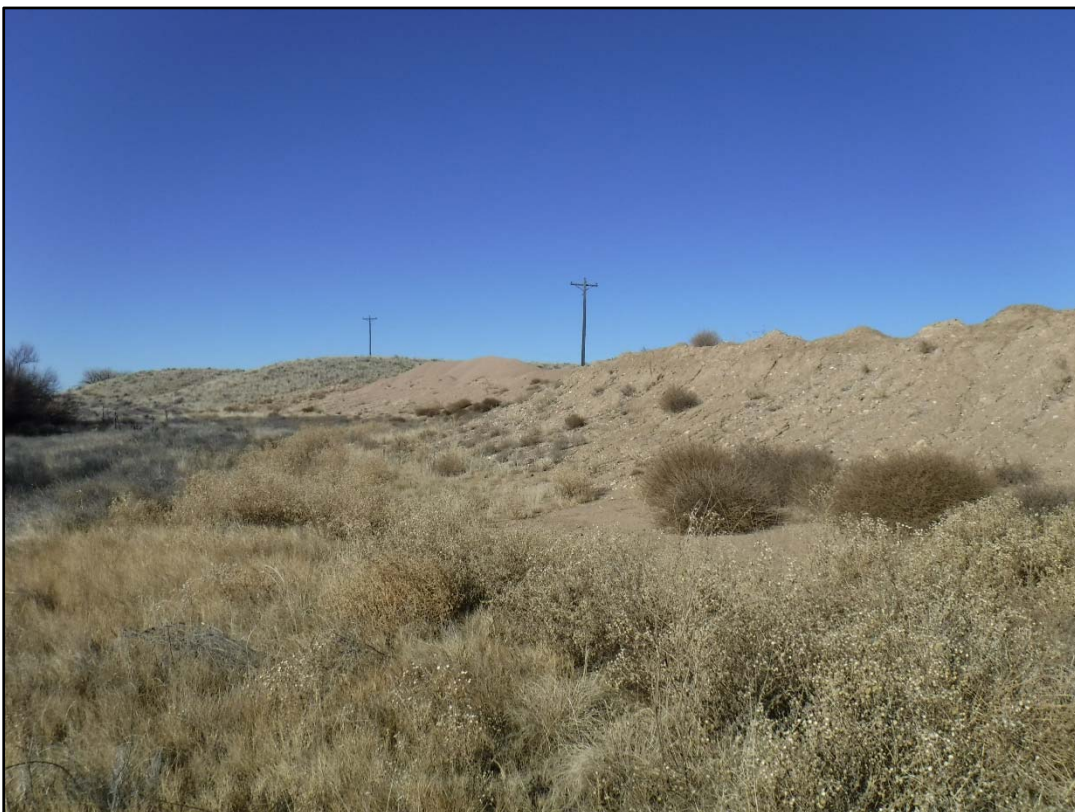
Photo 8: Looking west from the southern edge of affected land.

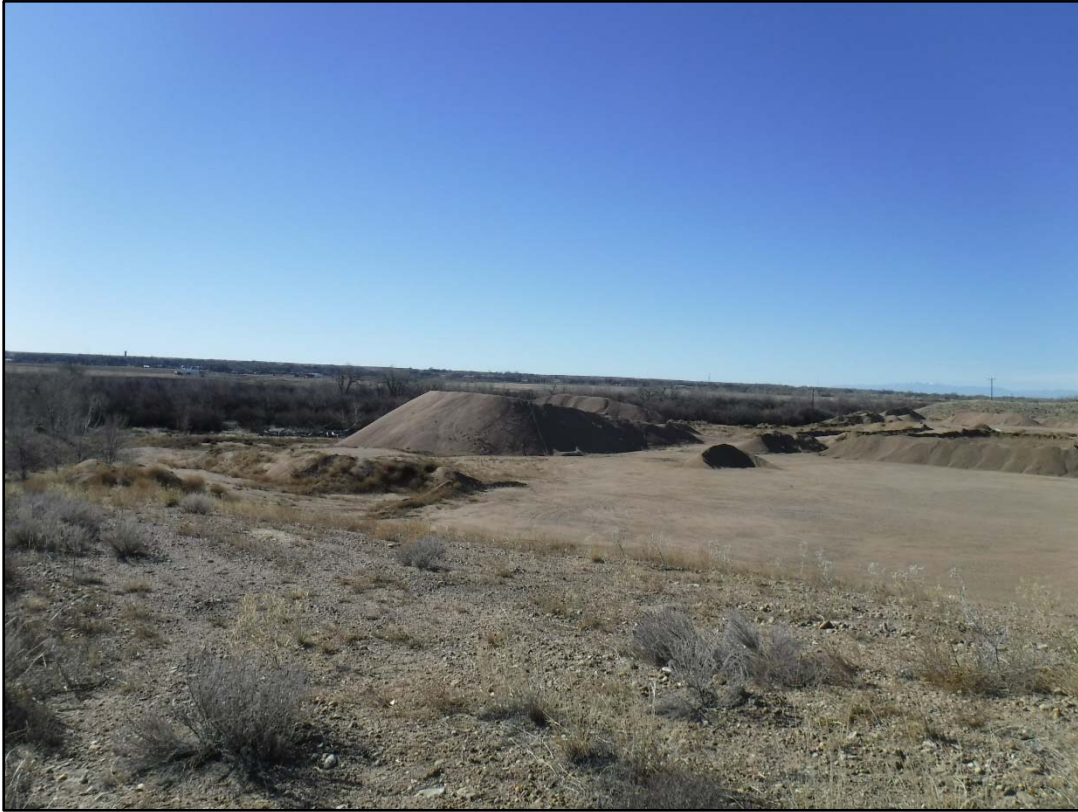
Photo 9: Typical stockpiles of material remaining at the site.

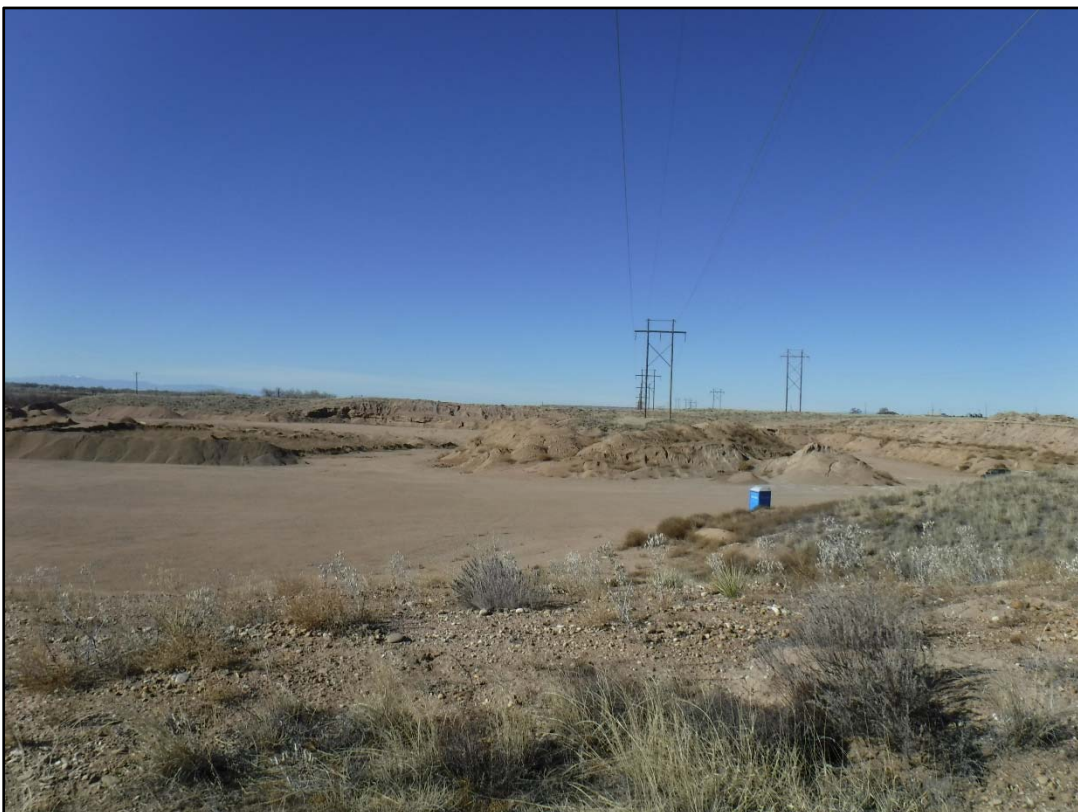
Photo 10: Looking west across the mine pit.

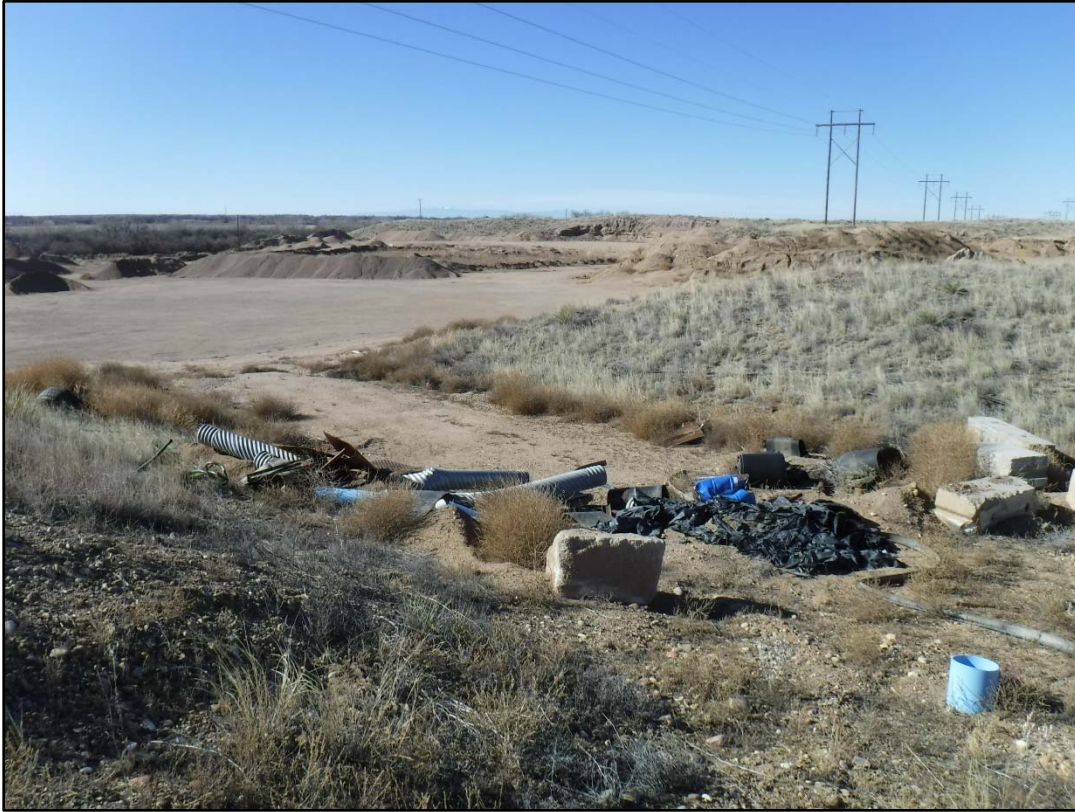
Photo 11: Debris left behind from recent mining operations.

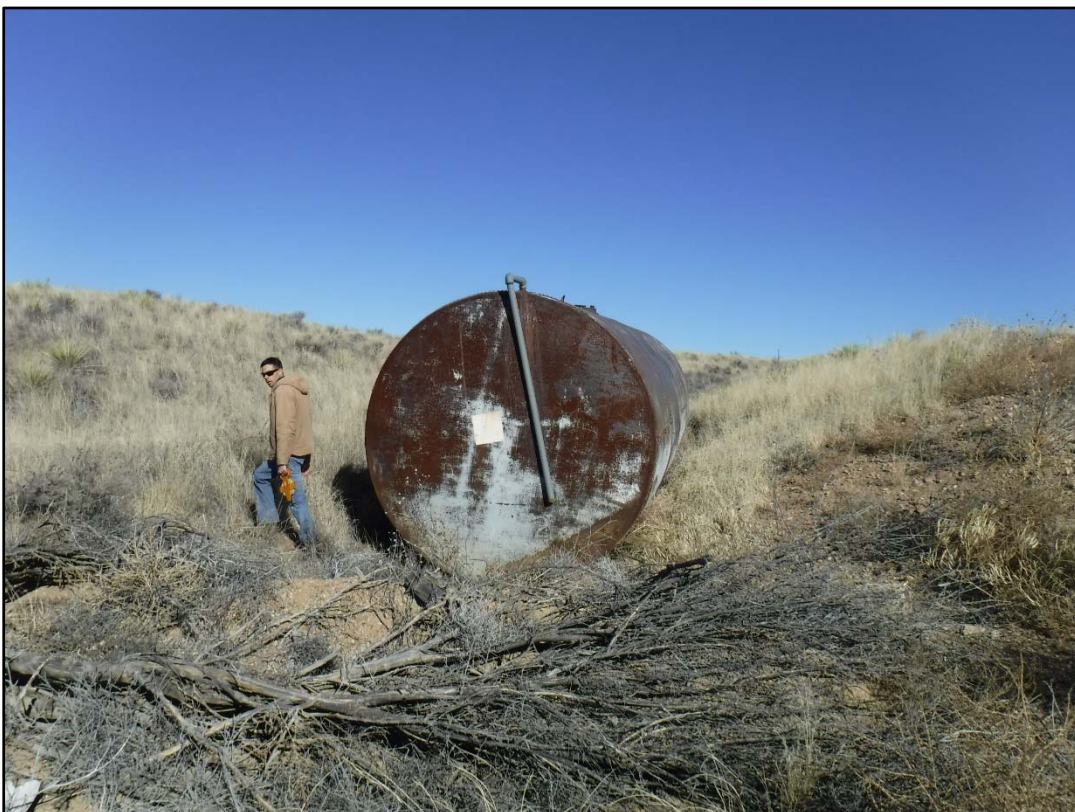
On the east side of the mining area a minor amount of metal debris was found in a small drainage. Associated with this debris was an approximately 2,000 gallon capacity metal underground storage tank. It is not clear where the tank came from or what it may have contained. It is currently not being used and has a rock plugging the drain spigot. The operator was unaware of the debris that has been deposited in the small drainage. Pursuant to C.R.S. 34-32.5-116 (4)(e), a duty of the operator, all refuse shall be disposed of in manner that controls unsightliness or deleterious effects of such refuse. Also, all storage tanks, petroleum and any hazardous materials on site for any period of time shall have appropriate secondary containment.

Photo 12: Metal underground storage tank in drainage.

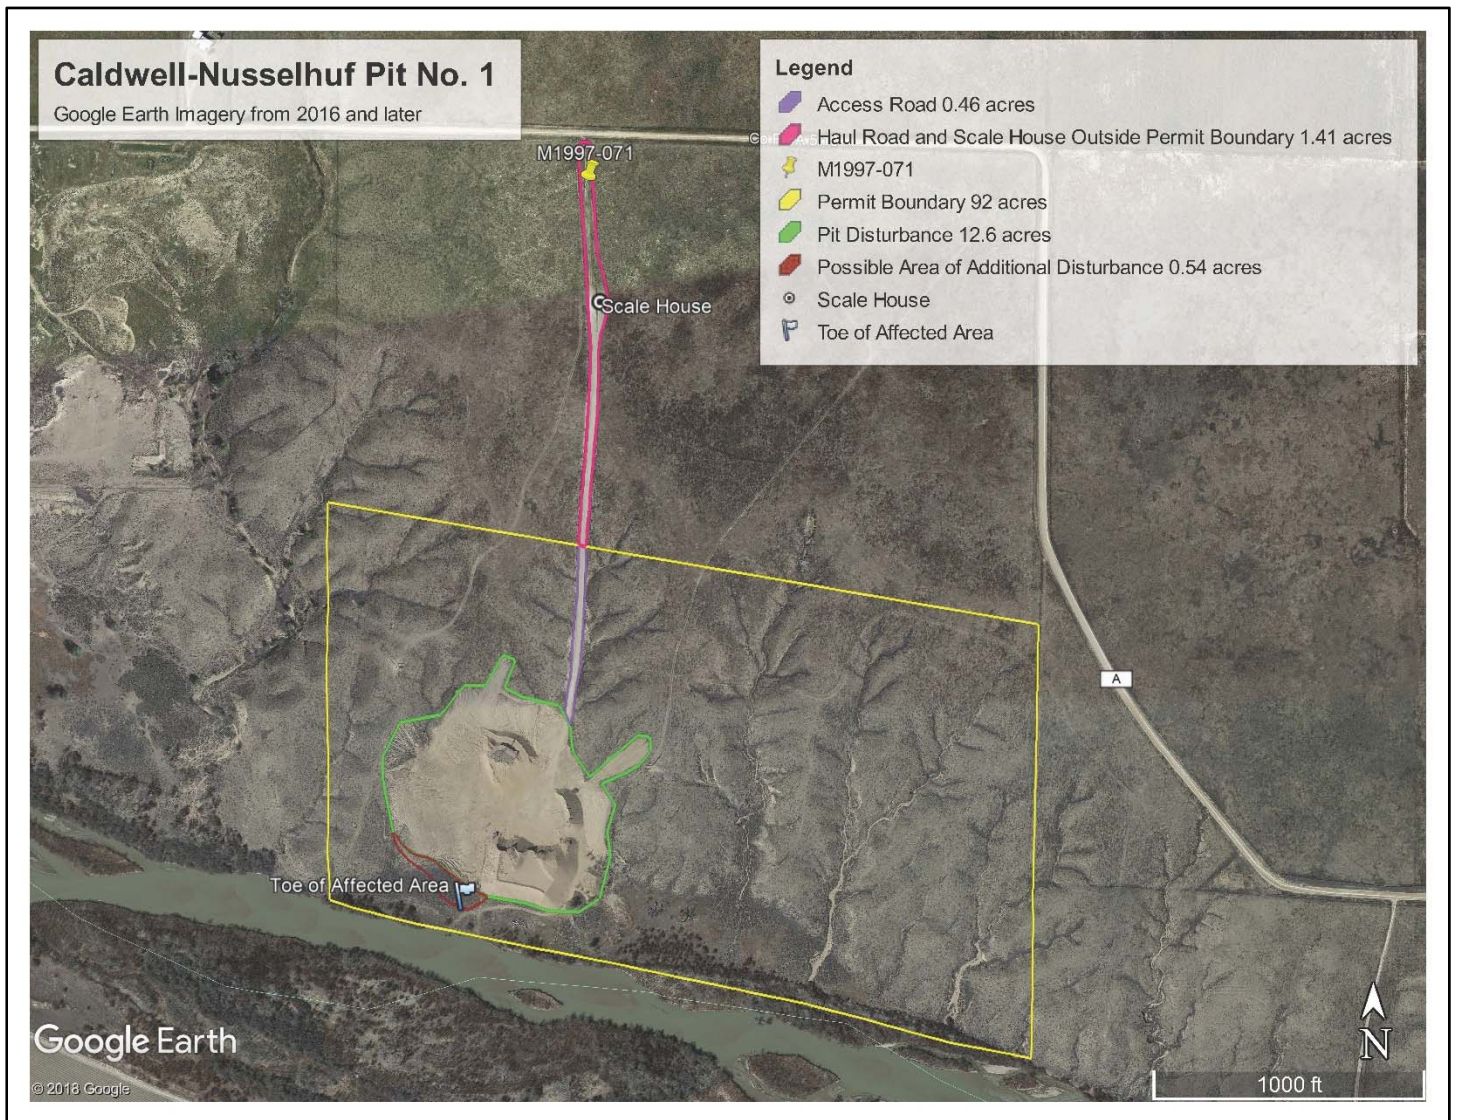
Figure 1: Map created after the inspection depicting conditions encountered during inspection.
