**MINERALS PROGRAM INSPECTION REPORT**  
**PHONE: (303) 866-3567**

<b>MINE NAME:</b> Pikeview Quarry	<b>MINE/PROSPECTING ID#:</b> M-1977-211	<b>MINERAL:</b> Limestone (general), granite, granite gneiss and dolomite	<b>COUNTY:</b> El Paso
<b>INSPECTION TYPE:</b> Monitoring	<b>INSPECTOR(S):</b> Timothy A. Cazier	<b>INSP. DATE:</b> January 8, 2019	<b>INSP. TIME:</b> 09:40
<b>OPERATOR:</b> Continental Materials Corporation	<b>OPERATOR REPRESENTATIVE:</b> Jerry Schnabel, Andre Laroche	<b>TYPE OF OPERATION:</b> 112c - Construction Regular Operation	
<b>REASON FOR INSPECTION:</b> Normal I&E Program	<b>BOND CALCULATION TYPE:</b> Complete Bond	<b>BOND AMOUNT:</b> \$4,226,000.00	
<b>DATE OF COMPLAINT:</b> NA	<b>POST INSP. CONTACTS:</b> None	<b>JOINT INSP. AGENCY:</b> None	
<b>WEATHER:</b> Clear	<b>INSPECTOR'S SIGNATURE:</b>

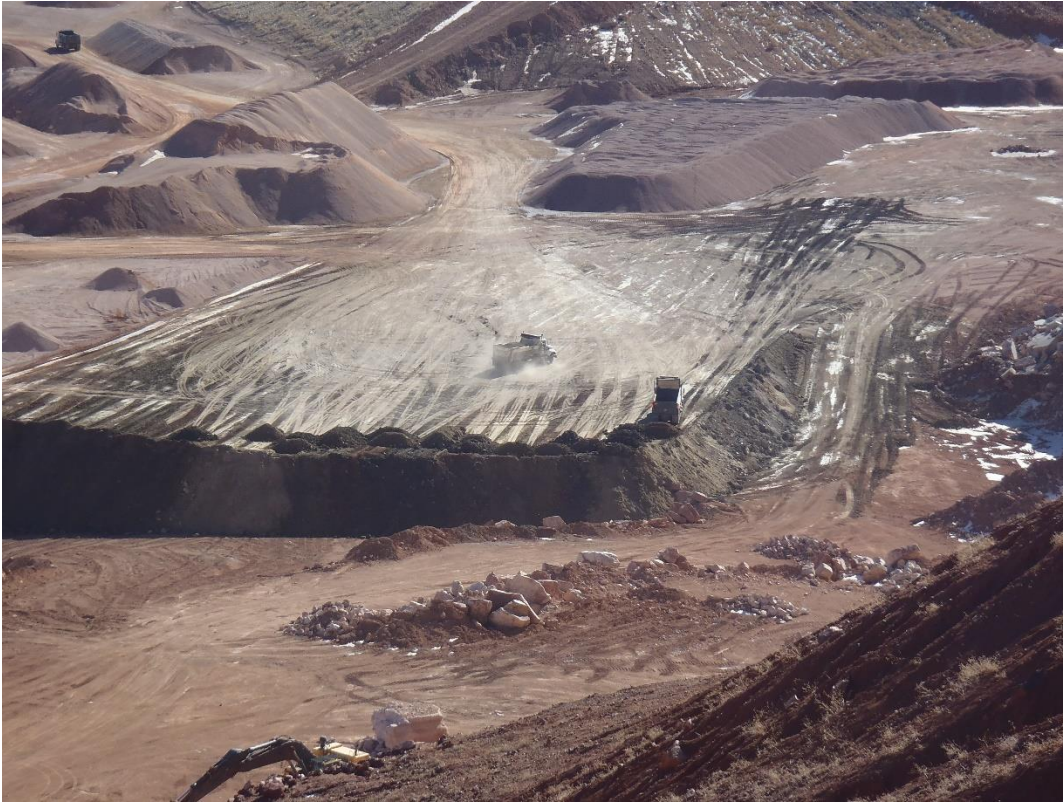
**Backfilling and Grading:** Backfilling continues in Area H (see enclosed **2018 Post Inspection Map**), the former pit (see **Photos 1 and 2**). Mine representatives indicated approximately 2.5 million tons of backfill have been placed in Area H with an additional estimated two million tons needed to complete the "Phase 1" reclamation backfill. The backfill is a combination of site material and imported material (allowed with the approval of TR-19 in 2017). A large portion of the remaining Phase 1 backfill will start sloping up the existing highwall at about a 3H:1V grade to provide additional buttressing for slope stability. The "phased" reclamation approach was discussed and clarified that what are referred to as phases would more accurately be called "regions" as they are not necessarily intended to be completed sequentially, but to be completed in a manner that optimizes safety as various portions of the slide area stabilize. Hence forth, the DRMS will refer to these areas as "regions", using the nomenclature presented in TR-18: Plant Area, Horseshoe Area, South Widows Peak, North Widows Peak, Bathtub Area, and Kiewit Cliffs Area.

Photo 1. Backfilling Area H (looking south from Kiewit cliffs).

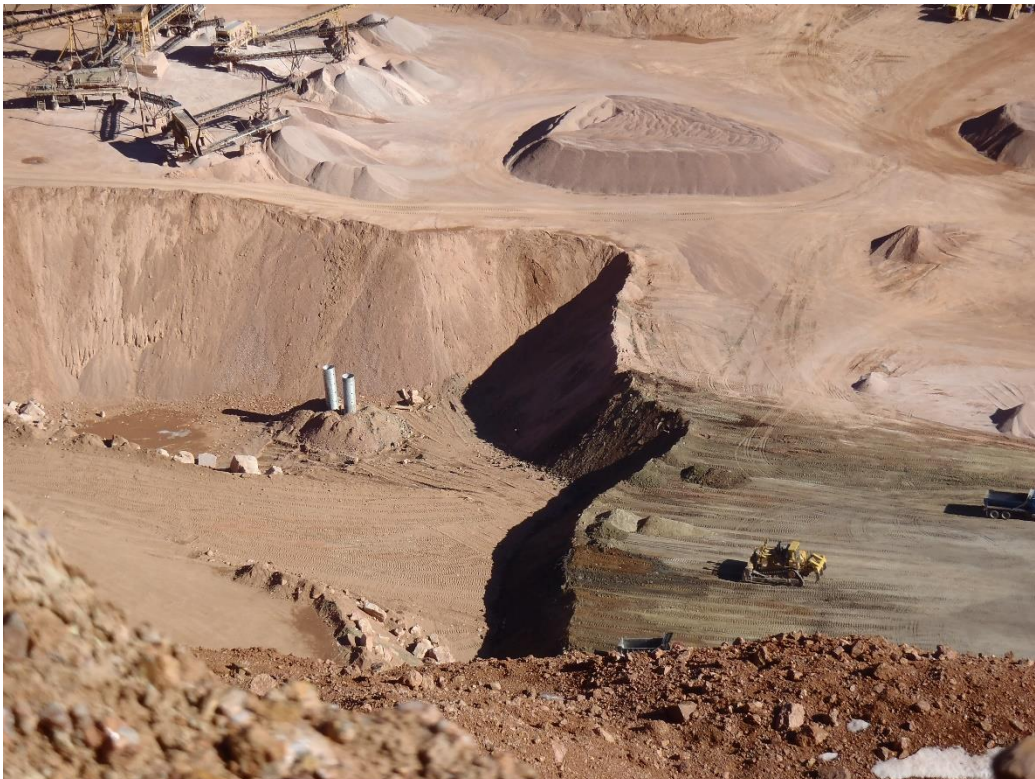
Photo 2. Backfilling Area H (looking east from above highwall).

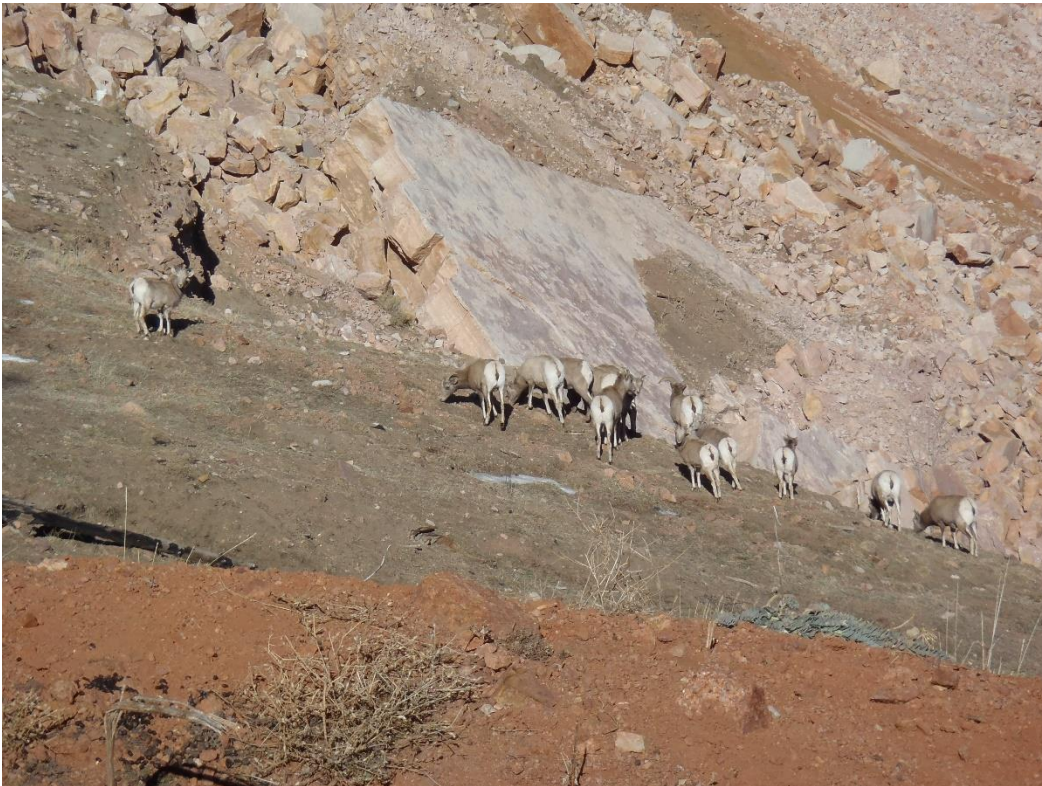
Fish and Wildlife: No impact to wildlife was observed. As is frequently observed in the reclaimed "horse shoe" area on the south end of the mine, bighorn sheep were observed grazing (see **Photo 3**).

Photo 3. Bighorn sheep grazing in Horseshoe area (south end, looking north).

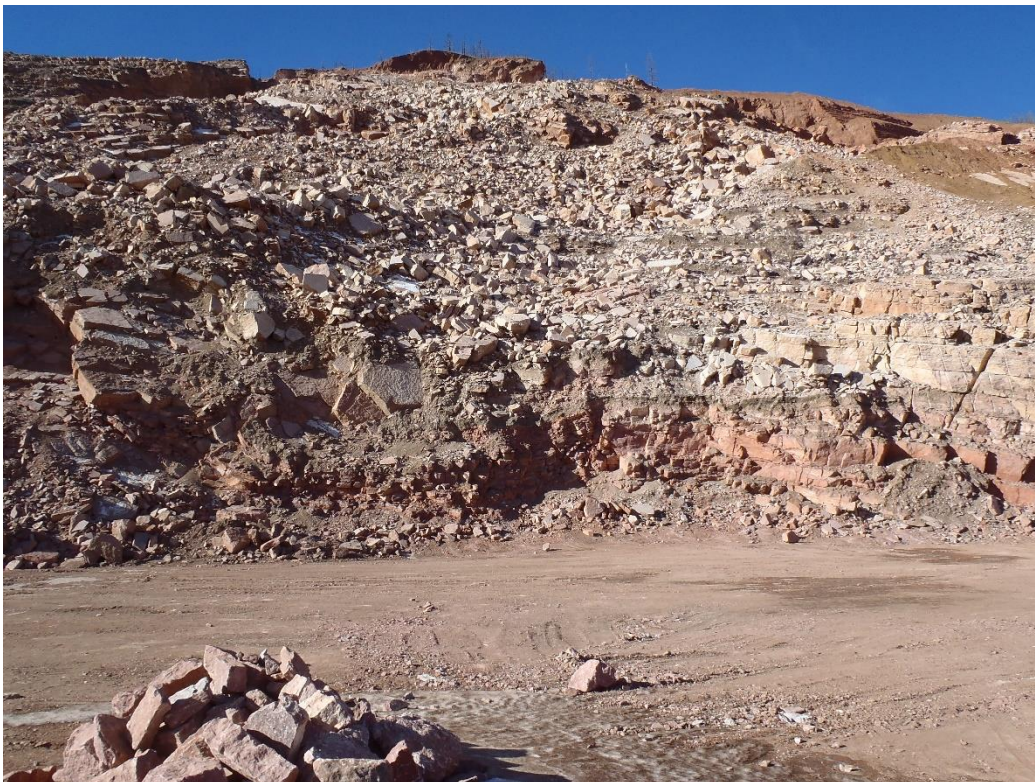
Gen. Compliance with Mine Plan: The operation appeared to be in compliance with the approved mine plan. CMC continues to work on stabilizing the highwall and backfilling with overburden as approved in amendment 3 (AM-03). Google Earth was used to measure the disturbed area, which was estimated to be approximately 127 acres, based on 2017 imagery (see enclosed **2018 Post Inspection Map**). The highwalls (see **Photos 4 and 5**) are constantly monitored using a prism system (see **Photo 6**) which will alert mine personnel in the event significant movement of the slide area begins.

Photo 4. Highwall from Area H (looking west).

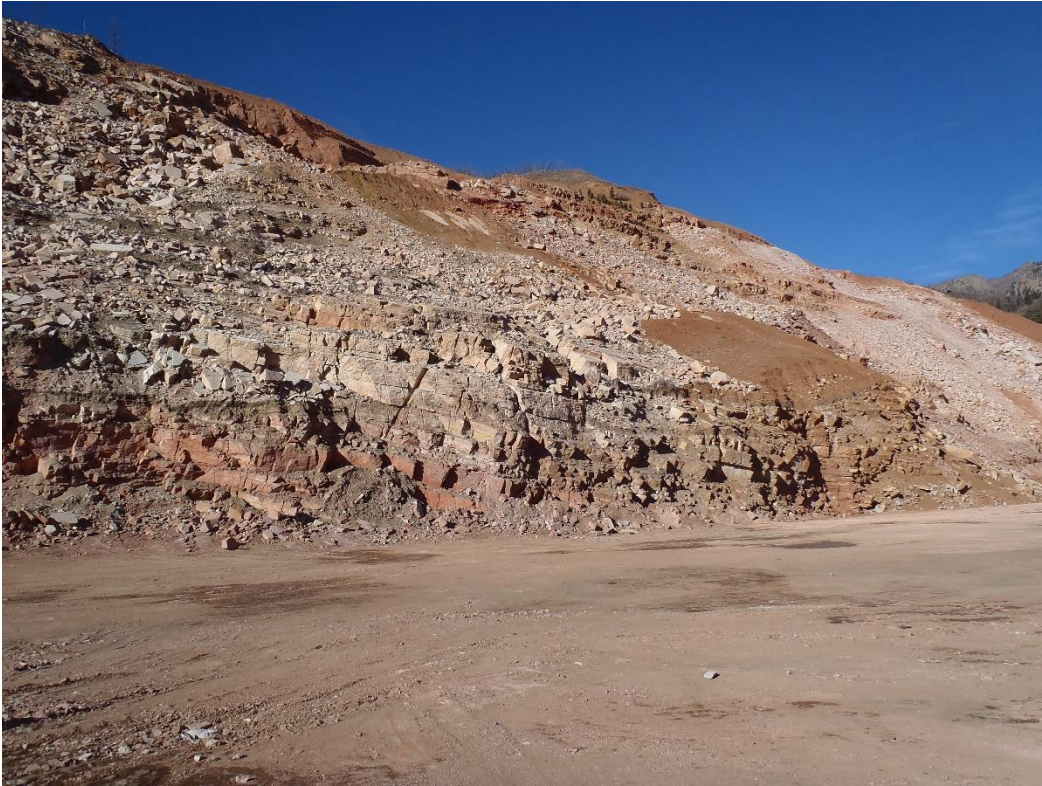
Photo 5. Highwall from Area H (looking NW).

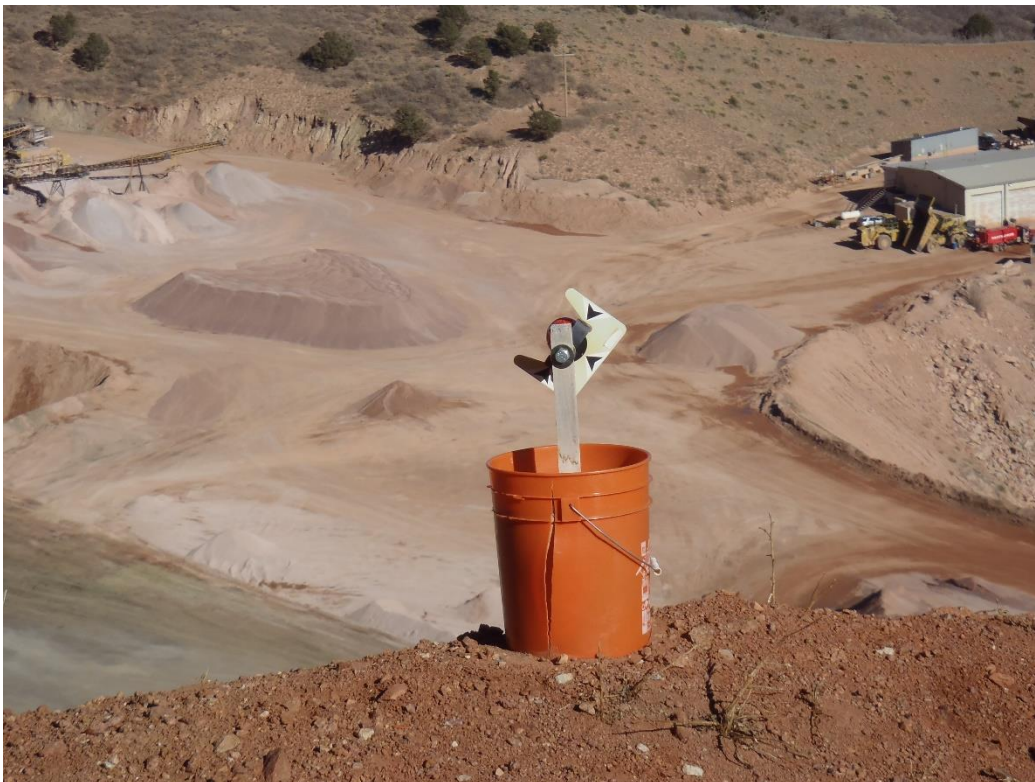
Photo 6. Typical prism for highwall monitoring system.

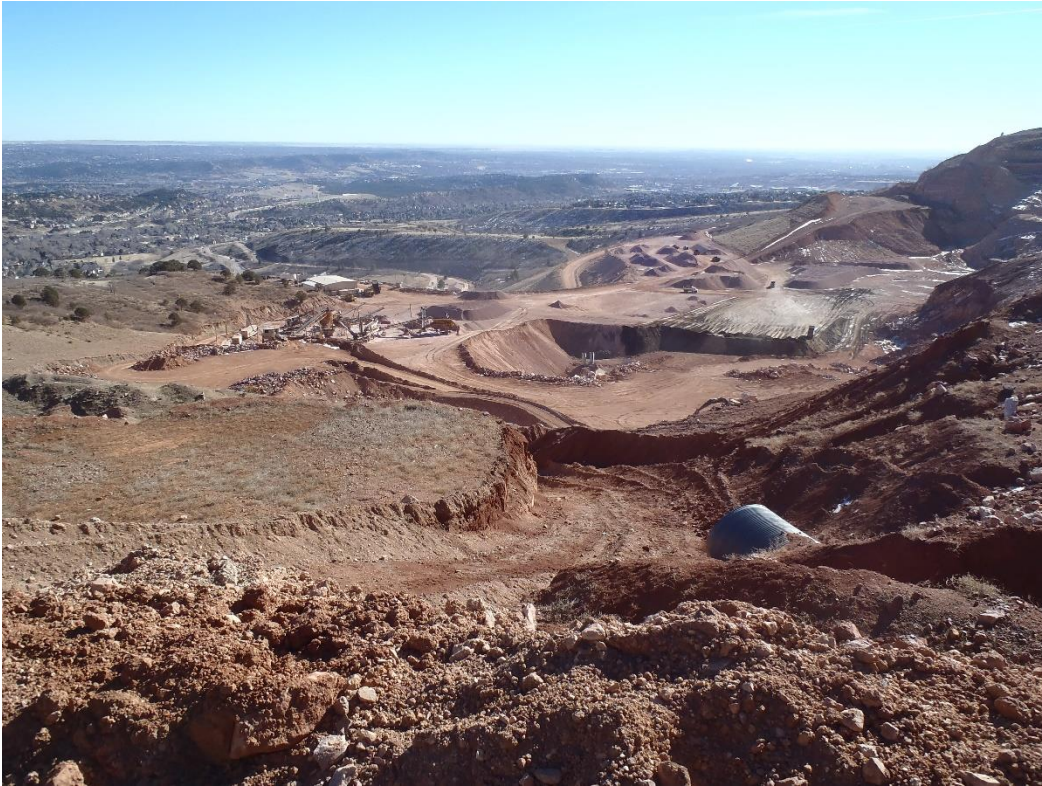
Support Facilities On-site: A screen plant, crusher, and various wheeled support equipment were observed on site (see **Photo 7**).

Photo 7. Screen/crusher (all mobile equipment) plant (looking SE).

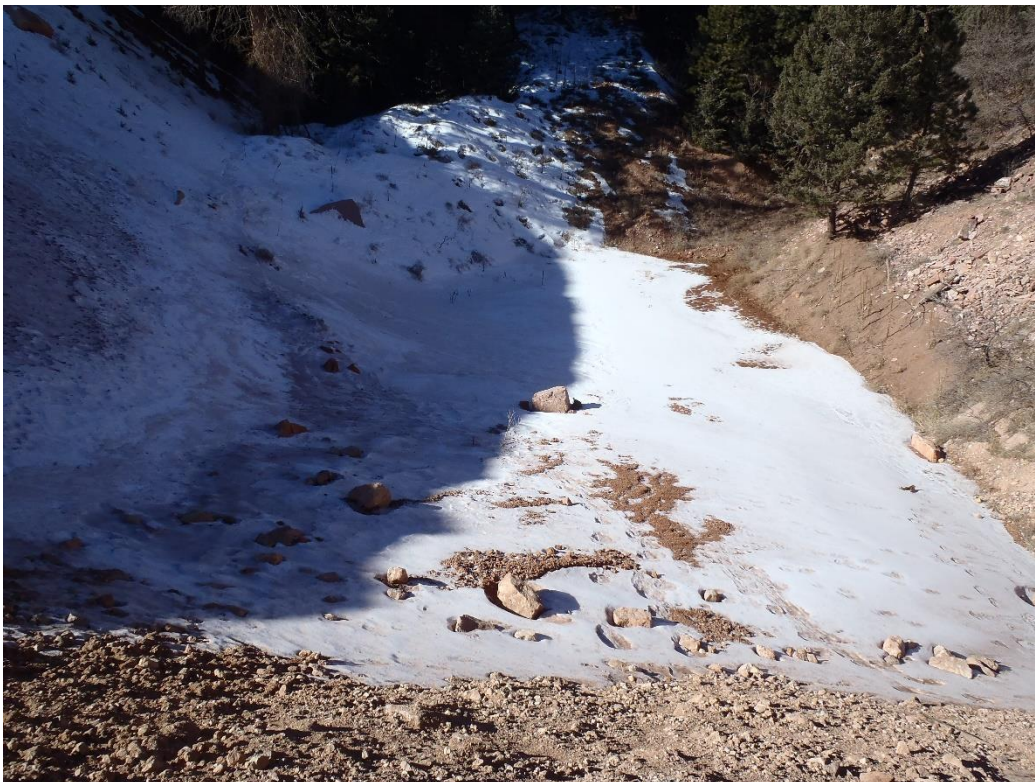
Storm Water MGT Plan: No oil or fuel spills were observed. The sediment pond in the northwest corner, opposite the access road from the Kiewit Cliffs was filled with snow (see **Photo 8**) so it could not be determined if maintenance is required to ensure the pond outlet is not plugged. [CMC personnel should check the pond and inspect the discharge culvert inlet once the snow has melted.](#)

Photo 8. Northwest sediment pond – possibly blocked.
