MINERALS PROGRAM INSPECTION REPORT

MINE NAME: Patton Clay Mine	MINE/PROSPECTING ID#: M-1998-067	MINERAL: Clay (general)	COUNTY: Fremont
INSPECTION TYPE: Monitoring	INSPECTOR(S): Timothy A. Cazier	INSP. DATE: August 1, 2018	INSP. TIME: 10:00
OPERATOR: Summit Brick & Tile Co.	OPERATOR REPRESENTATIVE: Mike Leidich & Mark Jesik	TYPE OF OPERATION: 112c - Construction Regular Operation	
REASON FOR INSPECTION: Normal I&E Program	BOND CALCULATION TYPE: Partial Bond	BOND AMOUNT: \$49,000.00	
DATE OF COMPLAINT: NA	POST INSP. CONTACTS: Colo. Land Board	JOINT INSP. AGENCY: U.S.BLM	
WEATHER: Clear	INSPECTOR'S SIGNATURE:

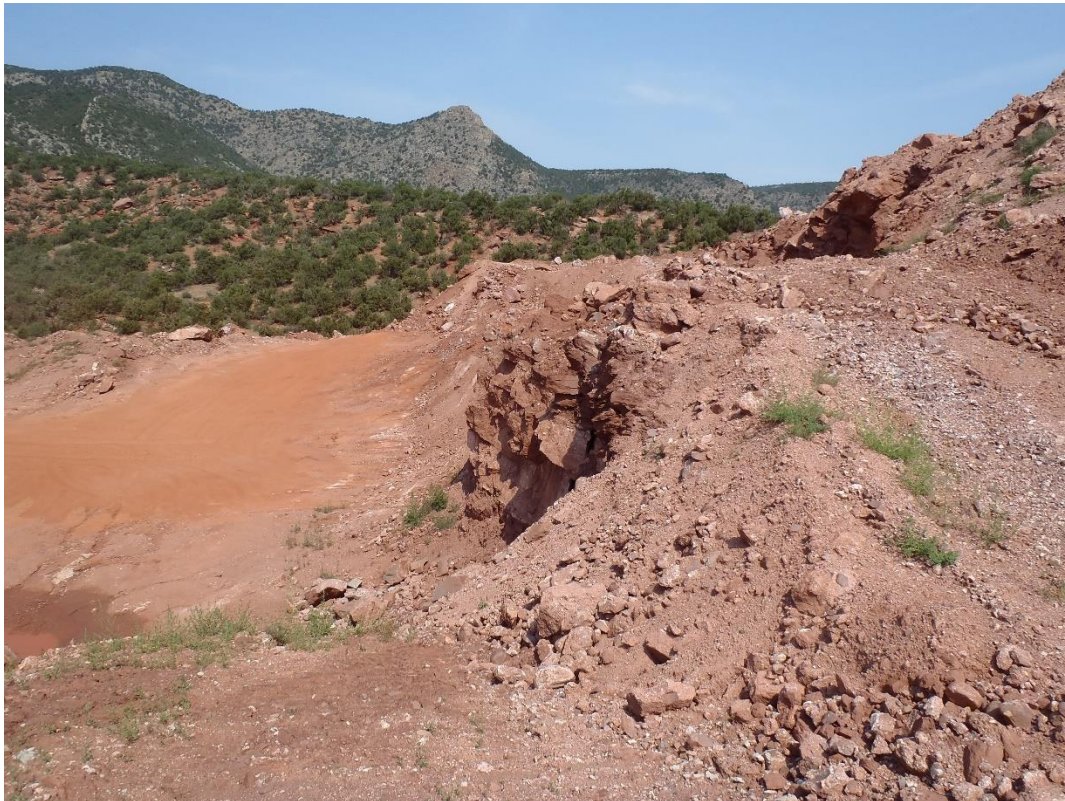
Gen. Compliance with Mine Plan: The operation appeared to be in compliance with the approved mine plan. Google Earth was used to measure the disturbed area, which was measured by Ms. Sanderson (BLM) using a handheld GPS unit to be 3.25 acres, Area F (see attached **2018 Post Inspection Map**). Highwalls were benched and estimated to vary between 8 and 12 feet in height and appeared stable (see **Photo 1**).

Photo 1. Benched highwall in Area F (looking NW).

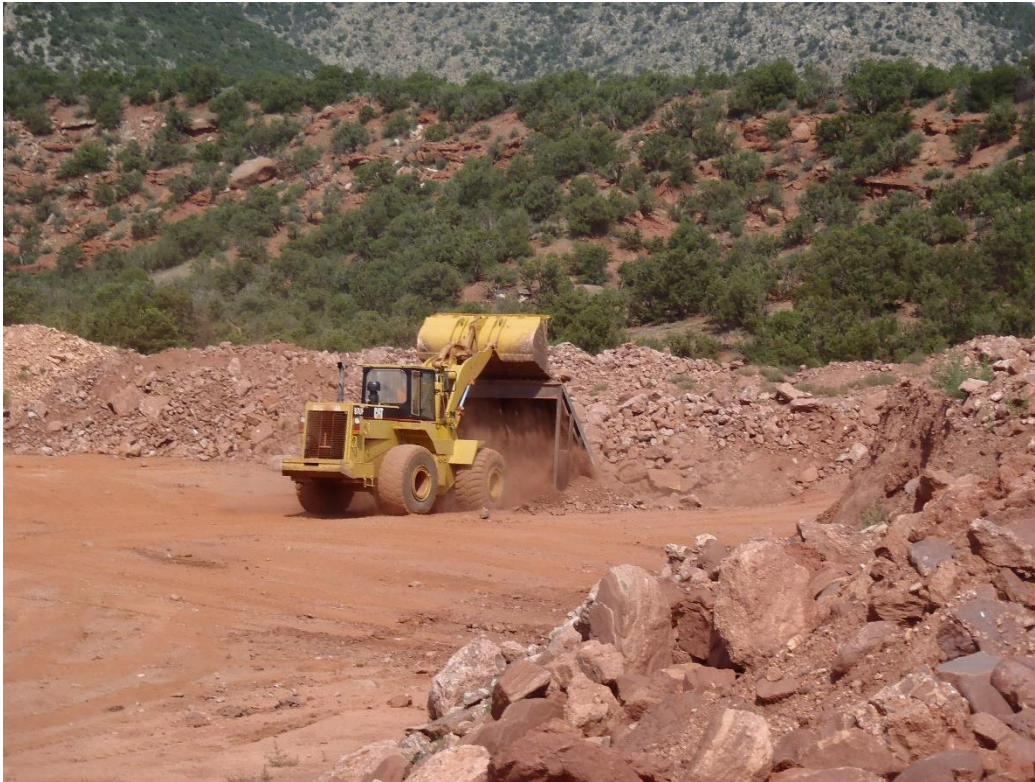
Processing Waste: A stockpile of oversized rock was observed on the northwest side of where loader was working in Area F (see **Photo 2**). This is material scalped by the grizzly screen.

Photo 2. Loader using grizzly in Area F (note stockpile of oversized material beyond).

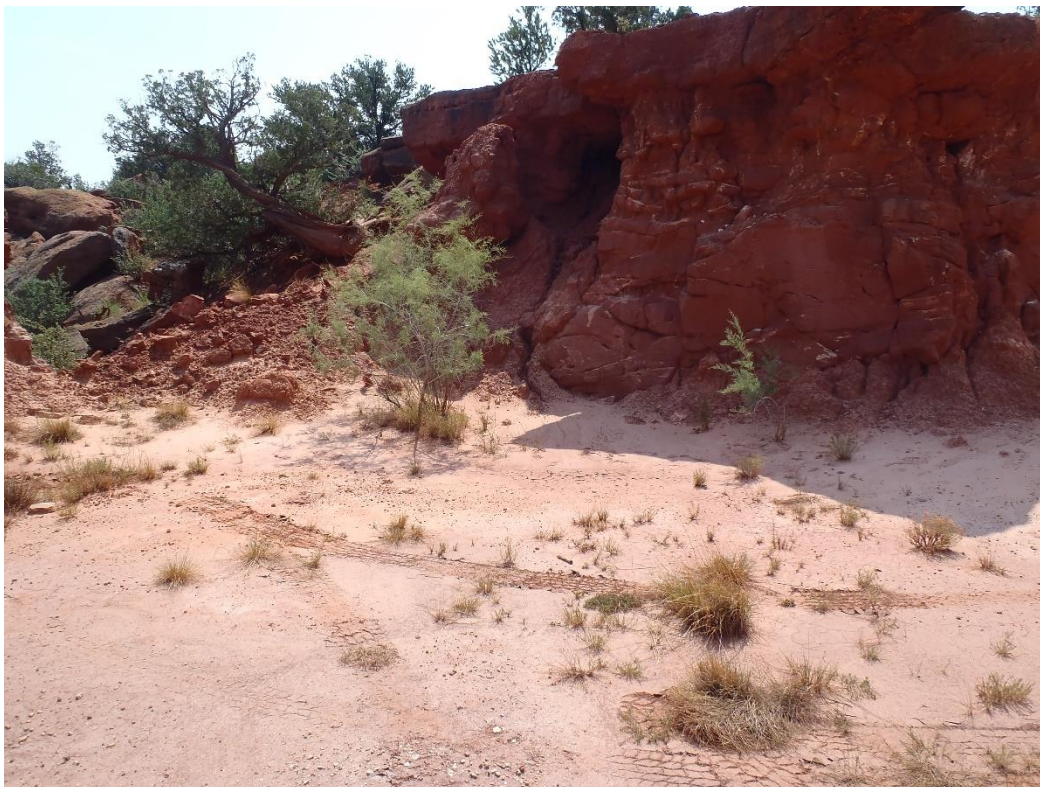
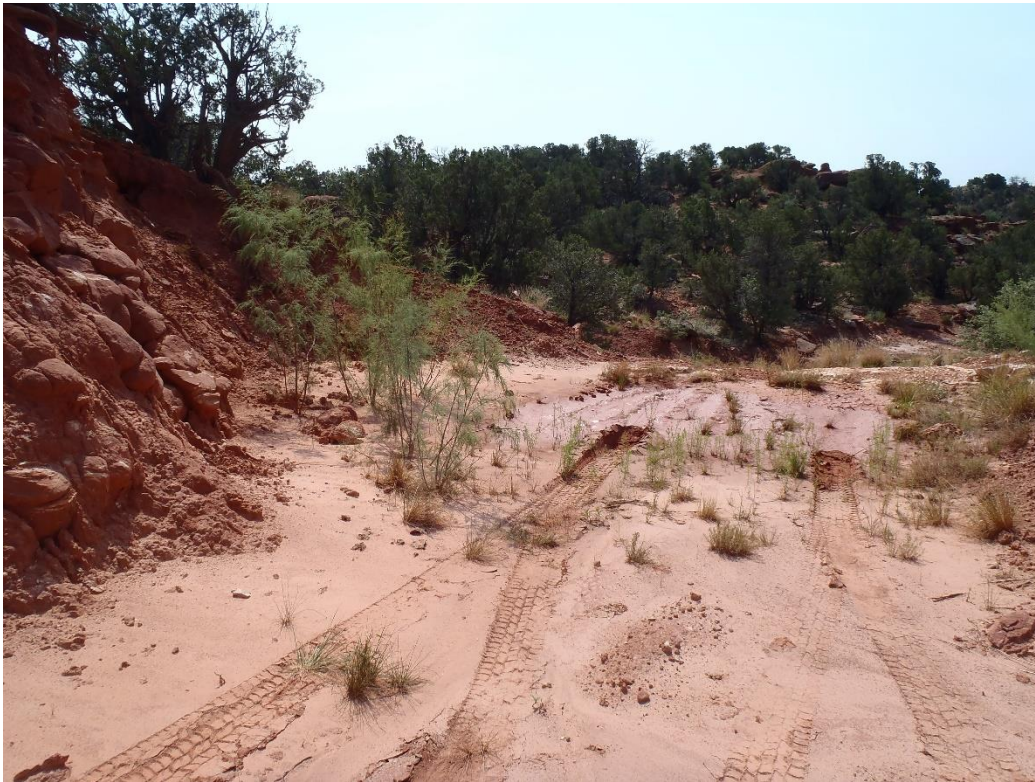
PROBLEM/POSSIBLE VIOLATION: Problem No. 1: Tamarisk (salt cedar) trees are present within or have volunteered into the Area A and are becoming established. This is a problem for failure to employ weed control methods for a state listed noxious weed species within the permitted area, and to reduce the spread of weeds to nearby areas as required by Section 3.1.10 (6) of the rule.

Revegetation: Some tamarisk were observed in Area A (see **Photos 3 and 4**). **The presence of tamarisk (or salt cedar, a noxious weed List B species) is cited as Problem No. 1 on page 1 of this report.** The Operator should implement a weed control program to control the tamarisk on site.

Photo 3. Tamarisk in Area A in access road (looking NE).

Photo 4. Tamarisk in Area A in access road (looking south).

CORRECTIVE ACTIONS: The operator shall either implement the existing weed control plan, or develop a weed control and management plan in accordance with Section 3.1.10 (6) of the Rule. This plan should be developed in consultation with the county extension agency, or weed control district office and should include specific control measures to be applied, a schedule for when control measures will be applied and a post-treatment monitoring plan. This weed control plan shall be submitted to the Division as a Technical Revision to the approved plan with the appropriate Technical Revision fee of \$216.00 by the corrective action date.

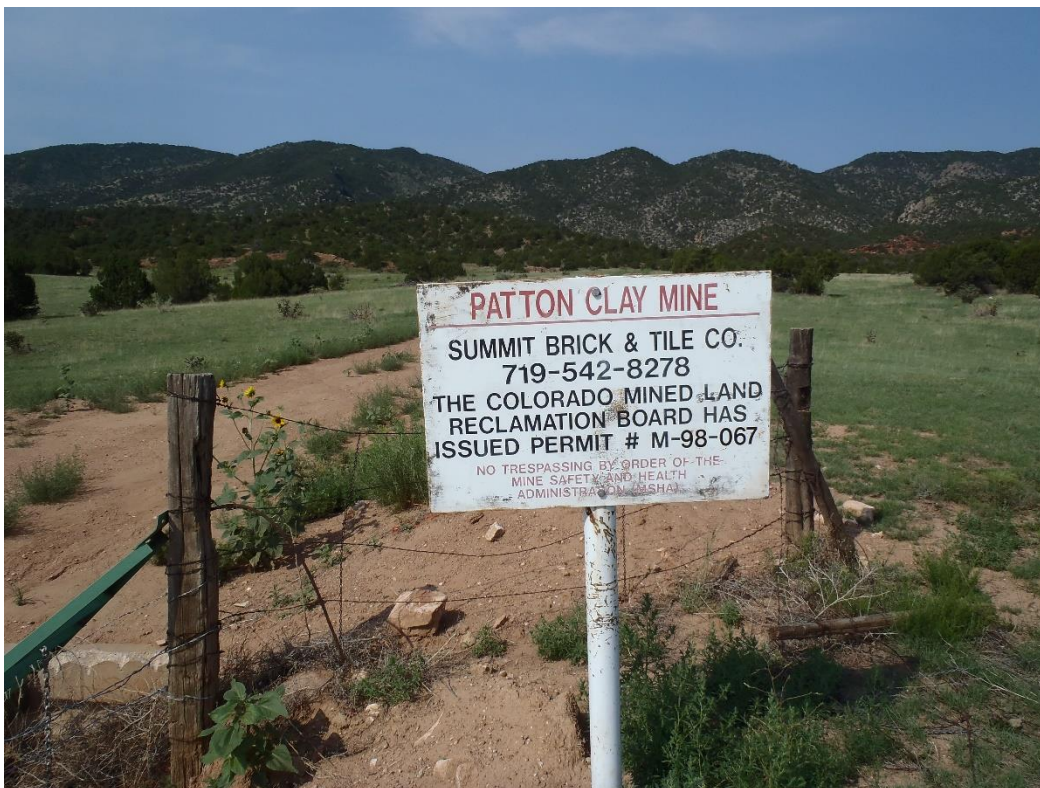
Signs and Markers: The permit sign was properly posted (see **Photo 5**). Only three boundary markers were located and insufficient to delineate the affected area boundary as required. The Exhibit C mining map submitted with the permit application delineates three different boundary types: a) the permit boundary; b) affected area boundaries for areas A through H; and c) clay area boundaries for areas A through H. The DRMS regulations (C.R.S. 32-34-???) require the affected area boundaries be marked. As such, Area F (the current active area) is required to be marked. **The lack of markers delineating the Area F boundary is cited as Problem No. 2 on page 1 of this report.** The Summit Brick & Tile Co. will also need to commit to marking the other areas affected area boundaries prior to initiating mining in Areas A through E, G and H.

Photo 5. Permit sign at gate (looking west towards mine).

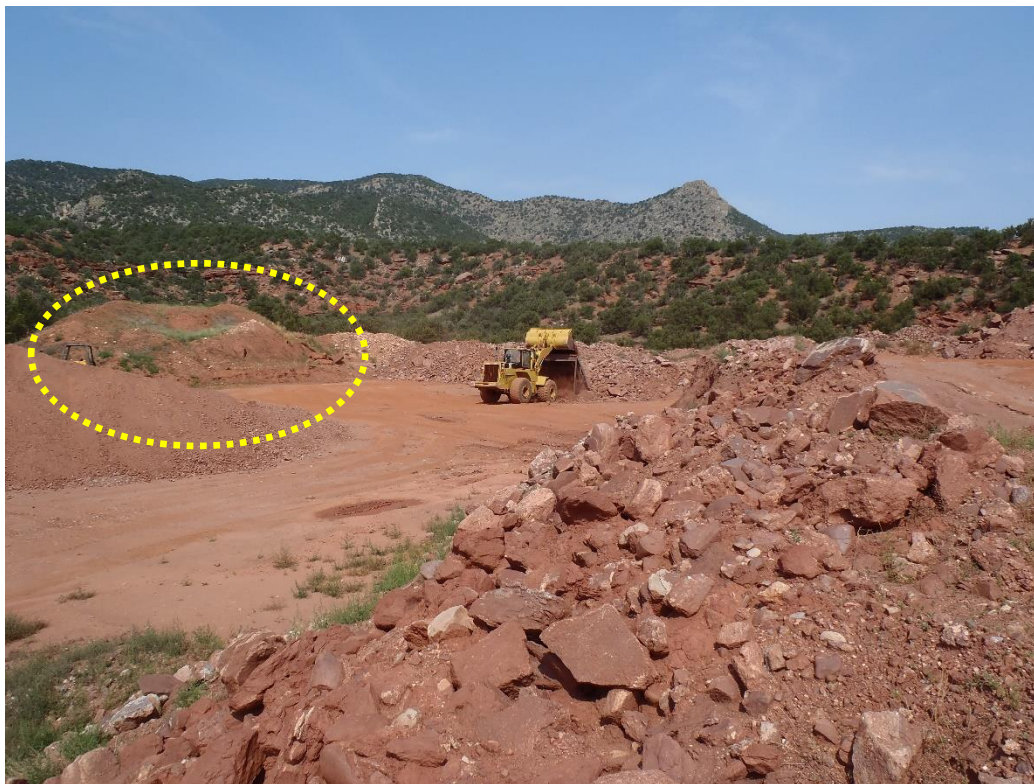
Topsoil: A topsoil stockpile was observed on the west side of the area being worked in Area F (see **Photo 6**).

Photo 6. Topsoil stockpile (looking west from east end of highwall).

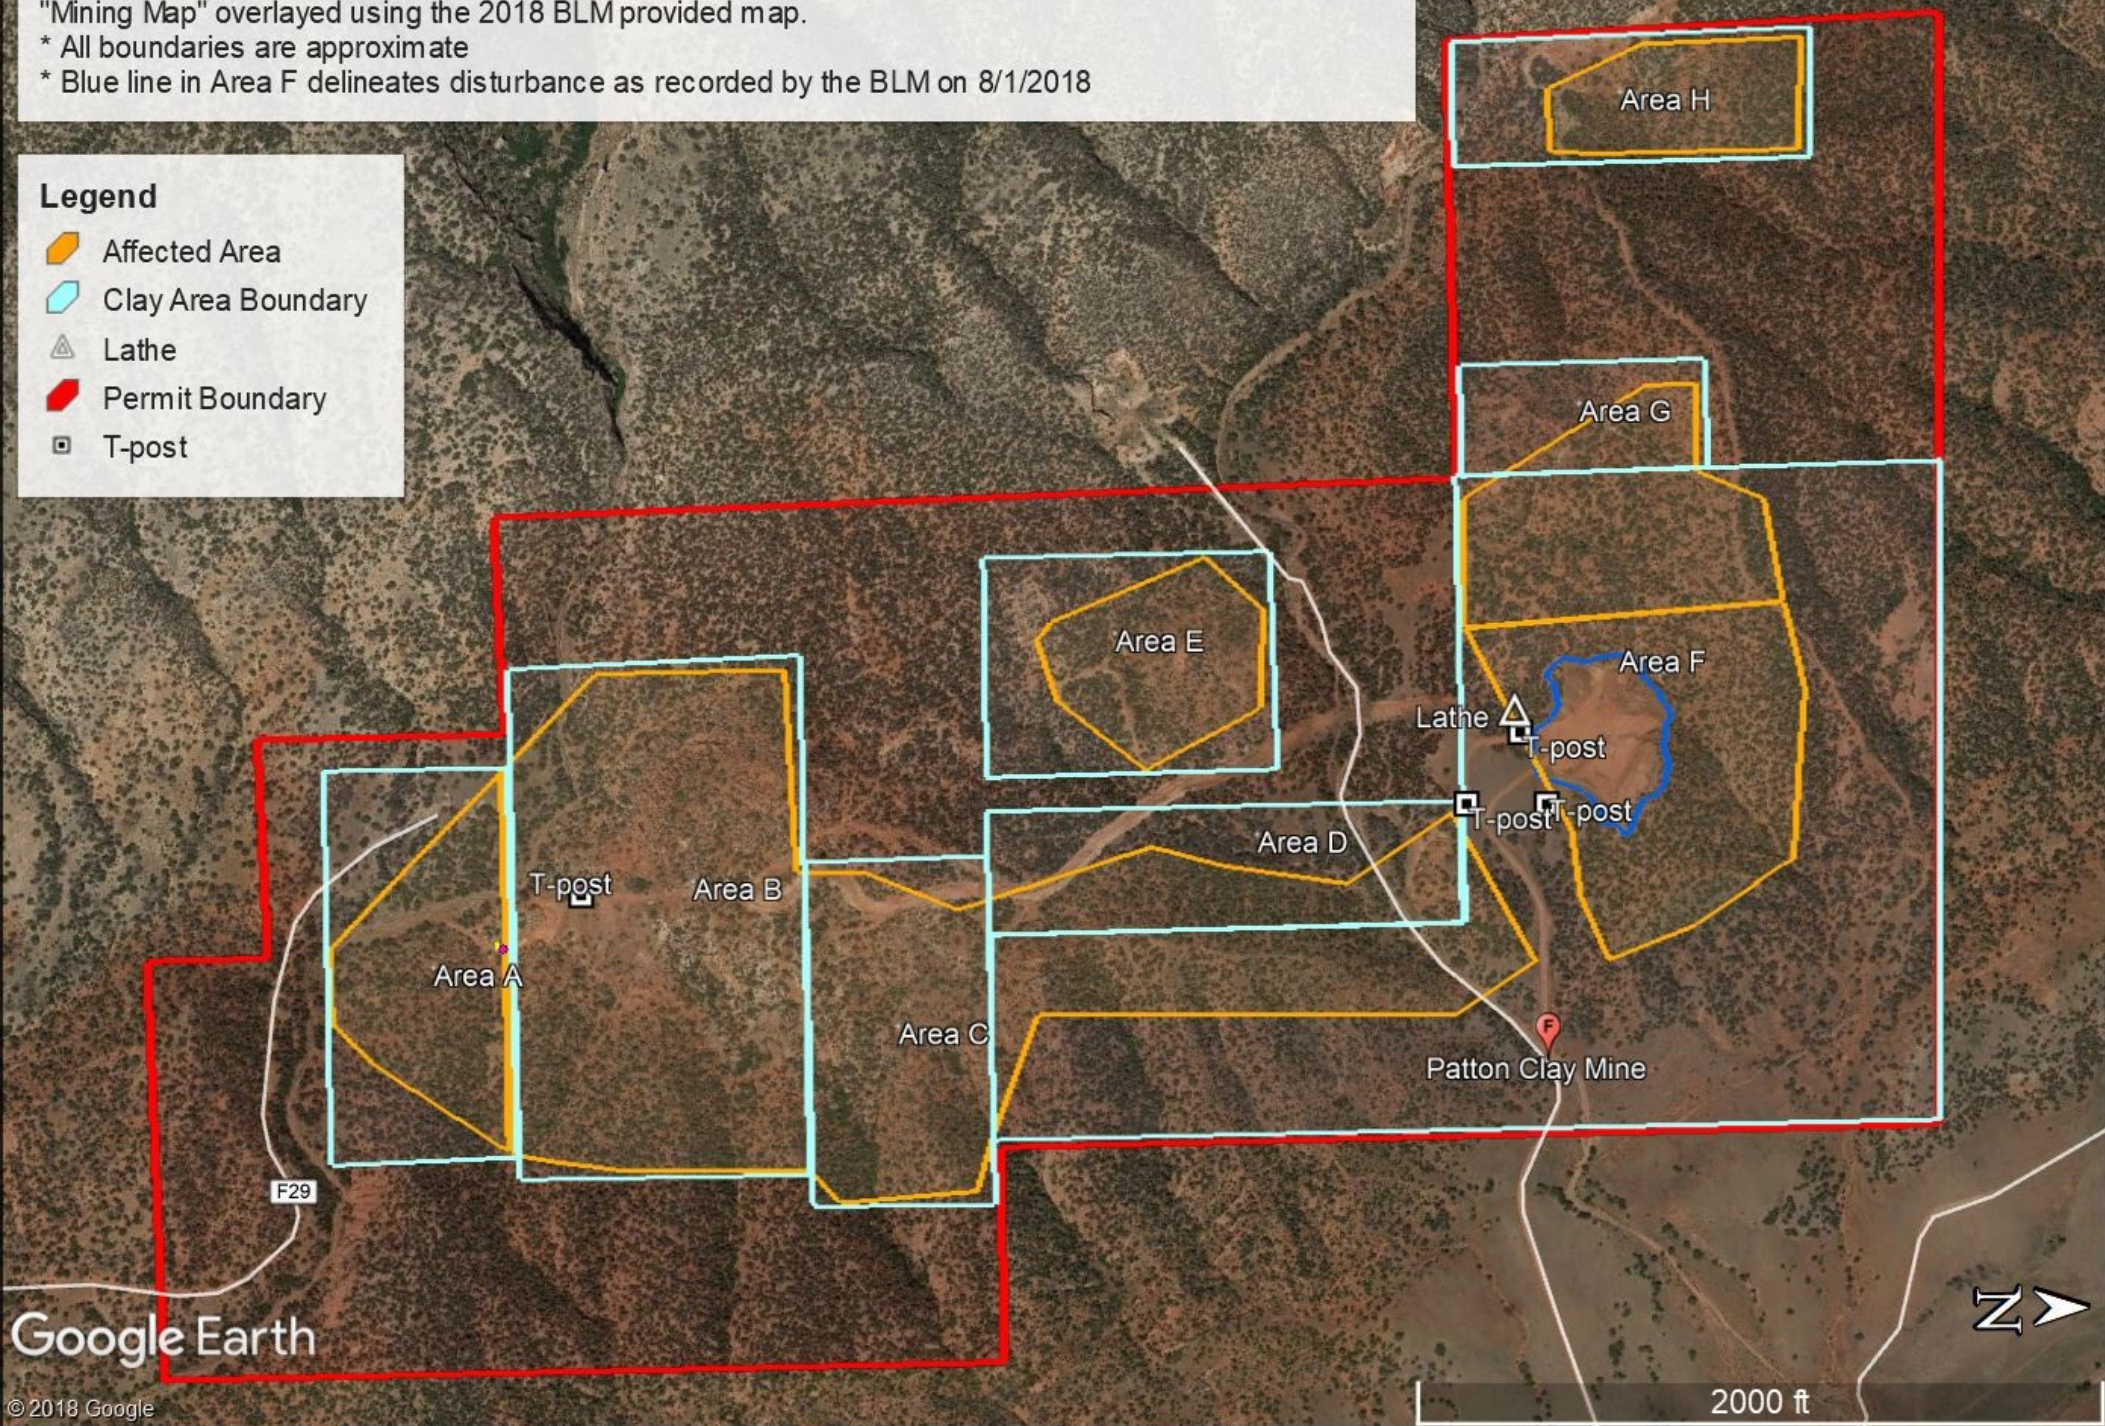
Patton Clay Mine 2018 Post-Inspection Map

* Blue line in Area F delineates disturbance as recorded by the BLM on 8/1/2018
