**MINERALS PROGRAM INSPECTION REPORT**  
**PHONE: (303) 866-3567**

<b>MINE NAME:</b> Stock Moss Rock	<b>MINE/PROSPECTING ID#:</b> M-2019-003	<b>MINERAL:</b> Stone (moss rock)	<b>COUNTY:</b> Fremont
<b>INSPECTION TYPE:</b> Illegal(Unpermitted Operation)	<b>INSPECTOR(S):</b> Timothy A. Cazier	<b>INSP. DATE:</b> August 1, 2018	<b>INSP. TIME:</b> 15:20
<b>OPERATOR:</b> unknown	<b>OPERATOR REPRESENTATIVE:</b> None	<b>TYPE OF OPERATION:</b> NP - Needs Permit	
<b>REASON FOR INSPECTION:</b> Priority	<b>BOND CALCULATION TYPE:</b> None	<b>BOND AMOUNT:</b> No Bond Held	
<b>DATE OF COMPLAINT:</b> NA	<b>POST INSP. CONTACTS:</b> None	<b>JOINT INSP. AGENCY:</b> None	
<b>WEATHER:</b> Clear	<b>INSPECTOR'S SIGNATURE:</b>

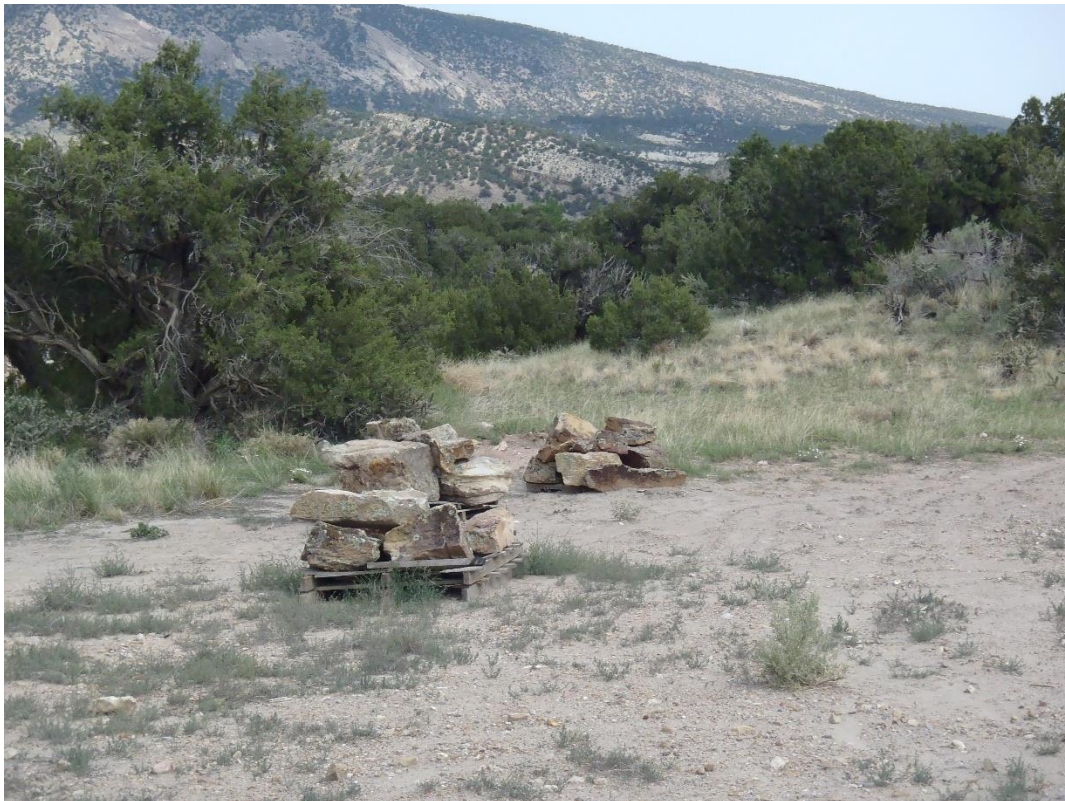
This inspection was prompted by observations made during a planned inspection to the Stocks Clay Mine (M-1977-324) on August 1, 2018. Upon returning to FR CO Rd 9, this inspector observed palletized moss rock along the access road (see **Photos 1** and **2**) and on a truck at the bottom of the access road in a pull off area near Wilson Creek (see **Photos 3**). A large stockpile of material and a loader was also observed here (see **Photos 3**).

Based on the observation of the palletized moss rock, the DRMS believes the moss rock operation has been re-started and a permit is required. Letters to that effect will be sent to both property owners.

Photo 1. Palletized moss rock along access road (1 of 2).

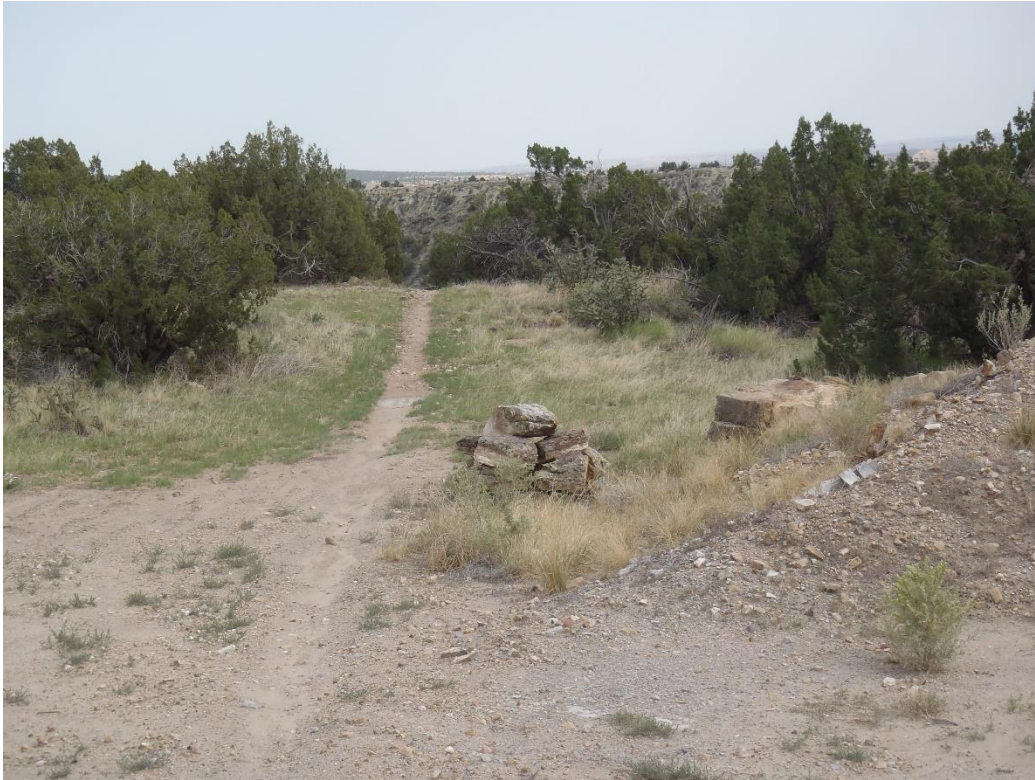
Photo 2. Palletized moss rock along access road (2 of 2).

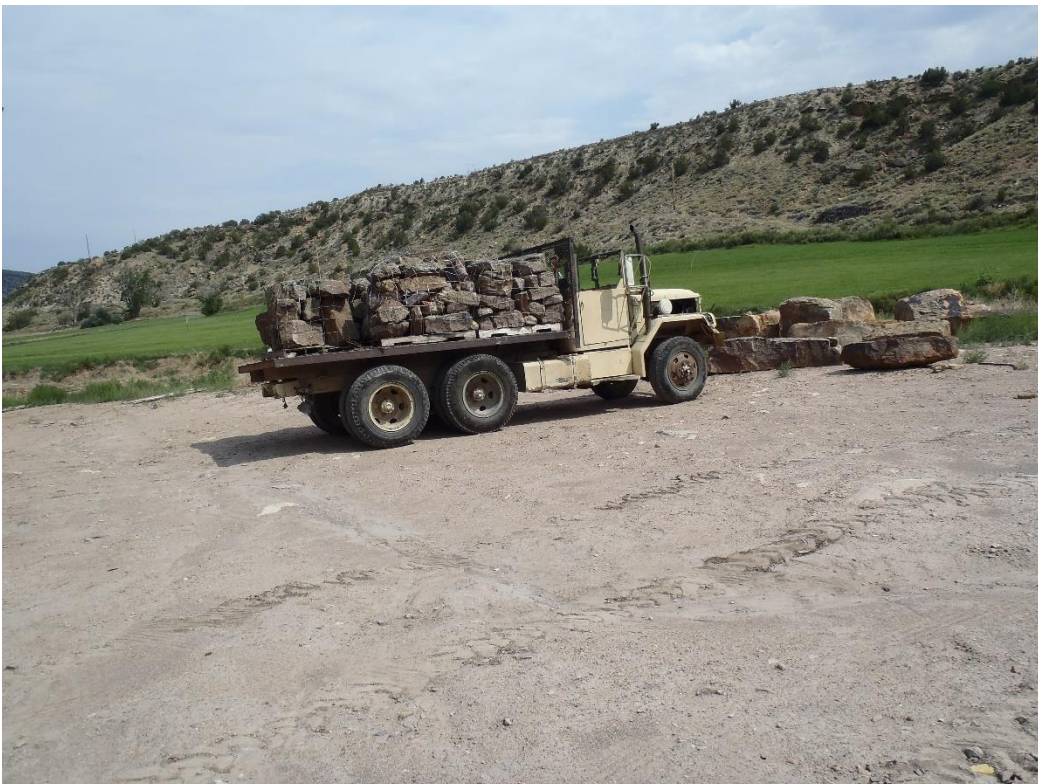
Photo 3. Palletized moss rock on truck near Wilson Creek (looking SE).

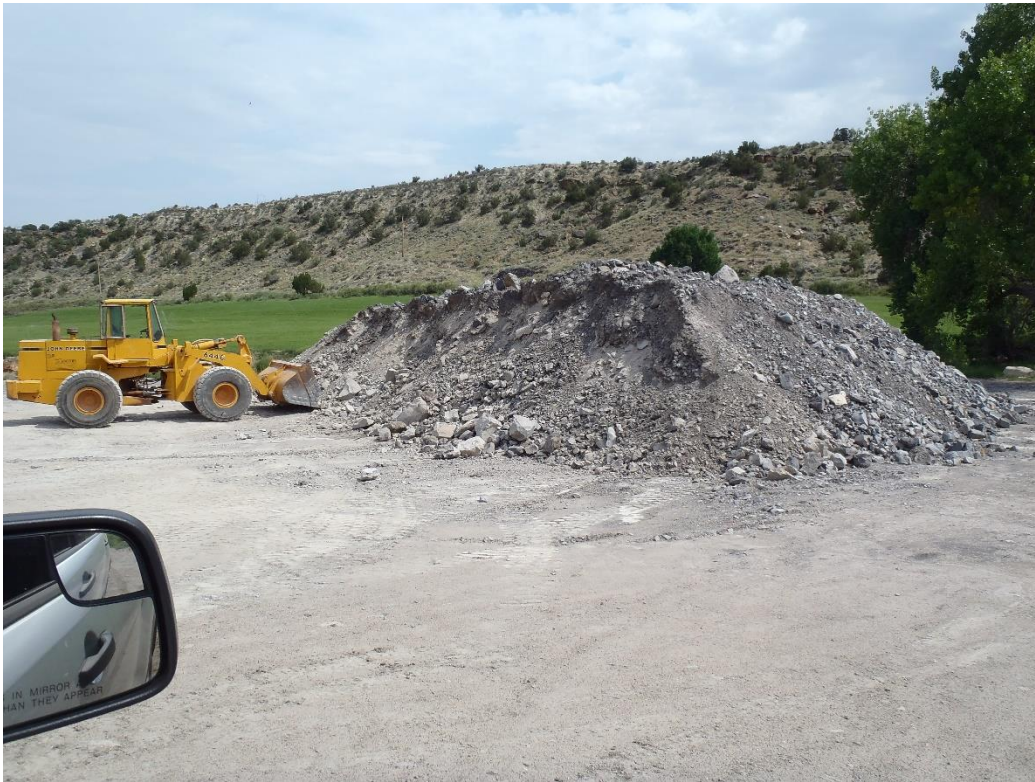
Photo 4. Material stockpile in pull-off near Wilson Creek (looking SE).
