#### BLM Inspection on 08/01/2018: Beaver Creek & Patton Mine

# **Minerals 3600 Mine and Reclamation Inspection**

#### U.S. Department of the Interior Bureau of Land Management Royal Gorge Field Office

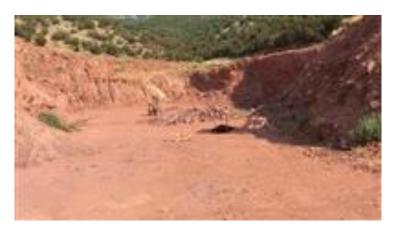
Image 1:

Comment: Overburden and stockpiles stored on working/staging floor. Recent removal of processed material (stockpile) from staging floor since previous inspection.

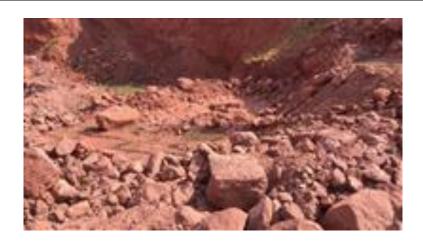
Image 2:

Comment: Overburden stockpiled east of working/staging floor on private lands.

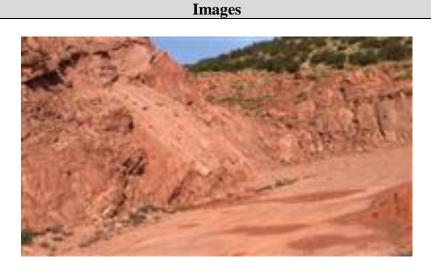
Image 3:

Comment: Area beneath highwall where raw material is pushed down to working floor for processing.

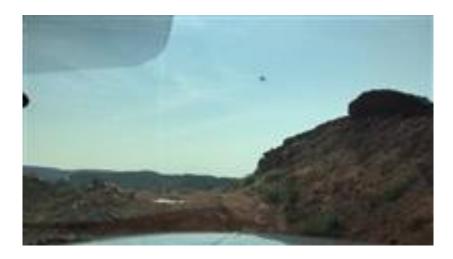
Image 4:

Comment: Haul road leading to highwall. Adequate ingress/egress to highwall.

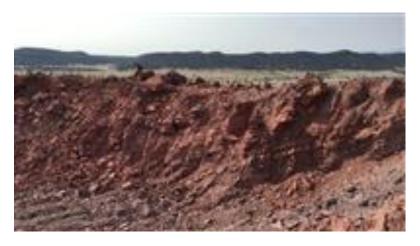
Image 5:

Comment: Active highwall where clay seams are excavated with a trackhoe and pushed to the working floor below via a dozer.

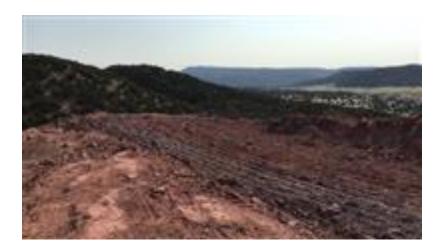
Image 6:

Clay seam that is actively being mined. Clay material is scraped off of highwall and then pushed to working floor with a dozer

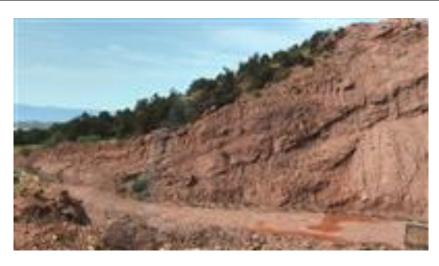
### Image 7:

Comment: Steep sloping clay seam actively being mined. Most likely have to blast the upper portion to remove sandstone overburden.
