MINERALS PROGRAM INSPECTION REPORT

MINE NAME: Stocks Clay Mine	MINE/PROSPECTING ID#: M-1977-324	MINERAL: Clay (general)	COUNTY: Fremont
INSPECTION TYPE: Monitoring	INSPECTOR(S): Timothy A. Cazier	INSP. DATE: August 1, 2018	INSP. TIME: 14:00
OPERATOR: Summit Brick & Tile Co.	OPERATOR REPRESENTATIVE: Mike Leidich & Mark Jesik	TYPE OF OPERATION: 112c - Construction Regular Operation

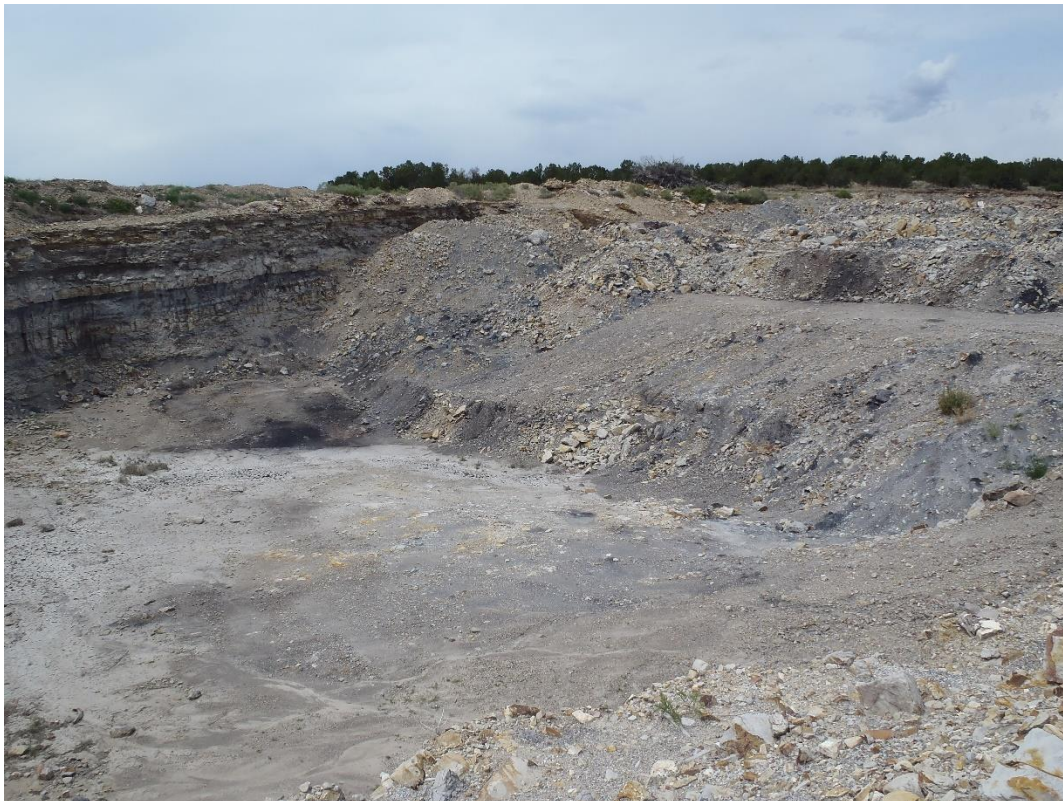
Backfilling and Grading: The southeast area of the site has been graded. Some backfill material appeared to be available for the active pit area (see **Photo 1**).

Photo 1. Backfill material available for the active pit area (looking west).

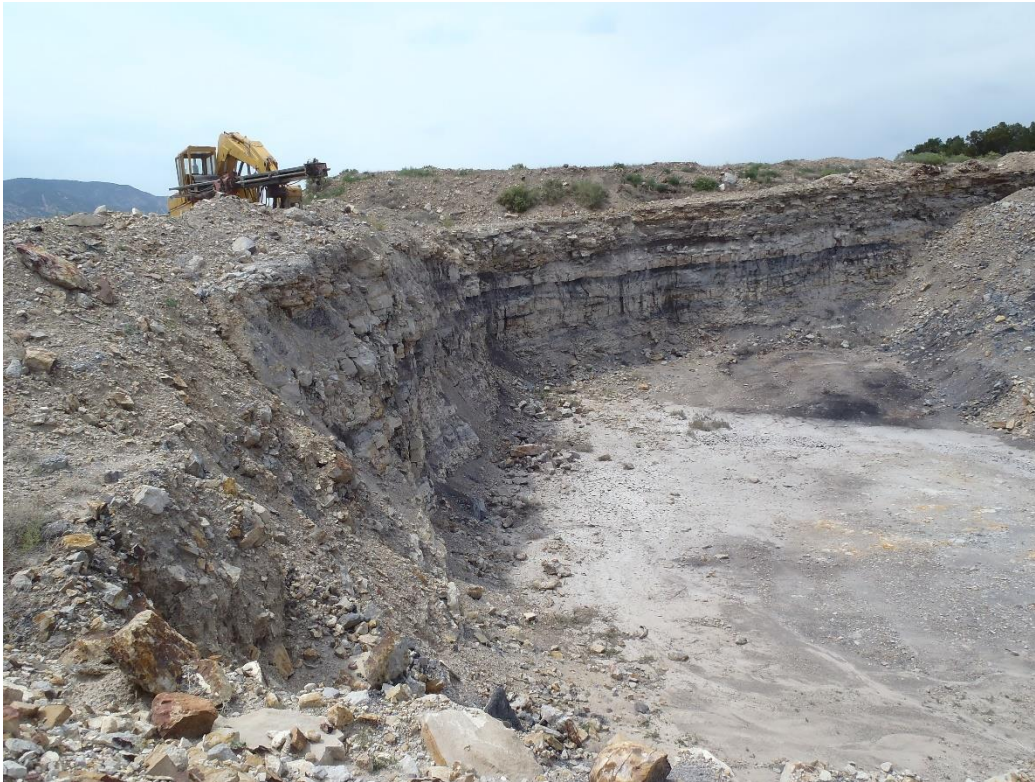
Gen. Compliance with Mine Plan: The operation appeared to be in compliance with the approved mine plan. Google Earth (2016 imagery) and data collected during the inspection using a handheld GPS unit (Juno 3B) was used to measure the disturbed area, which was estimated to be approximately 13 acres (see enclosed **Stocks Clay Mine 2018 Post Inspection Map**). This is well below the maximum allowed disturbance of 18.1 acres. It should be noted approximately 3.3 of those 13 acres are in active reclamation (southeast corner). Mine representatives indicated they are near to completing mining operations. Highwalls were estimated to vary between 15 and 20 feet in height (see **Photo 2**).

Photo 2. 15 to 20 highwall in active pit (looking west).

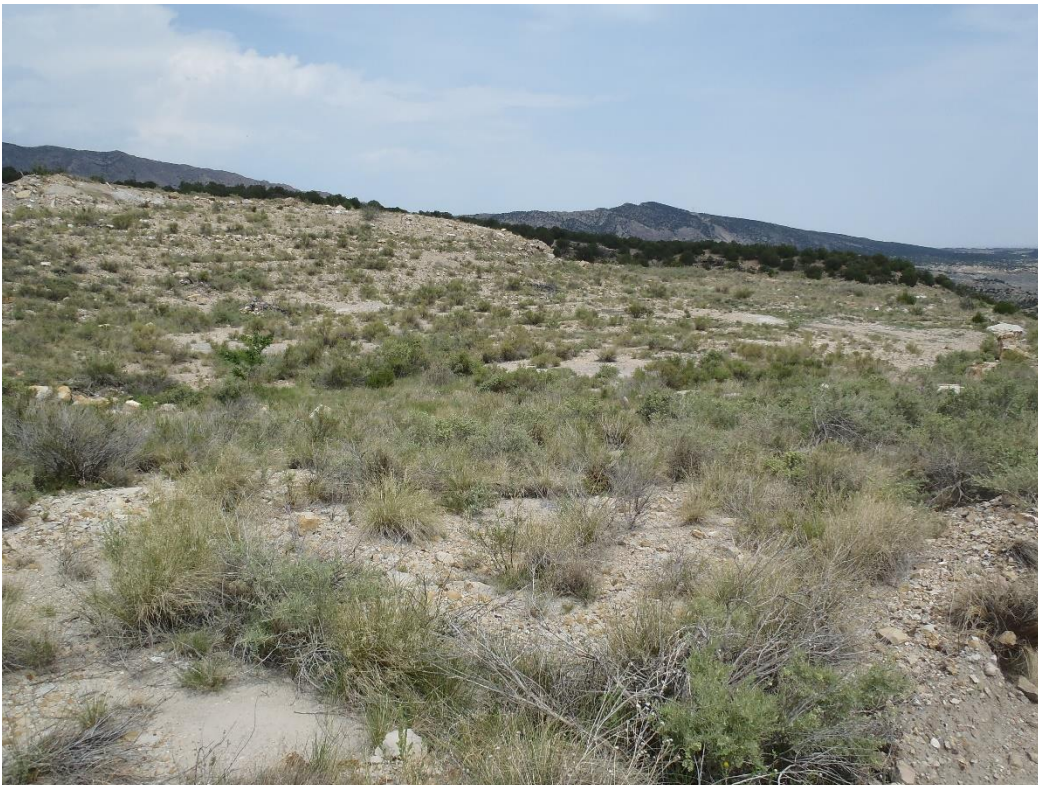
Reclamation Success: As discussed above under "Gen. Compliance with Mine Plan" the southeast portion of the site is in active reclamation (see **Photo 3**).

Photo 3. Southeast portion of the site in active reclamation (from access road, looking east).

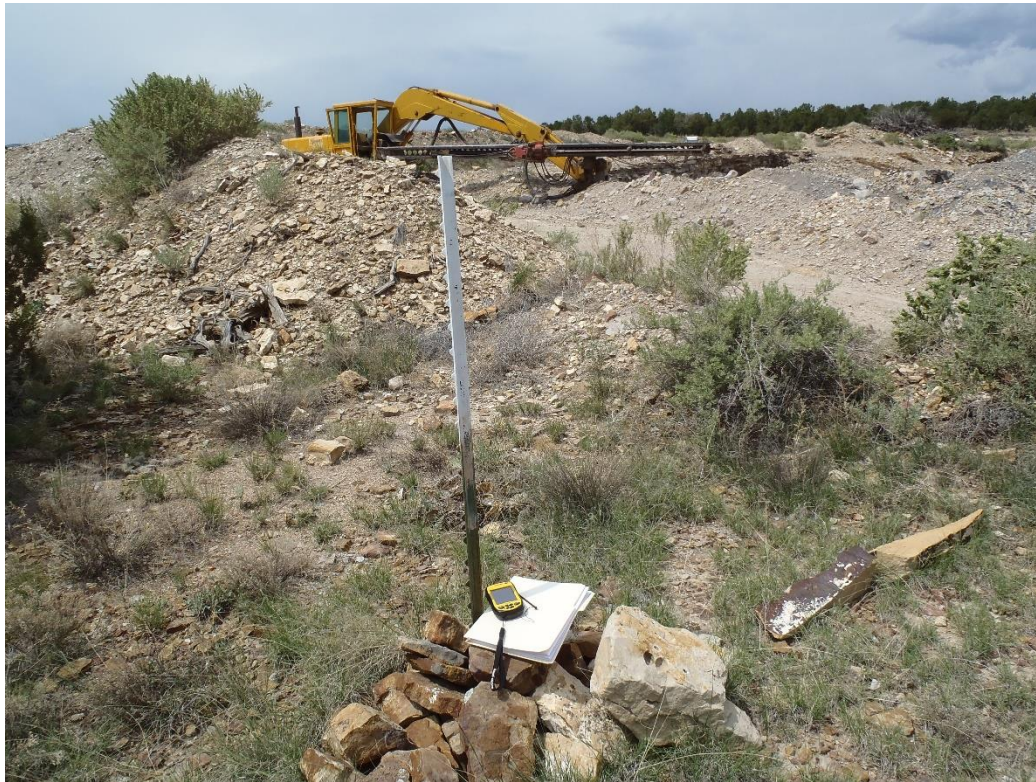
Support Facilities On-site: A drill rig (see **Photo 4**) and generator were observed on site.

Photo 4. Drill rig & typical boundary marker (south side, looking NW).

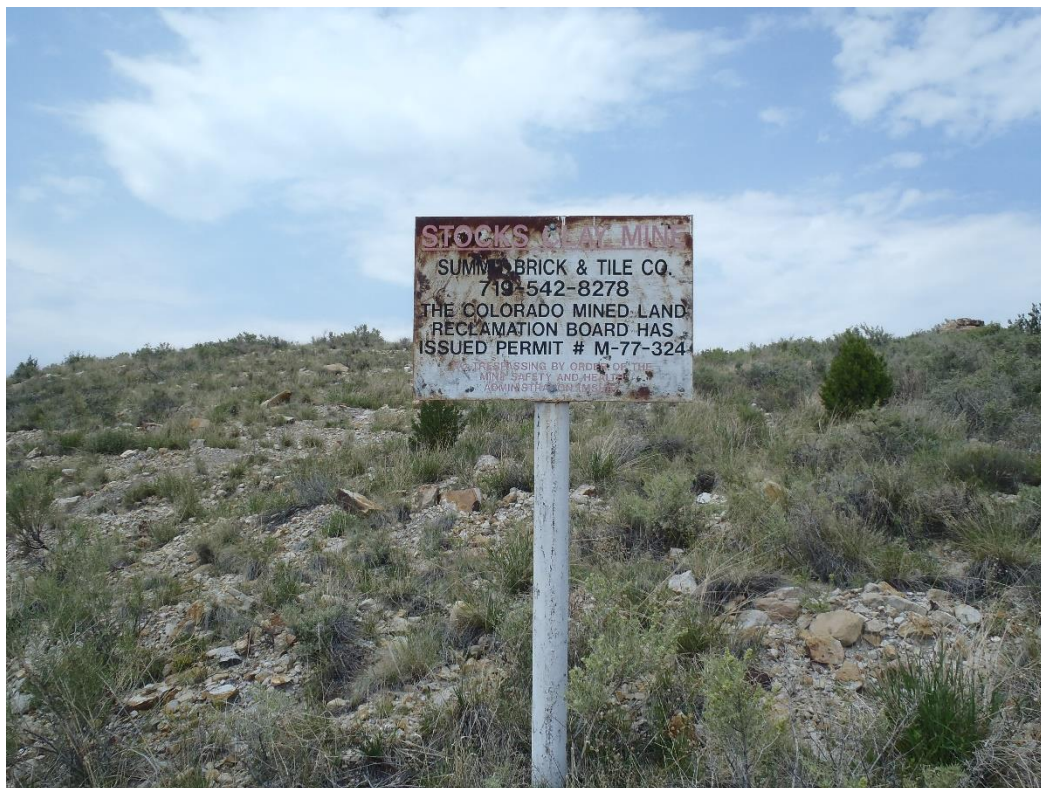
Signs and Markers: The permit sign was properly posted (see **Photo 5**) and boundary markers were observed to delineate the affected area boundary on the east end (see **Photo 6 and 7**). **The missing boundary markers for the active west portion of the pit is cited as a problem on page 1 of this report.**

Photo 5. Permit sign (at affected area boundary).

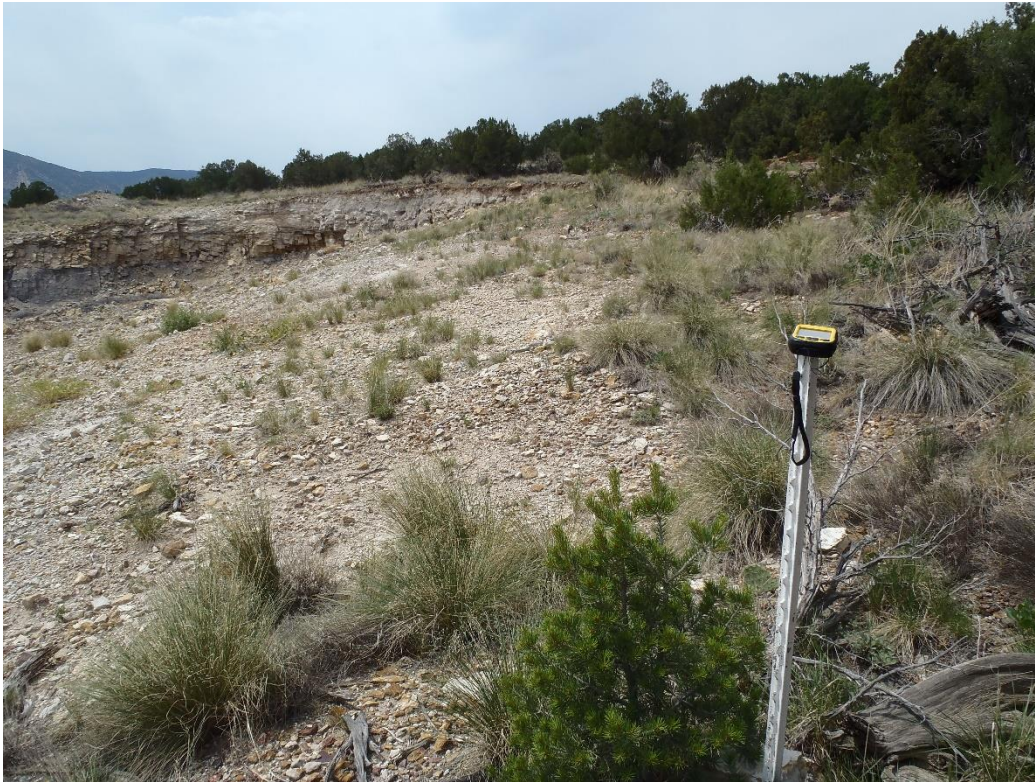
Photo 6. Typical boundary marker (north side, looking NW).

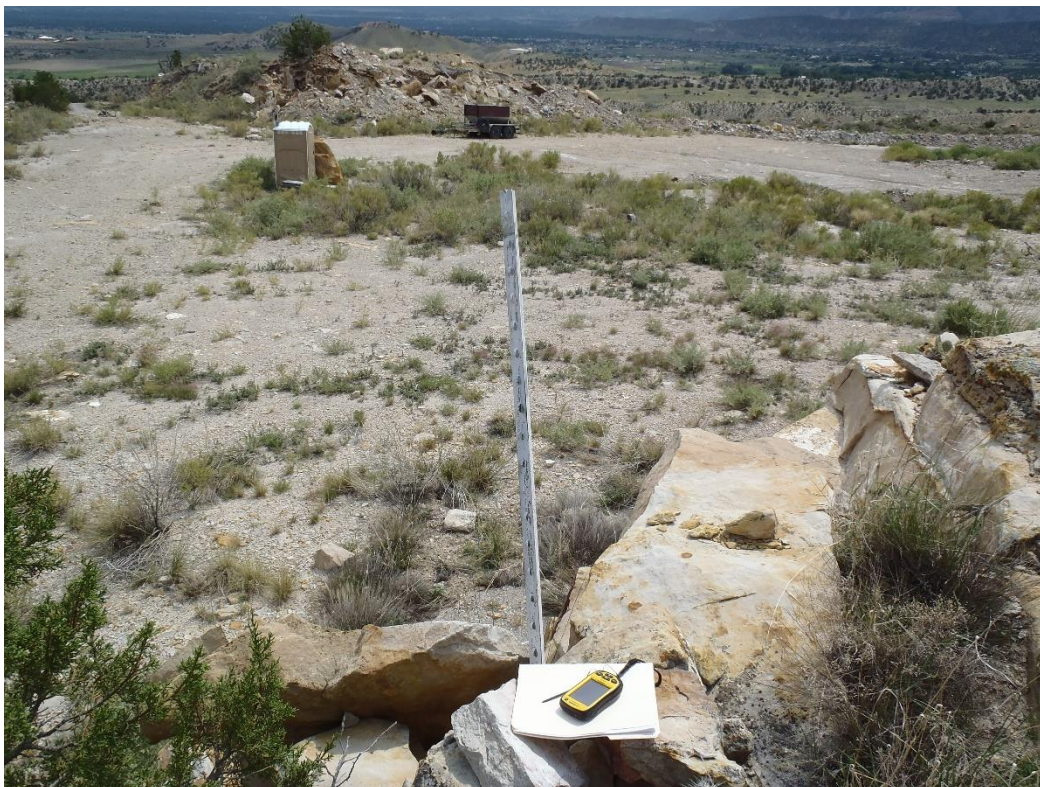
Photo 7. Typical boundary marker (north side, looking south).

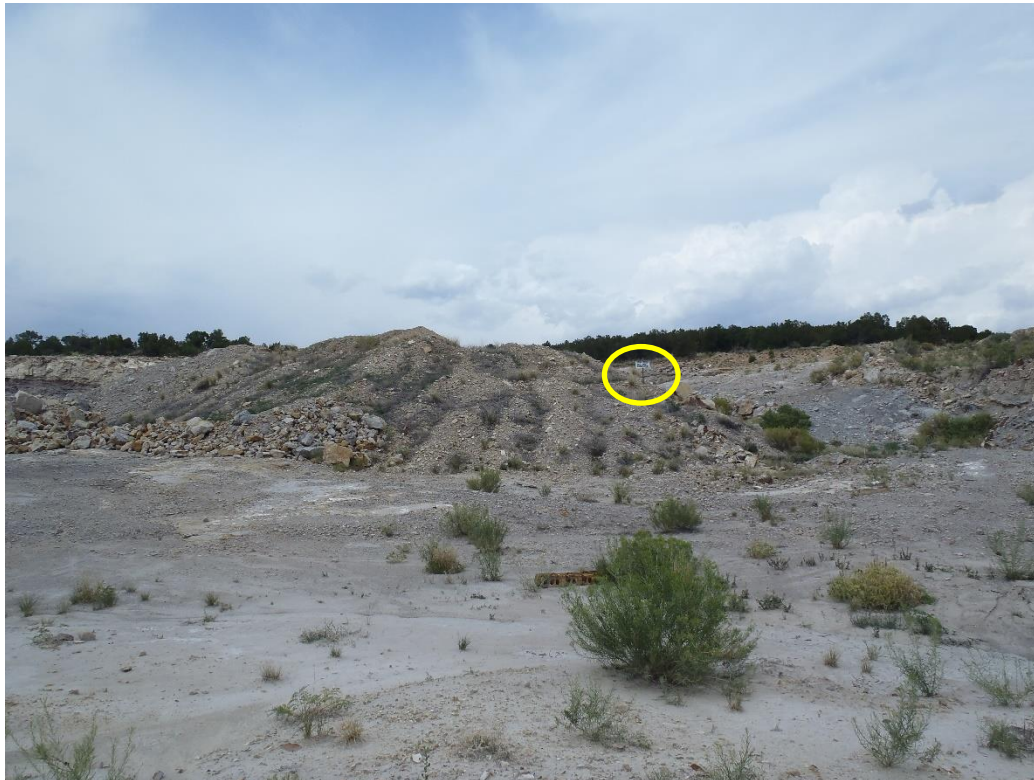
Topsoil: A topsoil stockpile was observed and labeled as such in between the east and west sides of the site (see **Photo 8**).

Photo 8. Topsoil stockpile with sign (circled), looking NE.

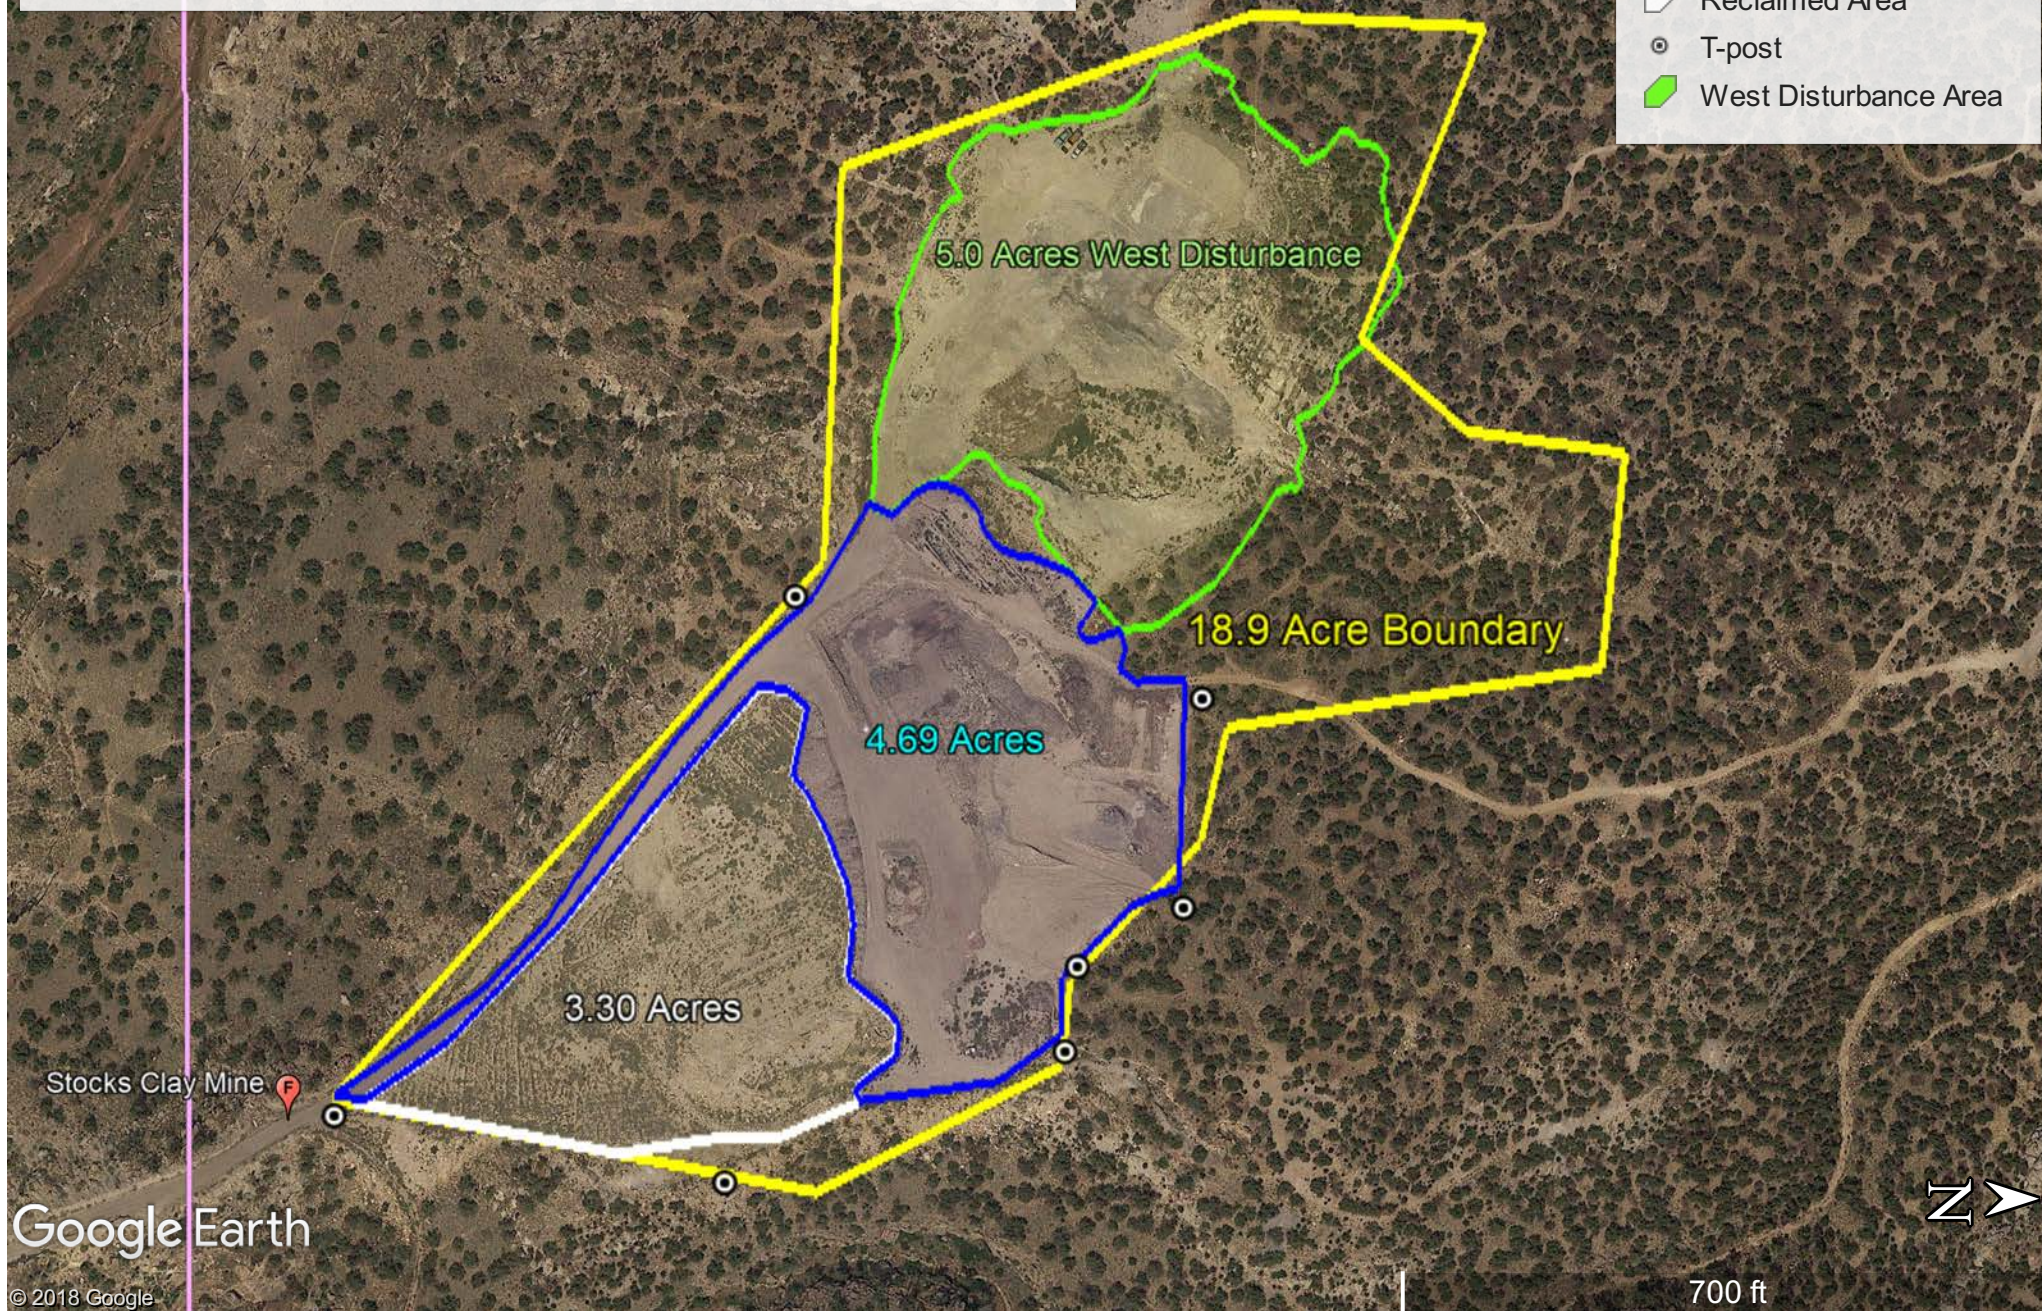
Stocks Clay Mine 2018 Post-Inspection Map

PROBLEM/POSSIBLE VIOLATION: Problem: The west side affected area boundary markers are missing or incorrectly placed. This is a problem for failure to maintain boundary markers around the affected area as required by Section 3.1.12(2) of the rule.

Off-site Damage: The east portion of the operation appeared to be confined to the permit boundary, based on observed boundary markers and Google Earth review. It is not certain if the west portion is entirely within the permit boundary as no boundary markers could be located (see Signs and markers discussion below).

CORRECTIVE ACTIONS: The operator shall conduct a survey and replace the west side boundary markers in the correct location(s). The operator shall provide proof to the Division that this has been done by the corrective action date.
