**MINERALS PROGRAM INSPECTION REPORT**  
**PHONE: (303) 866-3567**

<b>MINE NAME:</b> Yevoli Cobblestone Pit	<b>MINE/PROSPECTING ID#:</b> M-2007-003	<b>MINERAL:</b> Sand and gravel	<b>COUNTY:</b> Fremont
<b>INSPECTION TYPE:</b> Monitoring	<b>INSPECTOR(S):</b> Timothy A. Cazier	<b>INSP. DATE:</b> October 17, 2018	<b>INSP. TIME:</b> 10:00
<b>OPERATOR:</b> Yevoli Cobblestone Inc	<b>OPERATOR REPRESENTATIVE:</b> Mark Yevoli & Justin Allen	<b>TYPE OF OPERATION:</b> 110c - Construction Limited Impact	
<b>REASON FOR INSPECTION:</b> Preoperation Inspection	<b>BOND CALCULATION TYPE:</b> Complete Bond	<b>BOND AMOUNT:</b> \$34,925.00	
<b>DATE OF COMPLAINT:</b> NA	<b>POST INSP. CONTACTS:</b> None	<b>JOINT INSP. AGENCY:</b> None	
<b>WEATHER:</b> Cloudy	<b>INSPECTOR'S SIGNATURE:</b>

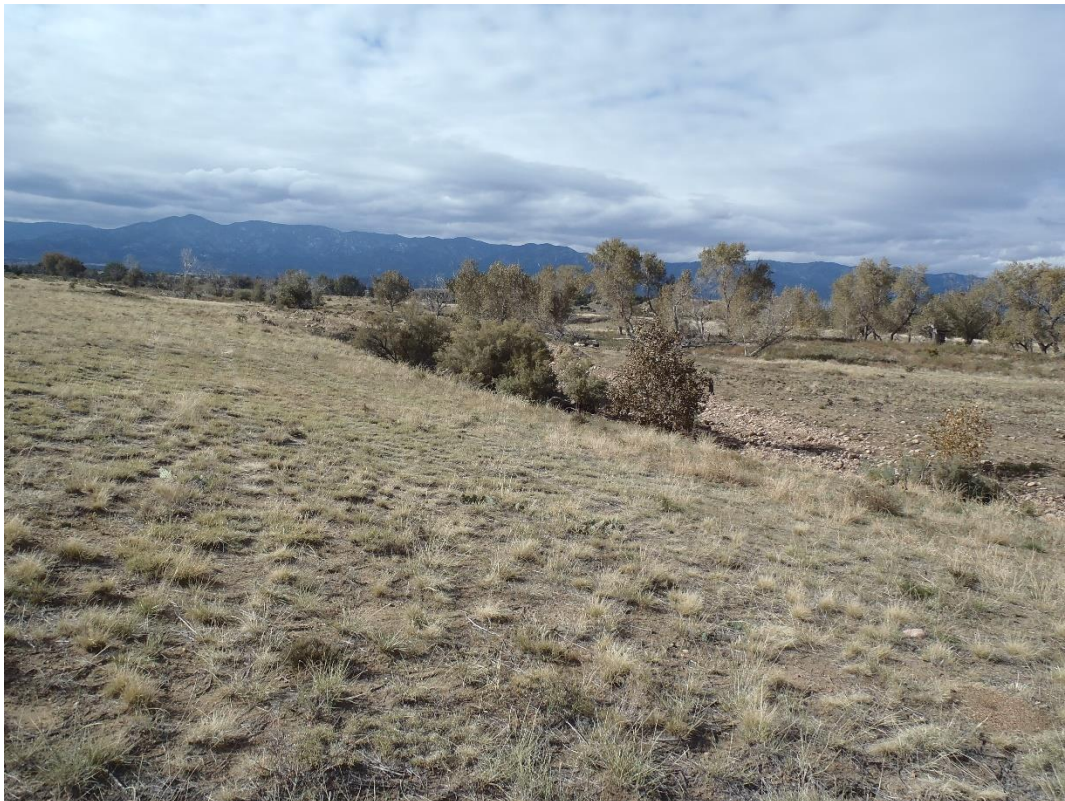
**Hydrologic Balance:** No standing water was observed in the pit and no exposed groundwater was observed. This inspector discussed floodplain delineation of Hardscrabble Creek (see **Photos 1 and 2**), which runs through the proposed expansion area with Mr. Yevoli. As most of the proposed mine area falls within the Hardscrabble designated floodplain, it was agreed offsets and mine extraction methods would be modified to reduce the potential for stream capture.

Photo 1. Hardscrabble Creek (looking south from near the existing east-west fence).

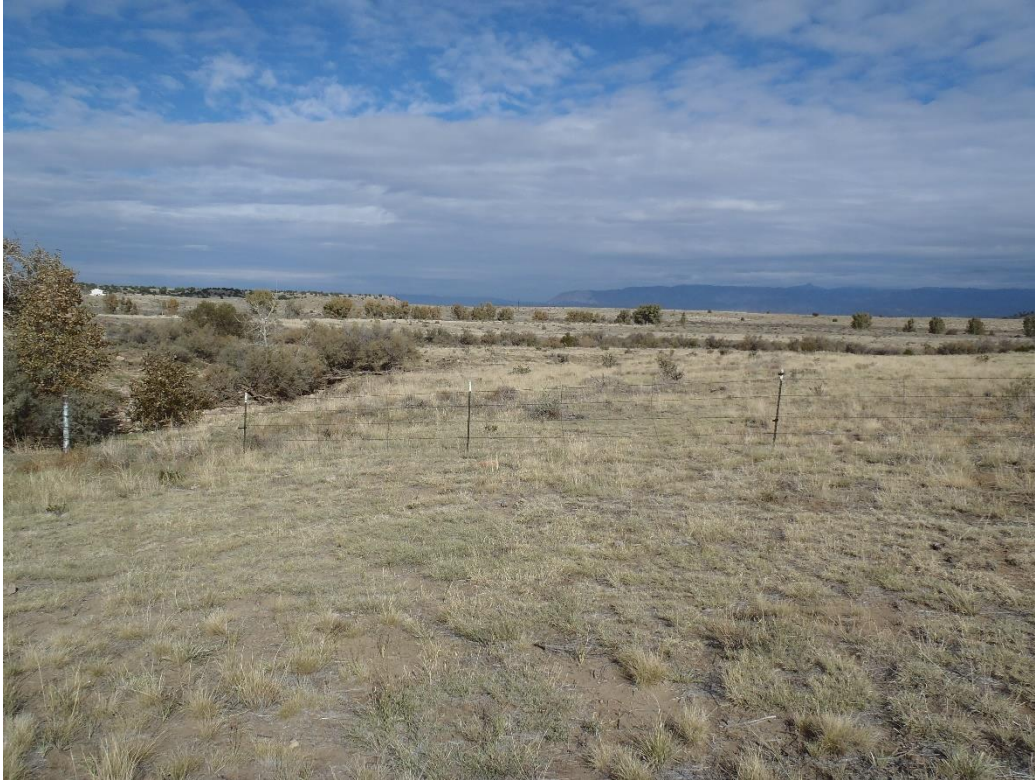
Photo 2. Hardscrabble Creek (looking north from the existing east-west fence - shown).

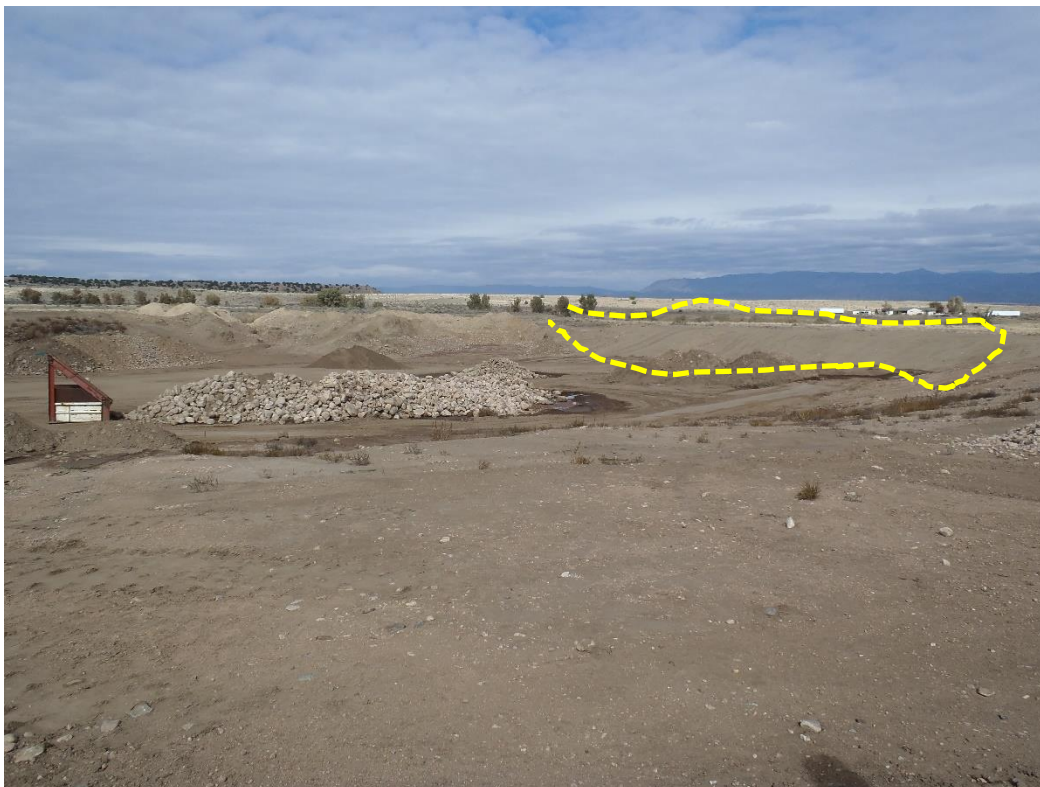
**Reclamation Success:** Some reclamation has been initiated in 3H:1V grading (see **Photo 3**), but no topsoiling or seeding yet.

Photo 3. 3H:1V grading in active pit (looking west).

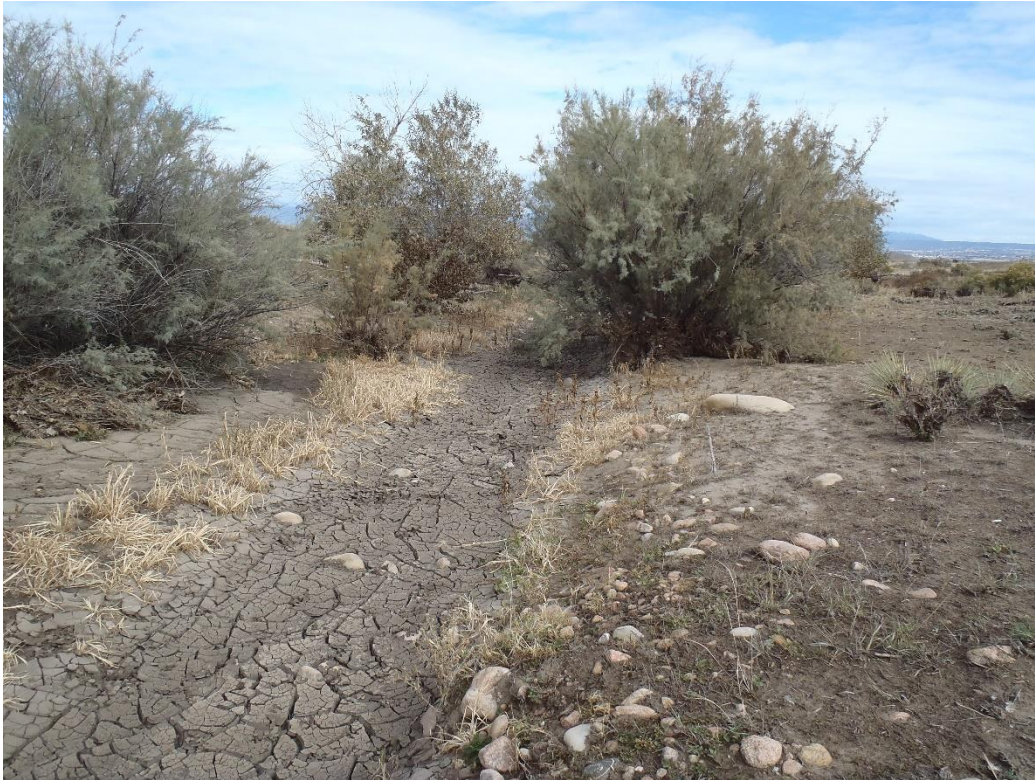
**Revegetation:** A large amount of tamarisk (salt cedar) was observed in the Hardscrabble Creek bed (see **Photo 4**). This is a noxious weed List B species. However, it was not in the current 110c permit boundary so it was not cited as a problem. This inspector informed the Operator of the [need to implement a weed control program to control tamarisk on site once Hardscrabble Creek is incorporated into the permit area](#) (i.e., with the approval of CN-01). No noxious weeds were observed in the 110c permit area.

Photo 4. Tamarisk in Hardscrabble Creek (south end, looking north).

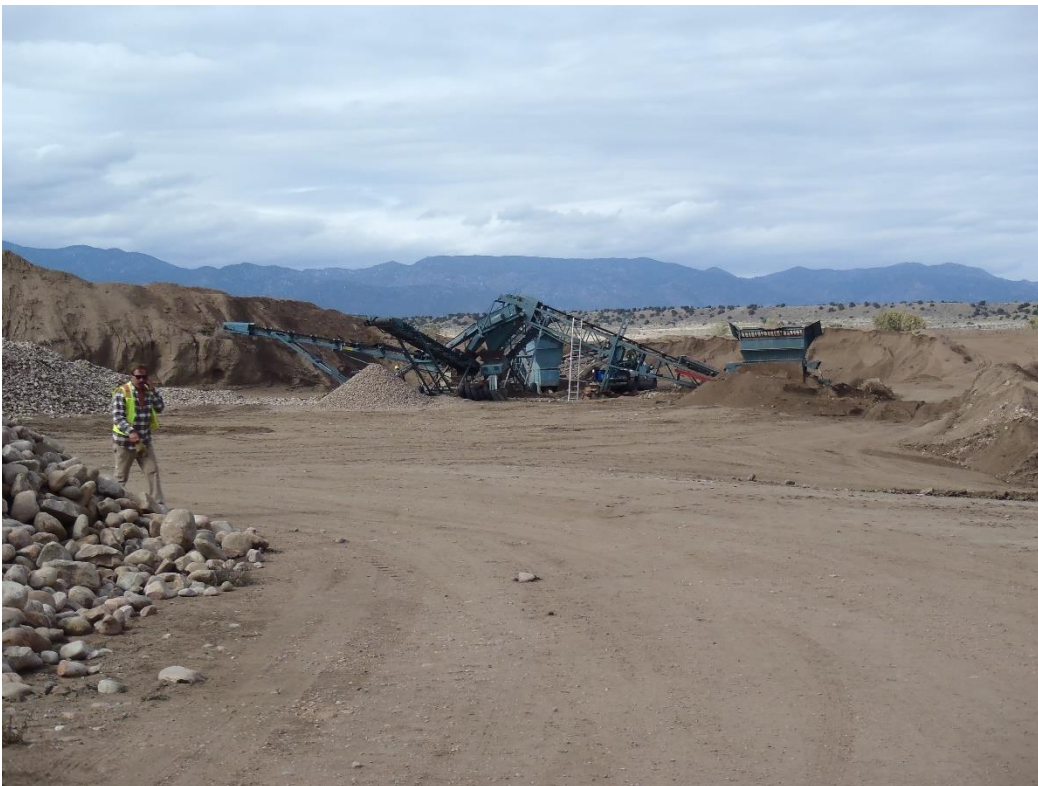
**Support Facilities On-site:** A screen plant (see **Photo 5**) and loader were observed on site.

Photo 5. Screen plant in active pit (looking SW).

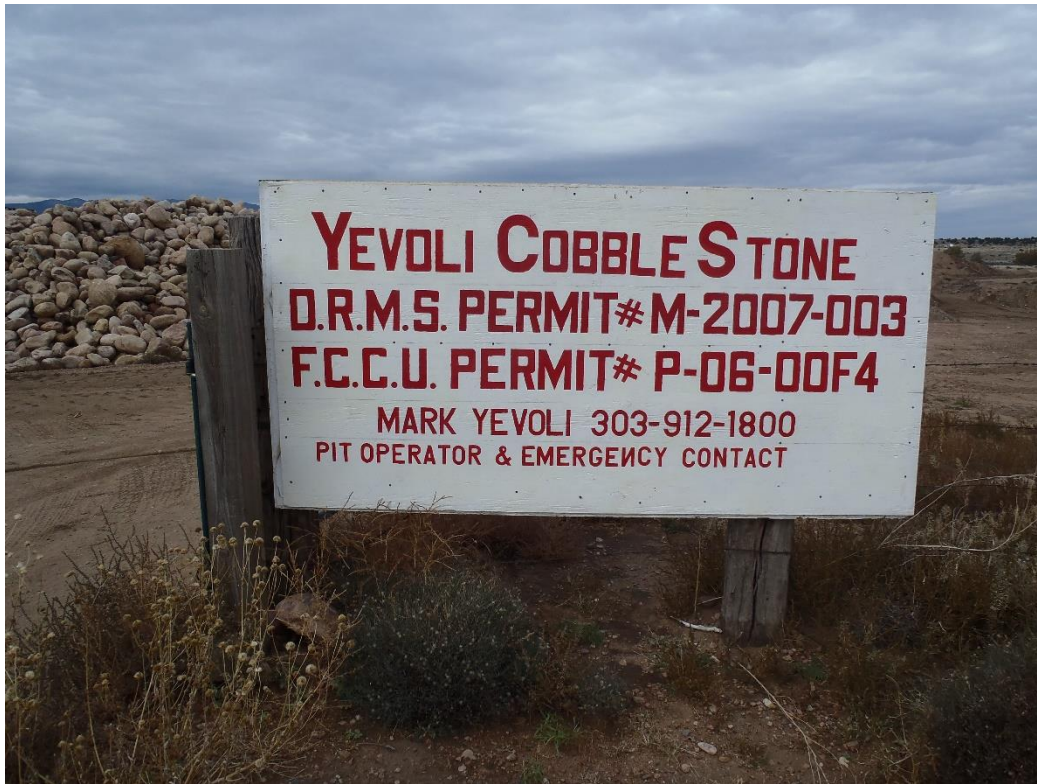
**Signs and Markers:** The permit sign was properly posted (see **Photo 6**) as well as the requisite public notice sign (see **Photo 7**). Existing fences will for the most part delineate the future (CN-01) affected area boundaries. However, the Operator/Permittee should delineate the offsets from the county road and Hardscrabble Creek

Photo 6. Permit sign.

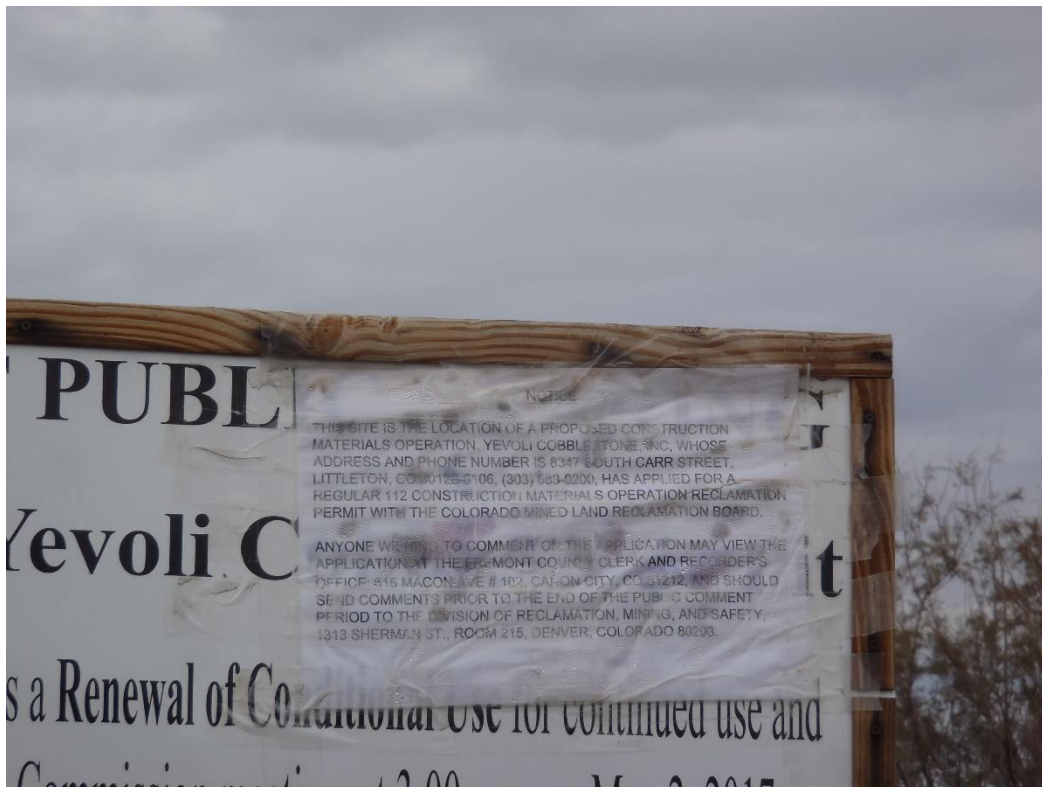
Photo 7. Public notice sign for CN-01 (at entrance).
