MINERALS PROGRAM INSPECTION REPORT
PHONE: (303) 866-3567

MINE NAME: Indian Springs Park Pit	MINE/PROSPECTING ID#: M-2001-087	MINERAL: Gravel	COUNTY: Fremont
INSPECTION TYPE: Monitoring	INSPECTOR(S): Timothy A. Cazier	INSP. DATE: August 7, 2018	INSP. TIME: 10:00
OPERATOR: Fremont County	OPERATOR REPRESENTATIVE: Sterling Rife & Paul Garrett	TYPE OF OPERATION: 112c - Construction Regular Operation	
REASON FOR INSPECTION: Normal I&E Program	BOND CALCULATION TYPE: None	BOND AMOUNT: \$0.00	
DATE OF COMPLAINT: NA	POST INSP. CONTACTS: Colo. Land Board	JOINT INSP. AGENCY: None	
WEATHER: Clear	INSPECTOR'S SIGNATURE:

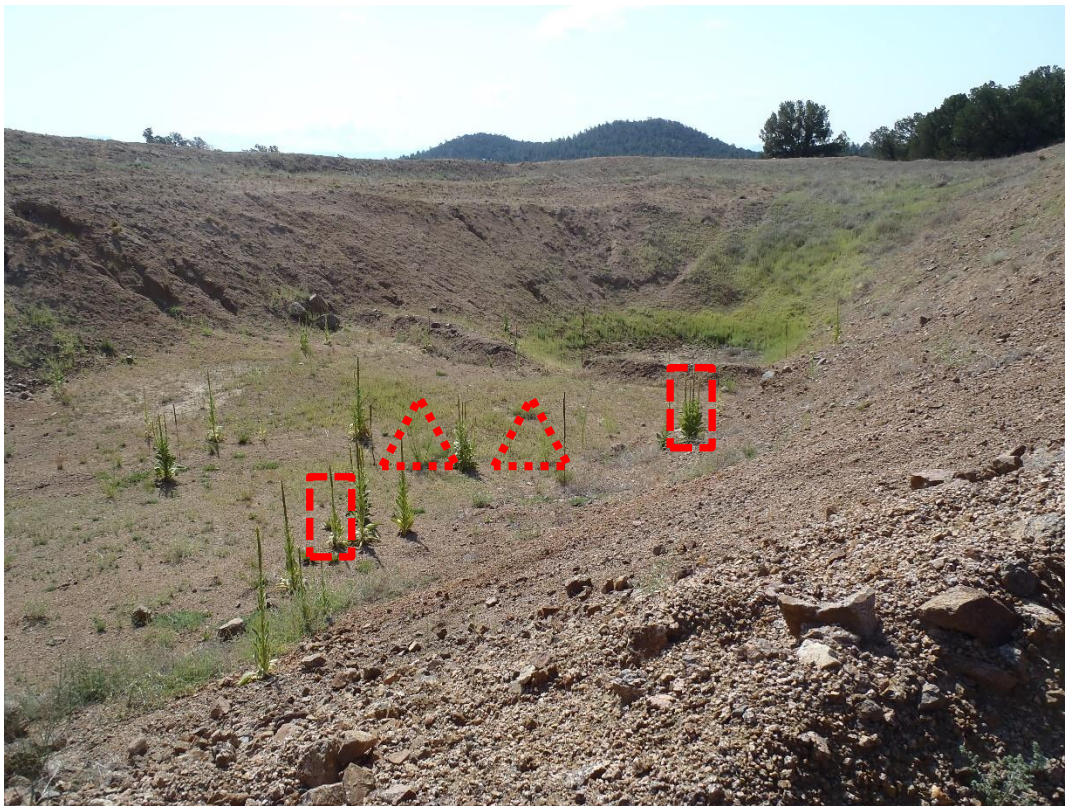
Hydrologic Balance: A small amount of standing water was observed in the pit (see **Photo 1**) which was judged as stormwater, not exposed groundwater.

Revegetation: Some revegetation is underway in small area east of the deepest (southeast) part of the pit (see **Photo 4**). Some Common Mullein, a List C noxious weed species and some small tamarisk, a List B noxious weed species were observed (see **Photo 1**). As there is a small amount in an isolated area the presence of these noxious weeds is not cited as a problem. However, the County should implement a weed control program before these weeds become problematic.

Photo 1. Deepest portion of pit with water (note small tamarisk

and common mullein

).

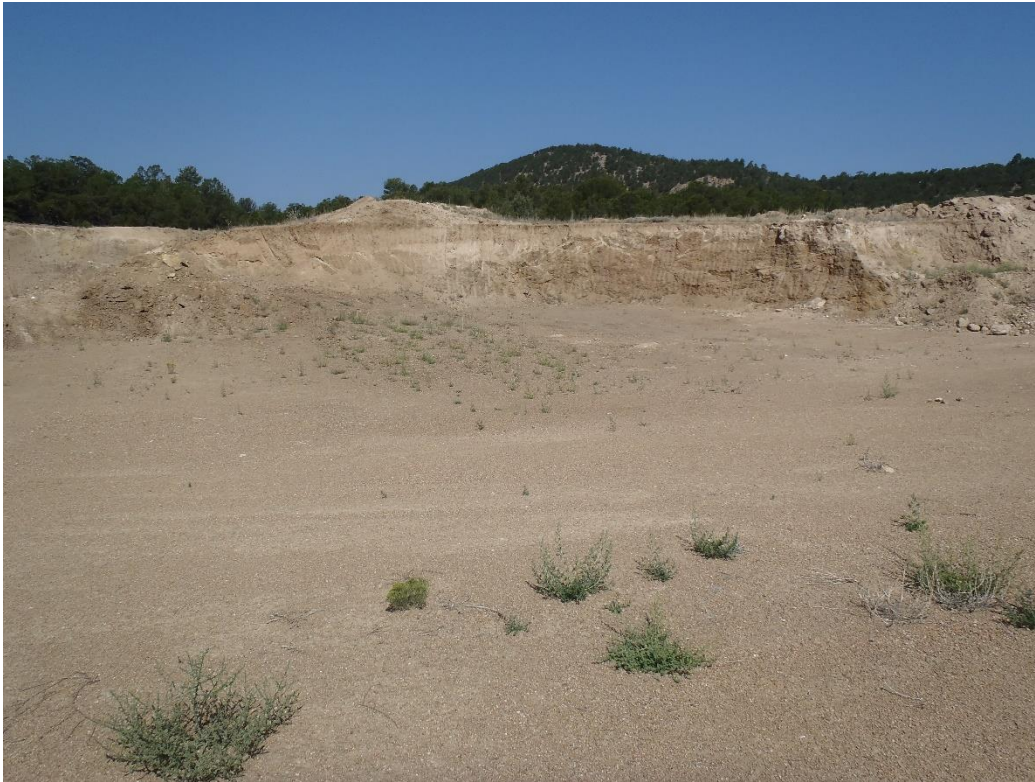
Gen. Compliance with Mine Plan: The operation appeared to be in compliance with the approved mine plan. The maximum allowed disturbed area is 20 acres. Google Earth was used to measure the disturbed area, which was estimated to be approximately 5.8 acres, based on 2016 imagery. Highwalls were estimated to eight feet in height and appeared stable (see **Photos 2 and 3**).

Photo 2. Typical highwall (NE corner, looking NE).

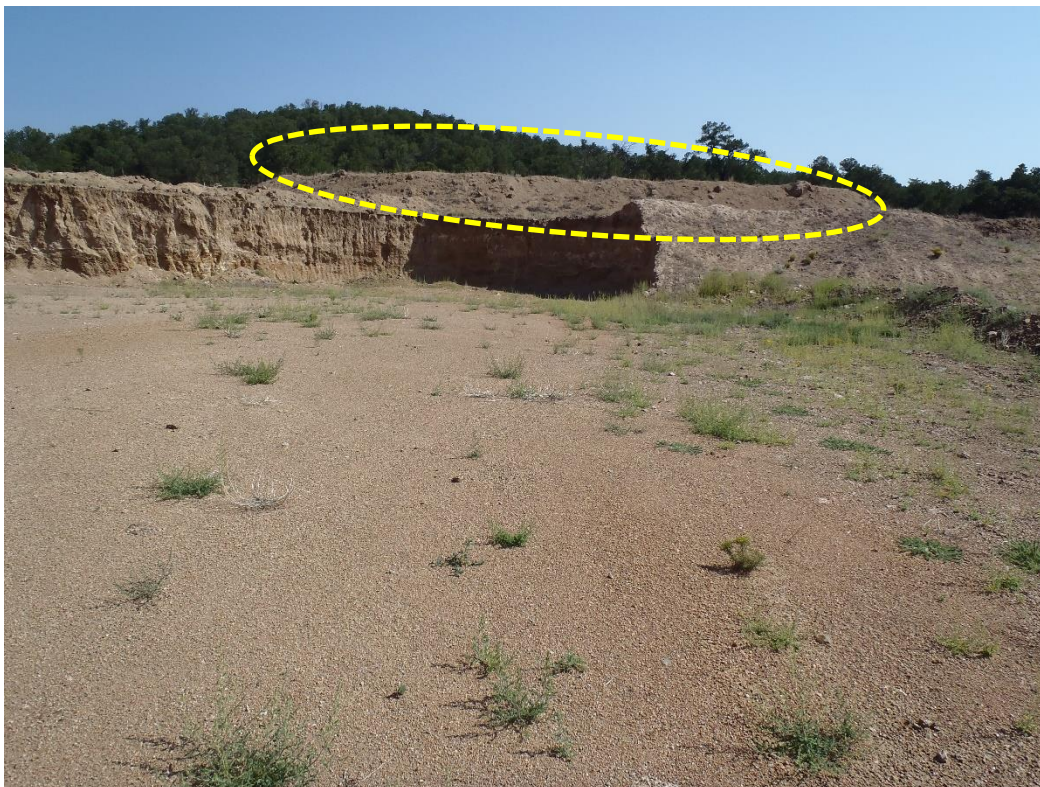
Topsoil: Topsoil is stockpiled on the east and north sides of the pit (see **Photos 3 and 8**).

Photo 3. Typical highwall (NE corner, looking east, note topsoil stockpile circled)

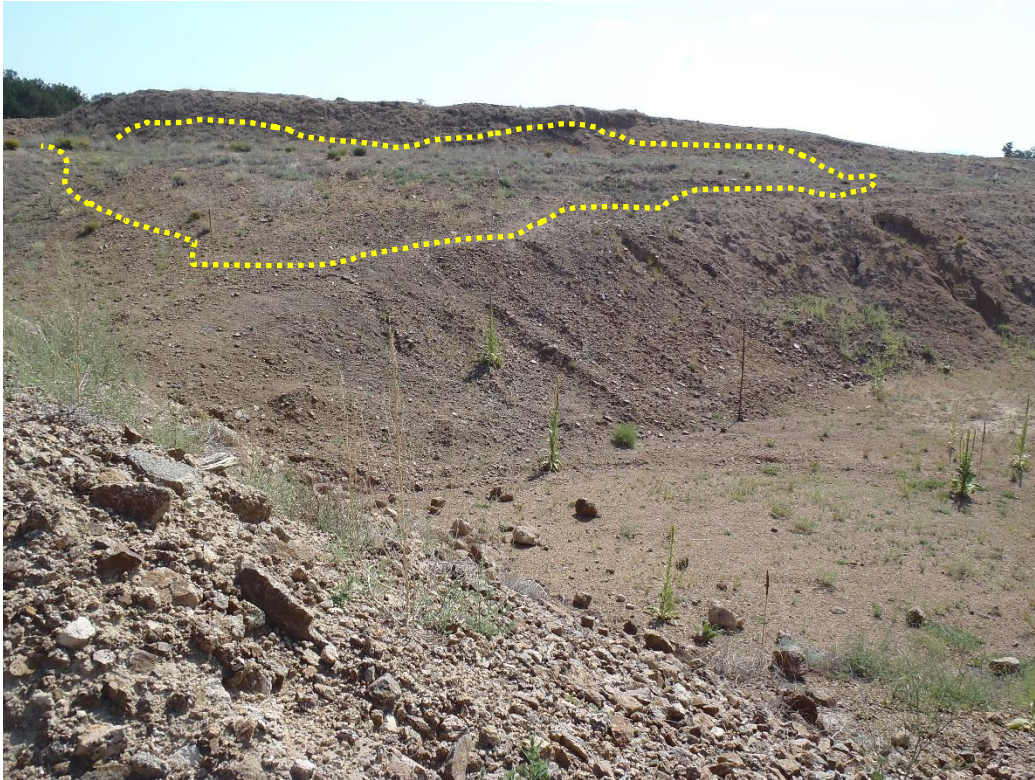
Reclamation Success: The County has begun reclaiming a small area east of the deepest (southeast) part of the pit (see **Photo 4**).

Photo 4. Area being reclaimed east of deep portion of pit (looking east).

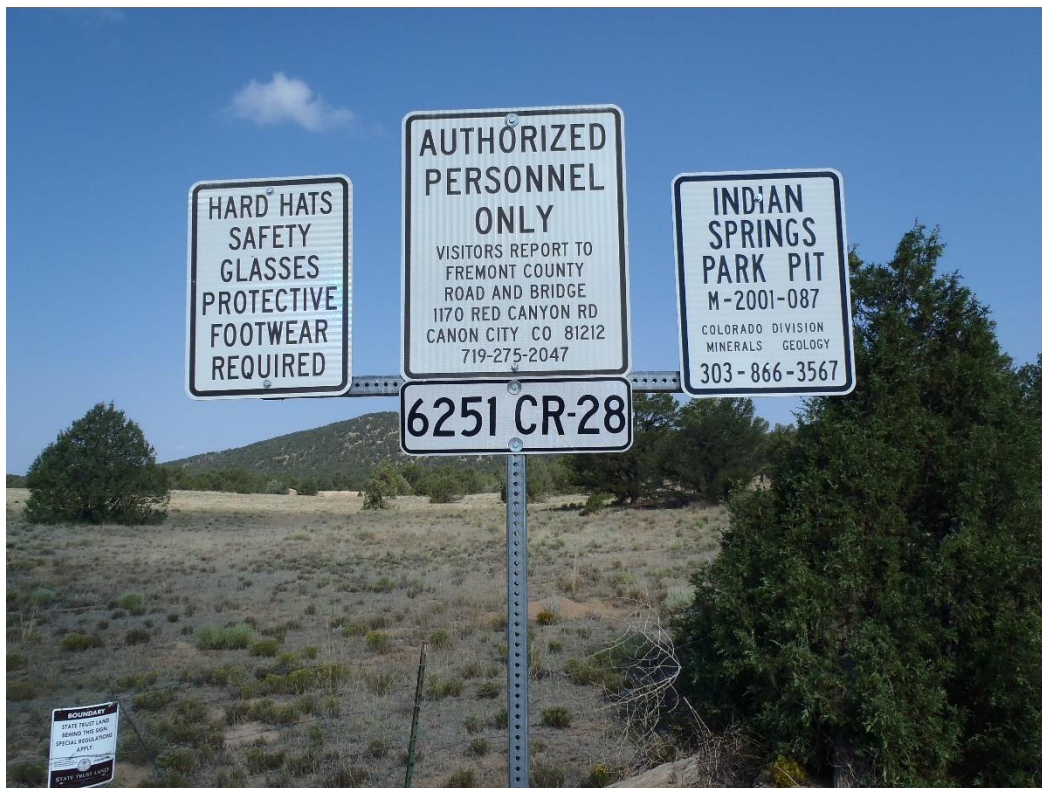
Signs and Markers: The permit sign was properly posted (see **Photo 5**) and boundary markers were observed

Photo 5. Permit sign (at entrance).

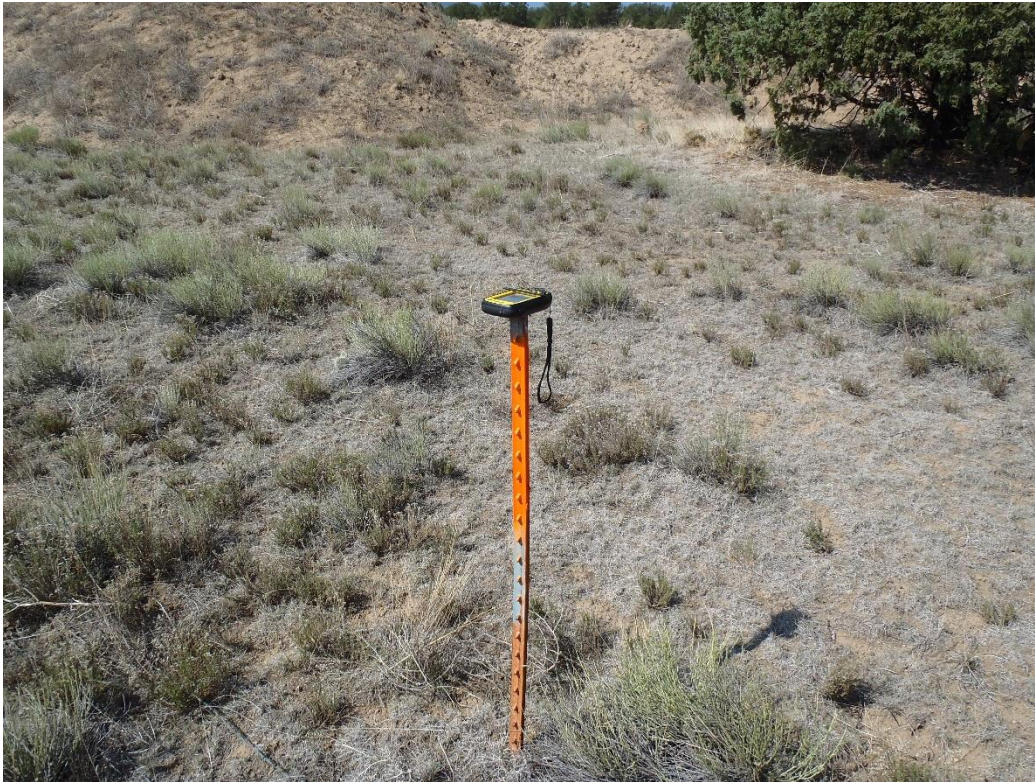
to delineate the permit boundary (see **Photos 6 and 7**).

Photo 6. Typical boundary marker T-post (note GPS unit on top).

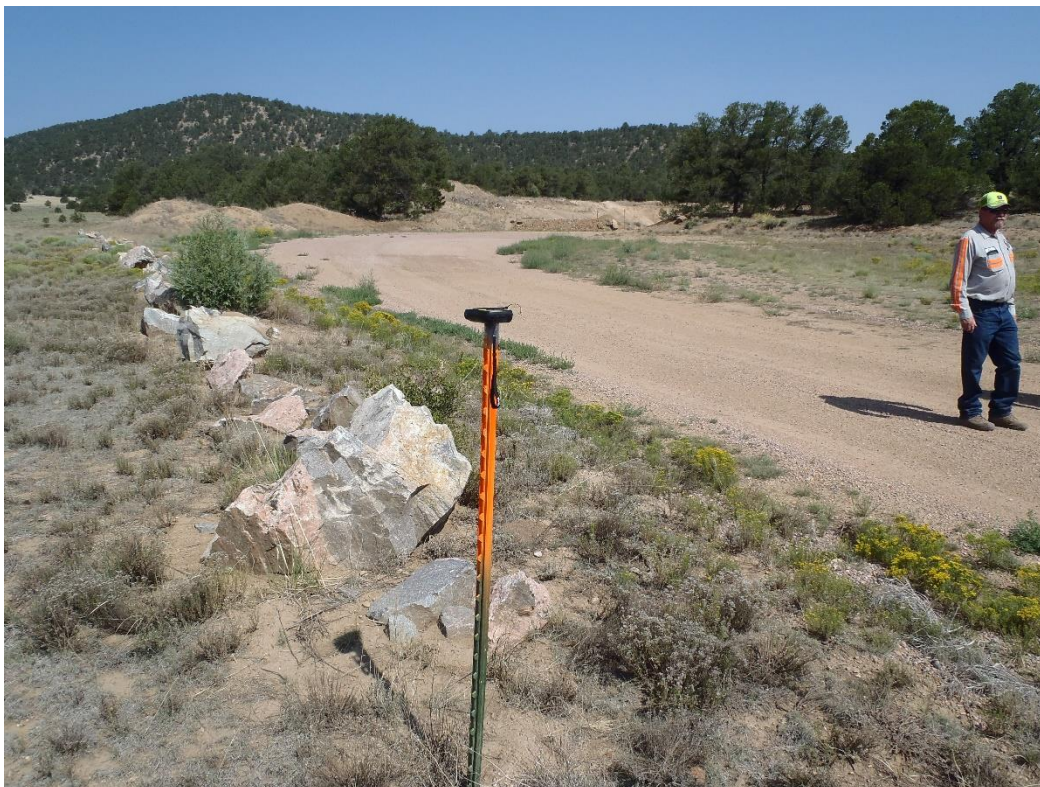
Photo 7. Boundary marker T-post on SW corner of access road (note GPS unit on top).

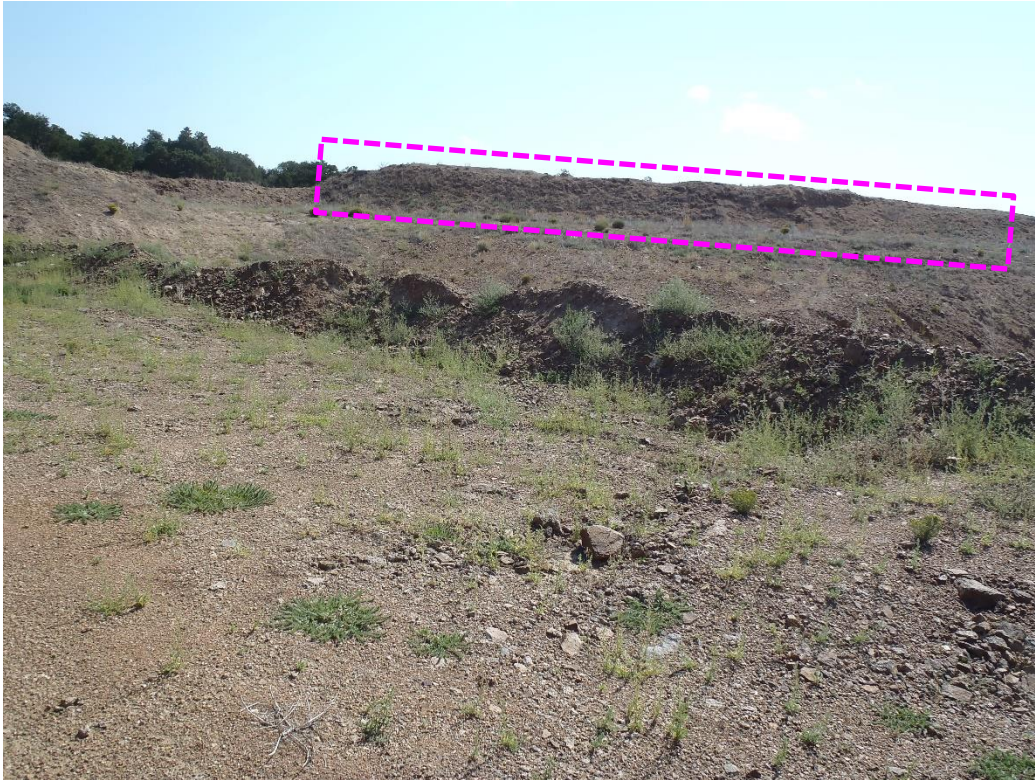
Photo 8. Topsoil stockpile (east side, looking east).

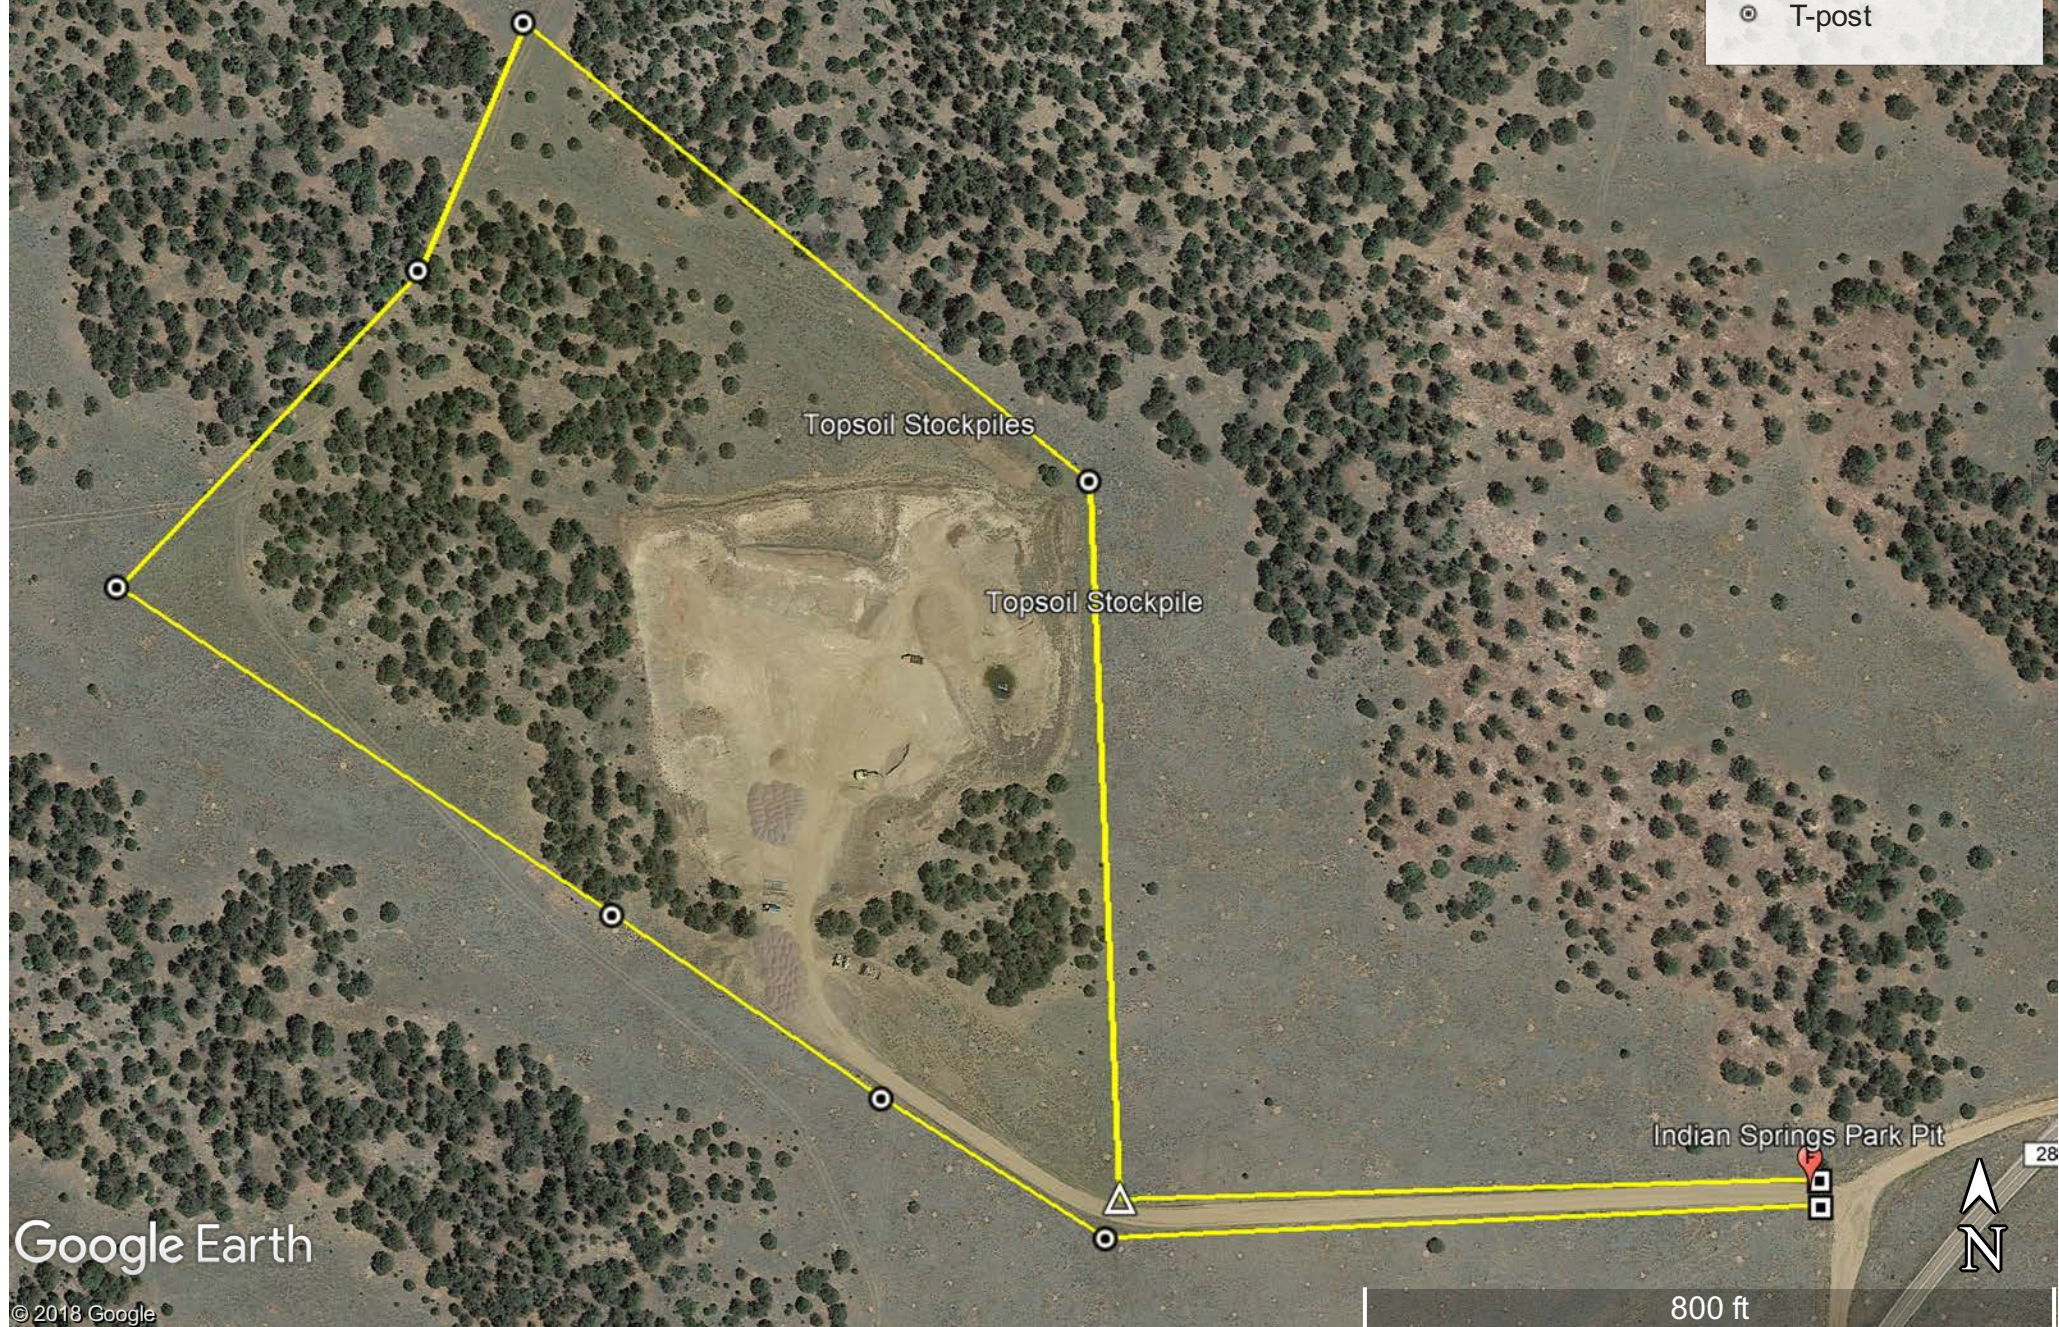
Indian Springs Park Pit 2018 Post-Inspection Map

Off-site Damage: The operation appeared to be confined to the permit boundary, based on Google Earth review and the collection of GPS locations of the site boundary markers using a handheld Trimble Juno 3B GPS unit (see enclosed **Post Inspection Map**).

* Permit Area boundary based GPS data collected 8/7/2018.
