Re: King I Mine, C-1981-035 Stoner Engineering: Quarterly Inspection: Refuse Pile 4th Quarter 2018

Date: December 19, 2018

Re: King Coal I – Quarterly Waste Pile/Embankment Inspection

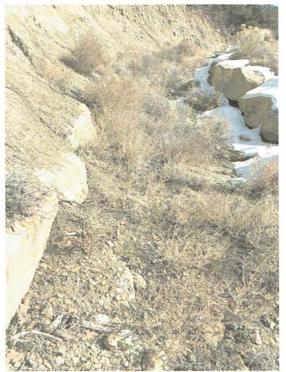
The north clean water ditch has had some work completed but, is still in need of additional cleaning (see Pic. 1). The south ditch was covered in snow and difficult to assess but, appears to be in good conditions (see Pic. 2). The culvert sections were found to be clear of debris and functioning as designed.

Pic. 1 – North channel requires additional cleaning.

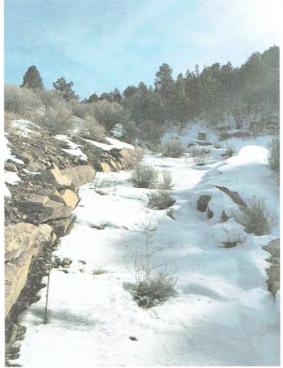
Pic. 2 - South channel covered in snow.

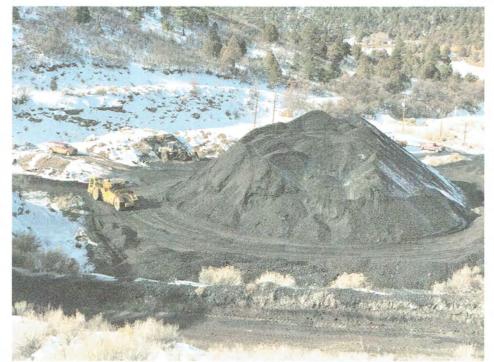
Additional embankment fill has been stockpiled at the base of the waste pile/embankment (see Pic. 3). There is also a stockpile of material at the top of the waste pile (see Pic. 4). The pipe that drains into Reach 10 is clear of debris/sediment and appears to be functioning as designed (see Pic. 5). The face of the embankment was covered in snow at the time of the inspection but, there were no signs of excessive erosion, instability or weakness (see Pic. 6).

Pic. 3 – Material at base of embankment/waste pile.

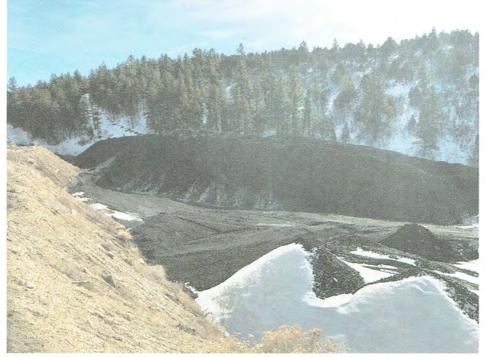
Pic. 4 – Material at top of embankment/waste pile.

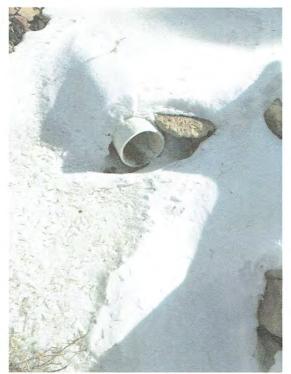
Pic. 5 – Pipe drain into Reach 10.

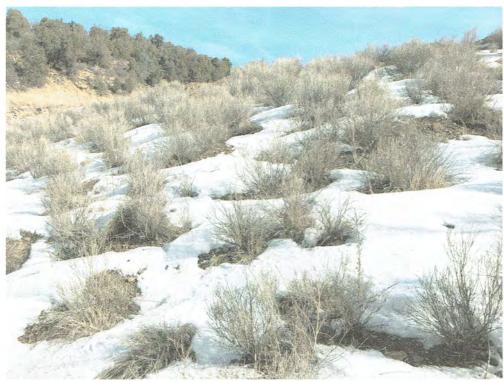
Pic. 6 - Waste pile/embankment covered in snow.
