Re: King I Mine, C-1981-035
Stoner Engineering: Quarterly Inspection: Water Quality Improvements
4th Quarter 2018

Date: December 19, 2018

Re: King Coal I – Quarterly Water Quality Improvements Inspection

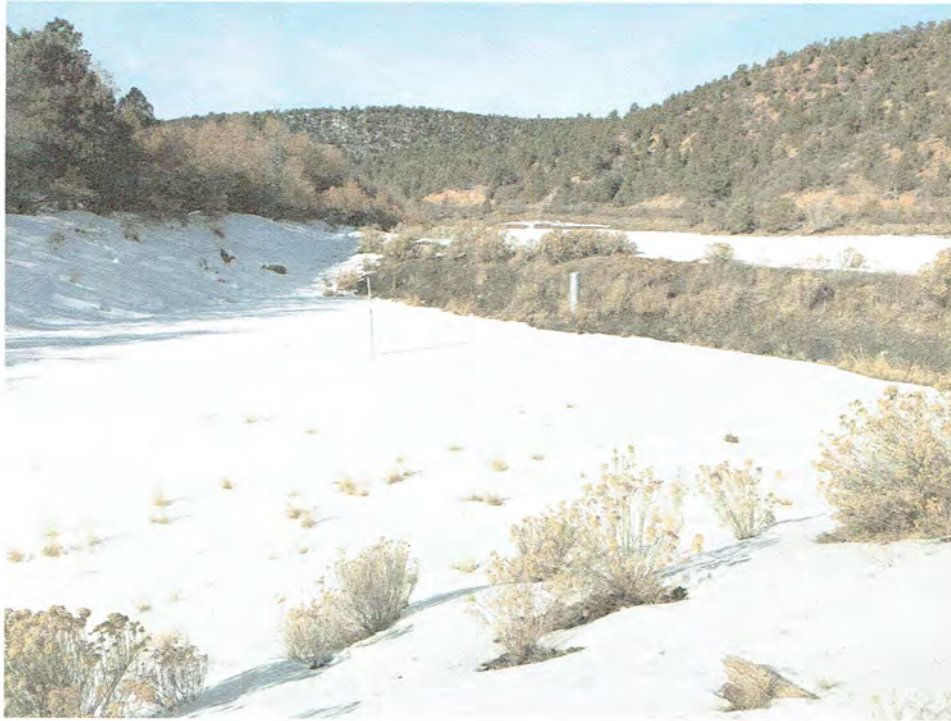
Both ponds appeared to be dry at the time of the inspection (see Pic. 1). The ponds both appeared to generally be in good condition though the ground was covered in snow. The required storage volume appears to be adequate at this time. The ponds should continue to be monitored after storm events to ensure that excess sediment does not reduce the required storage capacity available for storm water runoff.

Pic. 1 – West pond.

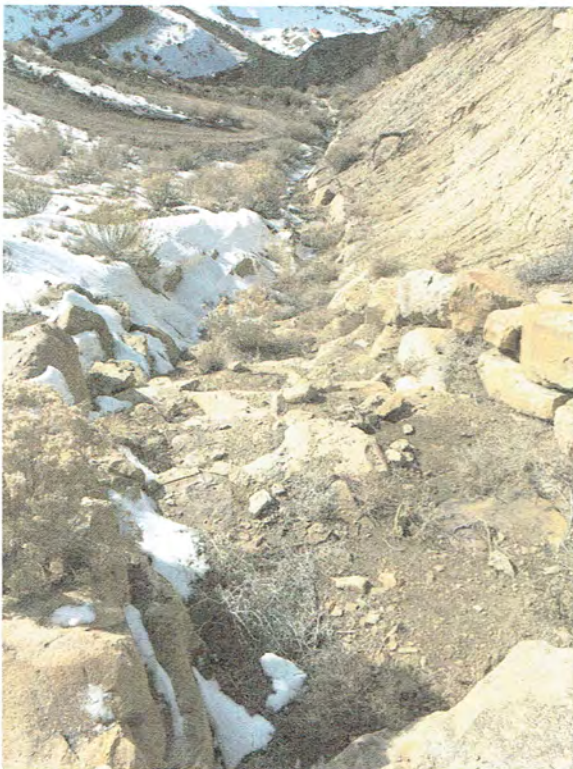
The drainage ditches were covered with snow and difficult to observe while the culvert pipes appeared to be generally in good condition based upon a visual inspection from the inlet and outlet locations. The north clean water ditch still needs to be cleaned out, though the lower portion appears to have had some work completed (see Pic. 2). The south treated water ditch was covered in snow at the time of the inspection (see Pic. 3). All pipes, ditches and sediment traps should be inspected and repaired as necessary, especially after storm events.

Pic. 2 – North clean water ditch requires cleaning.

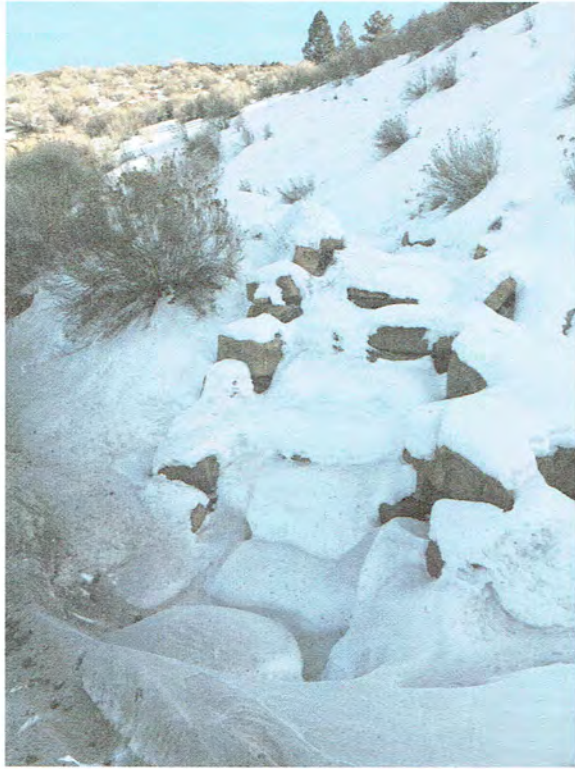
Pic. 3 – South ditch covered in snow.
