MINERALS PROGRAM INSPECTION REPORT**PHONE: (303) 866-3567**

MINE NAME: Midway Pit	MINE/PROSPECTING ID#: M-1988-018	MINERAL: Sand and gravel	COUNTY: El Paso
INSPECTION TYPE: Monitoring	INSPECTOR(S): Timothy A. Cazier	INSP. DATE: October 2, 2018	INSP. TIME: 12:30
OPERATOR: Midway Aggregates, RLLP	OPERATOR REPRESENTATIVE: David King	TYPE OF OPERATION: 112c - Construction Regular Operation

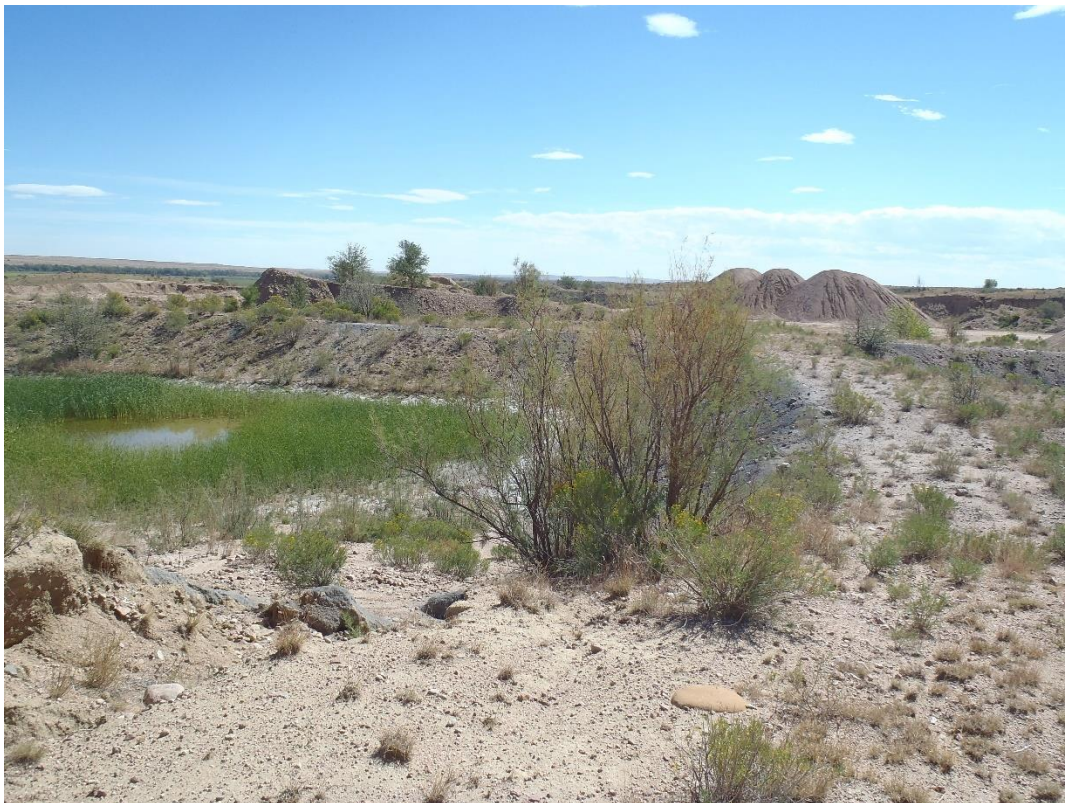
PROBLEM/POSSIBLE VIOLATION: Problem: Tamarisk (salt cedar) trees and Russian olive trees are present within or have volunteered into the permit area and are becoming established. This is a problem for failure to employ weed control methods for a state listed noxious weed species within the permitted area, and to reduce the spread of weeds to nearby areas as required by Section 3.1.10 (6) of the rule.

Revegetation: Some tamarisk (salt cedar) and Russian olive trees were observed (see **Photos 1 and 2**). **The presence of tamarisk and Russian olive (Colorado noxious weed List B species) is cited as a problem on page 1 of this report.**

Photo 1. Tamarisk near east lined sediment pond requiring noxious weed control.

CORRECTIVE ACTIONS: The operator shall either implement the existing weed control plan, or develop a weed control and management plan in accordance with Section 3.1.10 (6) of the Rule. This plan should be developed in consultation with the county extension agency, or weed control district office and should include specific control measures to be applied, a schedule for when control measures will be applied and a post-treatment monitoring plan. This weed control plan shall be submitted to the Division as a Technical Revision to the approved plan with the appropriate Technical Revision fee of \$216.00 by the corrective action date.

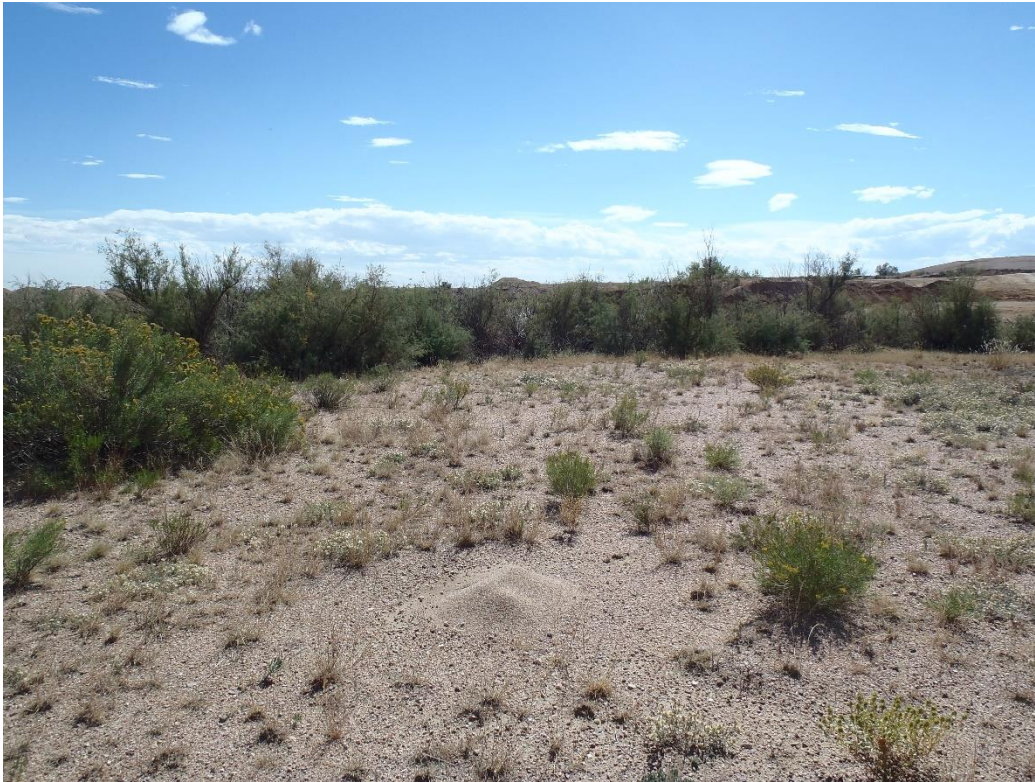
Photo 2. Tamarisk & Russian olive trees requiring noxious weed control (west of lined sediment ponds).

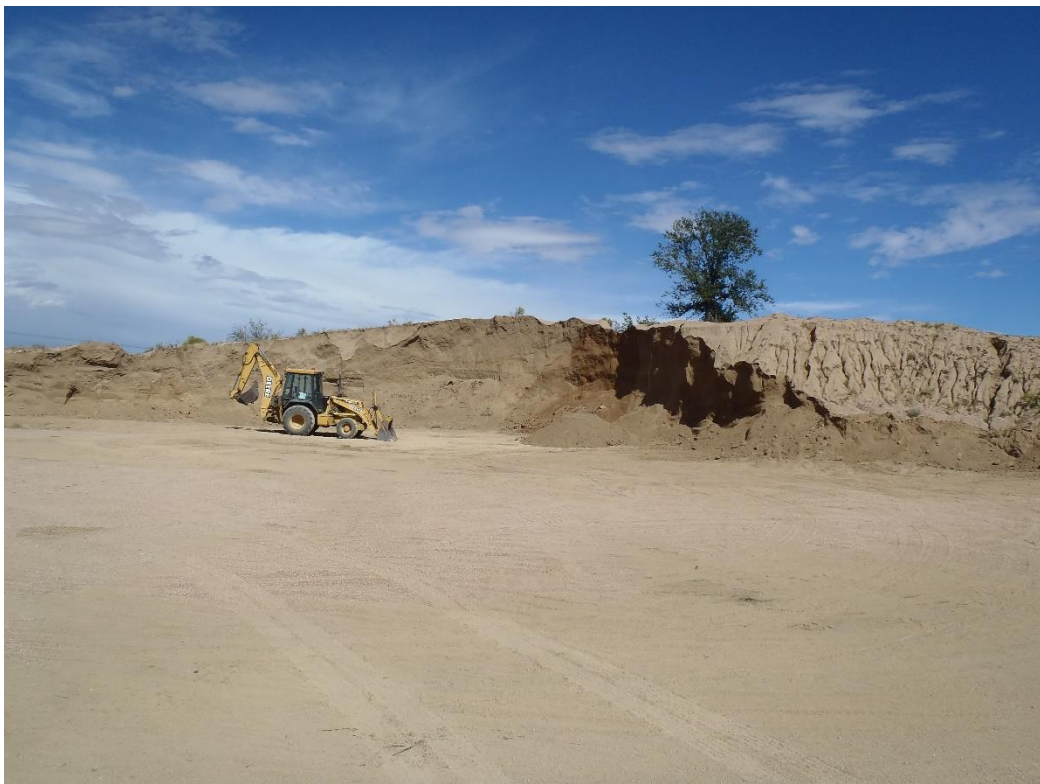
Support Facilities On-site: A backhoe (see **Photo 3**) and dump truck were observed on site.

Photo 3. Backhoe in active area, waiting for the next truck (south east corner of site).

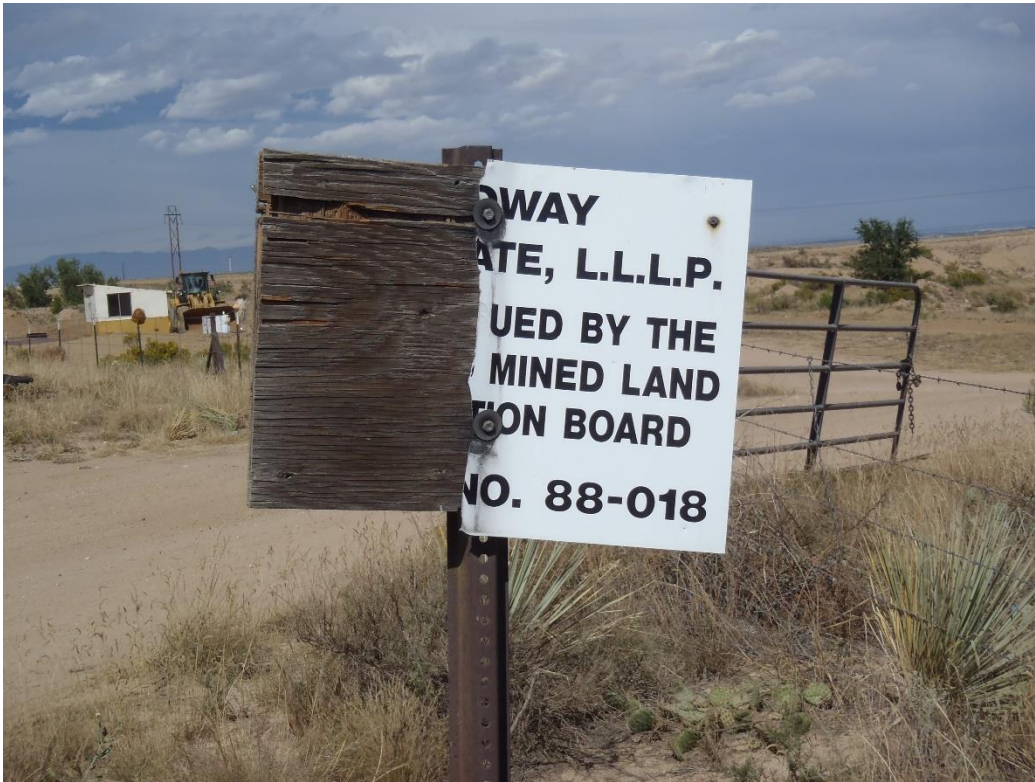
Signs and Markers: The right half of the permit sign was properly posted (see **Photo 4**). Apparently, the wind had ripped off the left half. The DRMS will not cite this as a problem, but [the permit sign does need to be replaced](#). Fences mark a majority of the affected area boundary (see **Photos 5 and 6**). There was some discussion as to whether the fences on the southeast were at the property boundary or the affected area boundary. [Mr. King committed to verifying the fence on the south side towards the east end and the marker post area are coincident with the affected area boundary in that area. The verification of affected area boundary markers will prevent potential future problems with respect to mining outside the affected area boundary.](#)

Photo 4. Permit sign (at entrance).

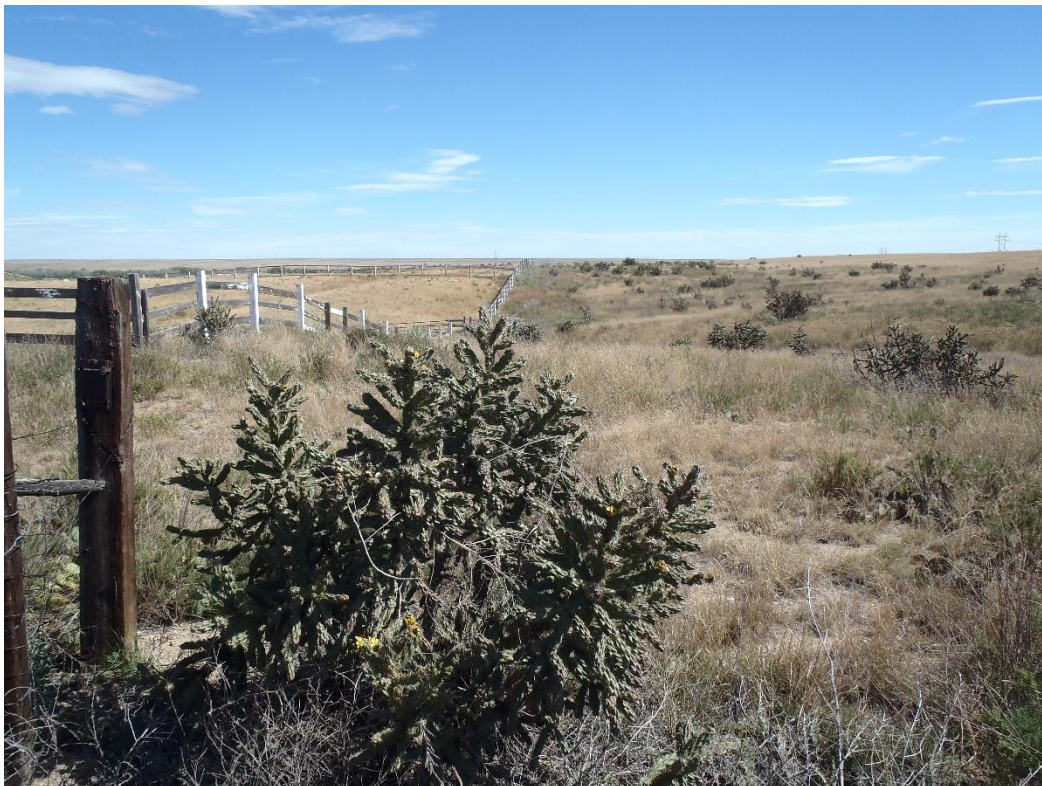
Photo 5. North fence, running east-west (looking east).

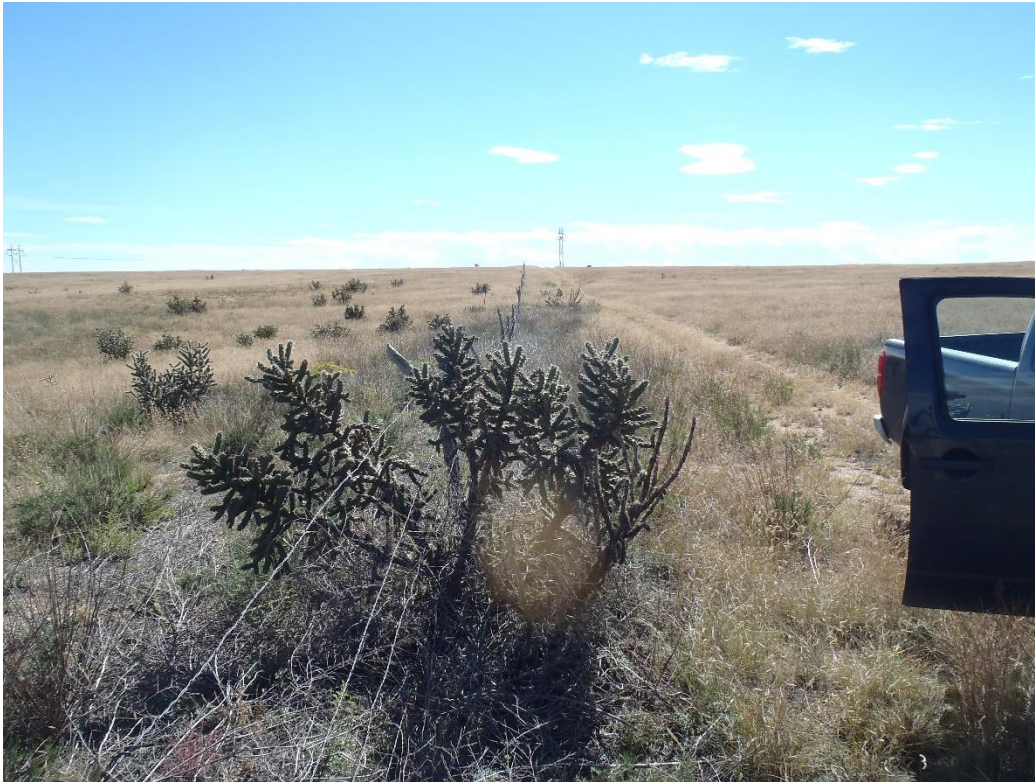
Photo 6. West fence, running north-south (looking south).

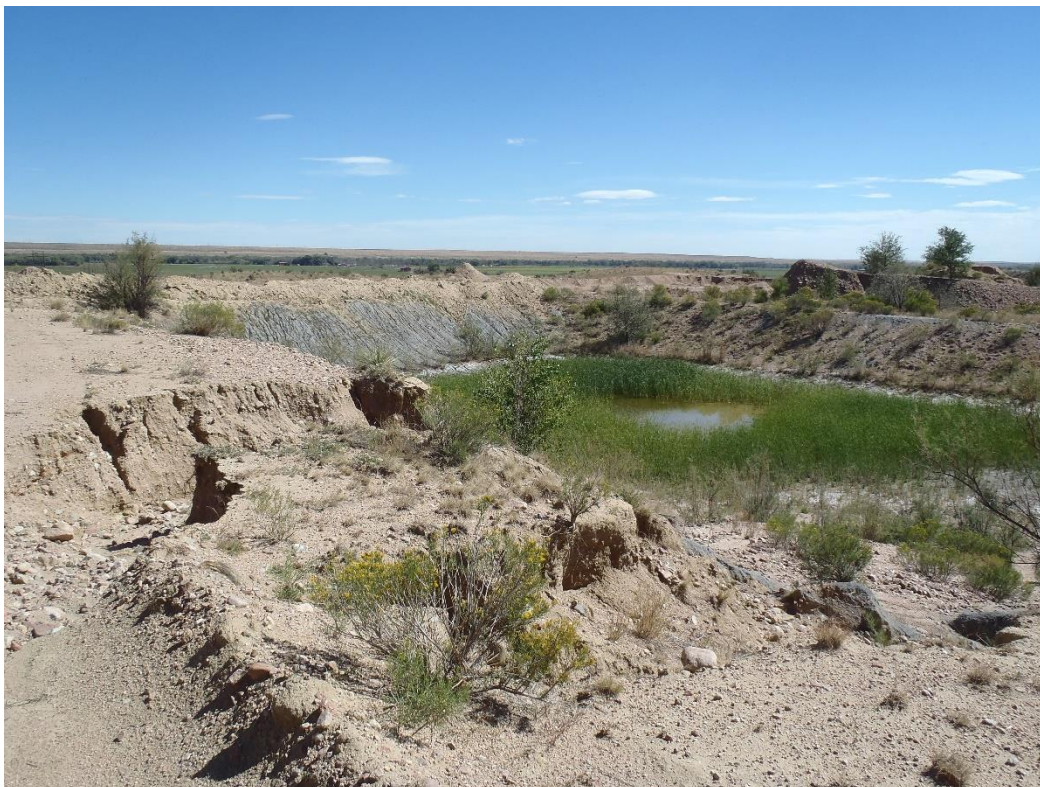
Storm Water MGT Plan: No oil or fuel spills observed. Water and wetland vegetation were observed in the lined stormwater ponds (see **Photos 7 and 8**).

Photo 7. East lined sediment pond (looking SE).

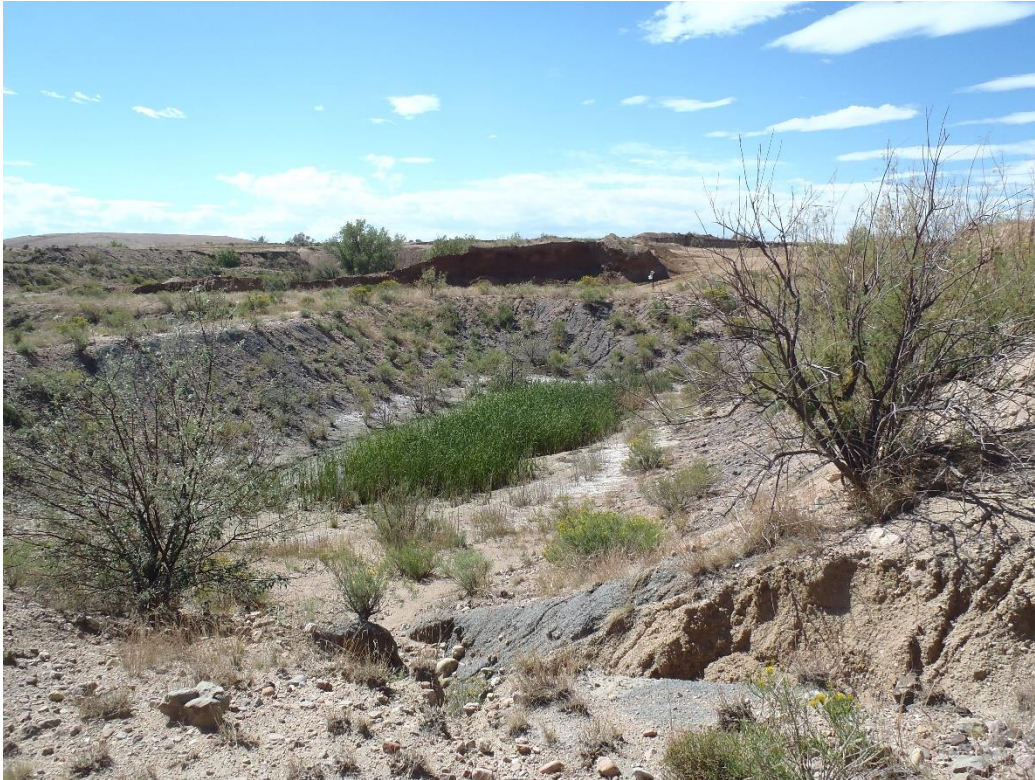
Photo 8. West lined sediment pond (looking SW).

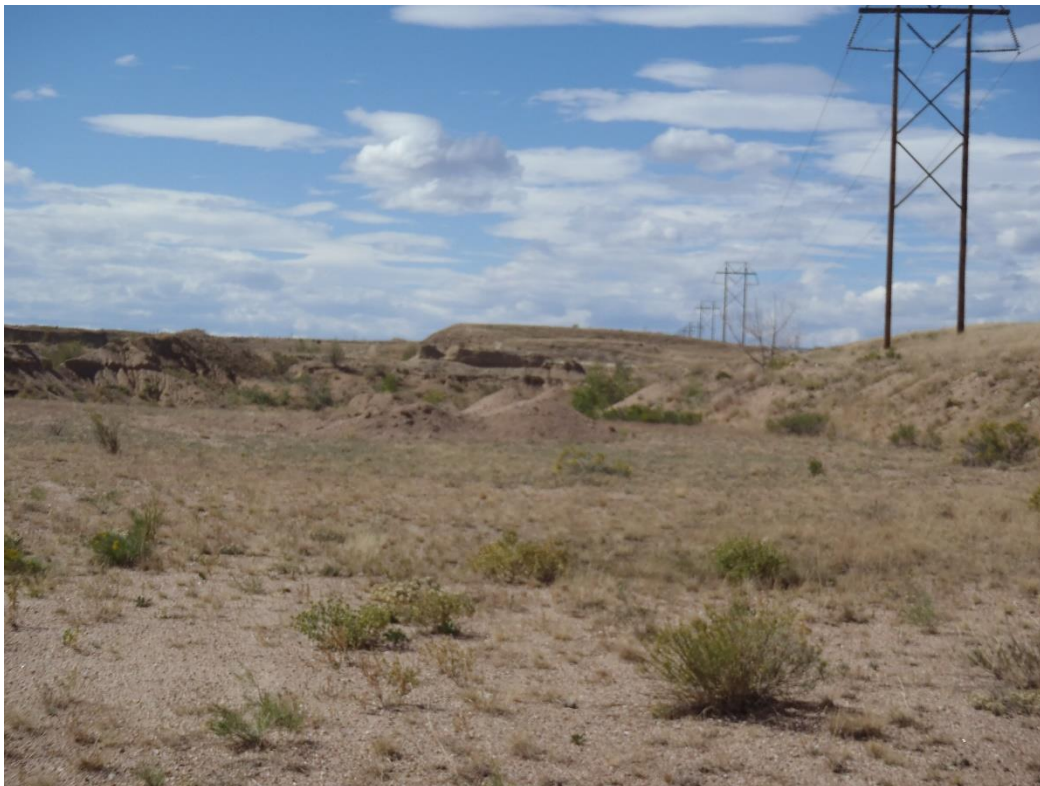
Structures: A powerline was observed within the permit boundary (see **Photo 9**). A utility agreement with Public Service Company of Colorado (Xcel Energy) for this powerline was obtained subsequent to the previous inspection.

Photo 9. Powerline running east-west on north side of pit (looking west).
