COLORADO DIVISION OF RECLAMATION, MINING AND SAFETY
MINERALS PROGRAM INSPECTION REPORT
PHONE: (303) 866-3567

MINE NAME: Leone Huerfano Gravel Pit	MINE/PROSPECTING ID#: M-2010-004	MINERAL: Gravel and sand	COUNTY: Huerfano
INSPECTION TYPE: Monitoring	INSPECTOR(S): Tyler V. O'Donnell	INSP. DATE: January 14, 2016	INSP. TIME: 15:15
OPERATOR: Leone Sand & Gravel LLC	OPERATOR REPRESENTATIVE: Frank Leone	TYPE OF OPERATION: 112c - Construction Regular Operation

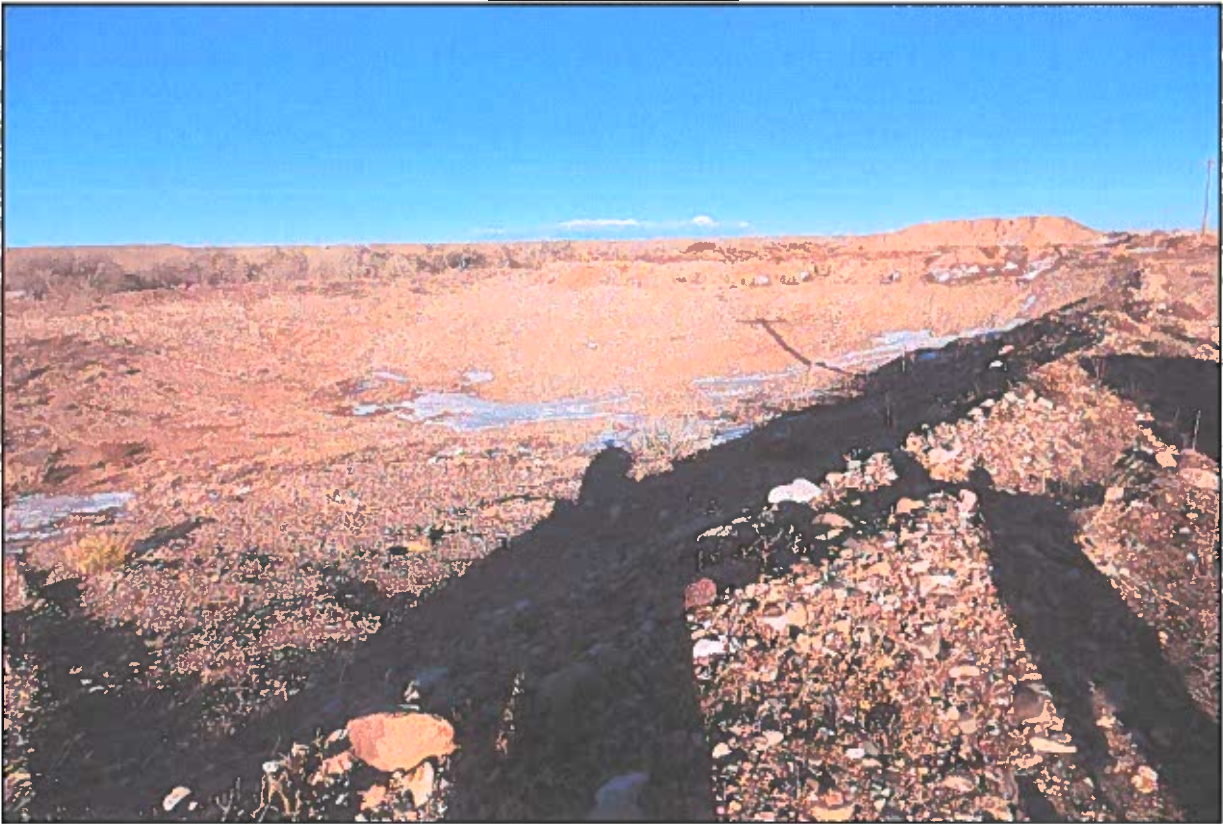
Photo 1: Active mining area north of the current powerline right of way. Slopes were graded to 3H:1V or flatter.

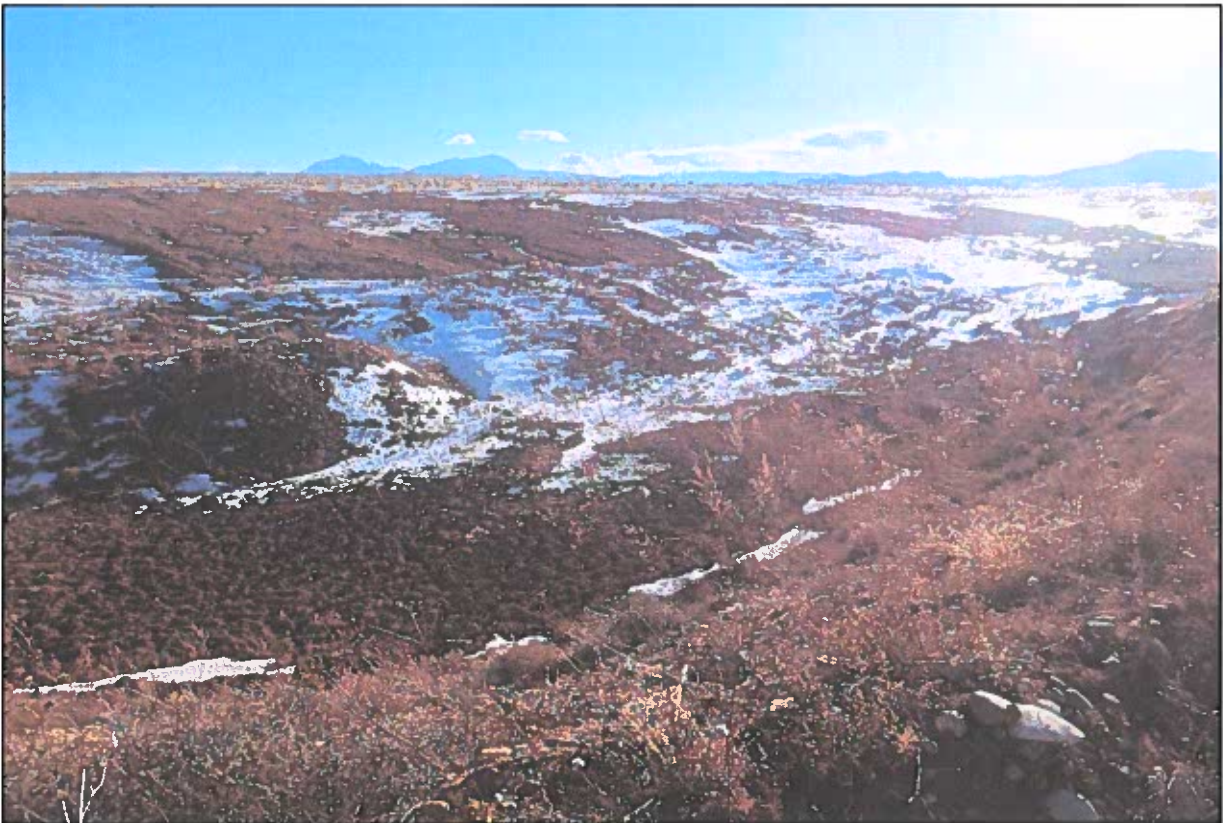
The current pit excavation is located on a gravel terrace just south of the Huerfano River. The bottom of the pit was mostly dry. No exposed groundwater was observed during the inspection. There were a few low laying areas that had damp soil and/or a little standing captured stormwater. When conducting final grading for reclamation the Operator will need to try to control surface drainage to create as much positive drainage as possible. There was no evidence of excessive erosion. There appeared to be no significant impacts to the prevailing hydrologic balance.

Photo 2: Active mining area south of the current powerline right of way. Slopes were graded to 3H:1V or flatter. There was a small portion at the toe of the slope that appeared to be damp from captured stormwater.

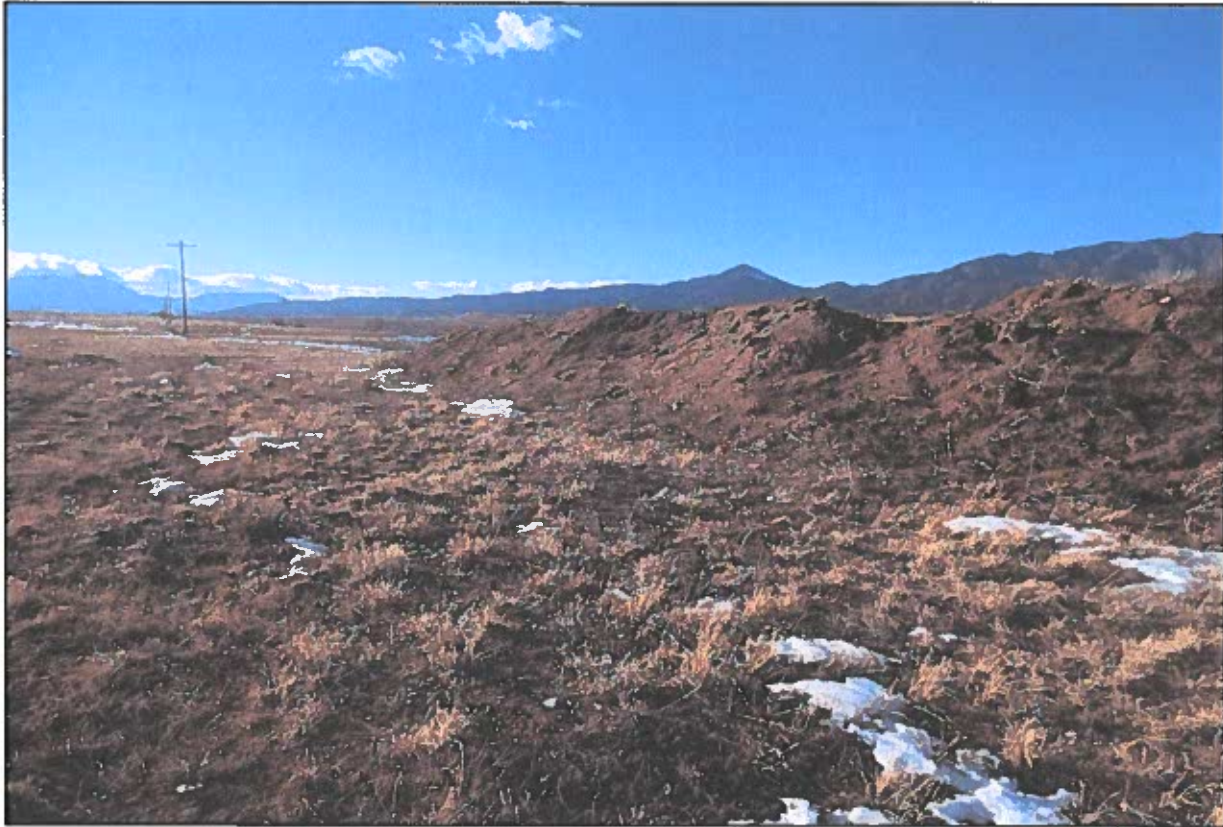
There were several stockpiles of topsoil scattered around phases 1 and 2. The topsoil stockpiles have begun to fill in with thin vegetation. Vegetative cover on the topsoil stockpiles is composed of primarily annual weeds and native vegetation. The Operator is encouraged to establish vegetative cover on all topsoil stockpiles that remain longer than a growing season. The vegetative cover on the topsoil stockpiles will help prevent erosion.

Photo 3: Topsoil stockpiles along the northern portion of Phase 1.

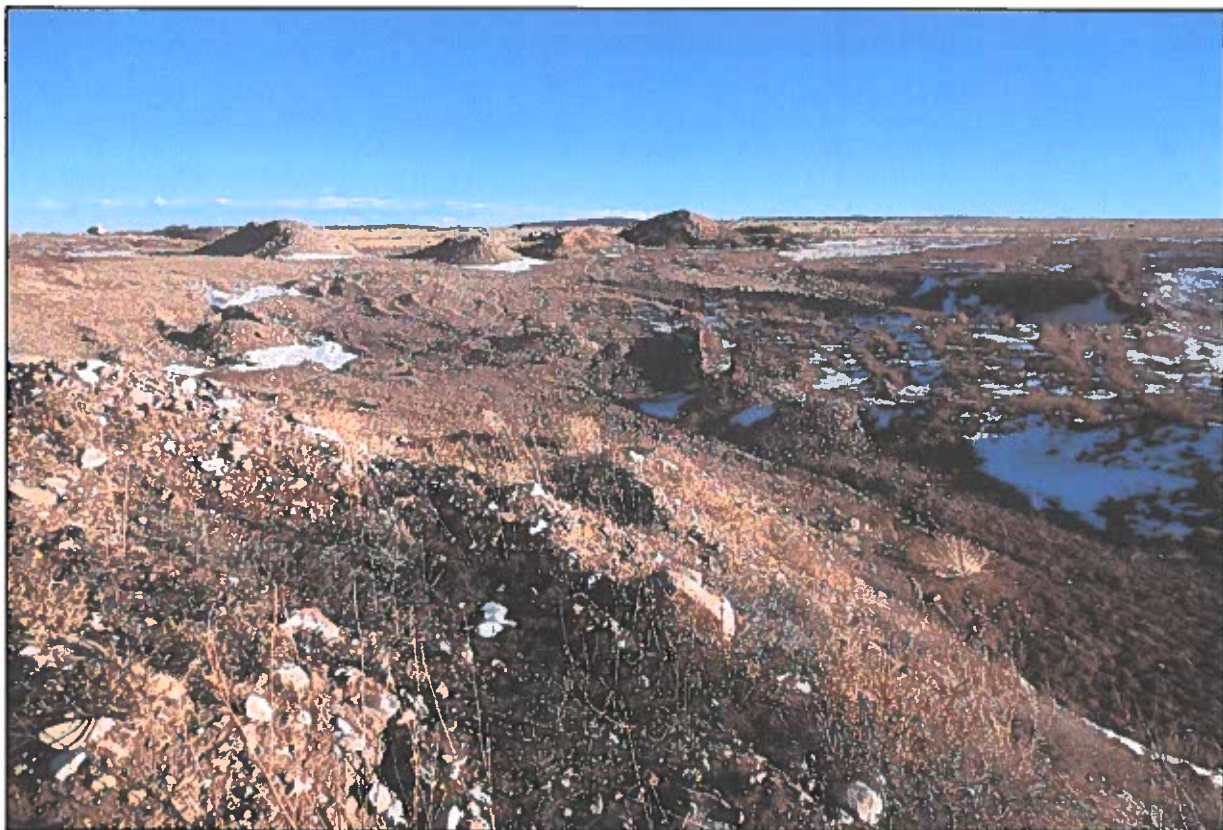
Photo 4: Various product stockpiles.
