## MINERALS PROGRAM INSPECTION REPORT

<b>MINE NAME:</b> Goddard Pit #1	<b>MINE/PROSPECTING ID#:</b> M-2018-050	<b>MINERAL:</b> Sand, gravel, clay	<b>COUNTY:</b> Sedgwick
<b>INSPECTION TYPE:</b> Monitoring	<b>INSPECTOR(S):</b> Elliott R. Russell	<b>INSP. DATE:</b> January 17, 2019	<b>INSP. TIME:</b> 09:15
<b>OPERATOR:</b> Town of Julesburg	<b>OPERATOR REPRESENTATIVE:</b> None.	<b>TYPE OF OPERATION:</b> 111 - Construction by Government Agency

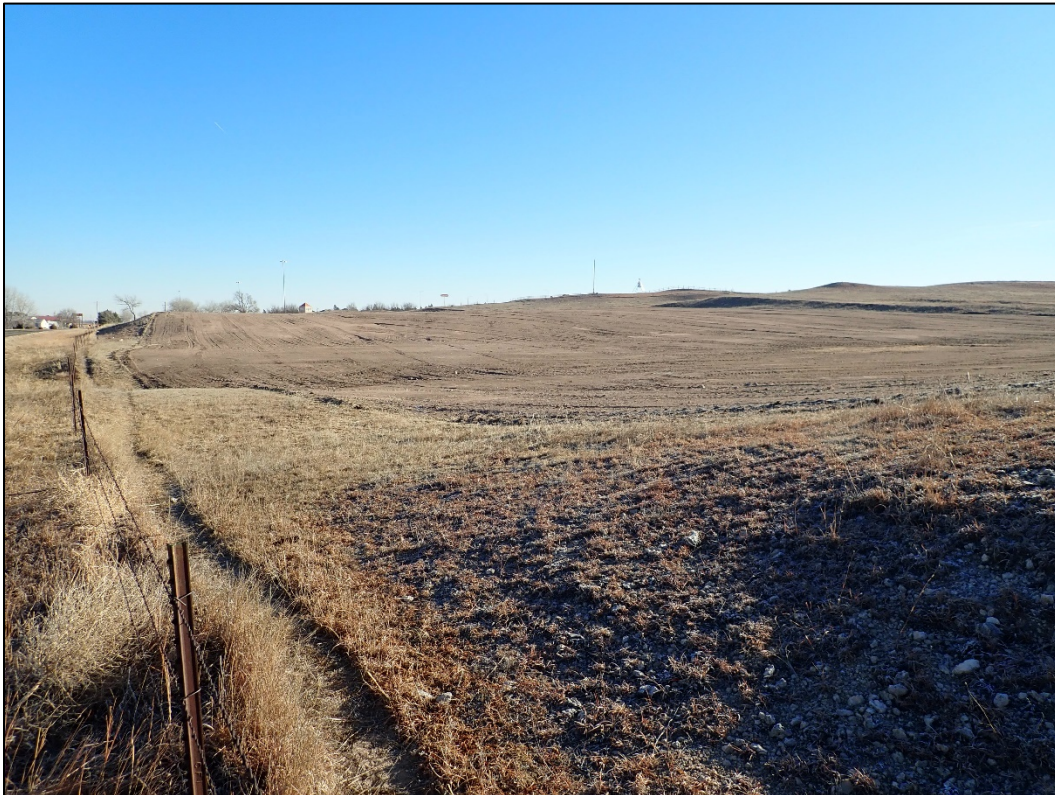
**Photo 1.** Western portion of the affected area; looking east.

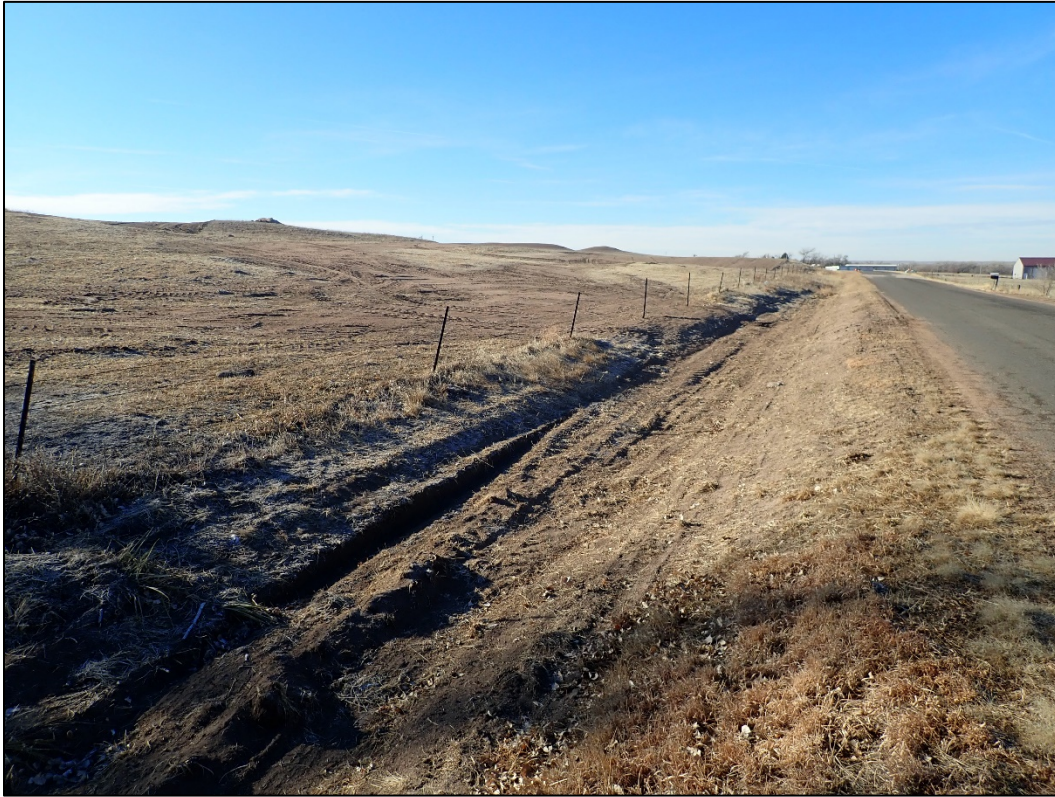
**Photo 2.** Eastern portion of the affected area; looking southwest.

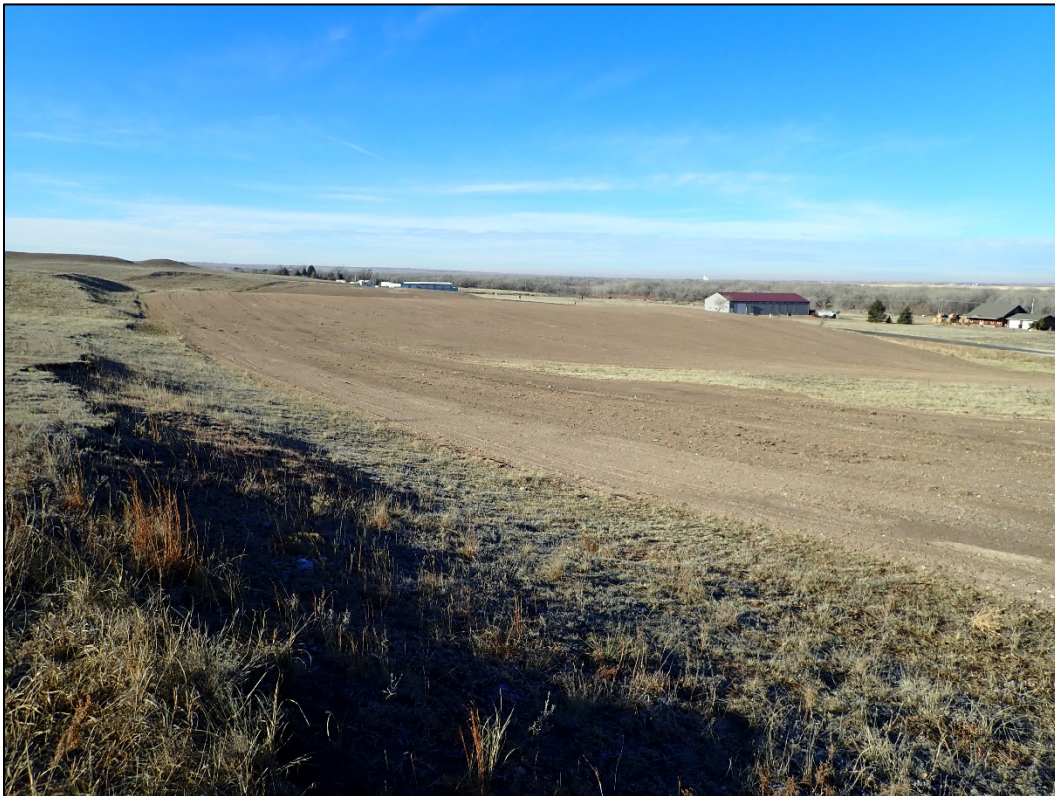
**Photo 3.** Eastern portion of the affected area; looking west.

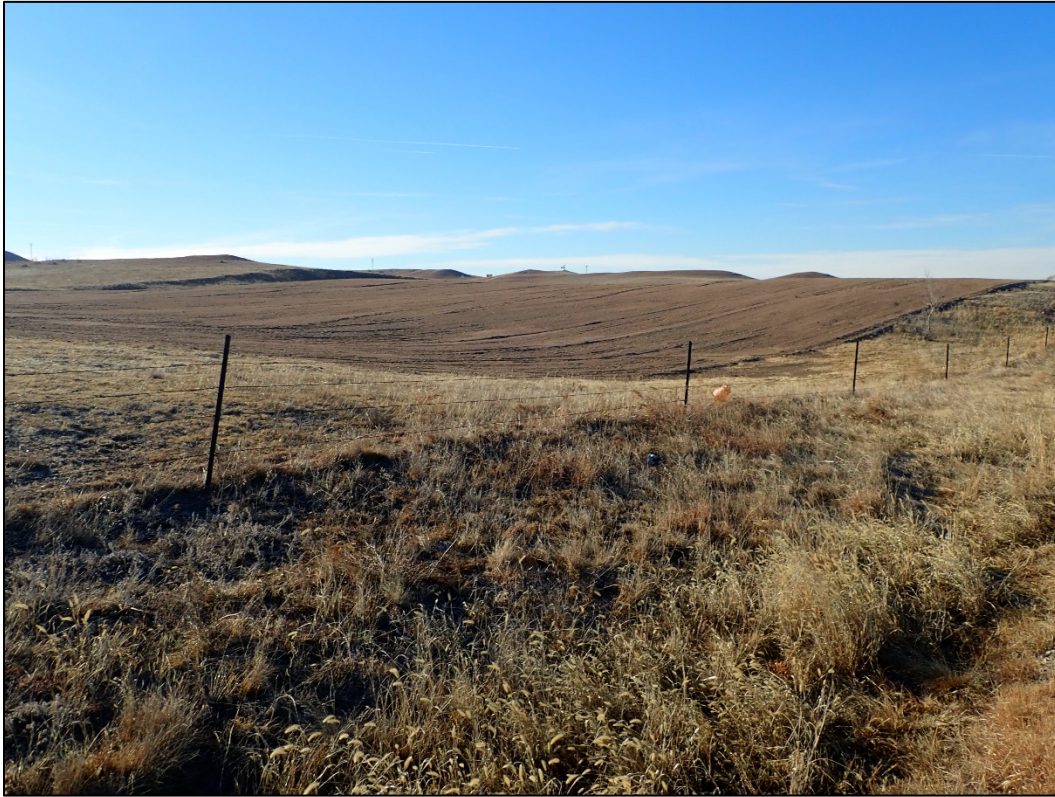
Sediment Control: The Division highly recommends the Operator install erosion control measures to prevent off-site sedimentation. The site has been graded to what appeared to be the original contour, however, since vegetative cover has yet to establish, there is a high chance for erosion. There are two drainages within the affected lands which lead northwest to the northern permit boundary. Utilization of silt fencing, straw bales, erosion control blankets, straw wattles, and/or contour furrows may help prevent erosion and off-site sedimentation. Please note, if off-site lands are affected from sedimentation, the Operator will be in violation of C.R.S. 34-32.5-116(4)(i), for failure to protect areas outside of the affected land from slides or damages

occurring during the mining operation and C.R.S. 34-32.5-116(4)(j), for failure to stabilize and protect all surface areas of the affected land as to effectively control erosion.

**Photo 4.** Eastern drainage area of where erosion control BMPs are likely needed; looking south.

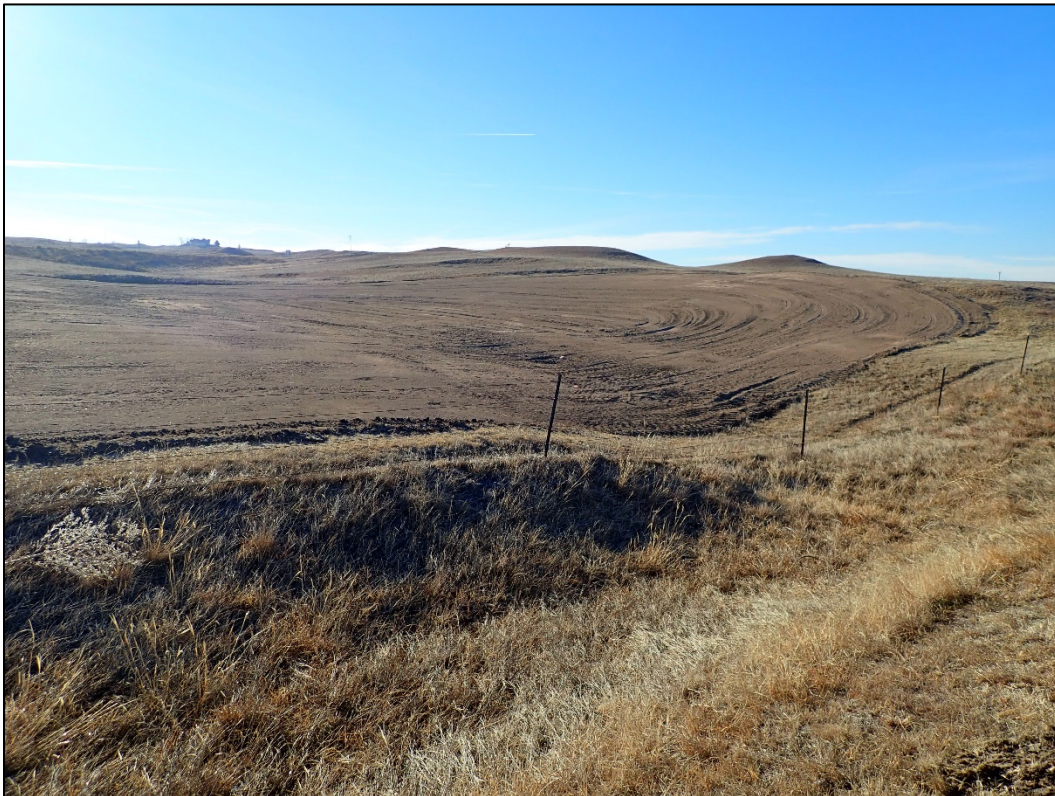
**Photo 5.** Western drainage area of where erosion control BMPs are likely needed; looking south.

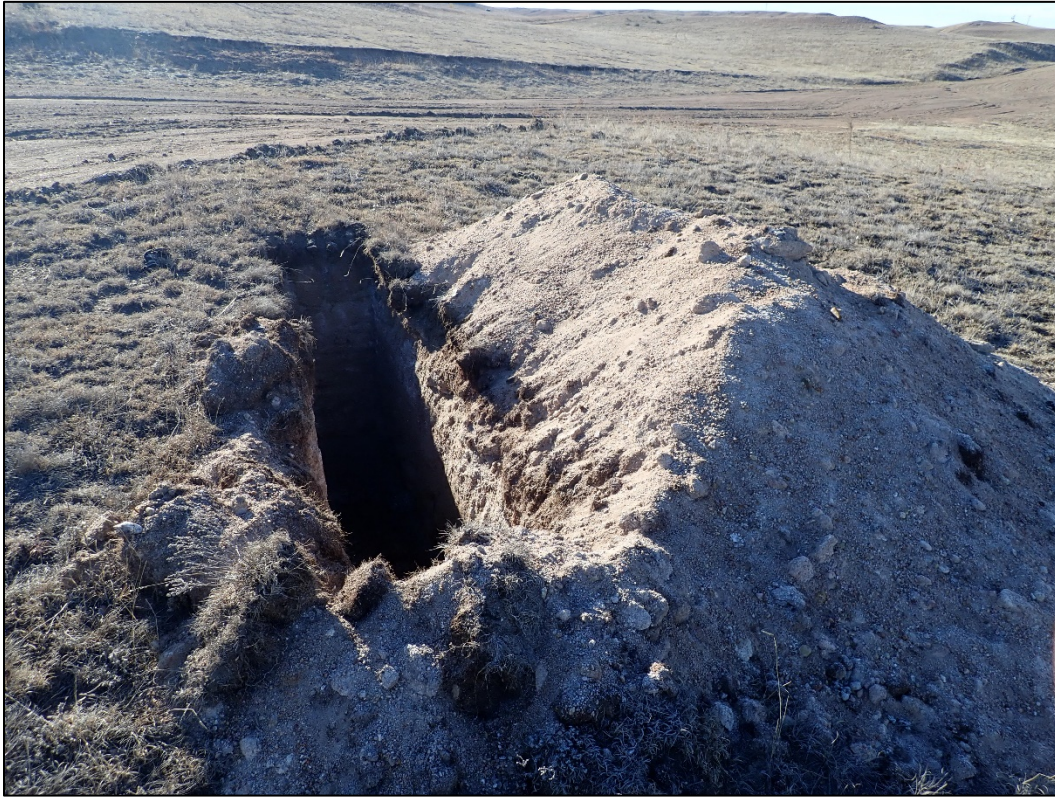
**COMPLIANCE PROBLEM #2:** An open test pit poses a threat to wildlife/livestock.

Fish & Wildlife: During the inspection, the Division observed an open test pit located in the eastern portion of the permit. It appears this pit/trench was used to determine the depth of the deposit, however, since it was left open with vertical sides, it is a wildlife hazard. If the site is grazed, this test pit could also be a hazard for livestock. This has been cited as Compliance Problem #2 requiring the operator to either backfill the test pit or safeguard it by other means

**Photo 6.** Open test pit which poses a potential hazard; looking south.

**CORRECTIVE ACTIONS:** The operator shall submit photographic evidence showing the test pit has been backfilled or safeguarded.
