MINERALS PROGRAM INSPECTION REPORT
PHONE: (303) 866-3567

MINE NAME: Una Pit	MINE/PROSPECTING ID#: M-1980-080	MINERAL: Sand and gravel	COUNTY: Garfield
INSPECTION TYPE: Monitoring	INSPECTOR(S): Amy C. Yeldell	INSP. DATE: January 17, 2019	INSP. TIME: 07:45
OPERATOR: Grand Junction Concrete Pipe Co.	OPERATOR REPRESENTATIVE: Jim Doody	TYPE OF OPERATION: 112c - Construction Regular Operation	
REASON FOR INSPECTION: High Priority	BOND CALCULATION TYPE: None	BOND AMOUNT: \$300,071.47	
DATE OF COMPLAINT: NA	POST INSP. CONTACTS: DRMS	JOINT INSP. AGENCY: None	
WEATHER: Foggy	INSPECTOR'S SIGNATURE:

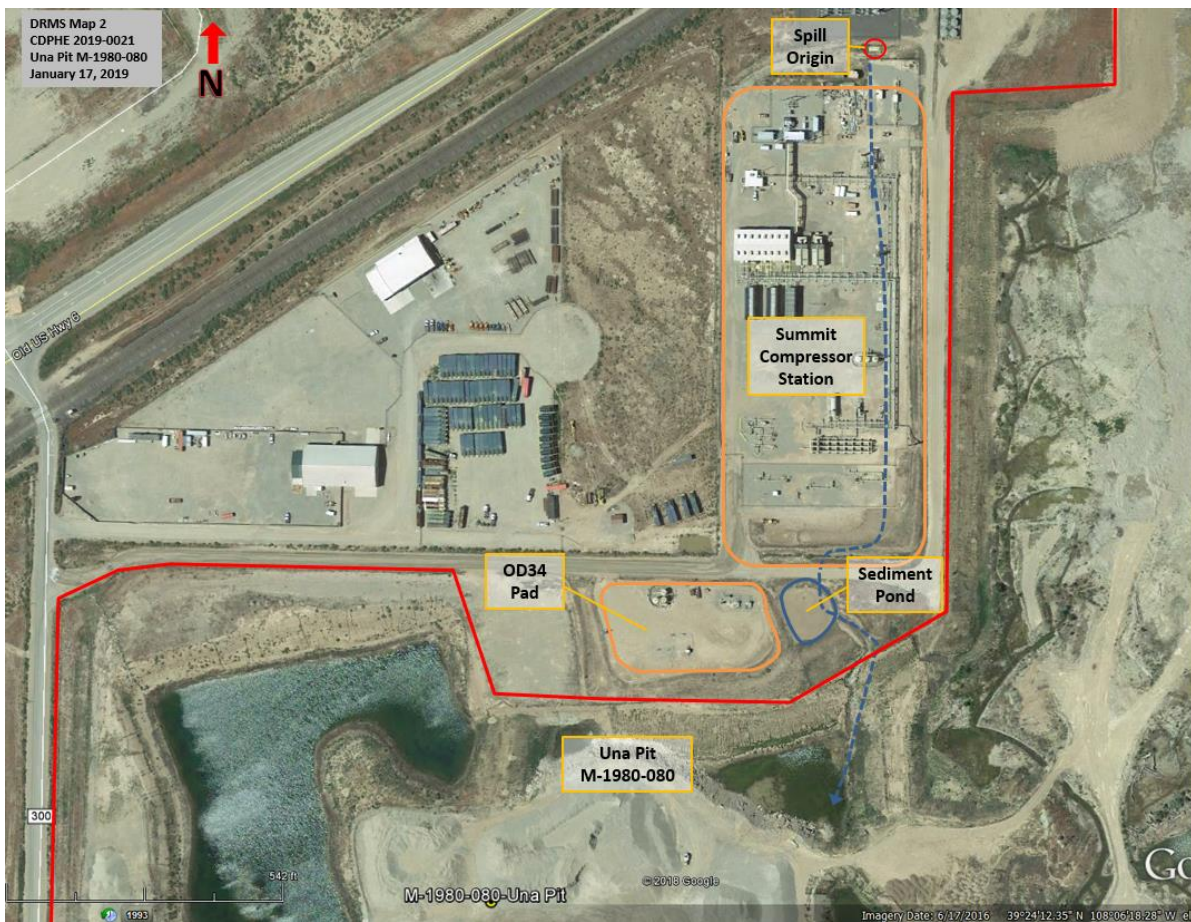
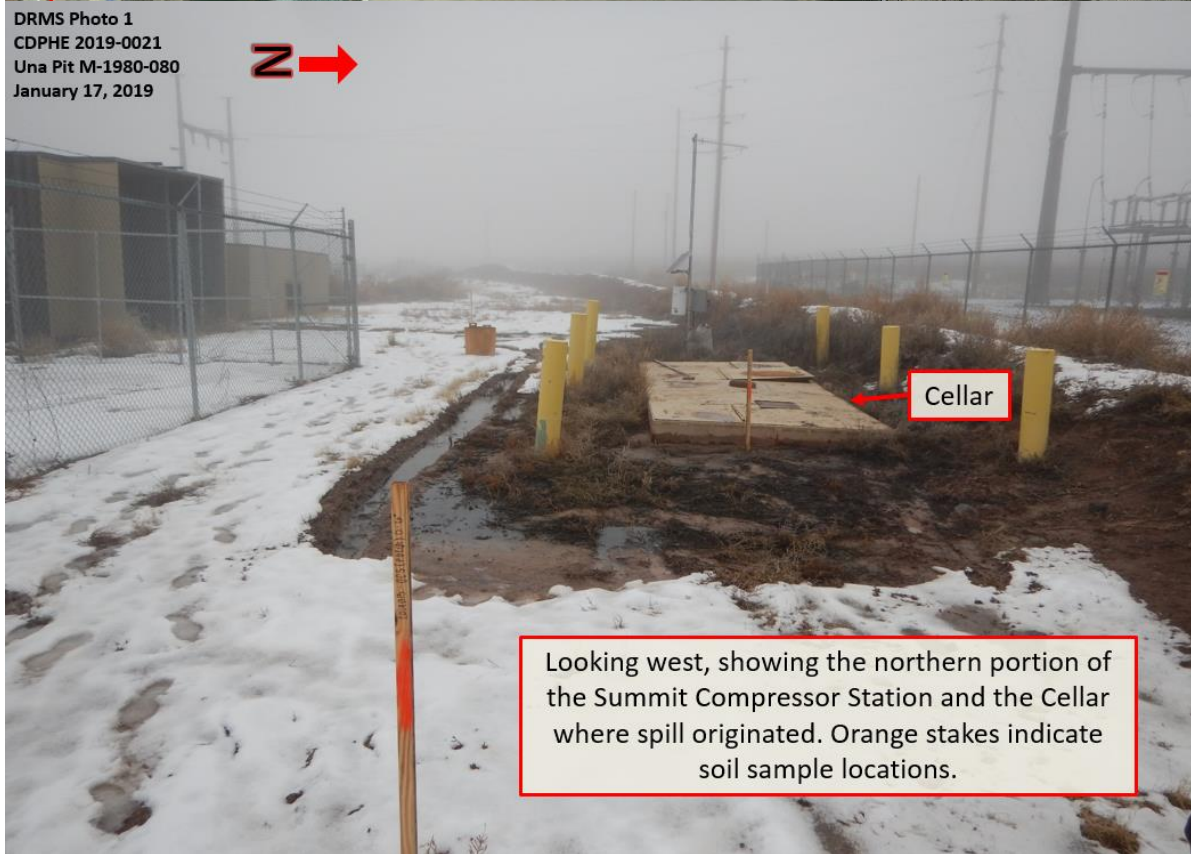
As shown in Photos 1-3, Caerus directed DRMS to the origin of the spill (approximately 39°24'14.37"N, 108°5'58.12"W), a cellar located at the north end of the Summit Compressor Station. The cellar had over flowed. The spill was estimated at a rate of approximately 30 gallons per minute for an undisclosed period of time. The soil around the cellar exhibited discoloration and strong odor of hydrocarbons. Caerus indicated the spilt fluids migrated south through the gravel surface of the compressor station and were intercepted by the stormwater structures for compressor station and access road. Locations of soil samples were marked by survey stakes with orange paint. As of the inspection day no additional soil removal or remediation action had occurred in this area. The leak had been repaired and the line reactivated.

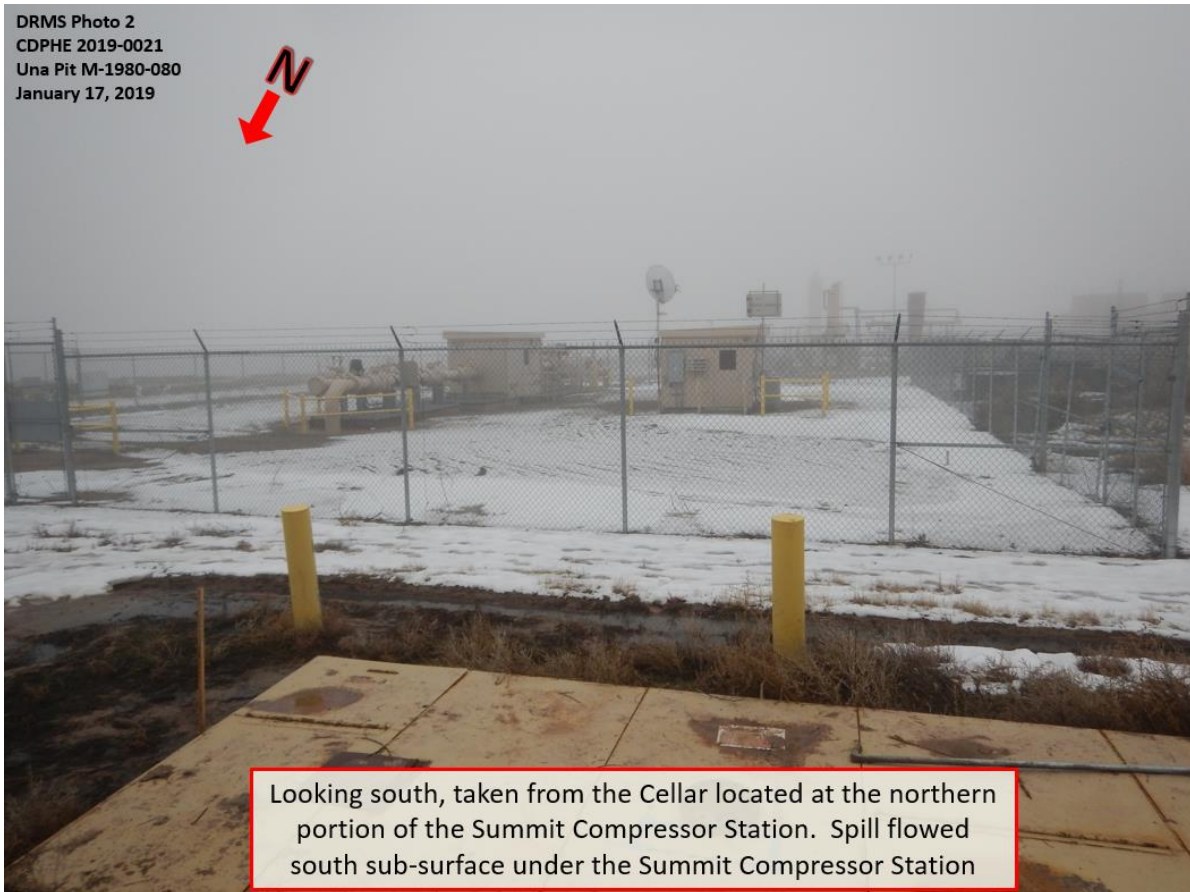
DRMS Photo 2
CDPHE 2019-0021
Una Pit M-1980-080
January 17, 2019

Looking south, taken from the Cellar located at the northern portion of the Summit Compressor Station. Spill flowed south sub-surface under the Summit Compressor Station

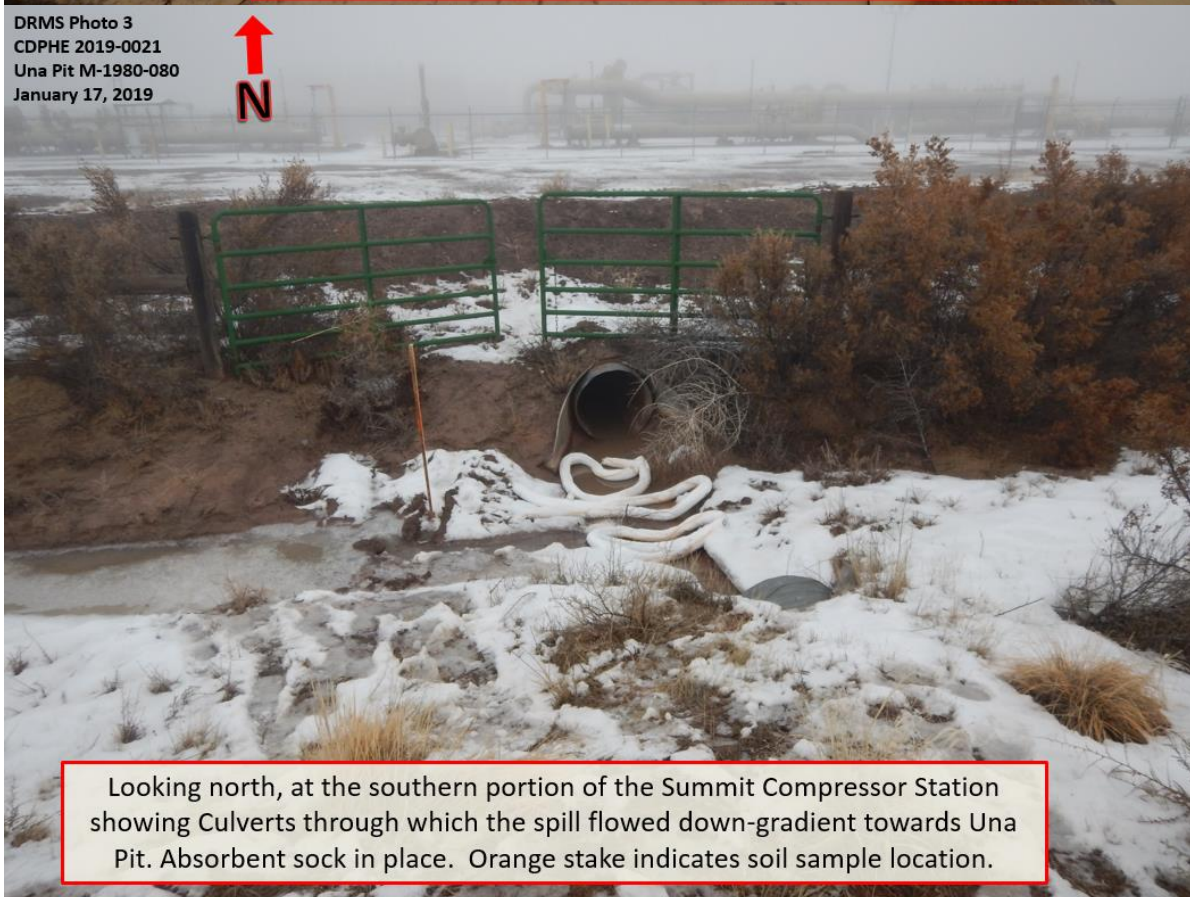
DRMS Photo 3
CDPHE 2019-0021
Una Pit M-1980-080
January 17, 2019

Looking north, at the southern portion of the Summit Compressor Station showing Culverts through which the spill flowed down-gradient towards Una Pit. Absorbent sock in place. Orange stake indicates soil sample location.

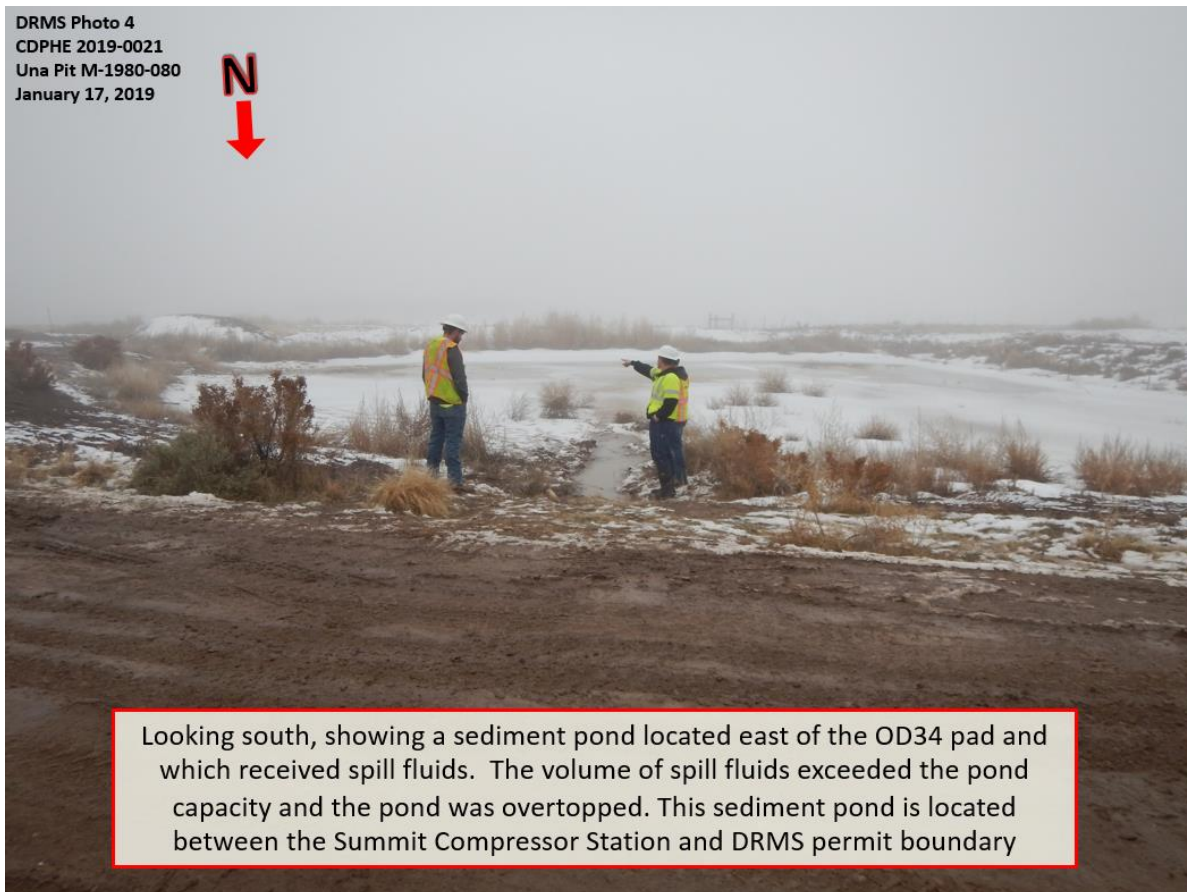
DRMS Photo 4
CDPHE 2019-0021
Una Pit M-1980-080
January 17, 2019

As shown in Photos 4-6, the spilt fluids, intercepted by the stormwater ditches and culverts, were directed to a sediment pond located south of the Summit Compressor Station and east of the OD34 pad. The spilt fluids, now augmented by seasonal snow melt, exceeded the capacity of the sediment pond. The impounded fluids discharged along the southeast corner of the sediment pond. The berms around the sediment pond have since been enlarged to enhance the pond's capacity. The sediment pond was being drained via pump truck and the fluids removed for disposal. According to Caerus, pumping was occurring around the clock. Water depth/volume remaining in the sediment pond was not determined due to snow and ice cover. The surrounding soils appeared saturated from the stormwater as well as spilt fluids. Minimal soil discoloration was observed. Little to no odor of hydrocarbons were observed at the sediment pond for the OD34 pad.

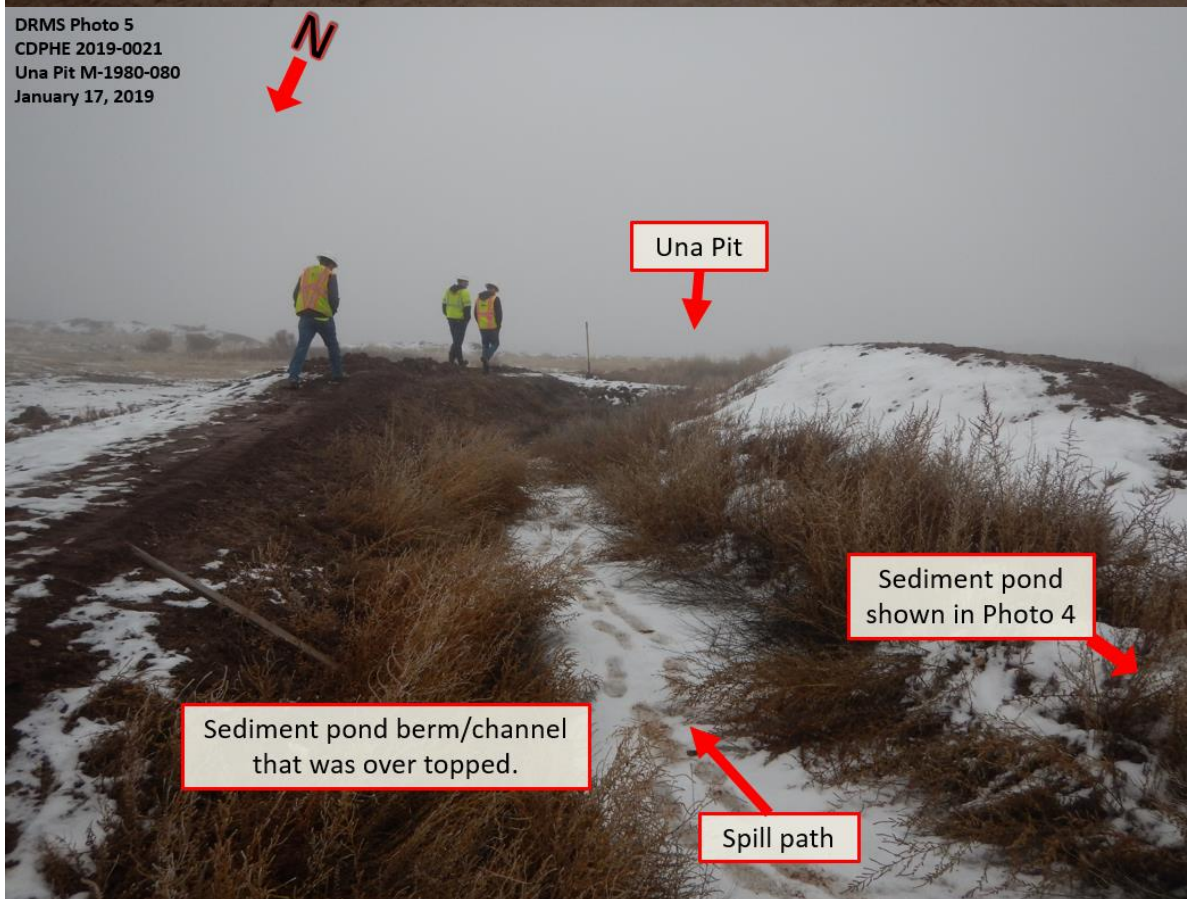
DRMS Photo 5
CDPHE 2019-0021
Una Pit M-1980-080
January 17, 2019

As shown in Photos 5-7, discharge from the sediment pond traveled south approximately 100 feet before entering the DRMS permit boundary (approximately 39°24'2.35"N, 108°5'58.07"W). The fluids were conveyed to a pond within the gravel pit via an armored stormwater channel. Due to pumping, inflow to the pit pond had ceased. No odor or oil sheen was observed on the water within the DRMS pit. Evidence of erosion to the rock armored pond inlet was not observed. Evidence of discharge from the DRMS sediment pond was not observed.
