MINERALS PROGRAM INSPECTION REPORT
PHONE: (303) 866-3567

MINE NAME: Falk Pit #1	MINE/PROSPECTING ID#: M-2010-043	MINERAL: Clay, gravel, sand	COUNTY: Phillips
INSPECTION TYPE: Monitoring	INSPECTOR(S): Elliott R. Russell	INSP. DATE: January 16, 2019	INSP. TIME: 11:00
OPERATOR: Chamberlain Concrete	OPERATOR REPRESENTATIVE: Mike Kerbs	TYPE OF OPERATION: 110c - Construction Limited Impact

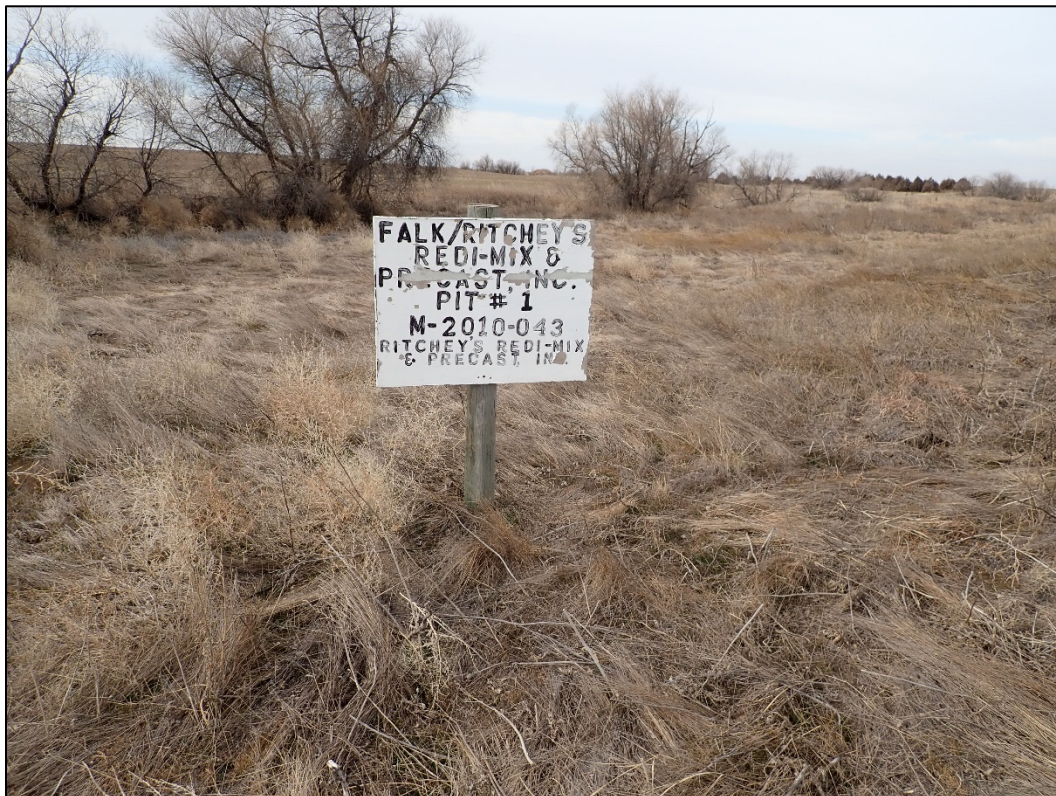
COMPLIANCE PROBLEM #2: The mine identification sign was not correctly posted at the entrance of the mine site. This is a problem for failure to post a mine identification sign as required by Rule 3.1.12(1).

Signs and Markers: The permit sign was posted at the entrance to the site, however, needs to be updated to reflect the current Operator. This has been cited as Compliance Problem #2 requiring the Operator to post a new sign or update the existing sign. The permit boundary was delineated with t-posts.

Photo 1. Mine identification sign; looking west.

CORRECTIVE ACTIONS: The operator shall submit photo documentation showing a sign posted at the entrance to the mine site, which shall be clearly visible from the access road, specifying the following:

- the name of the operator
- indicate that a reclamation permit for the operation has been issued by the Colorado Mined Land Reclamation Board
- the permit number

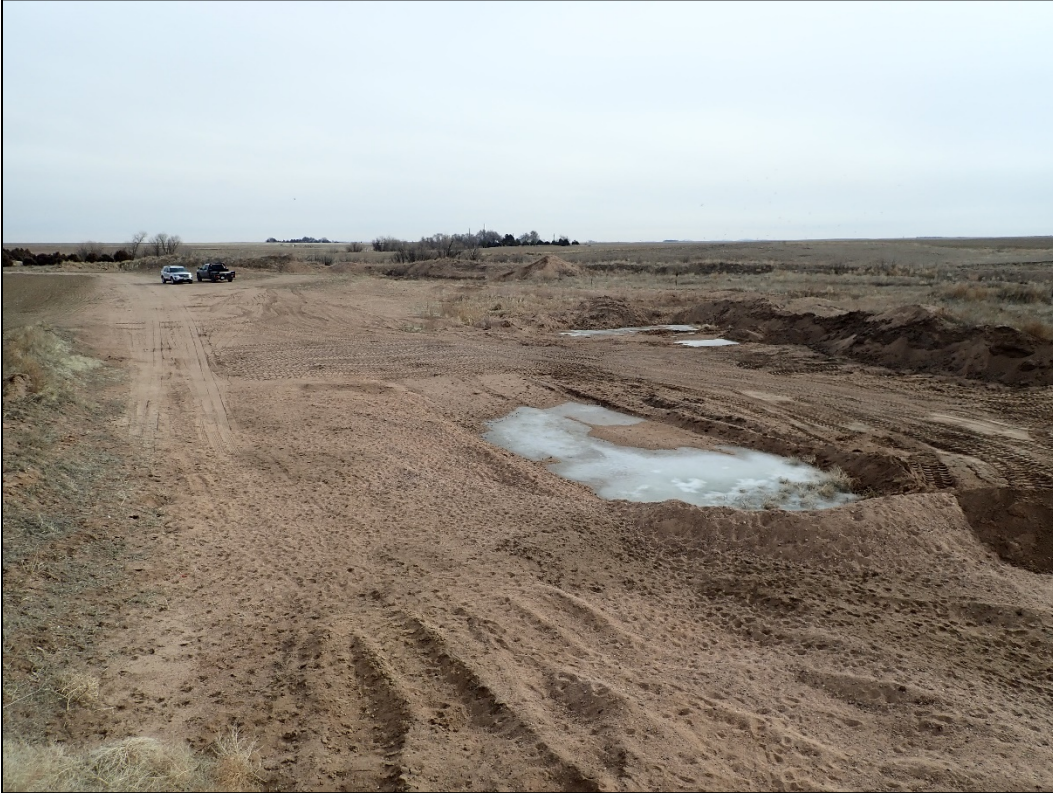
Photo 2. Northern portion of the site; looking east.

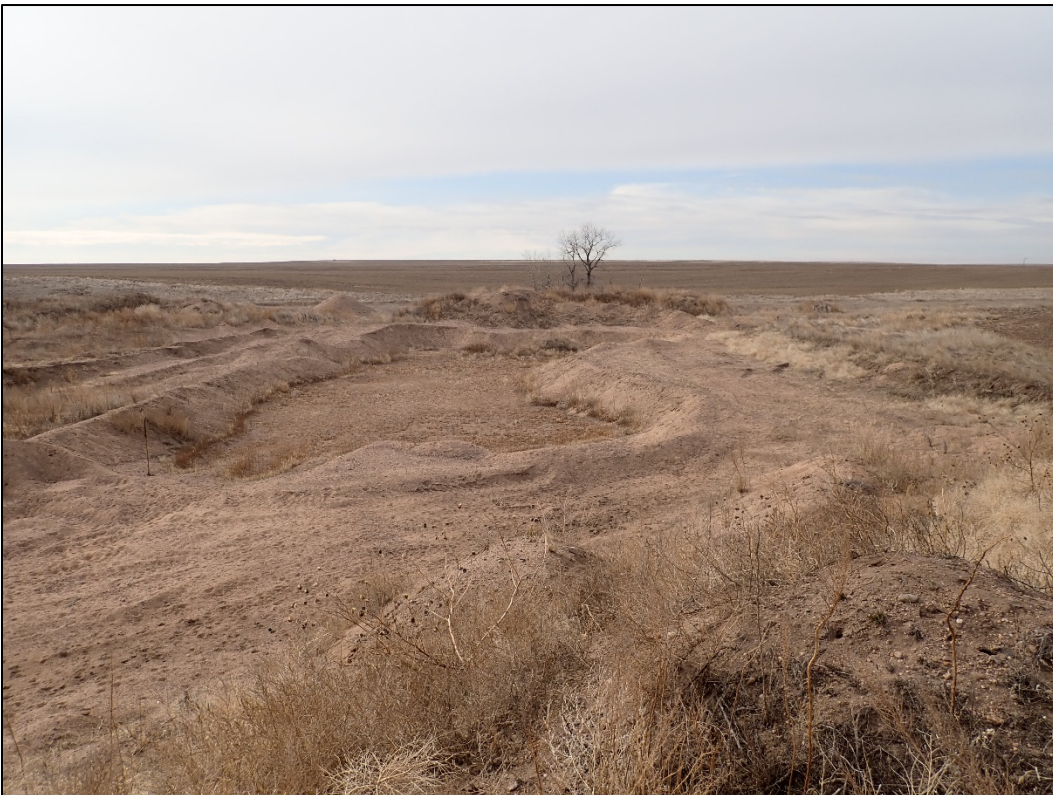
Photo 3. Western portion of the site; looking southwest.

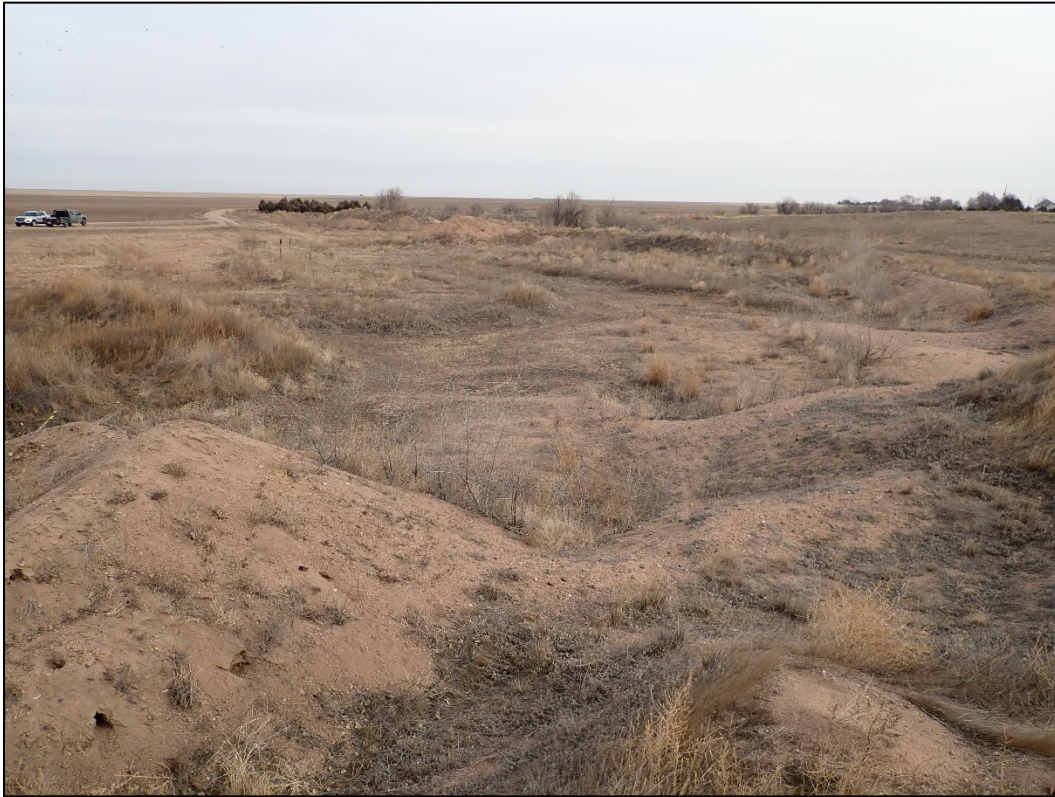
Photo 4. Southeast portion of the site; looking northeast.

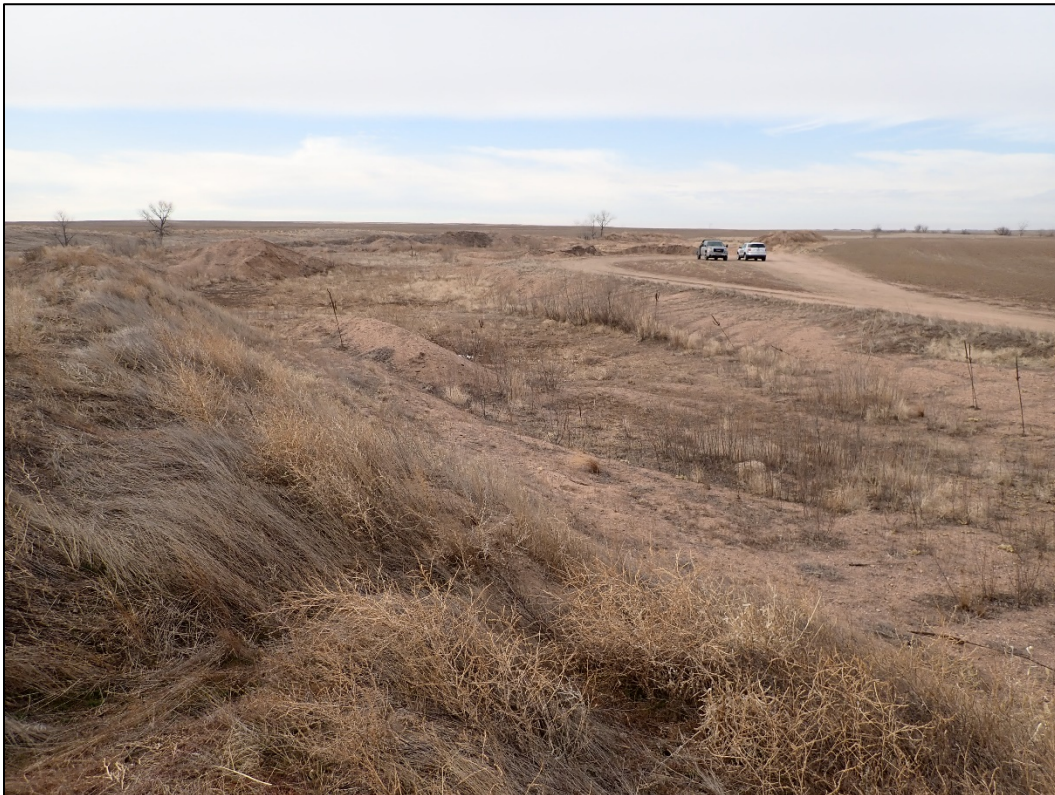
Photo 5. Northeast portion of the site; looking southwest.

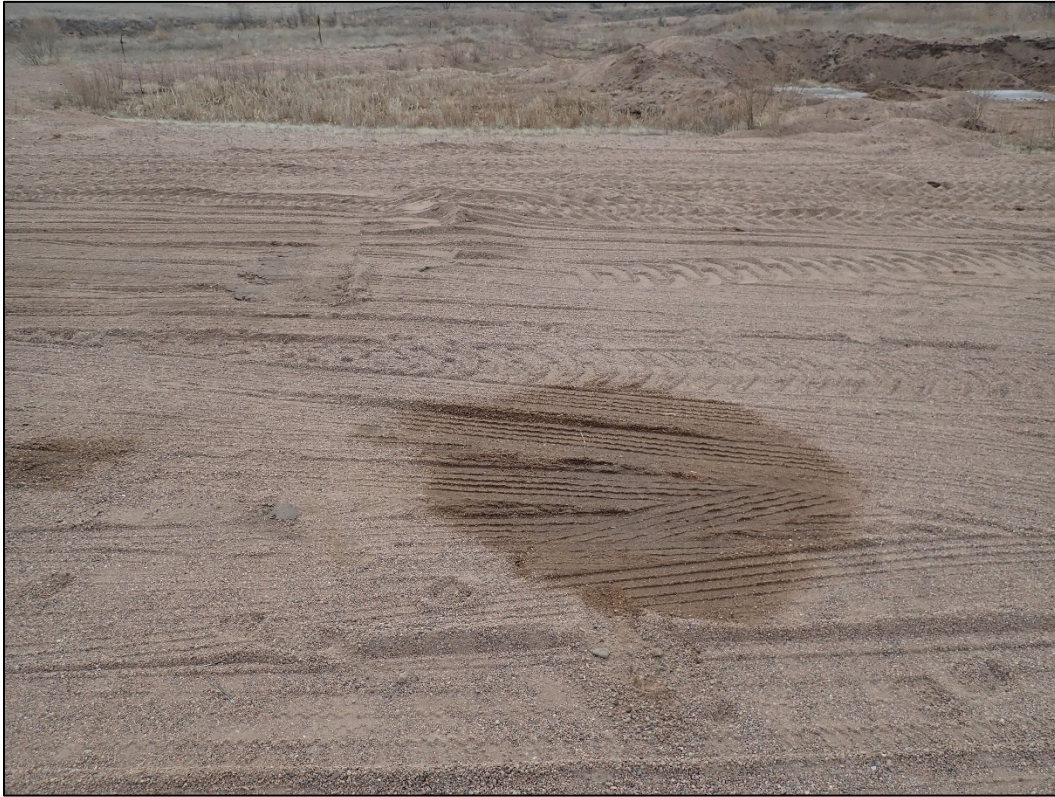
COMPLIANCE PROBLEM #1: A fuel/oil spill has occurred at the site which has impacted soils, surface water or groundwater.

contained frozen water, however this is likely captured snow melt. When the site thaws, the Operator shall ensure all captured storm water infiltrates or is allowed to continue down the creek within 72 hours to comply with Division of Water Resources regulations. During the inspection, the Division observed that a small fuel/oil spill occurred in the northern portion of the permit. The Division estimates the spill has impacted less than 1 cubic foot of contaminated soil. This has been cited as Compliance Problem #1 requiring the Operator to remediate the spill.

Photo 6. Small oil/fuel spill observed; looking south.

CORRECTIVE ACTIONS: The operator shall immediately remediate the spill and submit a final report to the Division containing at least the following information:

- 1.) A description of how the spill was cleaned up (narrative, maps, volumes removed, sample locations, analytical data, photo documentation, etc.)
- 2.) Evidence in the form of a receipt that the contaminated soil was disposed of by an approved method (such as sent to an approved landfill, land farming, recycling center, etc.)
