**MINERALS PROGRAM INSPECTION REPORT**  
**PHONE: (303) 866-3567**

<b>MINE NAME:</b> Carper Pit #2	<b>MINE/PROSPECTING ID#:</b> M-2008-072	<b>MINERAL:</b> Gravel, clay, sand	<b>COUNTY:</b> Phillips
<b>INSPECTION TYPE:</b> Monitoring	<b>INSPECTOR(S):</b> Elliott R. Russell	<b>INSP. DATE:</b> January 16, 2019	<b>INSP. TIME:</b> 14:00
<b>OPERATOR:</b> Tim Carper	<b>OPERATOR REPRESENTATIVE:</b> Doug Carper	<b>TYPE OF OPERATION:</b> 112c - Construction Regular Operation

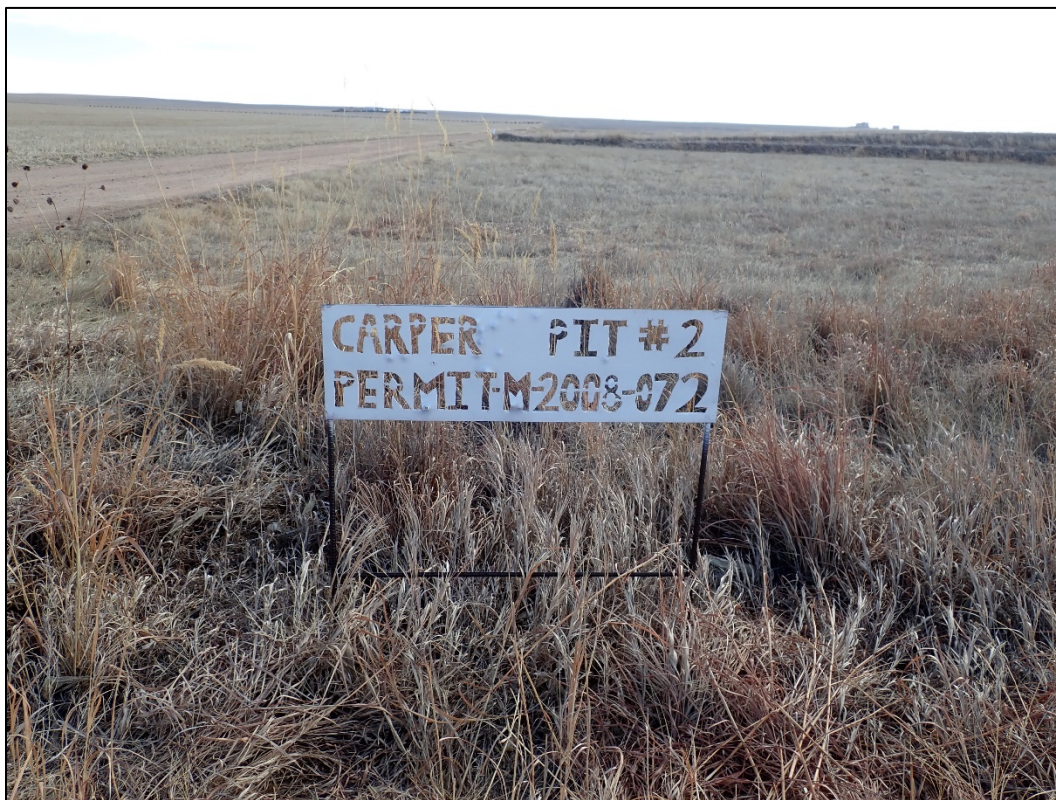
Signs and Markers: The permit sign was properly posted and boundary markers were observed to delineate the permit boundary and the bonded mining tracts.

**Photo 1.** Mine identification sign; looking south.

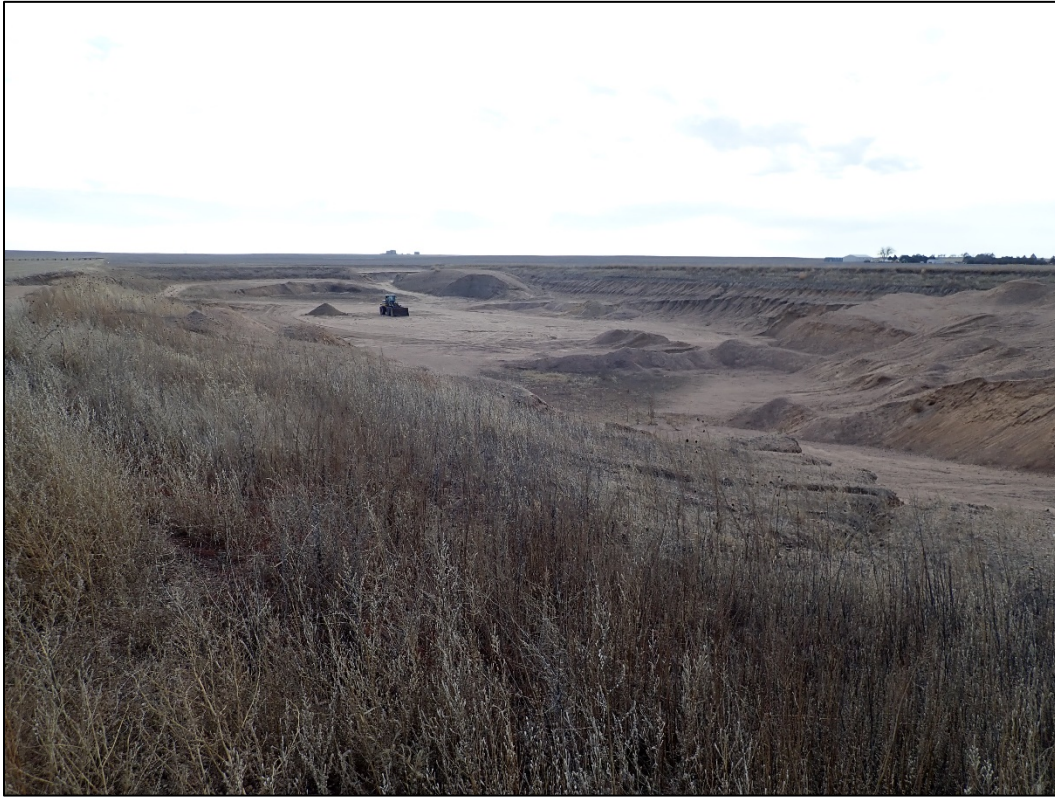
**Photo 2.** Track 2 pit overview; looking south.

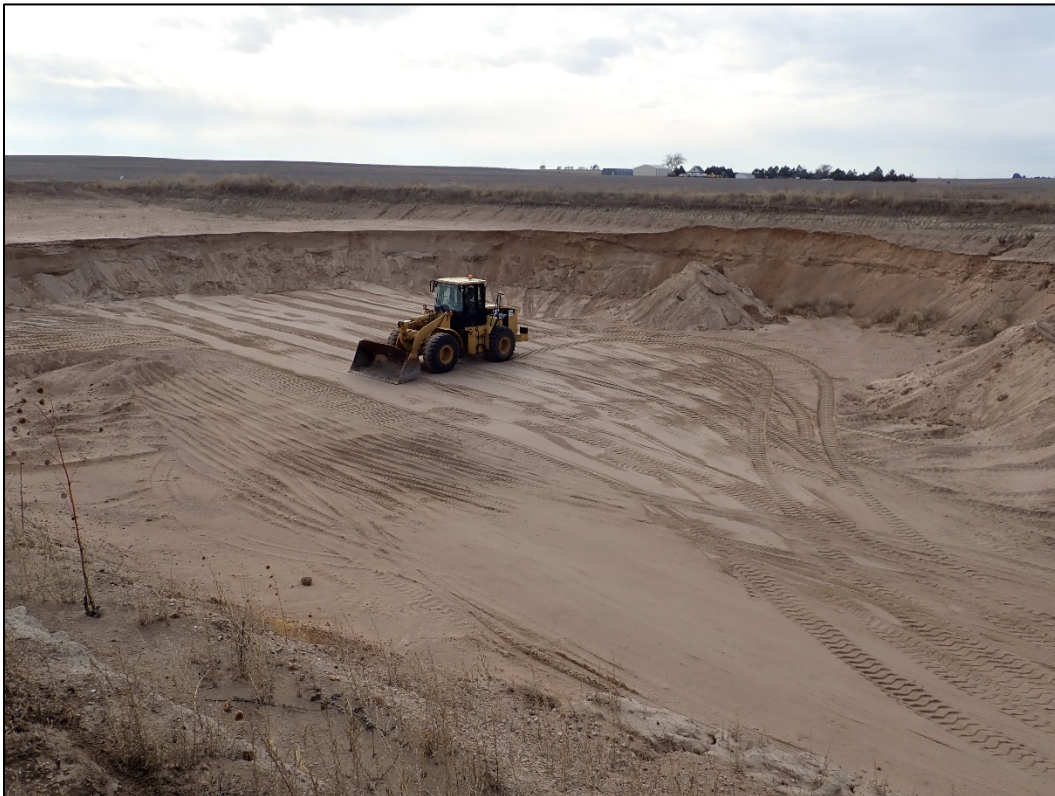
**Photo 3.** Track 5A pit overview; looking southwest.

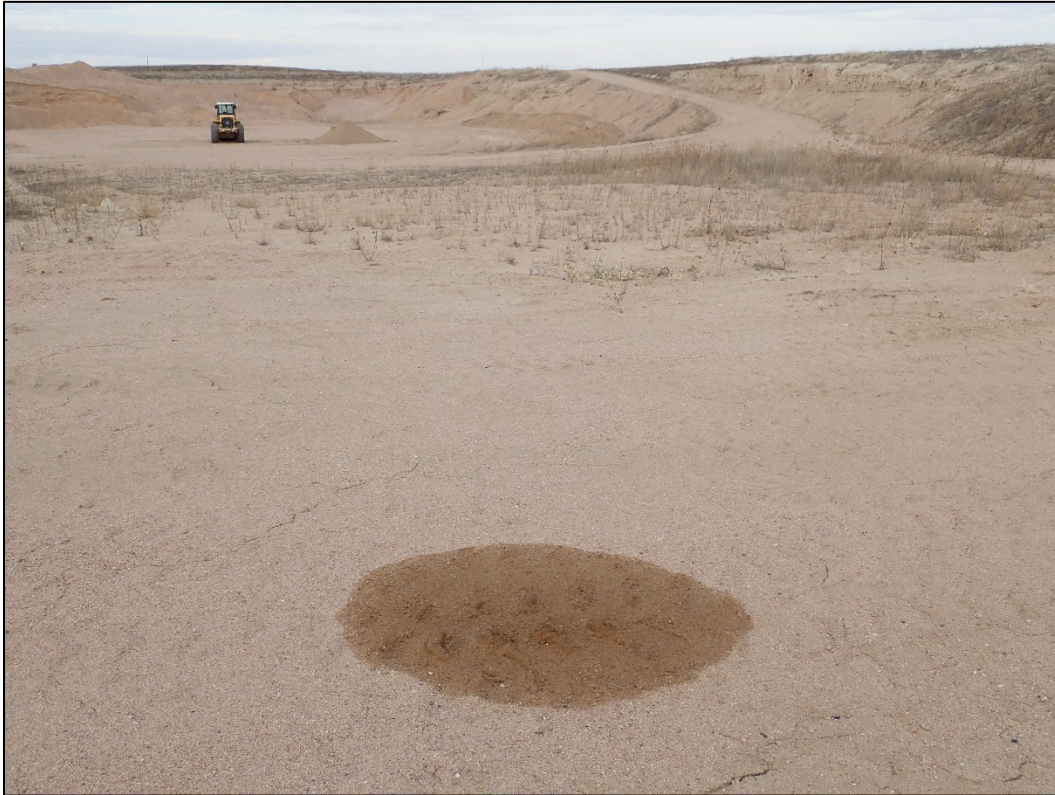
**COMPLIANCE PROBLEM #1:** A fuel/oil spill has occurred at the site which has impacted soils, surface water or groundwater.

Hydrologic Balance: No standing water or exposed groundwater was observed in the pit. During the inspection, the Division observed that a small fuel/oil spill occurred in the southern portion of Tract 2. The Division estimates the spill has impacted less than 1 cubic foot of contaminated soil. This has been cited as Compliance Problem #1 requiring the Operator to remediate the spill.

**Photo 4.** Small oil spill observed; looking northeast.

**CORRECTIVE ACTIONS:** The operator shall immediately remediate the spill and submit a final report to the Division containing at least the following information:

- 1.) A description of how the spill was cleaned up (narrative, maps, volumes removed, sample locations, analytical data, photo documentation, etc.)
- 2.) Evidence in the form of a receipt that the contaminated soil was disposed of by an approved method (such as sent to an approved landfill, land farming, recycling center, etc.).

**CORRECTIVE ACTION DUE DATE:** February 27, 2019

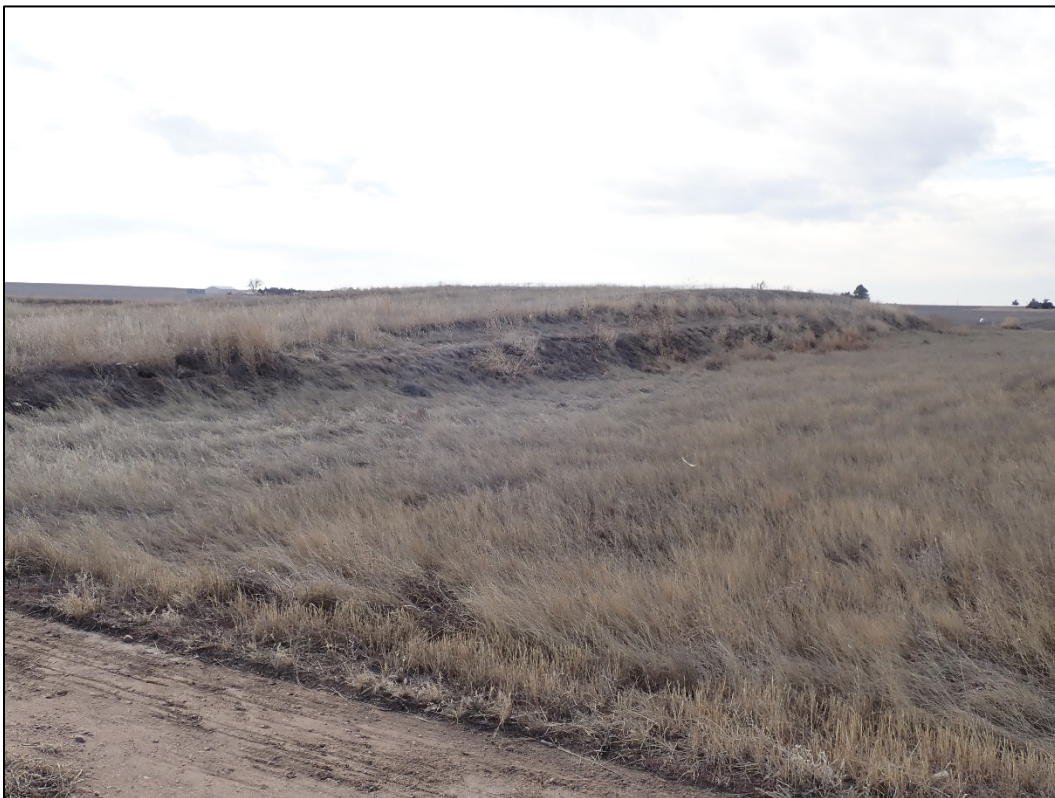
Topsoil: The Division observed a long topsoil stockpile located along the northern and eastern edges of the mining area. This stockpile was well vegetated.

**Photo 5.** Topsoil stockpile along northern portion of Tract 2; looking southwest.

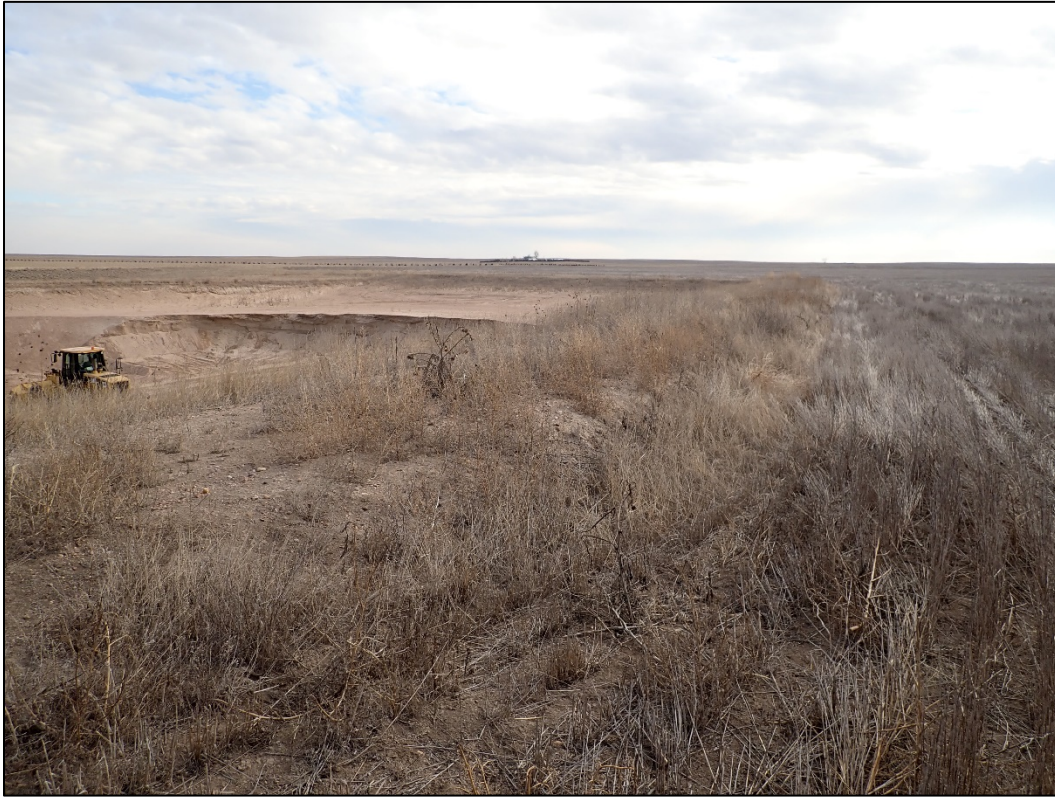
**Photo 6.** Topsoil stockpile along western portion of Tract 5A; looking south.
