**COLORADO**Division of Reclamation,  
Mining and Safety

**MINERALS PROGRAM INSPECTION REPORT****PHONE: (303) 866-3567**

<b>MINE NAME:</b> San Luis Project	<b>MINE/PROSPECTING ID#:</b> M-1988-112	<b>MINERAL:</b> Gold and silver	<b>COUNTY:</b> Costilla
<b>INSPECTION TYPE:</b> Monitoring	<b>INSPECTOR(S):</b> Lucas J. West	<b>INSP. DATE:</b> January 15, 2019	<b>INSP. TIME:</b> 10:00
<b>OPERATOR:</b> Battle Mountain Resources, Inc.	<b>OPERATOR REPRESENTATIVE:</b> Larry Fiske, Julio Madrid, Steve Carino	<b>TYPE OF OPERATION:</b> 112d-3 - Designated Mining Operation	
<b>REASON FOR INSPECTION:</b> Normal I&E Program	<b>BOND CALCULATION TYPE:</b> None	<b>BOND AMOUNT:</b> \$7,400,000.00	
<b>DATE OF COMPLAINT:</b> NA	<b>POST INSP. CONTACTS:</b> None	<b>JOINT INSP. AGENCY:</b> None	
<b>WEATHER:</b> Clear	<b>INSPECTOR'S SIGNATURE:</b>

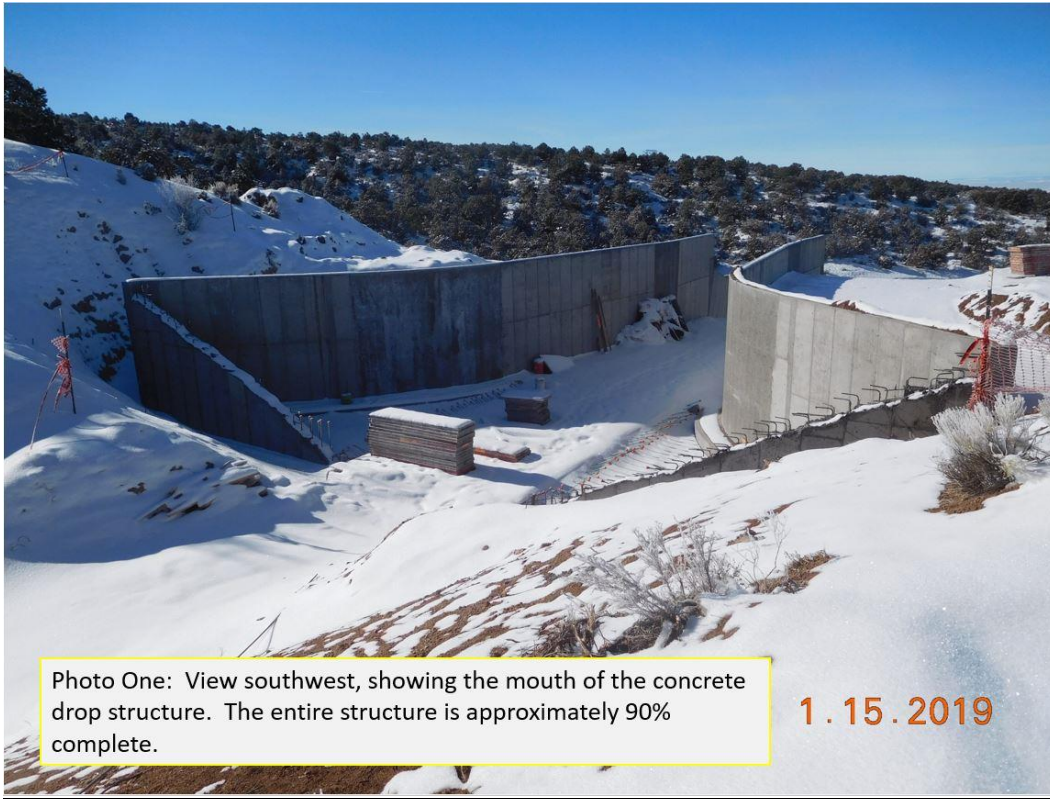
The main focus of this inspection was to monitor the construction of the new concrete drop structure located adjacent to the tailings dam. Construction of the spillway is nearly 90% completed. The main structural components of the structure have been poured. The remaining work consists of final capping of some of the concrete and completion the earthen backfill around the structure. The mouth of the structure, which can be seen in Photo One, is completed enough to be functional at this time. At its current state the structure will serve its intended function to convey storm water and snow melt around the tailings dam during the coming months. The main length of the structure appears to be complete. The energy dissipation portion of the structure at the base is nearly completed with some forms and heating blankets still in place. The main length and energy dissipation portion can be seen in Photos Two and Three. Work on the structure will be temporarily suspended due to cold temperatures and snowy conditions. As soon as conditions allow, the structure will be completed.

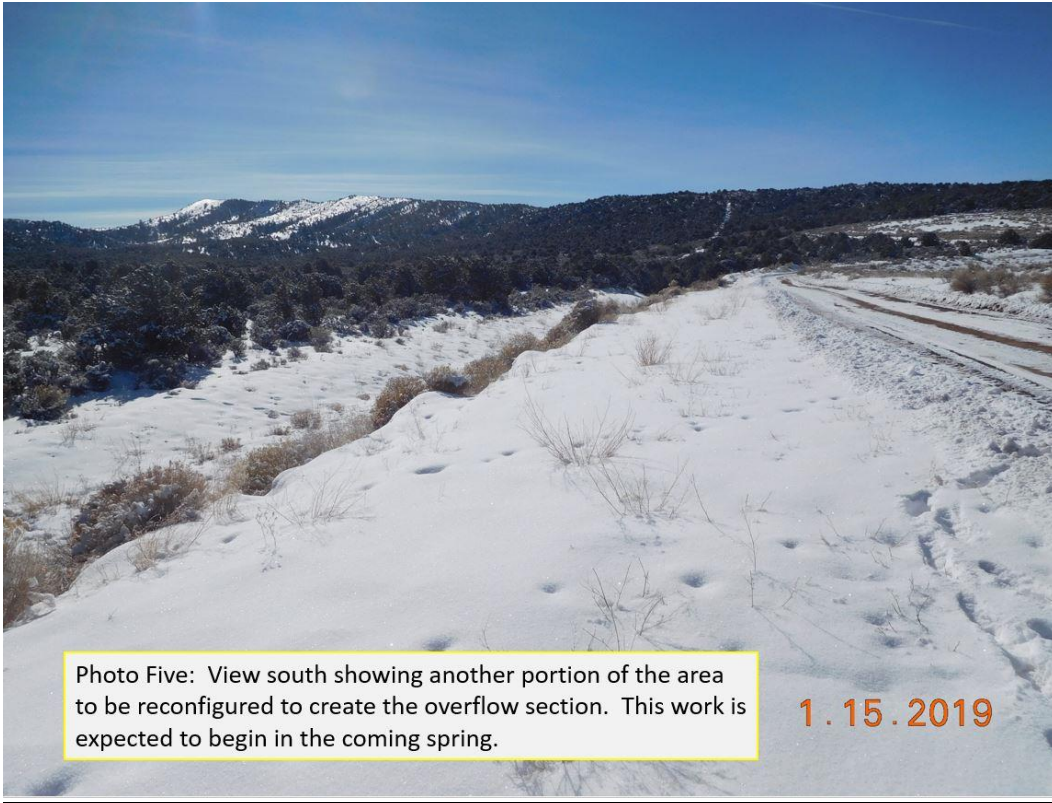
Photo Five: View south showing another portion of the area to be reconfigured to create the overflow section. This work is expected to begin in the coming spring.
