M-2008-025 Post 2018 Inspection Map

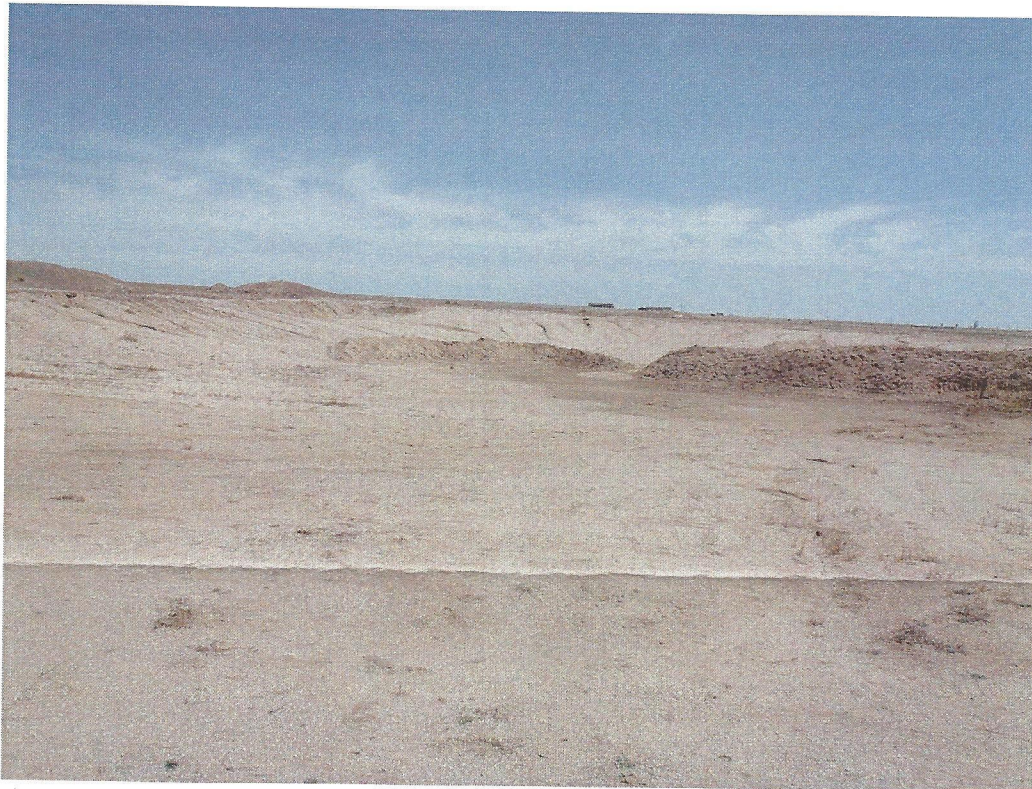
Photo 1. East (center background) and west (foreground) highwalls sloped at 5H:1V or flatter (looking NE).

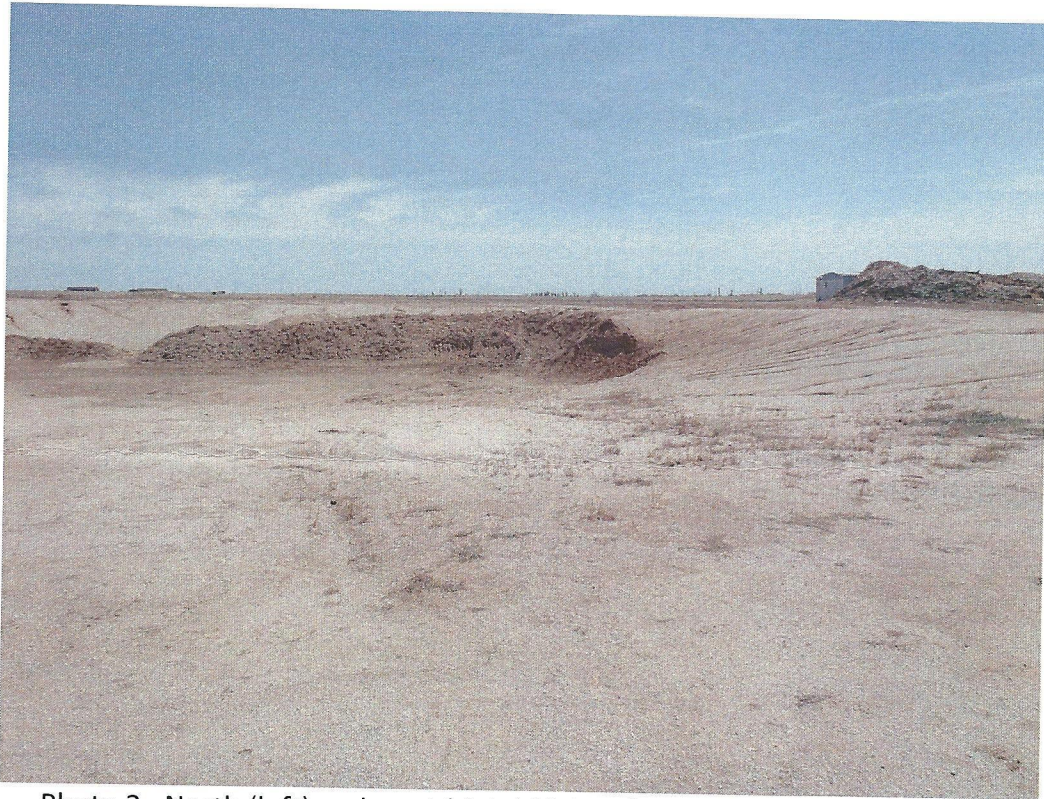
Photo 2. North (left) and west (right) highwalls sloped at 3H:1V or flatter.

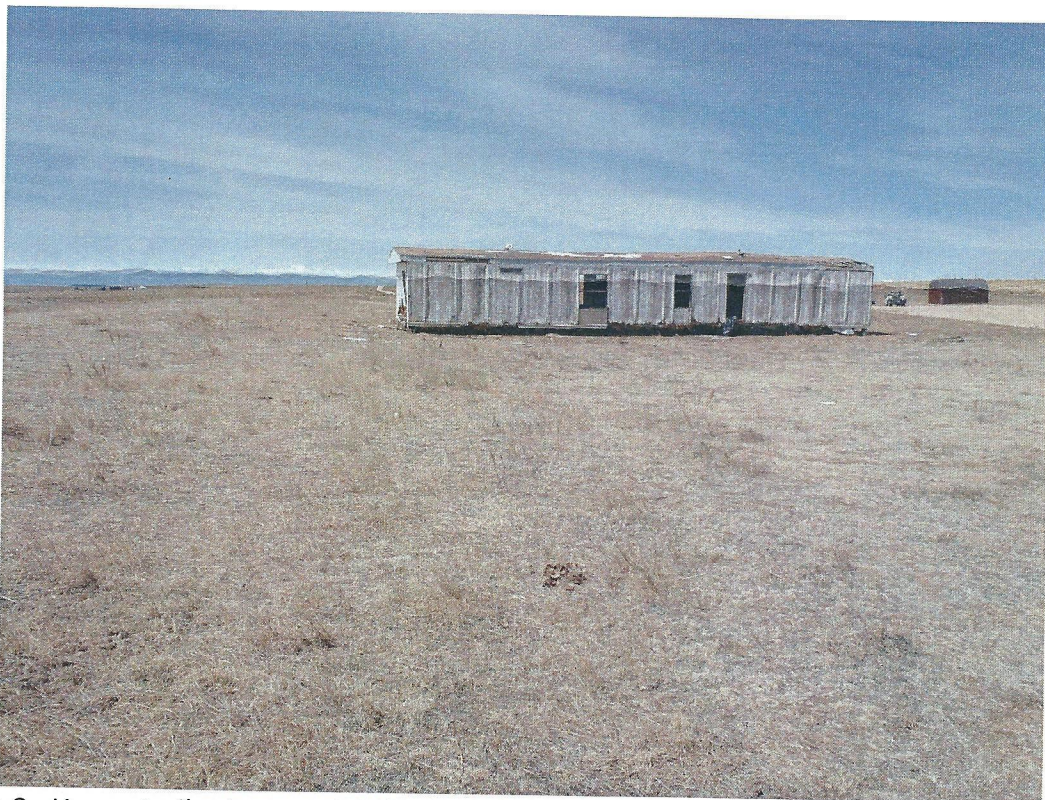
Photo 3. House trailer in poor condition within permit boundary (south side, looking west).

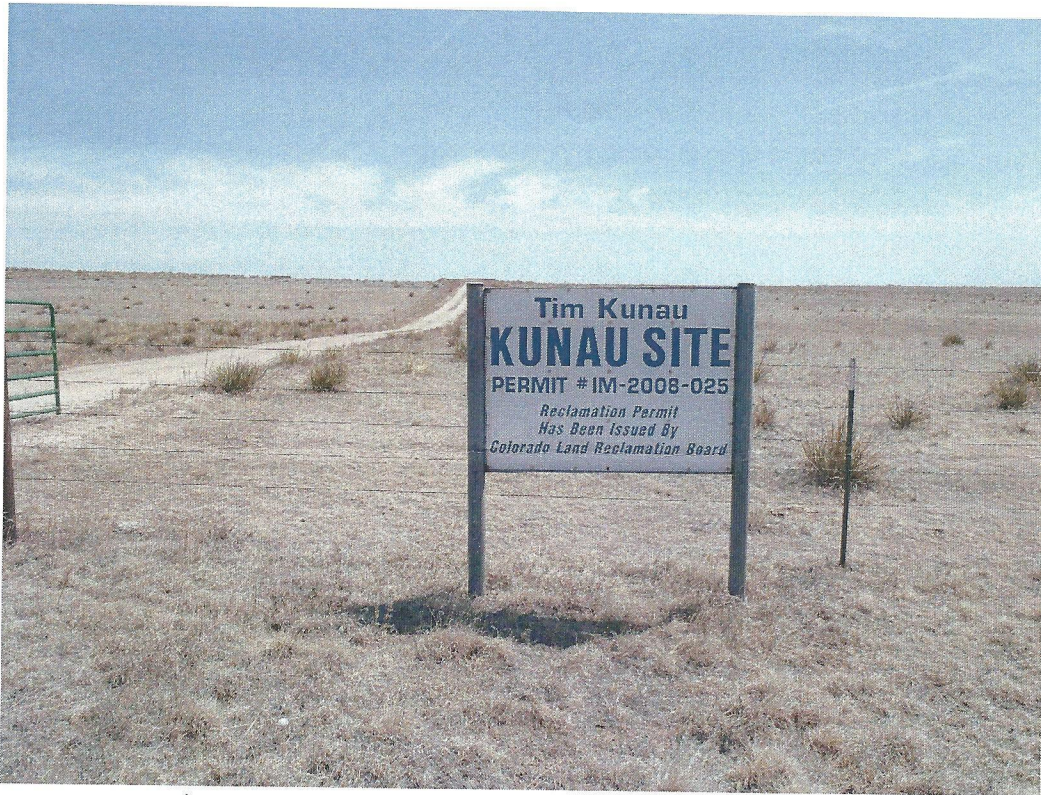
Photo 4. Permit sign (at gated entrance, looking east).

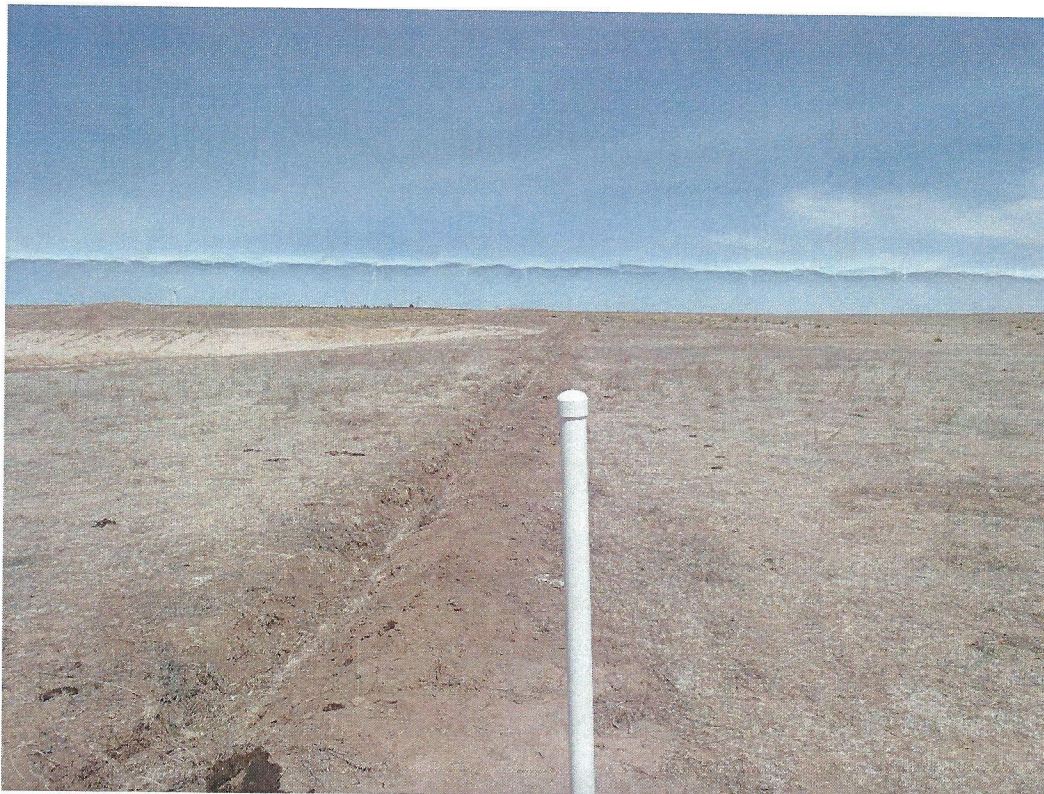
to delineate the permit boundary (see **Photo 5**).

Photo 5. Typical permit boundary marker (SE corner, looking north).

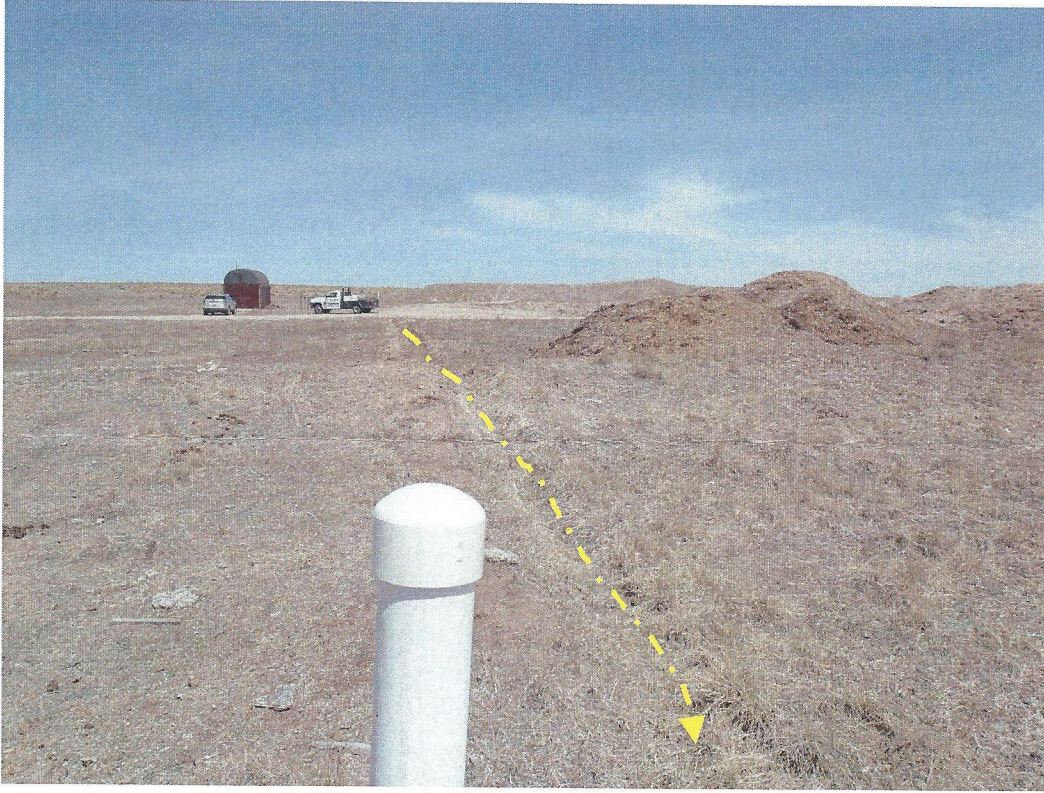
Storm Water MGT Plan: No oil or fuel spills observed. Ditches (see **Photo 6**) were observed intended to divert runoff away from the pit and towards a stormwater pond on the southwest corner of the existing pit. Stormwater captured within the pit, infiltrates.

Photo 6. West side diversion ditch (looking north).

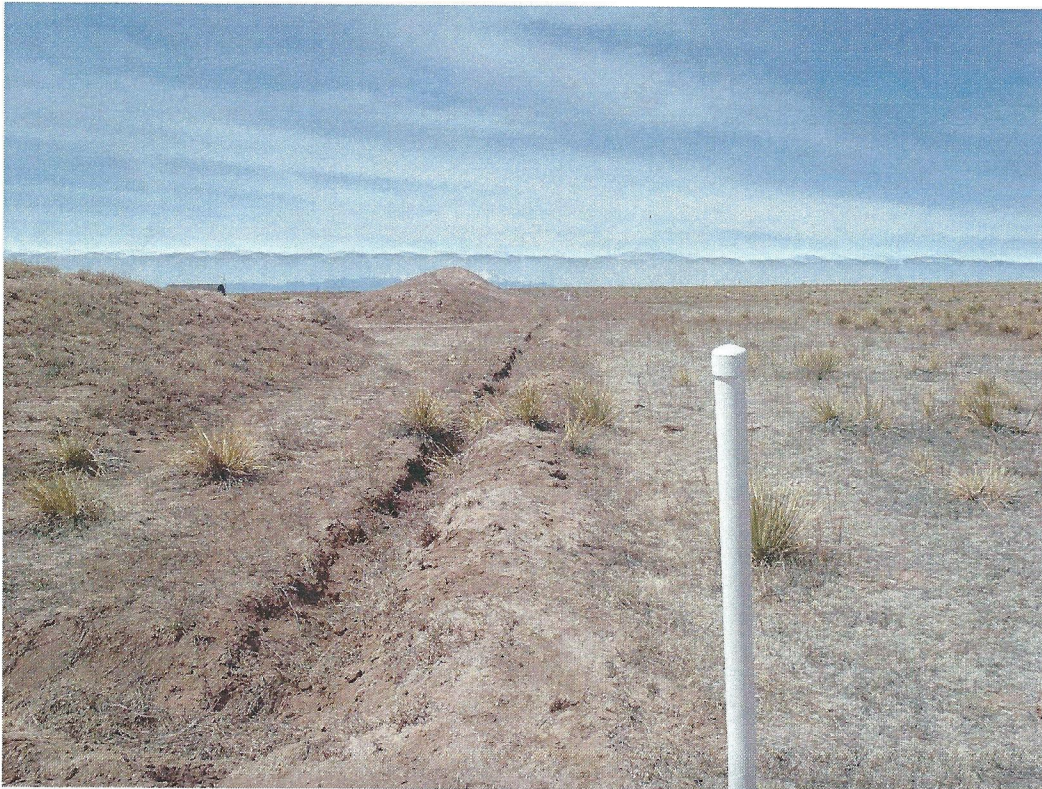
Topsoil: A topsoil stockpile was observed on the north side of the existing pit (see **Photo 7**).

Photo 7. North pit topsoil stockpiles (north side, looking west).
