COLORADO
Division of Reclamation,
Mining and Safety
Department of Natural Resources

Permit Number: C-1996-084 Mine Name: Lorencito Canyon Mine Operator: New Elk Coal Company, LLC Operator Address: Mr. Louis Head 12250 Highway 12 Weston, CO 81091	County: Las Animas Operation Type: Surface Permit Status: Permanent Cessation Ownership: Private
	Operator Representative Present: Nick Mason
Operator Representative Signature: (Field Issuance Only)

Inspection Start Date: January 30, 2019 Inspection Start Time: 07:00 Inspection End Date: January 30, 2019 Inspection End Time: 09:00		Inspection Type: Coal Partial Inspection Inspection Reason: Normal I&E Program Weather: Clear	
Joint Inspection Agency: None		Joint Inspection Contacts: 	
Post Inspection Agency: None		Post Inspection Contacts: 	
Inspector(s): Robert D. Zuber, P.E.	Inspector's Signature:

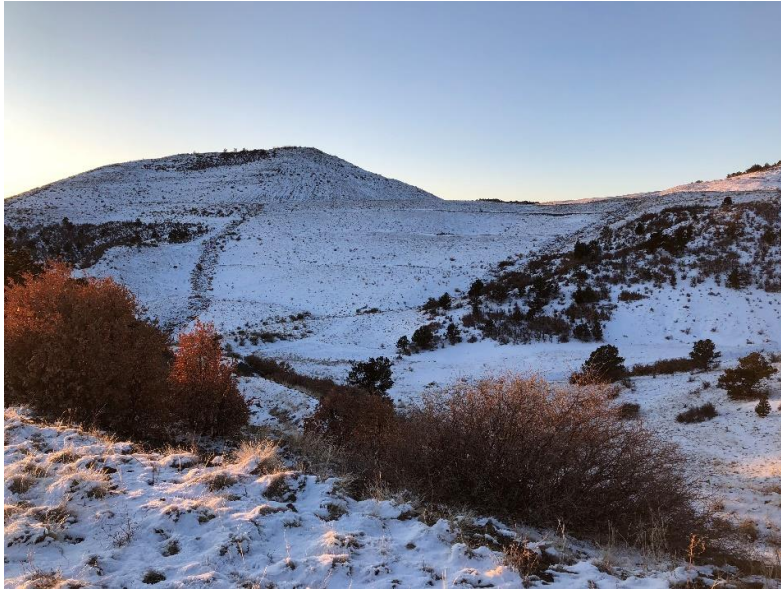
Fill 8

Fills 7, 8, and 9 were inspected. No large rills or gullies were seen.

A large herd of elk (approximately 200 animals) was seen moving above Fill 8.

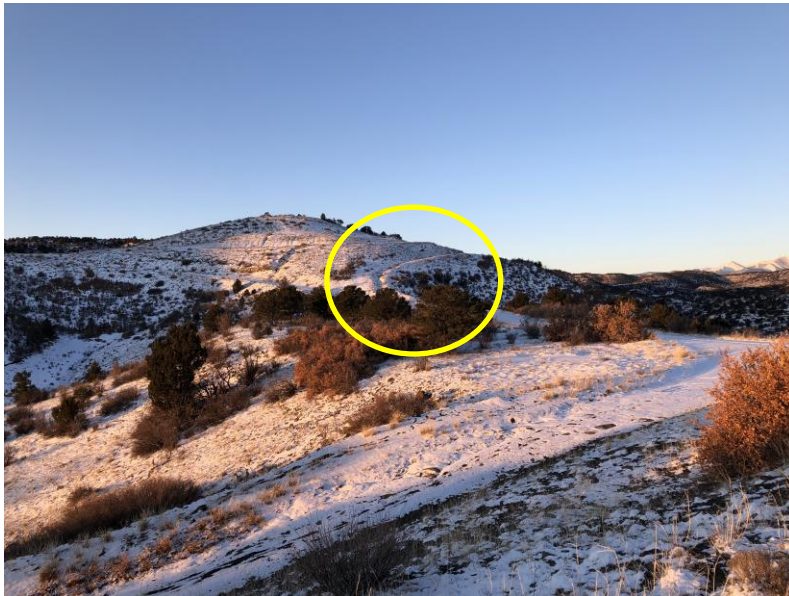
Ditch D15 and hill above (ditch is circled)

No significant problems were found with ditches. In particular, the following ditches (at least significant segments of them) were inspected: D5, D9, D15, D71, D83, D84, and D86. The riprap in D84 appears to be stable as it has not shifted considerably from past inspections.

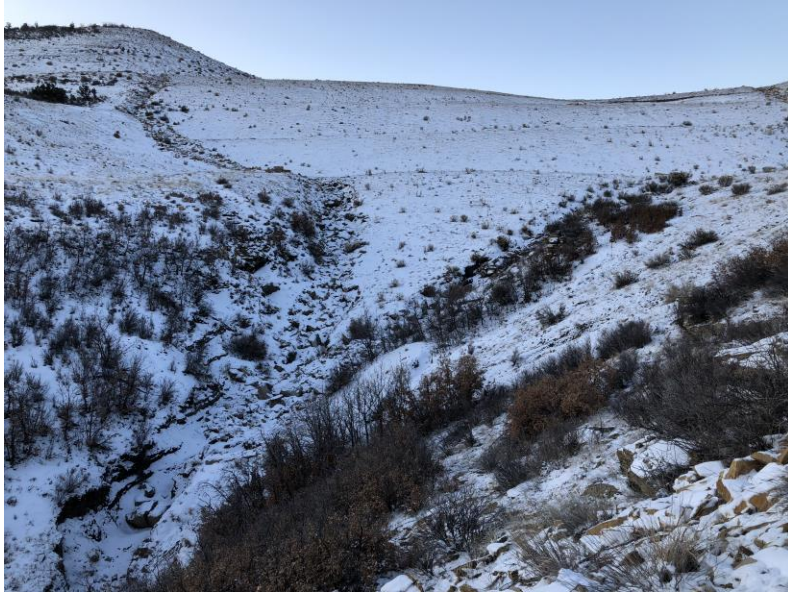
Lower portion of Fill 8 and ditches D83 (left side) and D84

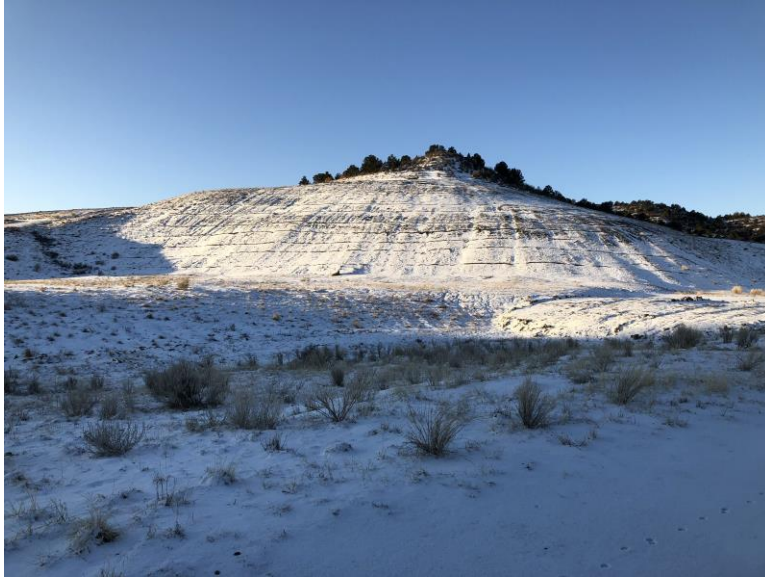
As noted in the past, there are many rills on the hillside above Pond 6 and on the hillside above the pond cleaning dump area.

Hill above dump area for pond sediment

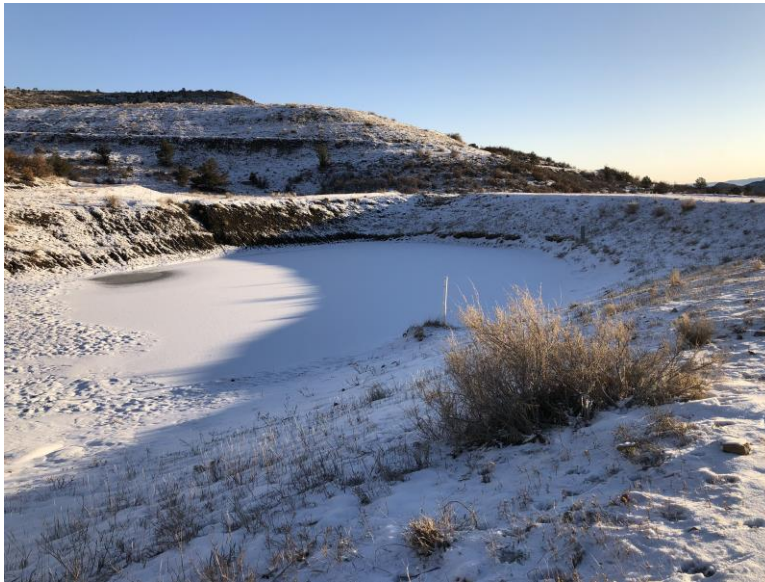
Pond 6

The following ponds were inspected: 6, 8, and 9A. Pond 9 was viewed from the road above. They all contained some snow and ice. None of them were discharging. No problems were identified with embankments, spillways, or other features of the ponds.

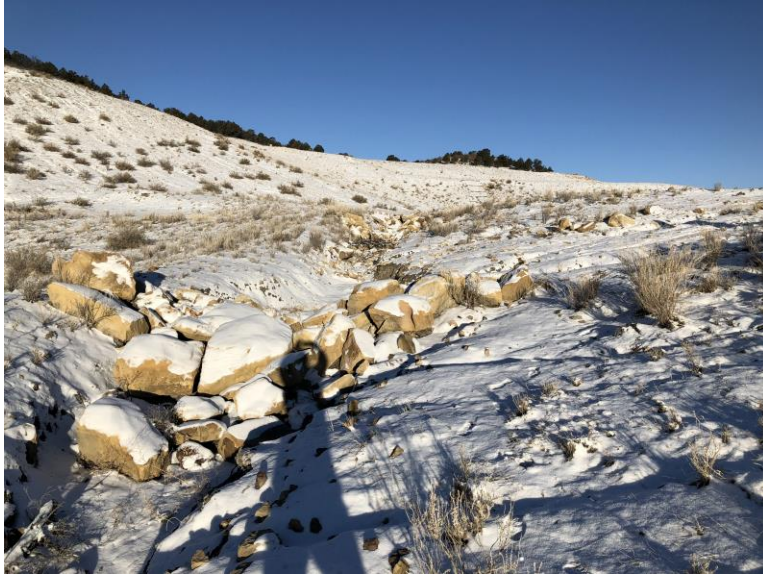
Ditch D9 with check dams

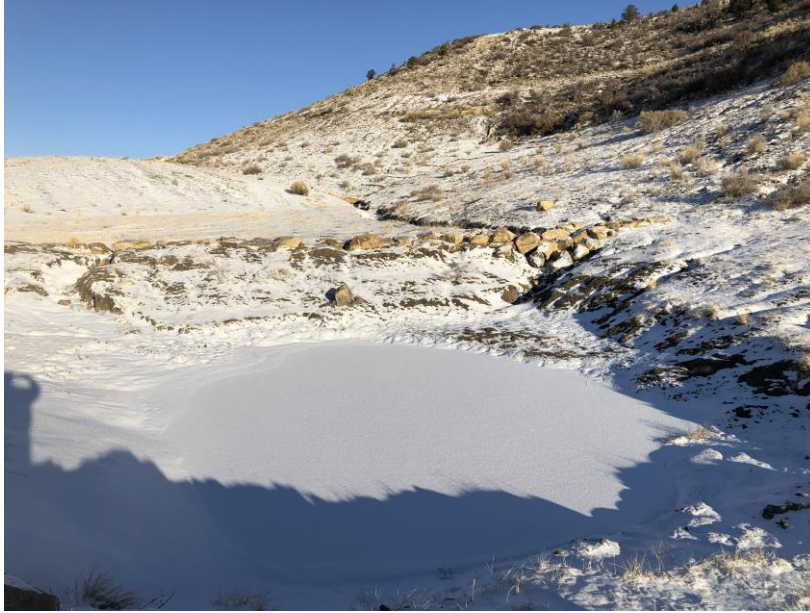
Ditch D5 and sump above culvert C4

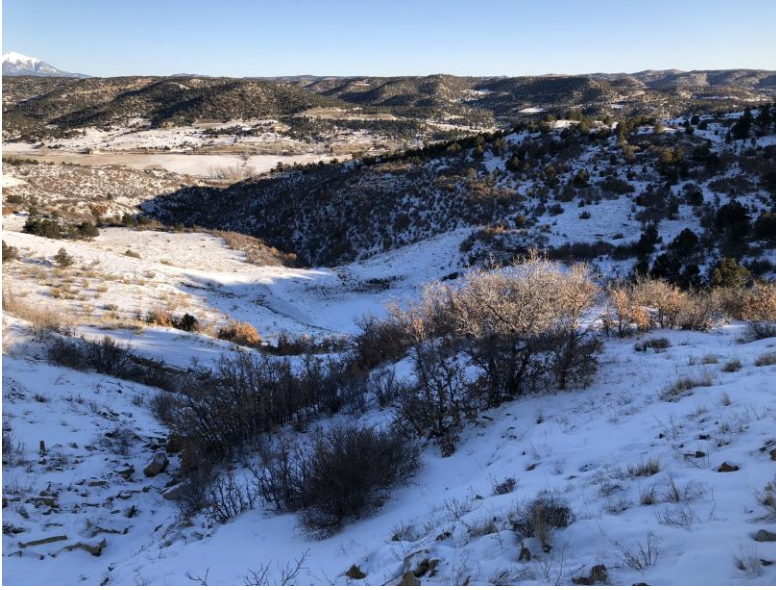
Pond 9 from road above
