**MINERALS PROGRAM INSPECTION REPORT**  
**PHONE: (303) 866-3567**

| <b>MINE NAME:</b><br>Penrose Ranch's | <b>MINE/PROSPECTING ID#:</b><br>M-1992-016 | <b>MINERAL:</b><br>Sand and gravel | <b>COUNTY:</b><br>Fremont |
| <b>INSPECTION TYPE:</b><br>Monitoring | <b>INSPECTOR(S):</b><br>Timothy A. Cazier | <b>INSP. DATE:</b><br>August 7, 2018 | <b>INSP. TIME:</b><br>15:15 |
| <b>OPERATOR:</b><br>Rocky Mountain Materials and Asphalt, Inc. | <b>OPERATOR REPRESENTATIVE:</b><br>David Bieber | <b>TYPE OF OPERATION:</b><br>112c - Construction Regular Operation | |

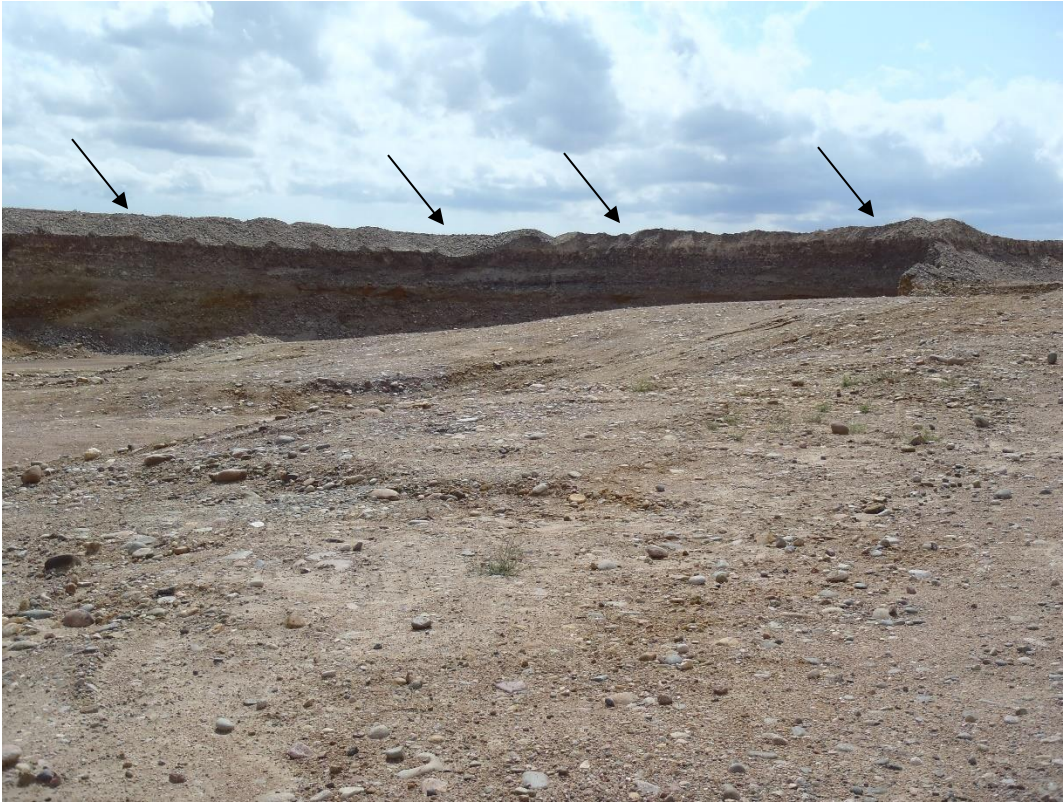
**Excess Spoil and Dev. Waste:** Overburden was stockpiled on top of the highwalls to construct safety berms (see **Photo 1**).

Photo 1. Overburden stockpiled on top of highwalls to construct safety berms (looking SW).

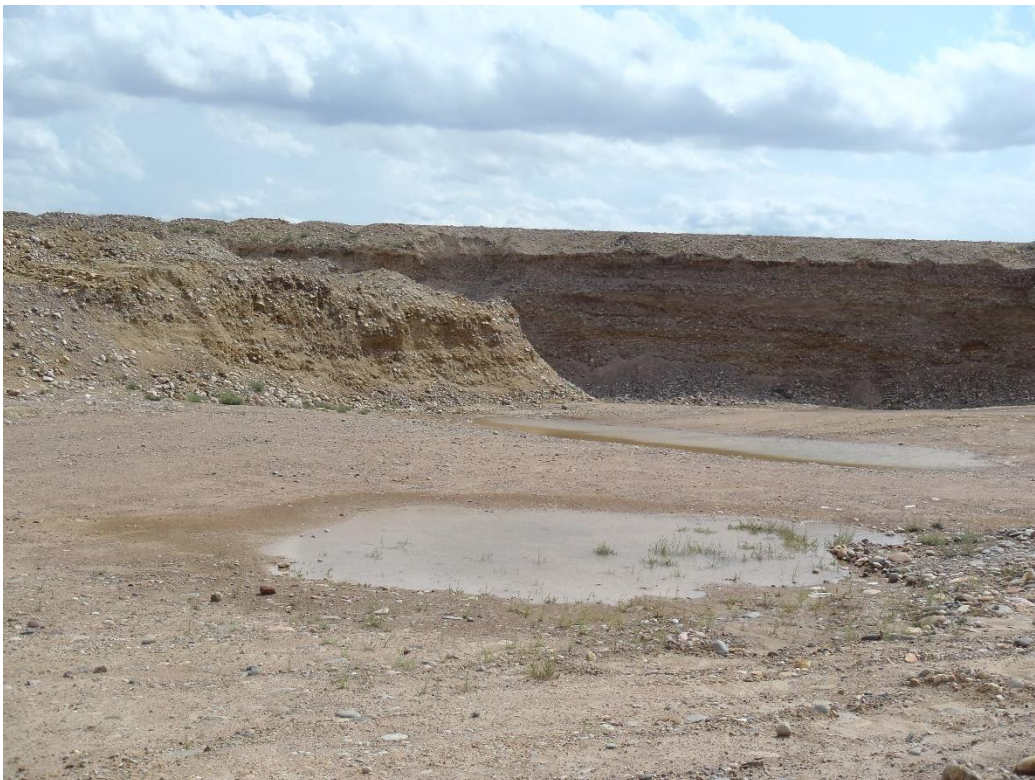
**Hydrologic Balance:** Some puddles (see **Photo 2**) were observed in the pit, but no exposed groundwater was observed.

Photo 2. Puddles from recent rain in pit floor.

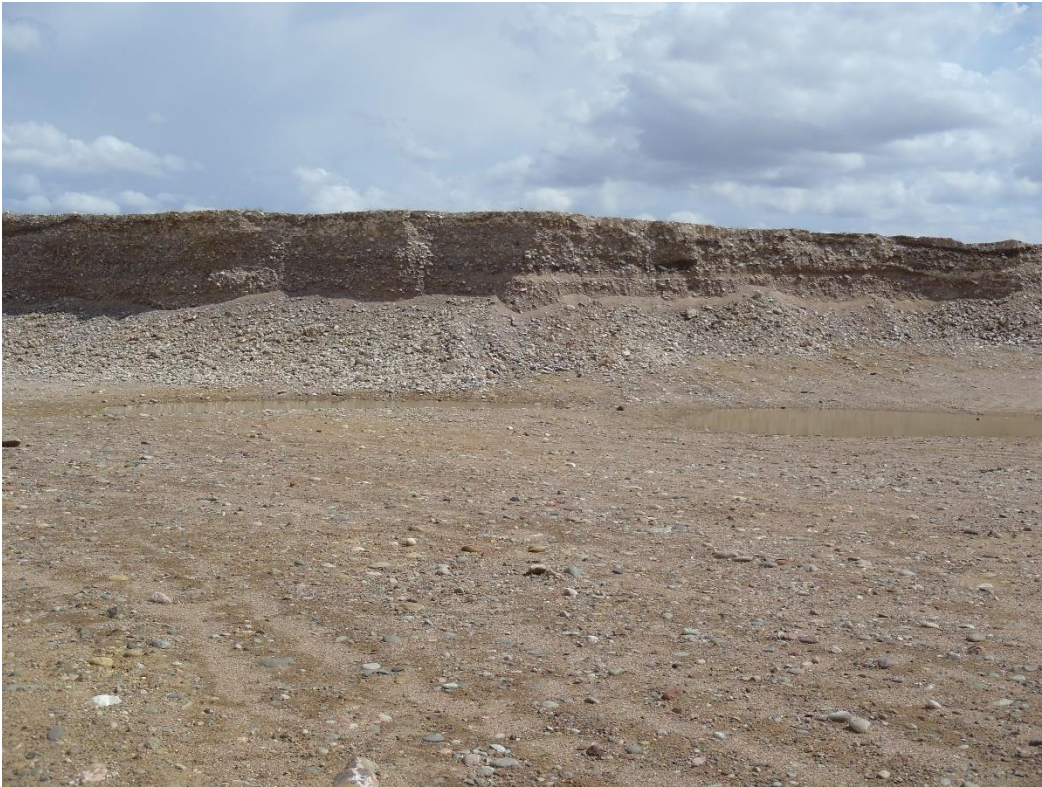
Gen. Compliance with Mine Plan: The operation appeared to be in compliance with the approved mine plan. Google Earth was used to measure the disturbed area, which was estimated to be approximately 158.5 acres, based on 2018 imagery (see enclosed **Post 2018 Inspection Map**). This does not include Areas or portion of Areas 1 – 5 considered reclaimed, but not released as part of the 2014 approved surety reduction. Highwalls were estimated to be 15 feet in height and appeared stable (see **Photo 3**). Mining is progressing towards the south.

Photo 3. Typical highwall (south end).

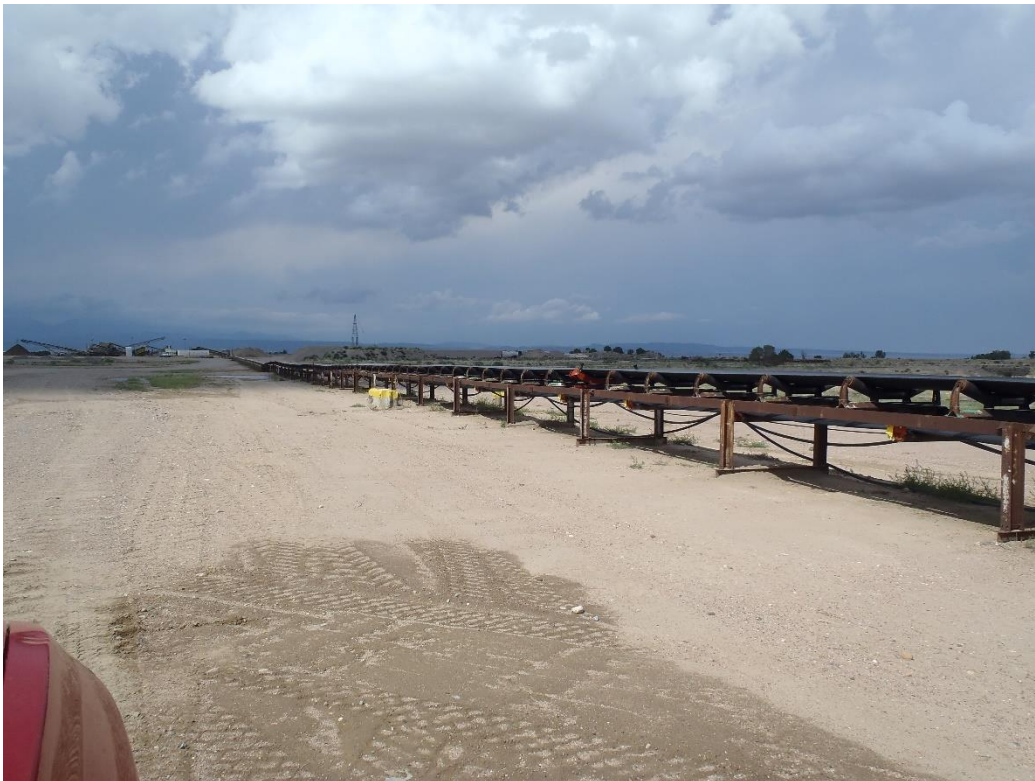
Support Facilities On-site: A screen plant, conveyor system (see **Photos 4 and 5**), loaders, and scrapers were observed on site.

Photo 4. Conveyor system, screen plant beyond on left (looking NE).

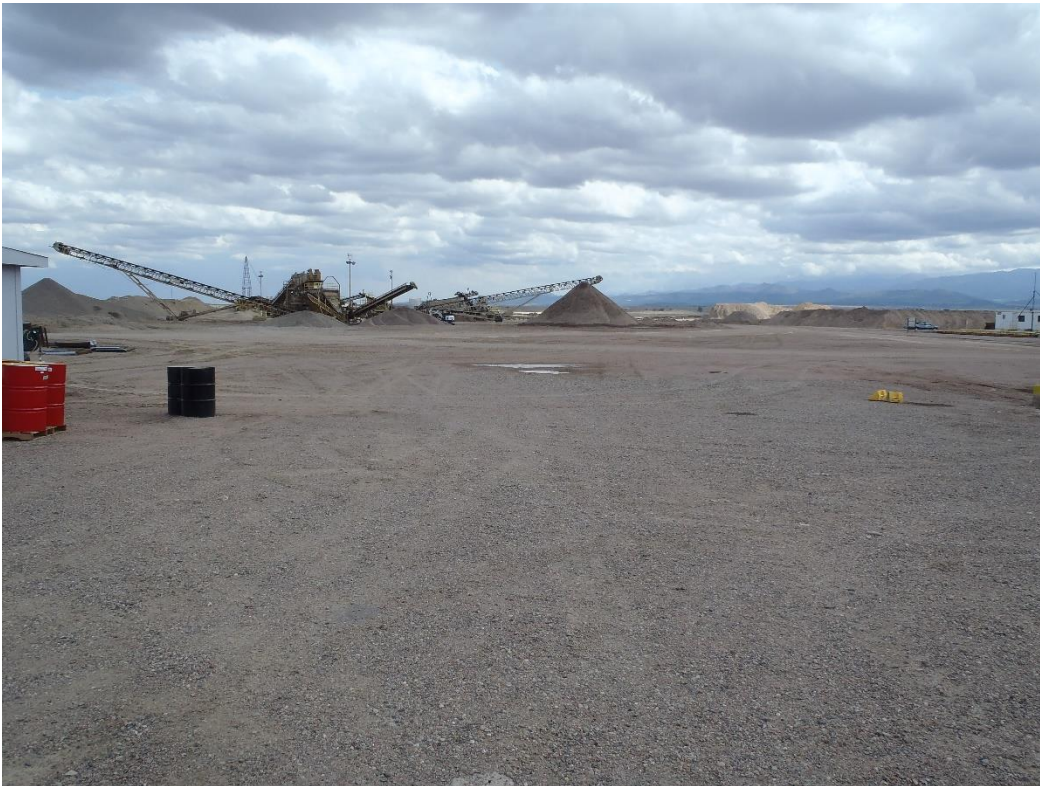
Photo 5. Screen plant (looking south, scale house on right).

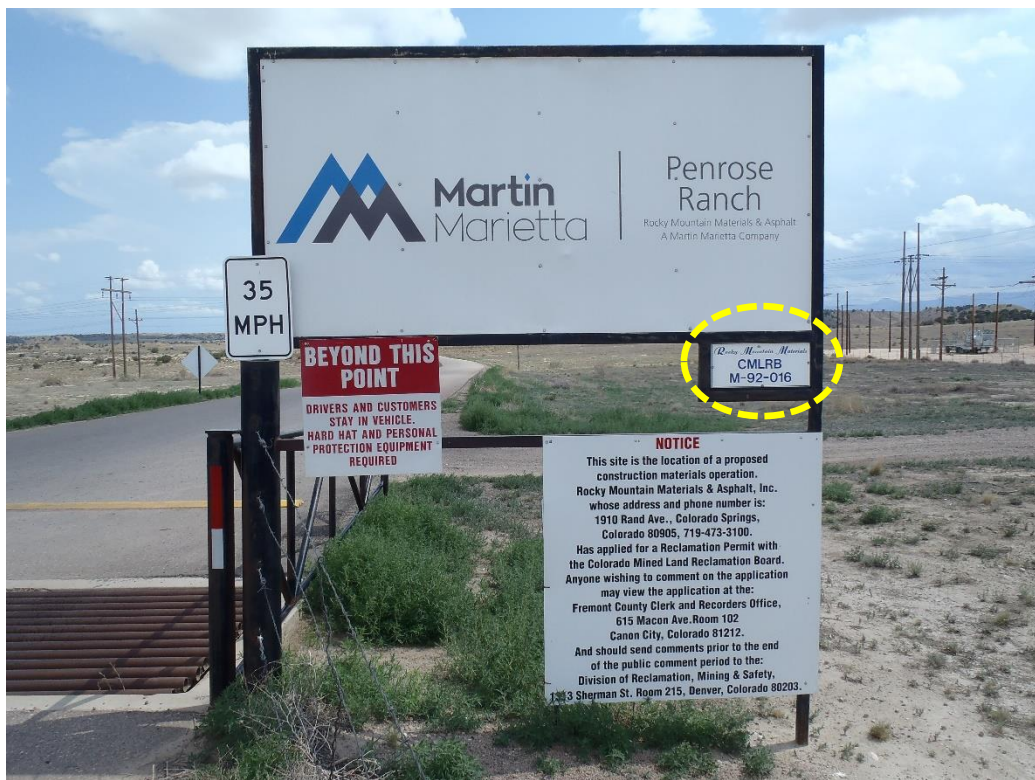
Signs and Markers: The permit sign was properly posted (see **Photo 6**). The boundary is fenced.

Photo 6. Permit sign (at entrance off CR 112).

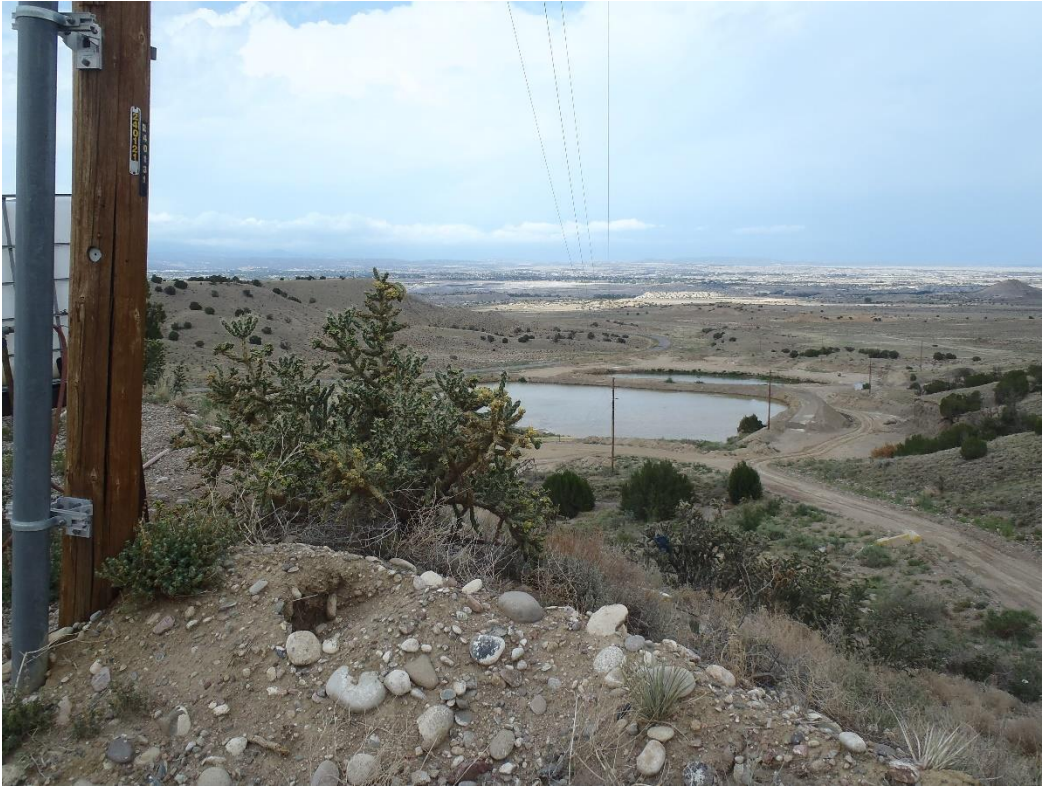
Structures: A power line was observed (**Photo 7**) extending from the water storage ponds up the hill to the maintenance area. Because this line terminates here and extends some distance, [RMMA should determine who owns the power line and if a structures agreement \(if owned by the landowner\) or utility agreement \(if owned by the utility\) is required.](#) If RMMA owns the power line, no agreement is needed.

Photo 7. Power line from water storage ponds to maintenance area (looking NE from maintenance area).
