Permit Number: C-1981-012 Mine Name: New Elk Mine Operator: New Elk Coal Company, LLC Operator Address: Mr. Louis Head 12250 Highway 12 Weston, CO 81091	County: Las Animas Operation Type: Underground Permit Status: Active Ownership: Private
	Operator Representative Present: V. Massarotti and N. Mason
Operator Representative Signature: (Field Issuance Only)

Inspection Start Date: January 29, 2019 Inspection Start Time: 11:40 Inspection End Date: January 30, 2019 Inspection End Time: 09:45		Inspection Type: Coal Partial Inspection Inspection Reason: Normal I&E Program Weather: Cloudy	
Joint Inspection Agency: None		Joint Inspection Contacts: 	
Post Inspection Agency: None		Post Inspection Contacts: 	
Inspector(s): Robert D. Zuber, P.E.	Inspector's Signature:

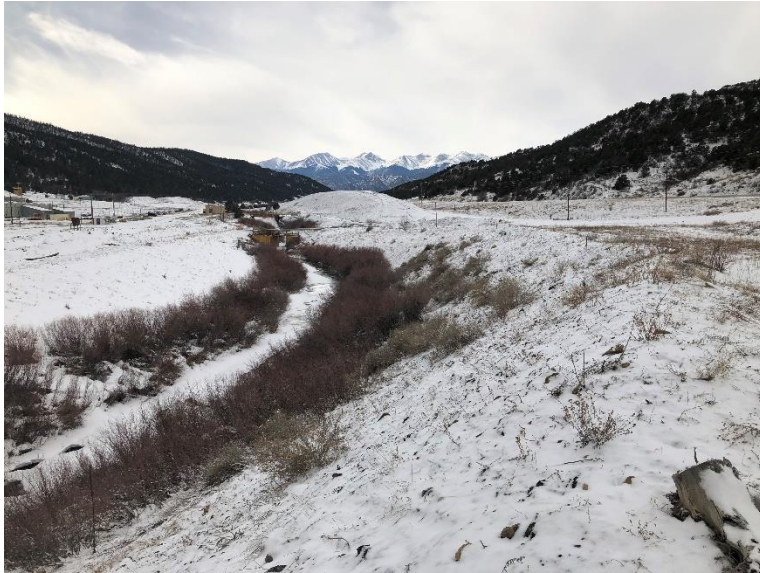
Middle Fork of the Purgatoire River (DWDA#2 below mountains)

Erosion on DWDA#2 persists. The sump below DWDA#2 did not need immediate maintenance.

The Middle Fork of the Purgatoire River was inspected, and no eroding banks or signs of pollutant loading from the New Elk Mine were seen. Particular areas that were inspected include the main entrance road crossing, the stretch below DWDA#2, and beside Pond 007A.

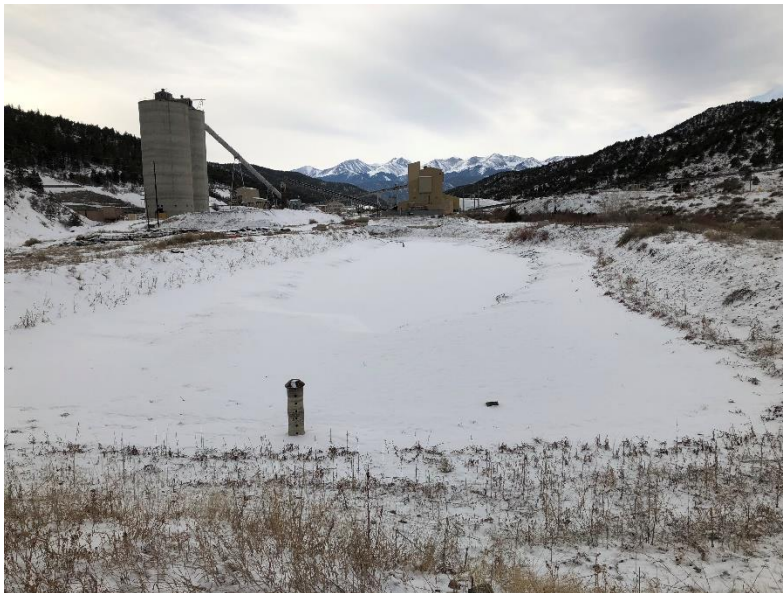
Ponds 001A, 004A, 006A, 007A, and 08 were inspected. None of them were discharging, but all held at least a small amount of water/snow/ice. The impounded water in Pond 08 appeared to be more than 13 feet below the primary spillway. The impounded water in Pond 007A was approximately four feet below the top of the primary spillway. No water was seen flowing into the ponds from the pipe and pump systems on site. No significant issues were seen with the embankments or spillways of any ponds.

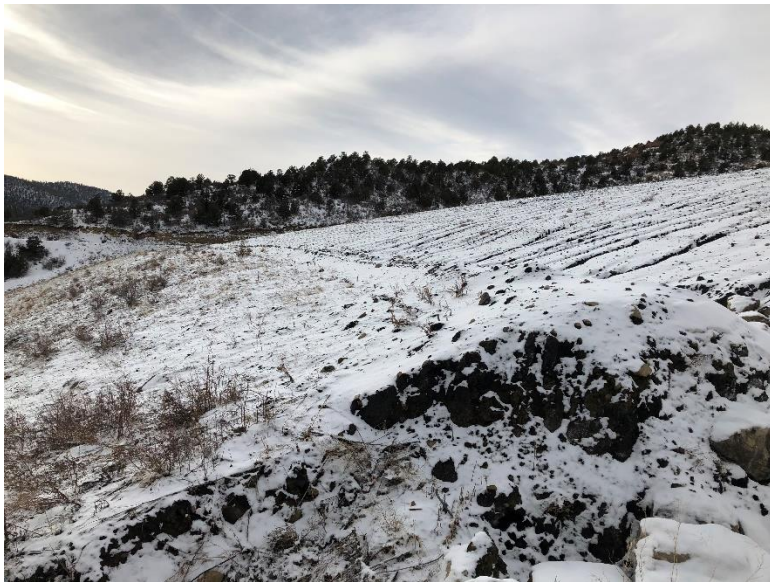
RDA (reclaimed portion to left)

No erosion was seen on the reclaimed portion of the RDA. The ditch between the upper and lower portions of the RDA is in good shape. On the upper portion of the RDA, NECC still needs to spread some piles of material.

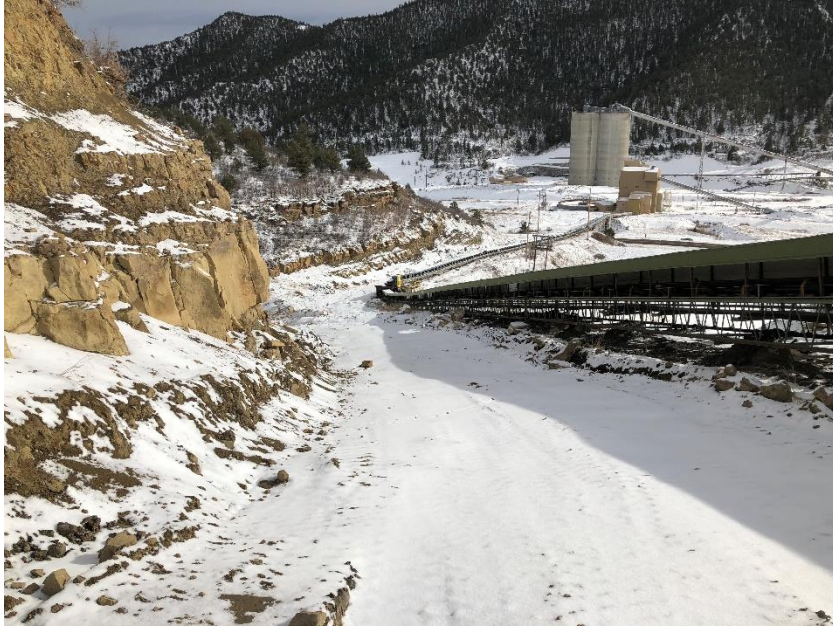
Road beside conveyor

No significant problems with roads were observed. The road beside the conveyor to the RDA has been improved since the December inspection.

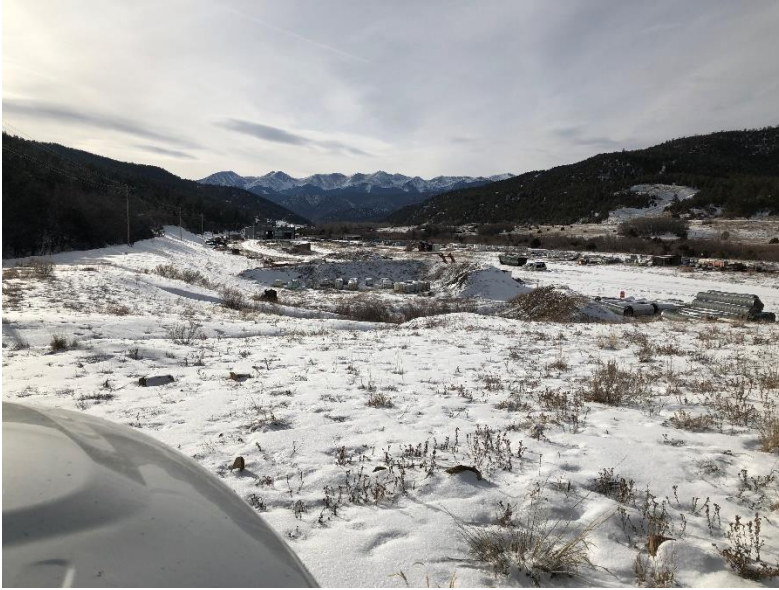
Chemical storage area

The chemical storage area, west of the soil storage area, appeared to be contained well with a berm.

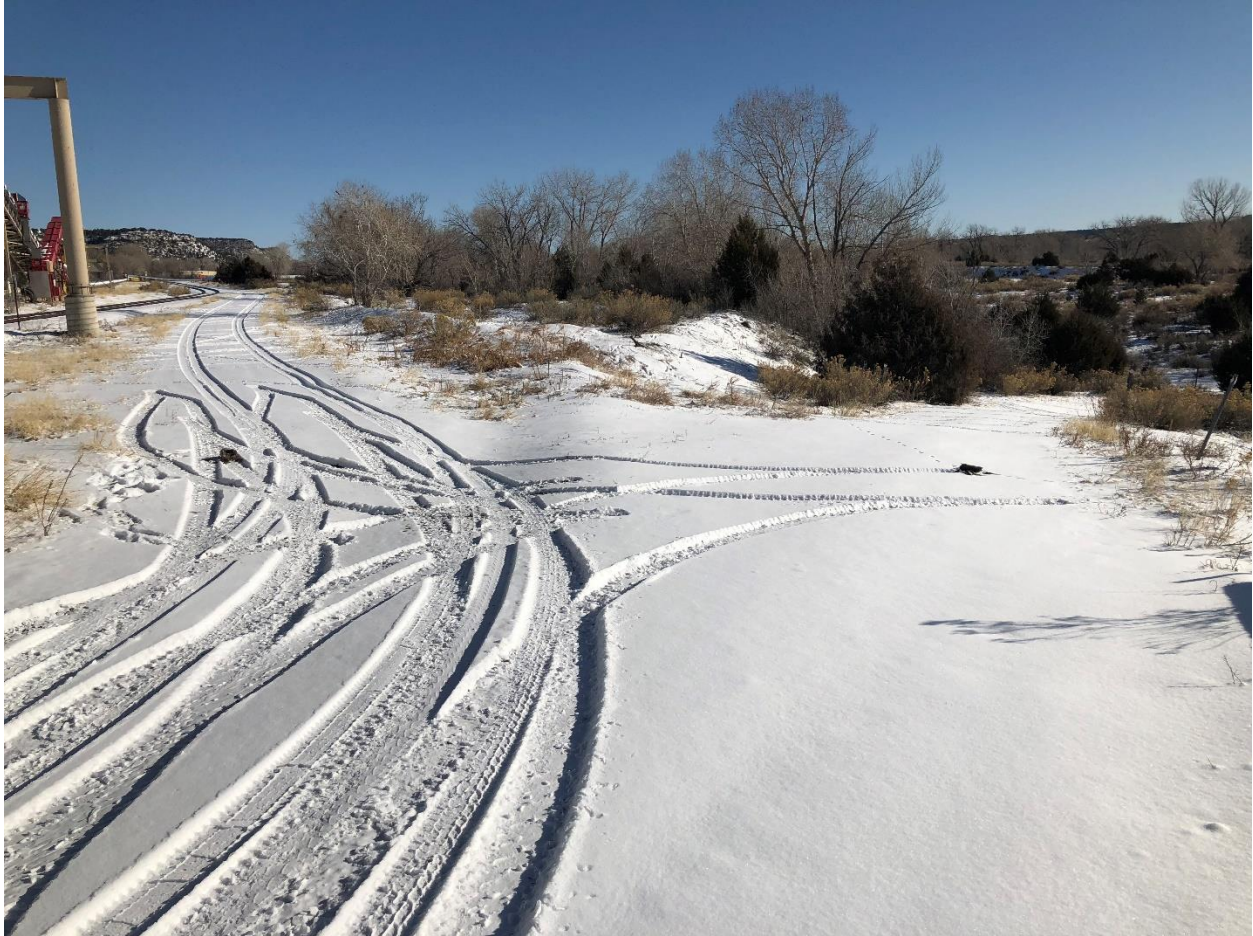
Lower portion of Jansen Loadout

No erosion or other problems were seen at the Jansen loadout.
