**PERMIT INFORMATION**

<b>Permit Number:</b> C-1981-028 <b>Mine Name:</b> Keenesburg Strip Mine <b>Operator:</b> Coors Energy Company <b>Operator Address:</b> Mr. Danny Kipp P.O Box 467 Golden , CO 80402	<b>County:</b> Weld <b>Operation Type:</b> Surface <b>Permit Status:</b> Active <b>Ownership:</b> Private
	<b>Operator Representative Present:</b>  None
<b>Operator Representative Signature: (Field Issuance Only)</b>

**INSPECTION INFORMATION**

<b>Inspection Start Date:</b> January 29, 2019 <b>Inspection Start Time:</b> 10:22 <b>Inspection End Date:</b> January 29, 2019 <b>Inspection End Time:</b> 10:24		<b>Inspection Type:</b> Aerial Inspection <b>Inspection Reason:</b> Normal I&E Program <b>Weather:</b> Clear	
<b>Joint Inspection Agency:</b>  None		<b>Joint Inspection Contacts:</b>  	
<b>Post Inspection Agency:</b>  None		<b>Post Inspection Contacts:</b>  	
<b>Inspector(s):</b>  Robert D. Zuber, P.E.  Harry B. Ranney	<b>Inspector's Signature:</b>

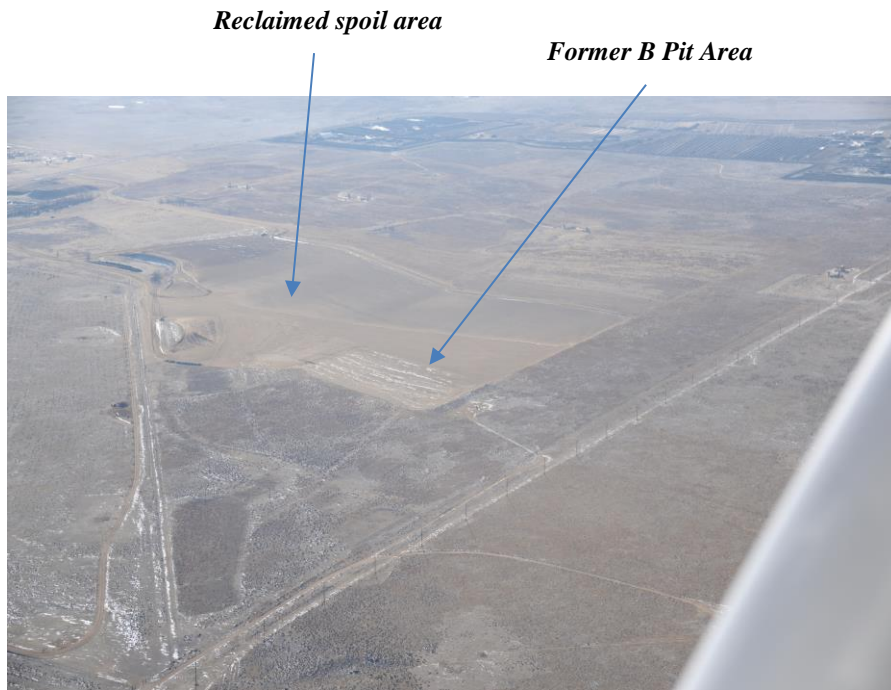
**Northwest corner of site and areas undergoing reclamation**

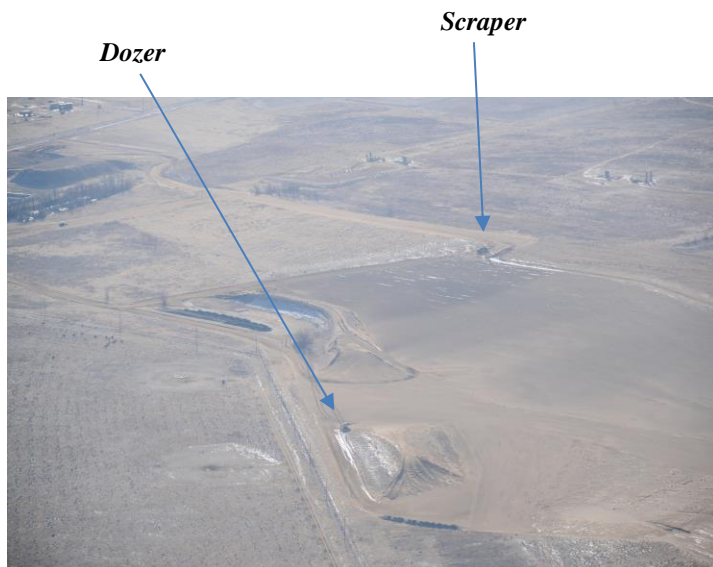
No erosion problems were seen at any of the topsand piles.

**Topsand Pile A-3**

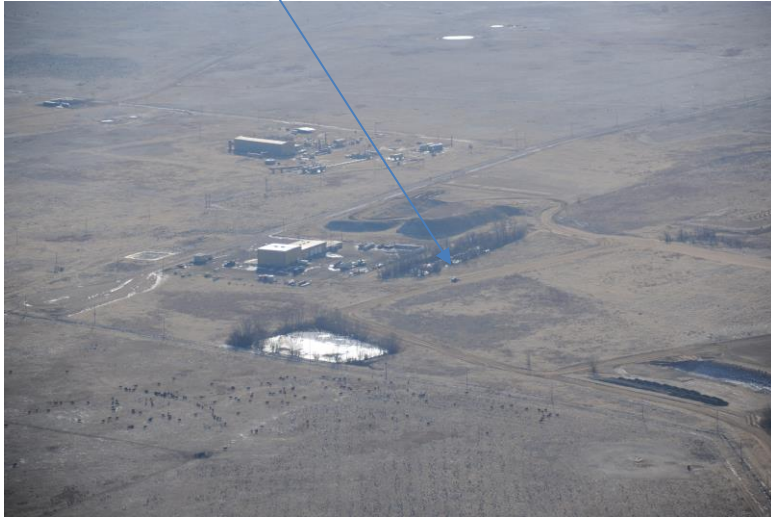
No problems were identified with Sediment Pond 2 or the Dugout Pond. Neither pond appeared to be discharging during the inspection.

**Ponds and facility area**

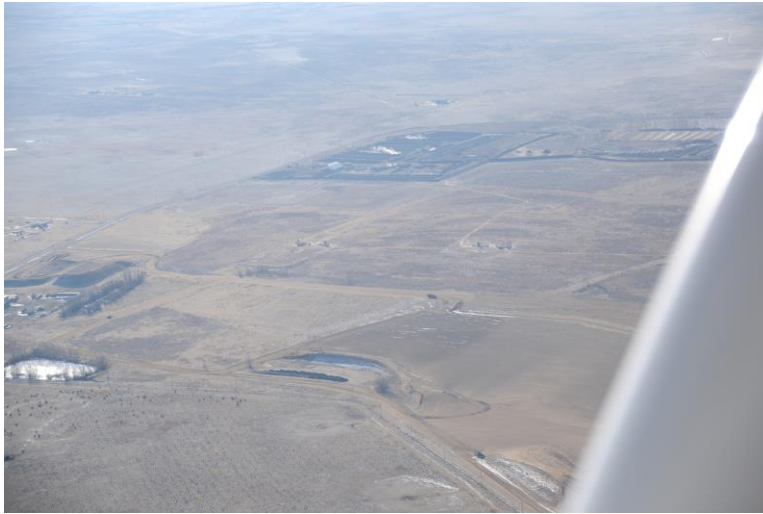
**Looking south at site with A1 Organics in background**
