MINERALS PROGRAM INSPECTION REPORT
PHONE: (303) 866-3567

MINE NAME: Orchard Grove Industrial Pit	MINE/PROSPECTING ID#: M-1990-094	MINERAL: Gravel	COUNTY: Mesa
INSPECTION TYPE: Surety-Related Inspection	INSPECTOR(S): Amy C. Yeldell	INSP. DATE: January 16, 2019	INSP. TIME: 08:50
OPERATOR: Kilgore Companies LLC dba Elam Constructi	OPERATOR REPRESENTATIVE: None	TYPE OF OPERATION: 112c - Construction Regular Operation	
REASON FOR INSPECTION: Priority	BOND CALCULATION TYPE: Complete Bond	BOND AMOUNT: \$52,600.00	
DATE OF COMPLAINT: NA	POST INSP. CONTACTS: None	JOINT INSP. AGENCY: None	
WEATHER: Cloudy	INSPECTOR'S SIGNATURE:

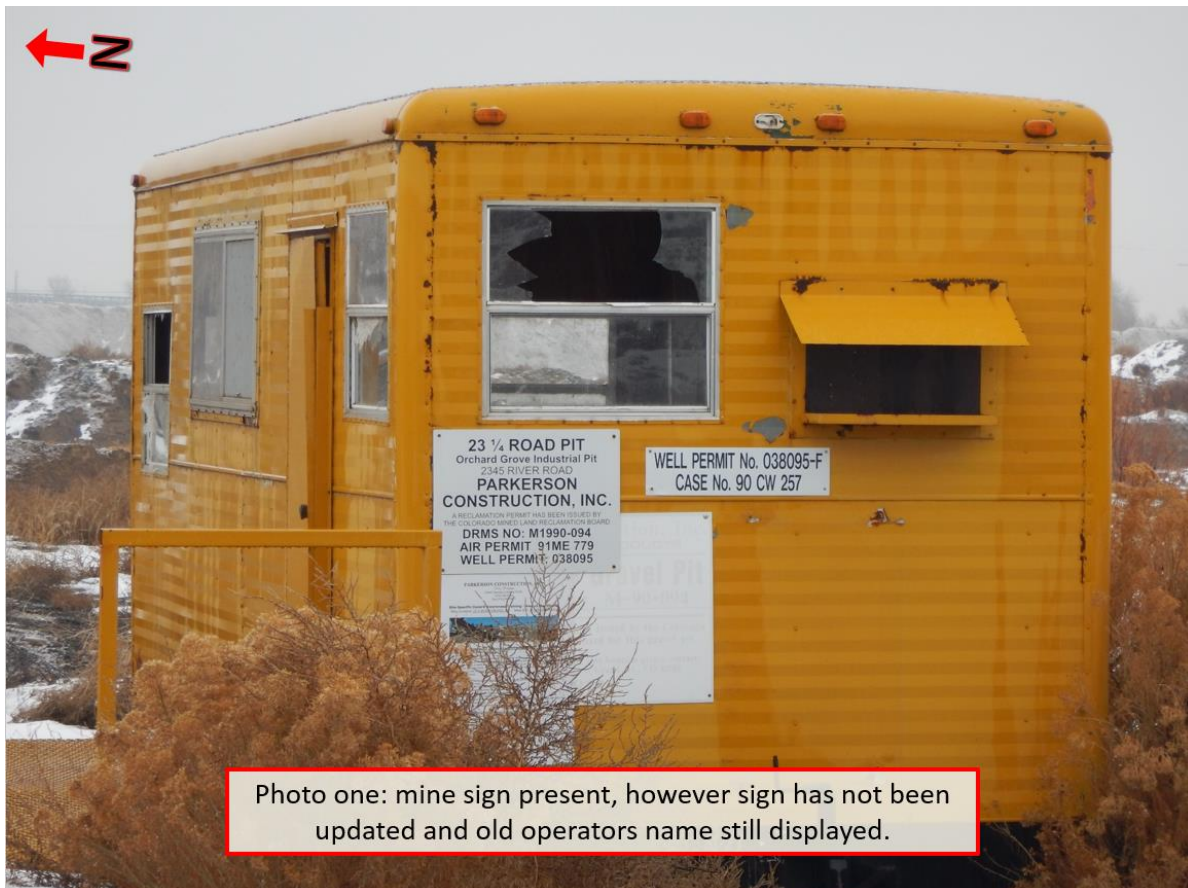
PROBLEM 3: The mine identification sign identifies a previous permit holder and not the current Operator, as required under Rule 3.1.12(a). The mine sign needs to be updated to reflect the current Operator.

The mine identification sign was affixed to the scale house on the west side of the pit (photo one). The mine sign has not yet been update to identify the Operator. This is cited as a problem pursuant to Rule 3.1.12(a). Please modify/replace the mine sign so that it is posted in accordance with Rule 3.1.12. Specifically, the sign must be clearly visible from the access road and display the name of the current Operator, a statement that a reclamation permit for the operation has been issued by the Colorado Mined Land Reclamation Board; and the permit number. The Operator shall submit photo documentation by the corrective action date listed on page two of this inspection report. Please be aware that the Division is undergoing rulemaking with regards to signage. If approved signs will also have a minimum size requirement of 24 inches in height by 36 inches in width and a minimum of two inch lettering.

CORRECTIVE ACTIONS: The Operator shall within 30 days from the signature date of this inspection report, post an updated mine identification sign at the entrance of the mine site in accordance with Rule 3.1.12. Specifically, the sign must be clearly visible from the access road and display the name of the current Operator, a statement that a reclamation permit for the operation has been issued by the Colorado Mined Land Reclamation Board; and the permit number. The Operator shall submit photo documentation, demonstrating that a proper sign has been posted by the corrective action date.

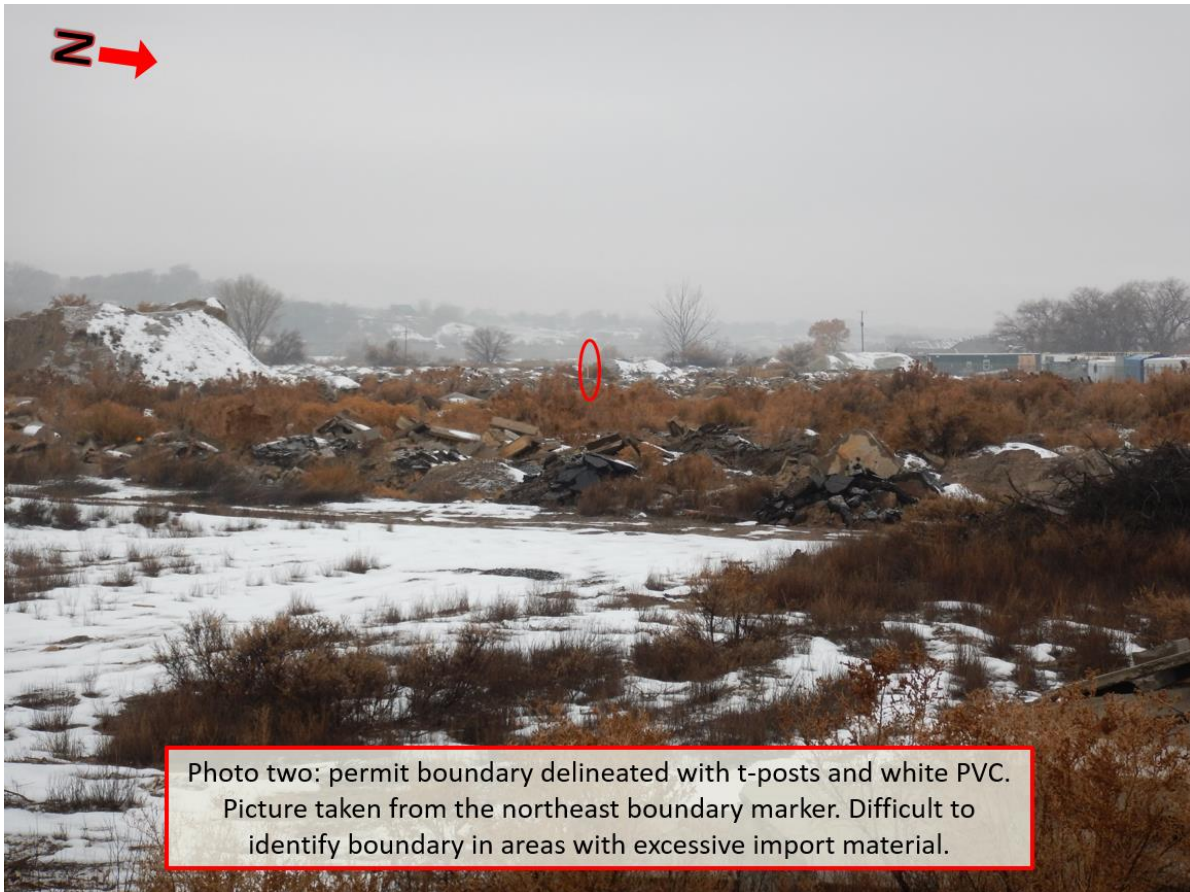
The permit boundary was delineated by t-posts with white PVC markers and is in compliance with Rule 3.1.12(2). These markers were placed in the corners of the permit boundary and periodically along the sides. Though the permit is visually delineated the actual boundary is difficult to distinguish amongst the large quantities of imported material, as shown in photo two. This is especially true along the northern permit boundary where there appears to be no difference in land use inside or outside of the permit boundary. These imported piles have been brought in by the landowner. No excavation to date has occurred outside of the permit boundary however stockpiles could be interpreted as off-site disturbance at first glance. The Division recommends that the permit boundary be delineated on the ground in the form of a berm or pathway through the piles to better differentiate between similar disturbances.

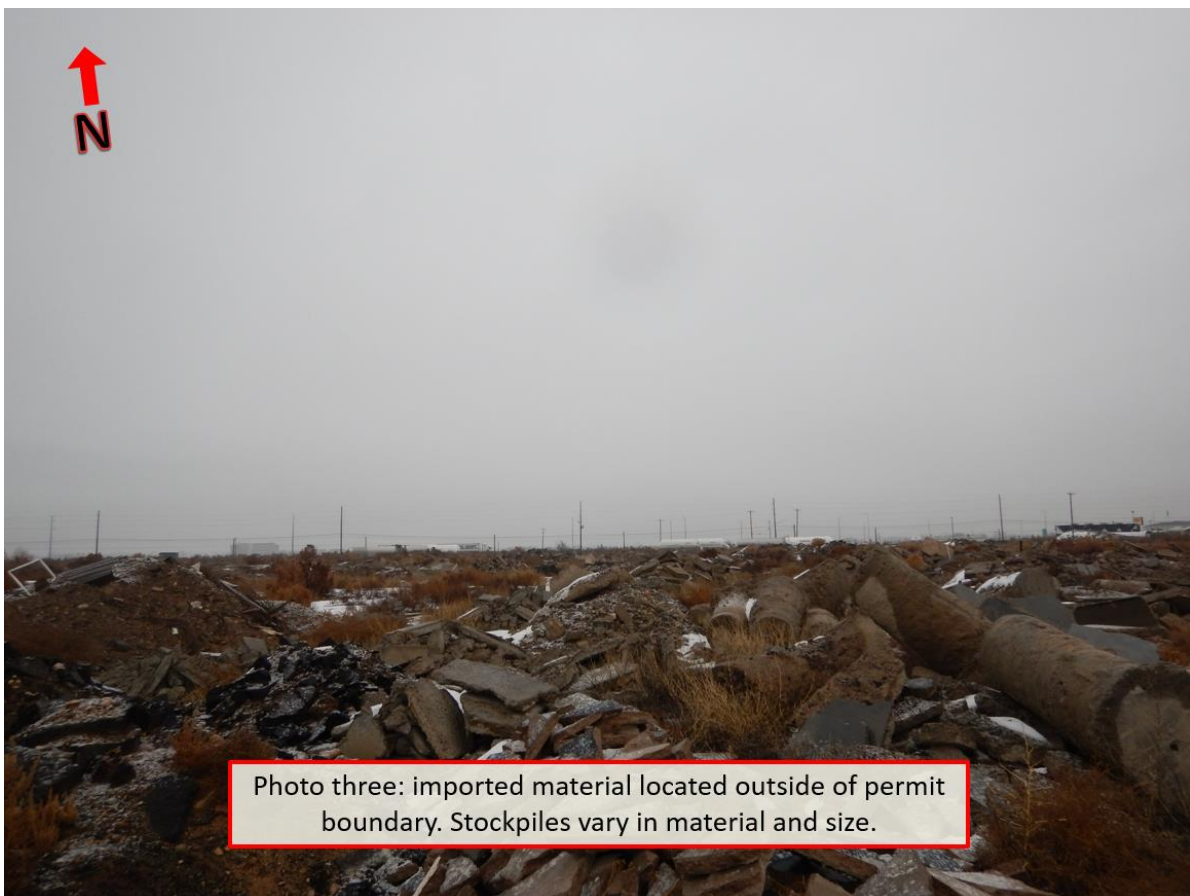
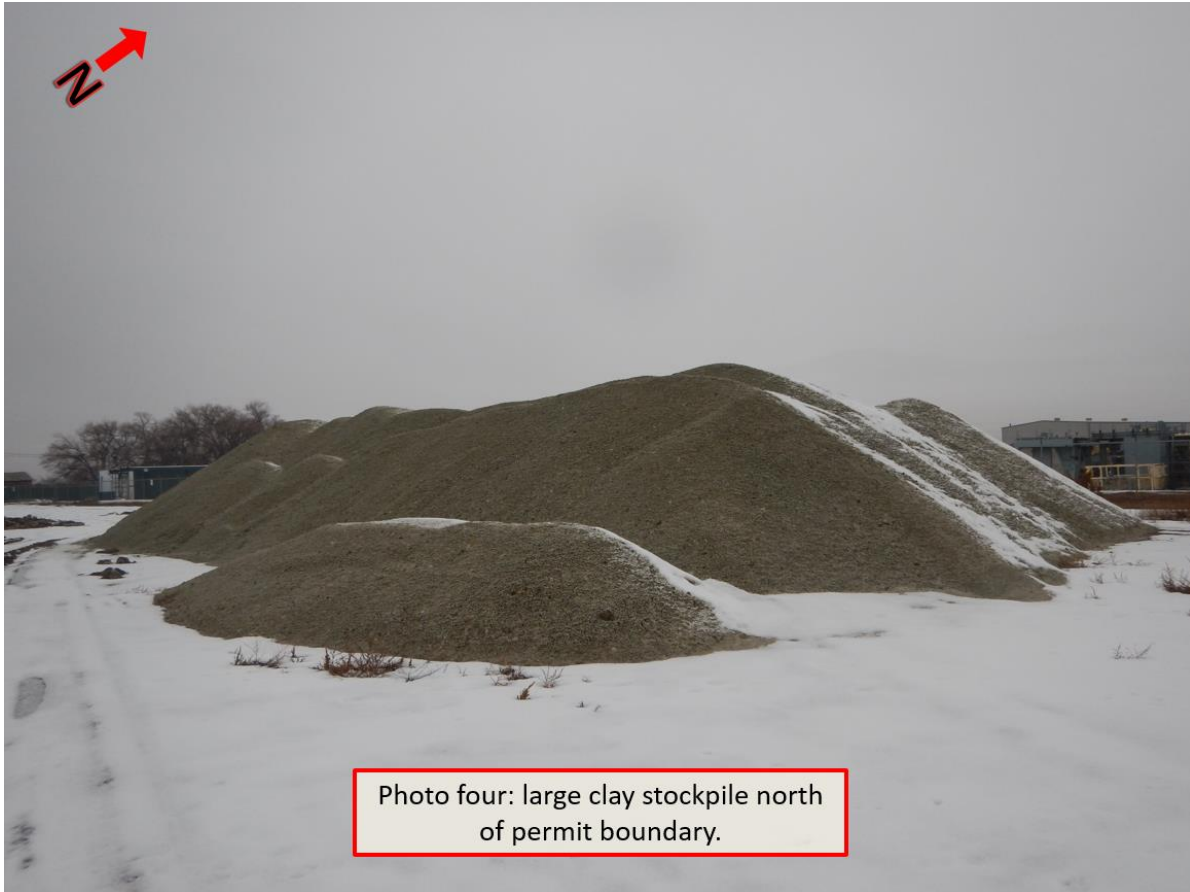
A shown in photos three and four several of the imported stockpiles are located north of the permit boundary. There is also a large stockpile of what appears to be clay. This pile is approximately 15'H x 25'W x 45'D and located just south of the rig yard. There is another pile of overburden type material that is approximately 10'H x 10'D x 20'W. In follow up correspondence with the operator these are the landowner's stockpiles and not to be associated with the mining operation. Further delineation of the permit boundary will help ensure that these piles do not get misinterpreted as off-site storage.

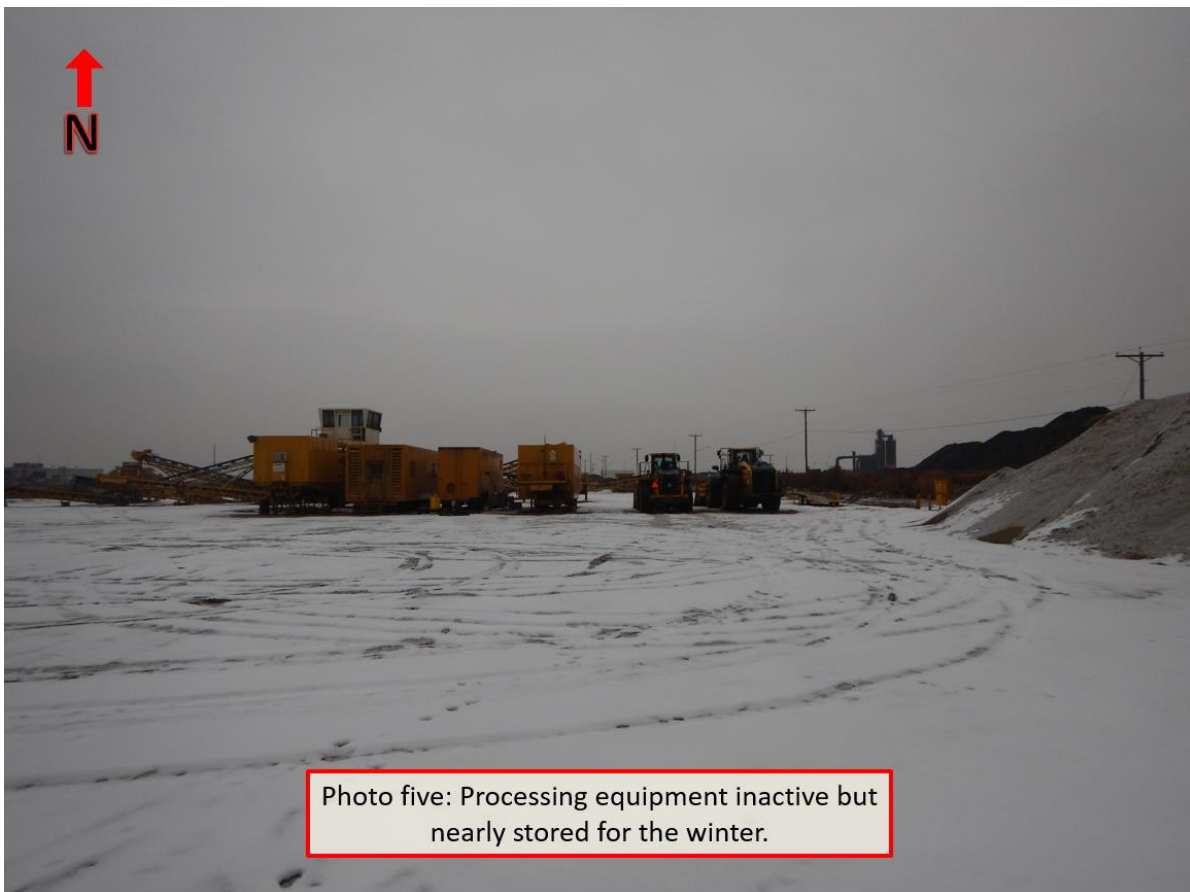
A processing plant and associated equipment is on site however it was inactive at the time of the inspection and appeared to be winterized (see photo five). Equipment was neatly lined up. Several fuel tanks were observed in secondary containment throughout the permit boundary. A water pump is located in the southwest corner of the permit boundary.

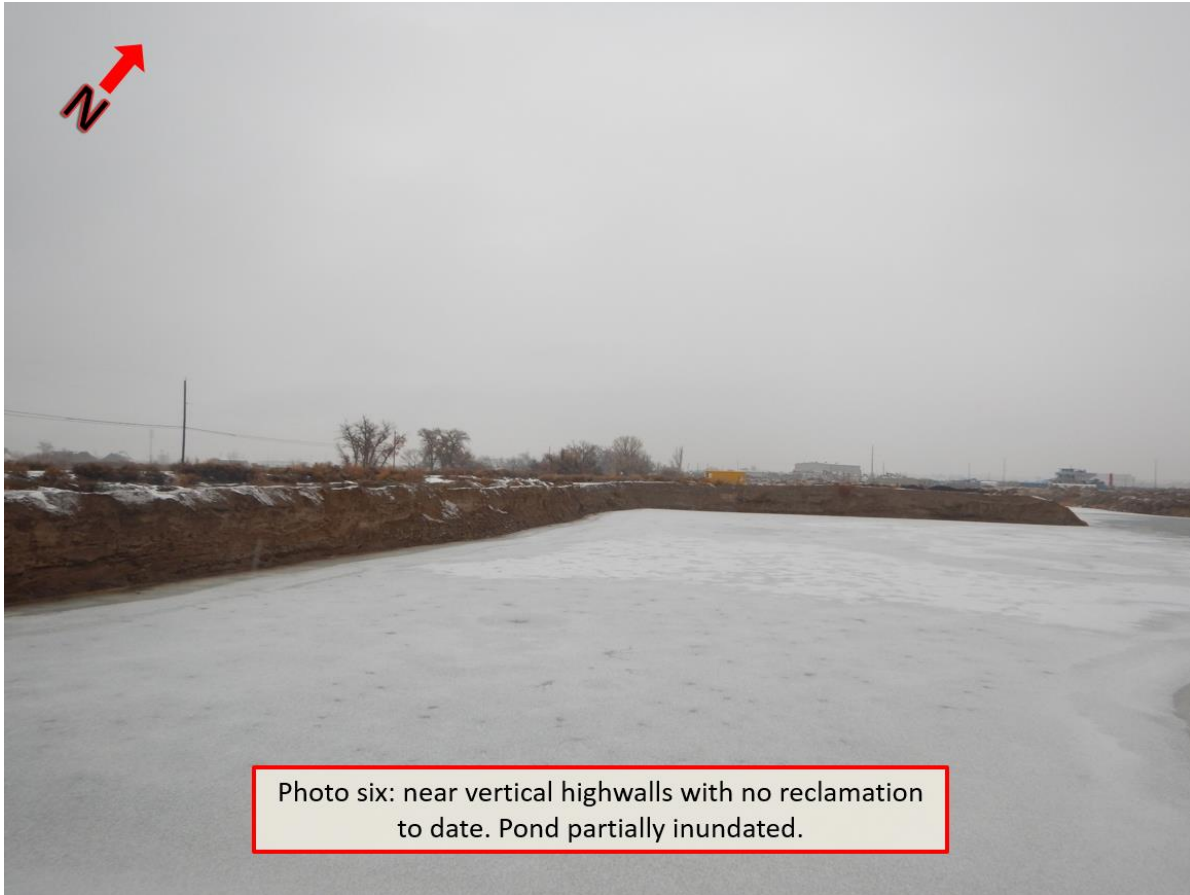
Mining is occurring in the western half of the permit. The most recently excavated highwalls are along the southern boundary and are near vertical as shown in photo six. The highwall height is estimated to be approximately 15 feet tall. At the time of the inspection the pond was partially inundated, exposed highwalls were approximately 10 feet above groundwater. The older mined highwalls are sloped more closely to a 1H:1V.

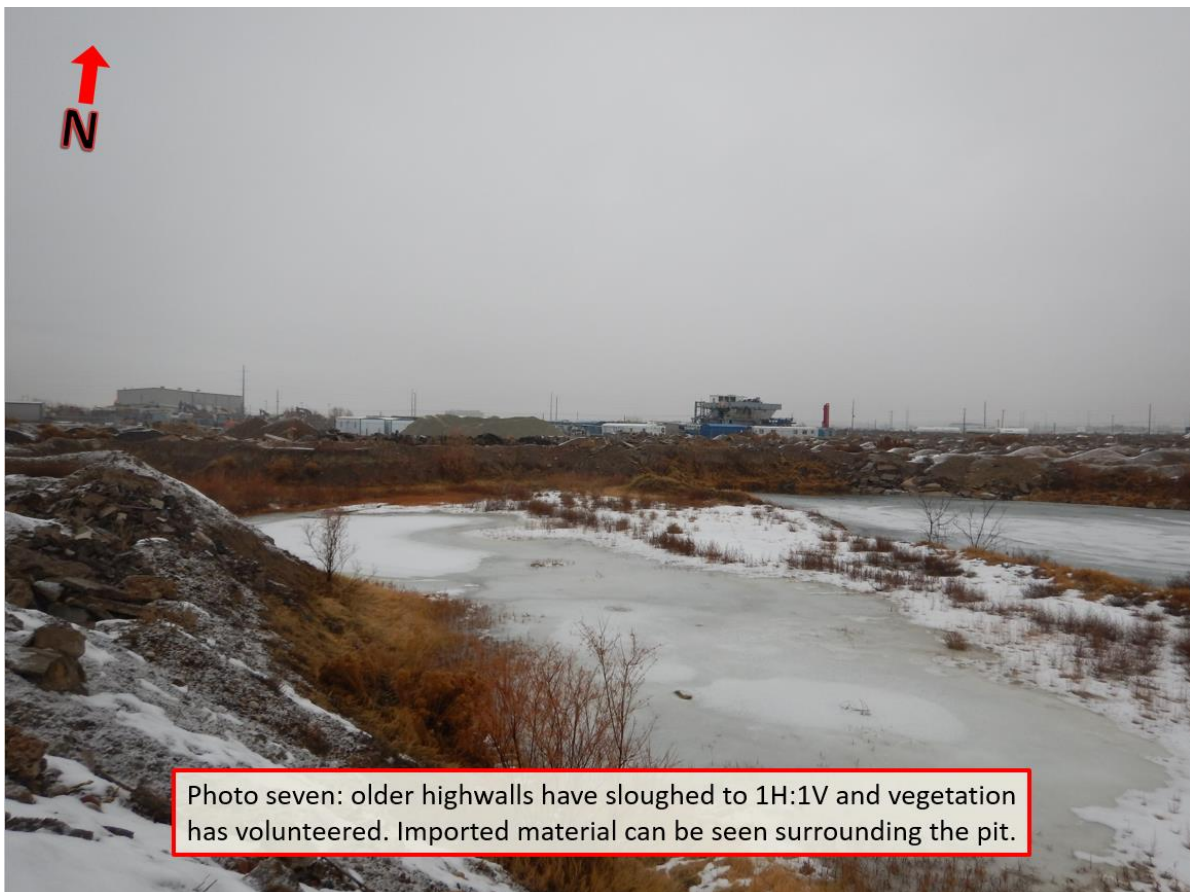
Northern highwalls have remained unchanged for the past ten years or more and vegetation has begun to volunteer as shown in photo seven. The Division estimates that the currently excavated pond area is 8.2 acres.

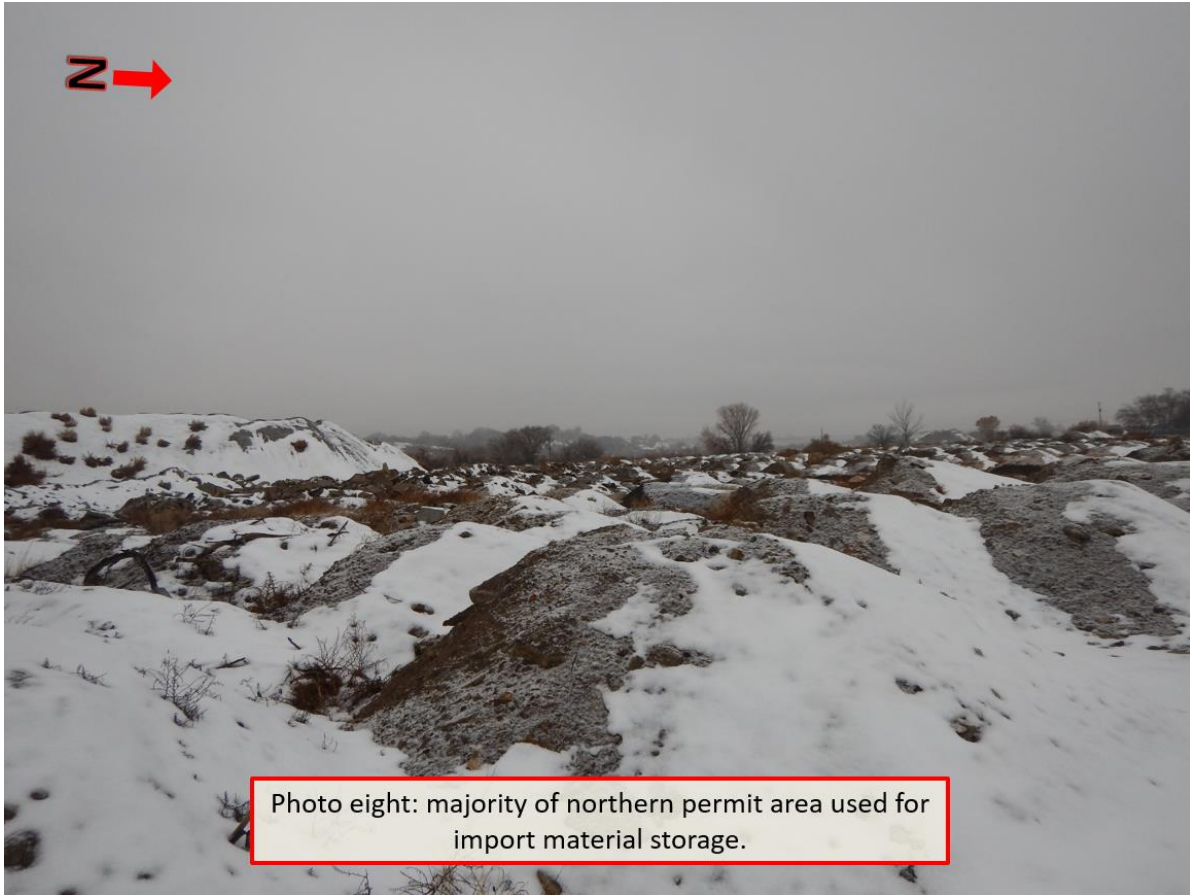
PROBLEM 2: The conditions of the permit authorize the stockpiling of 15,000 cubic yards of imported fill before initiating backfilling activities. The Division estimates that approximately 26,217 cubic yards are currently stockpiled on site, a substantial exceedance of the permit condition. This is cited as a problem for failure to follow the approved condition of the permit and reclamation plan, pursuant to C.R.S. 34-32.5-116 (1).

With regards to the imported material, roughly six and half acres appears to be used as import storage within the permit boundary (see photo eight). Based on the Mesa County Assessor's GIS imagery this pit has had several period of excessive storage before backfilling occurs. A large portion of the imported material currently on site has been in place for roughly 20 years. There are various types of material on site ranging from waste asphalt, concrete with and without exposed rebar, pit run and unscreened soils. Staff estimates that each pile is approximately 2-5 cu. yds. for a total of approximately 26,217 cu. yds. (Assuming 3 cu. yds. piles flattened to an average of 30" over 6.5 ac). In 1998 this imported fill was cited as an inspection problem which was later resolved and abated. In a letter received by the Division on May 11, 1998, the operator committed to stockpiling no more than 15,000 cu. yds. on site before backfilling activities would be initiated. This is cited as a problem for failure to follow the approved condition of the permit and reclamation plan. The operator has continued to import fill material substantially above the 15,000 cu. yds. threshold without backfill. To resolve this problem the operator shall complete one of the following: 1) backfill imported fill material within the pit so that no more than 15,000 cu. yds. is stockpiled on site; OR 2) remove the imported material from the affected lands to ensure no more than 15,000 cu. yds. is stockpiled; OR 3) submit a technical revision to the mining and reclamation plans to allow for a greater volume of material to be stockpiled before backfilling activities occur. The Operator shall submit documentation for one of the three options listed above to resolve this issue by the corrective action date listed on page two of this inspection report. Be advised that the Division does not have an inert fill affidavit for this operator at this pit. If additional material will be imported the operator should submit in the form of a technical revision an inert fill affidavit as required by Rule 3.1.5(9).

CORRECTIVE ACTIONS: The Operator shall within 60 days from the signature date of this inspection report, complete one of the following three options: 1) backfill imported fill material within the pit so that no more than 15,000 cu. yds. is stockpiled on site; OR 2) remove the imported material from the affected lands to ensure no more than 15,000 cu. yds. is stockpiled; OR 3) submit a technical revision to the mining and reclamation plans to allow for a greater volume of material to be stockpiled before backfilling activities occur. The Operator shall submit documentation for one of the three options listed above by the corrective action date.
