Fwd: CC&V Mill tails

I'm effectively notifying DRMS of the ongoing violations on VLF 2 at CC&V (Newmont) as follows:

**Re: Permit No. M-1980-244; Cripple Creek & Victor Gold Mining Company; Cresson Project; -
TR 103- VLF2 Ore Stacking Guidelines**

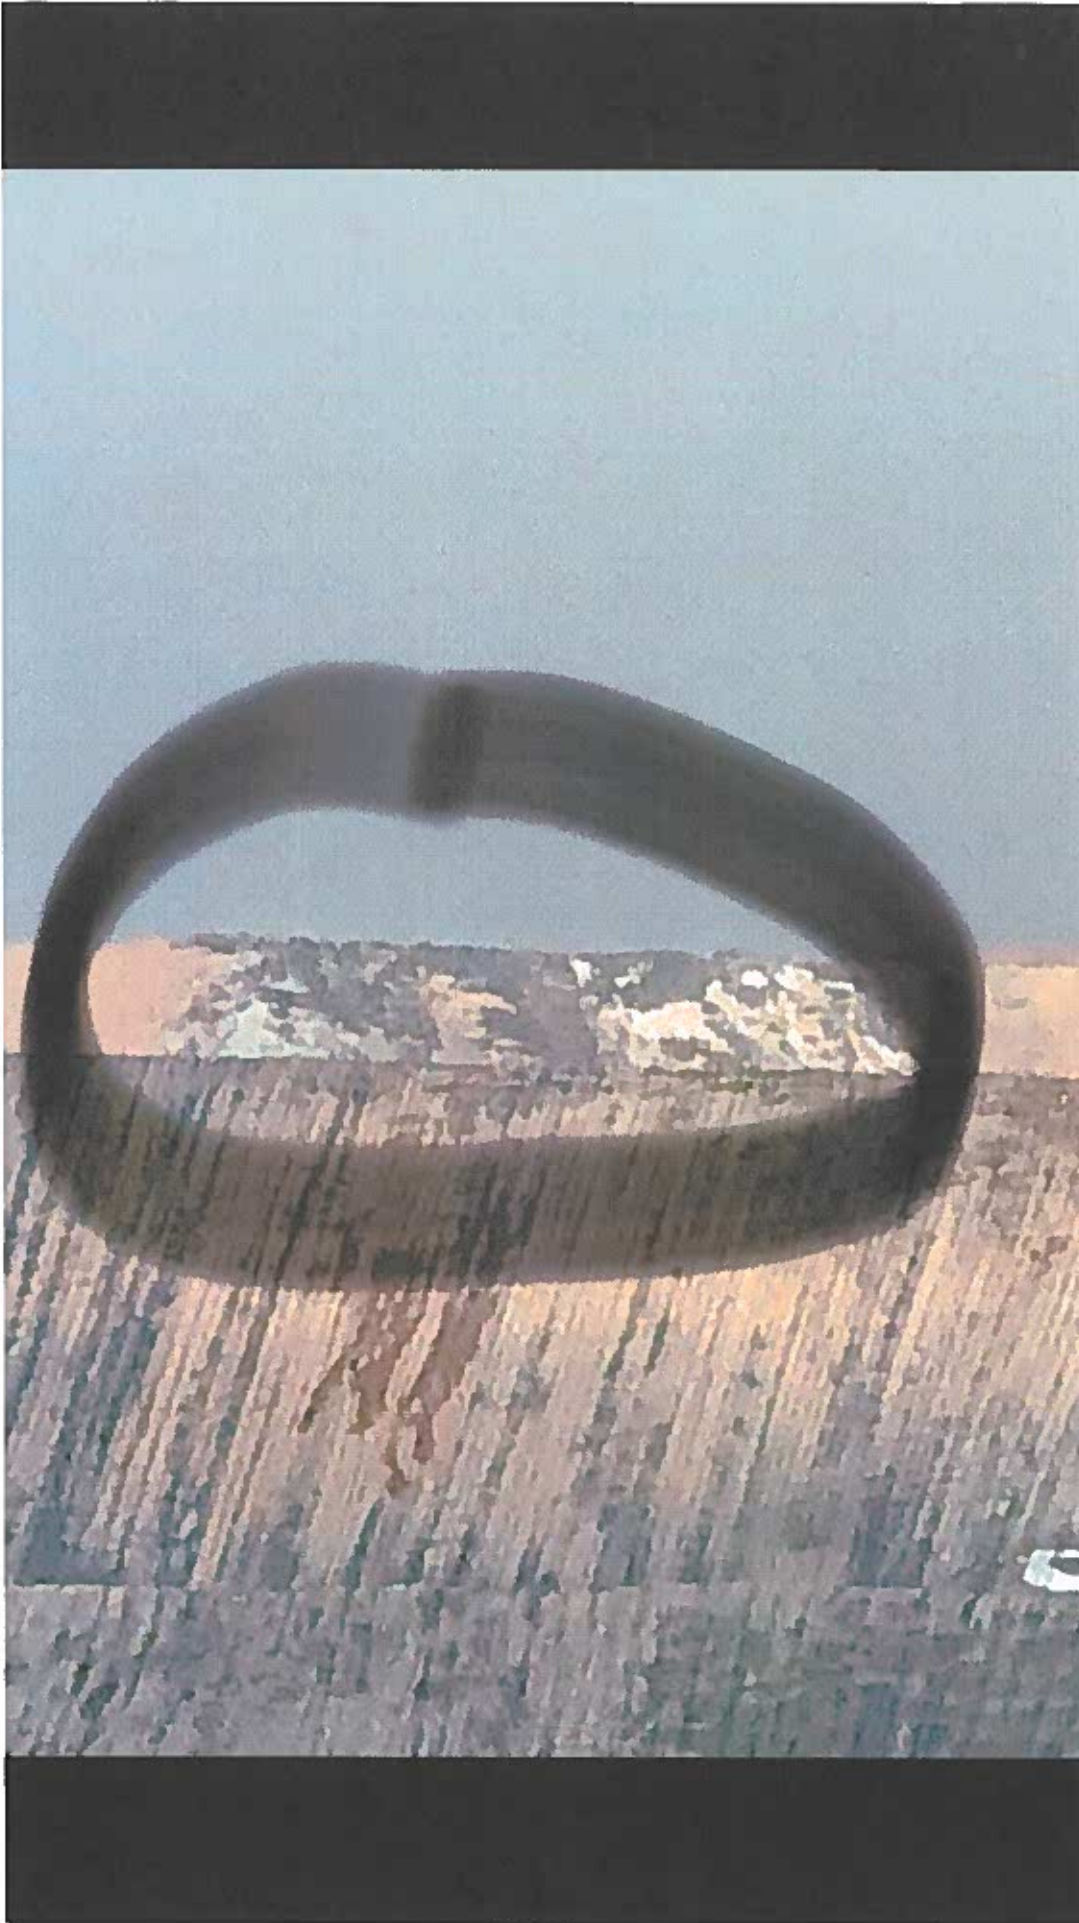
Mill tails 001.PNG
2717K

1. Newmont is continually dumping raw (unmixed mill tails) mill tails on the leach pad at the 9950 elevation.
2. When they do mix the mill tails it's 25% mill tails to 75% crushed ore. Not the permitted 10% mill tails to 90% crushed ore.
3. They are still dumping mill tails over the outside face of the lift not staying back 25ft. from the face of the pile.

- When the lift consists of blended tailings material, this material should be placed a minimum distance of 25' back from the final exposed slope (outside face) of each lift.

- The nominal ratio of materials placed on VLF2 is 10% tailings to 90% ore.
