**MINERALS PROGRAM INSPECTION REPORT**  
**PHONE: (303) 866-3567**

<b>MINE NAME:</b> El Rancho Bondo	<b>MINE/PROSPECTING ID#:</b> M-2018-028	<b>MINERAL:</b> Gold	<b>COUNTY:</b> Fremont
<b>INSPECTION TYPE:</b> Monitoring	<b>INSPECTOR(S):</b> Timothy A. Cazier	<b>INSP. DATE:</b> October 17, 2018	<b>INSP. TIME:</b> 12:00
<b>OPERATOR:</b> Thomas Zimmerman	<b>OPERATOR REPRESENTATIVE:</b> Thomas Zimmerman & Joe Lovett	<b>TYPE OF OPERATION:</b> 110(1) - Hard Rock Limited Impact	
<b>REASON FOR INSPECTION:</b> Normal I&E Program	<b>BOND CALCULATION TYPE:</b> Complete Bond	<b>BOND AMOUNT:</b> \$2,166.00	
<b>DATE OF COMPLAINT:</b> NA	<b>POST INSP. CONTACTS:</b> None	<b>JOINT INSP. AGENCY:</b> U.S.BLM	
<b>WEATHER:</b> Cloudy	<b>INSPECTOR'S SIGNATURE:</b>

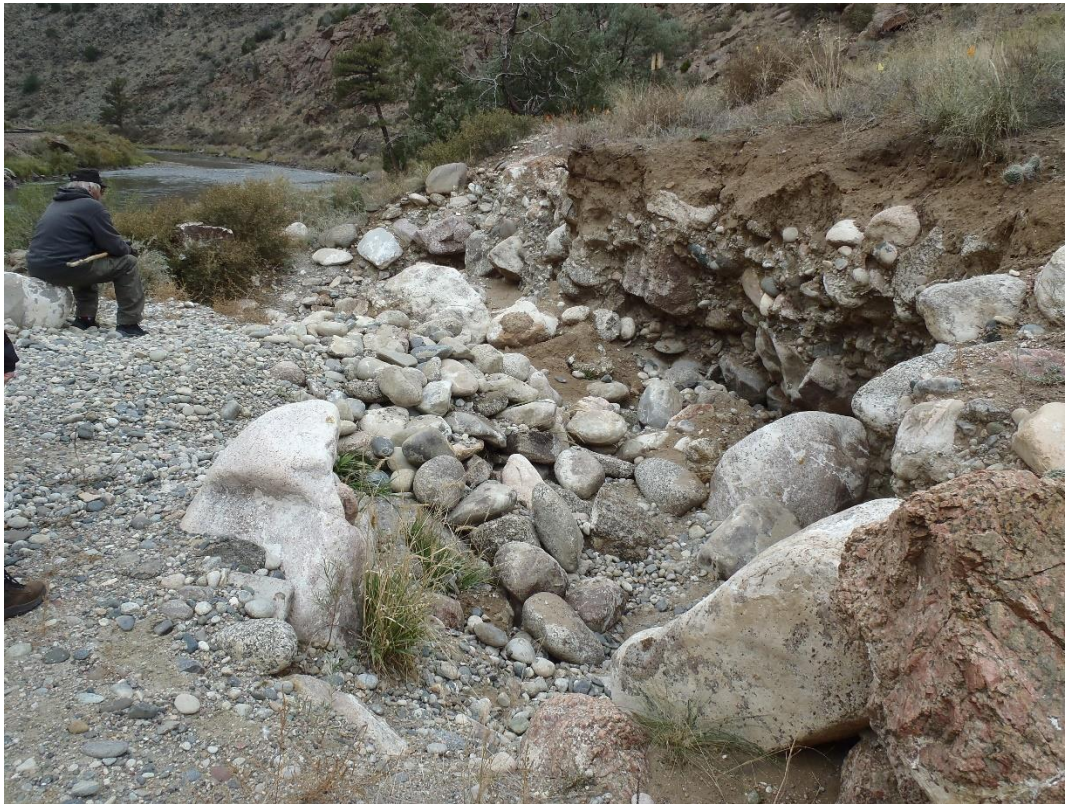
**Hydrologic Balance:** No standing water was observed in the bank excavation (see **Photo 1**) and no exposed groundwater was observed.

Photo 1. Active higwall, looking south.

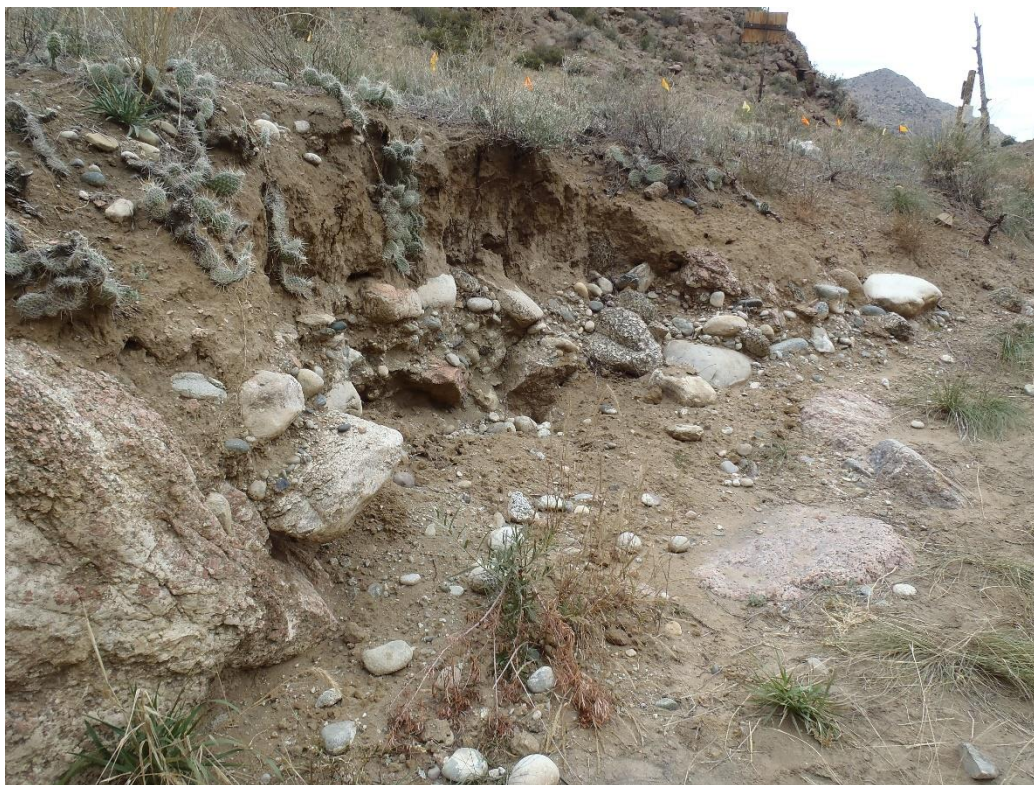
Photo 2. Active higwall, looking north.

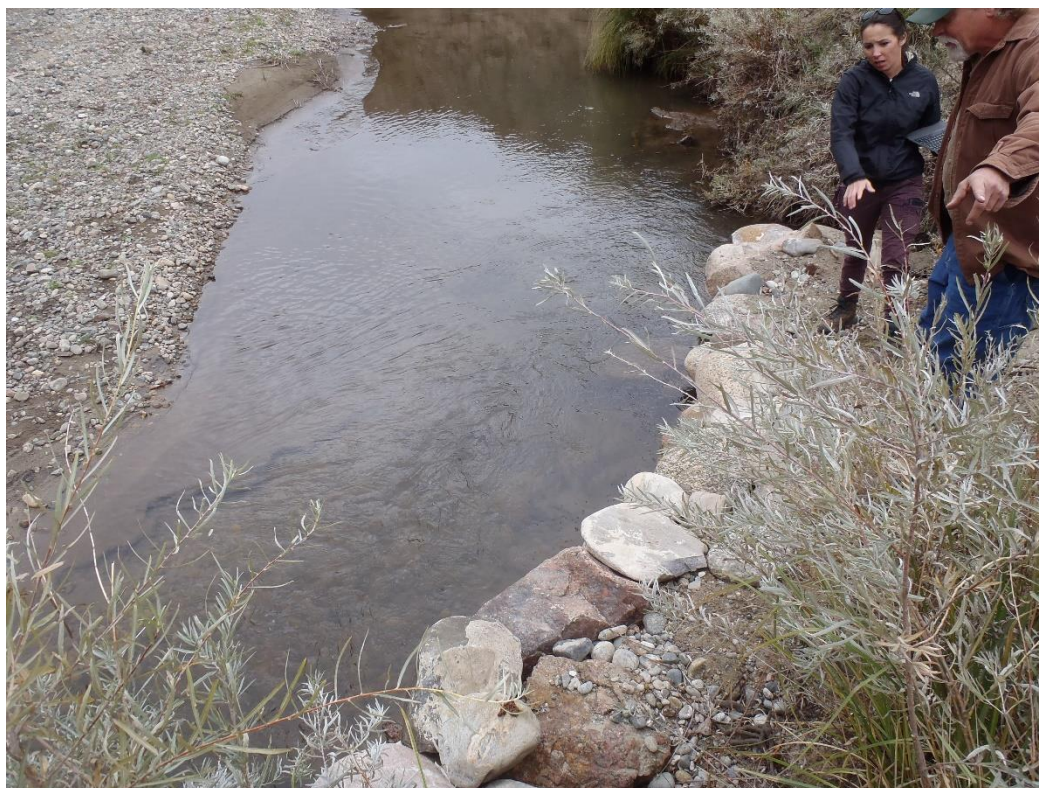
**Gen. Compliance with Mine Plan:** The operation appeared to be in compliance with the approved mine plan. A handheld GPS unit (Trimble Juno 3B) was used to record the boundary marker locations and the to determine the disturbed area, which was measured to be approximately 0.1 acres (see enclosed **Post 2018 Inspection Map**). Highwalls were estimated to vary between 4 and 6 feet in height and did not show signs of raveling. (see **Photos 1** and **2**). Towards the downstream end of the permit area, the BLM had asked Mr. Zimmerman to stabilize the river bank (see **Photo 3**). The effort appeared to be adequate.

Photo 3. Riverbank scour control installed (boulders, just south of active working area).

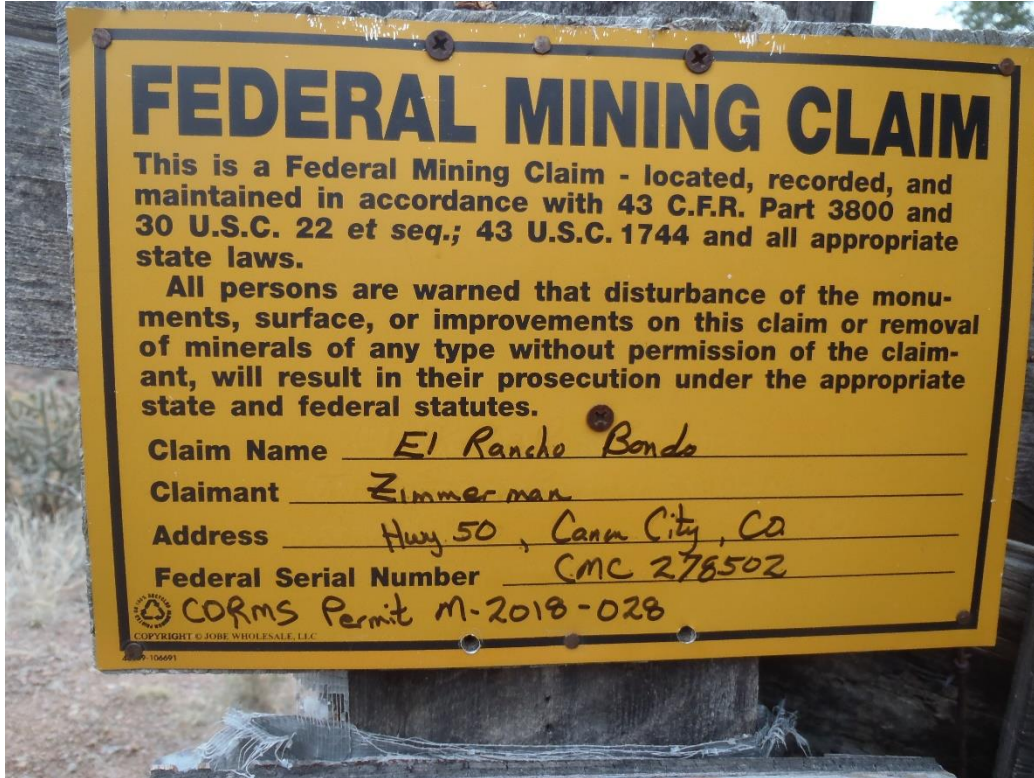
Signs and Markers: A permit sign was posted at the claim entrance (see **Photo 4**) and T-post boundary markers were observed to delineate the permit boundary (**Photos 5 and 6**).

Photo 4. DRMS permit number added to Mining Claim sign (at two-track road entrance).

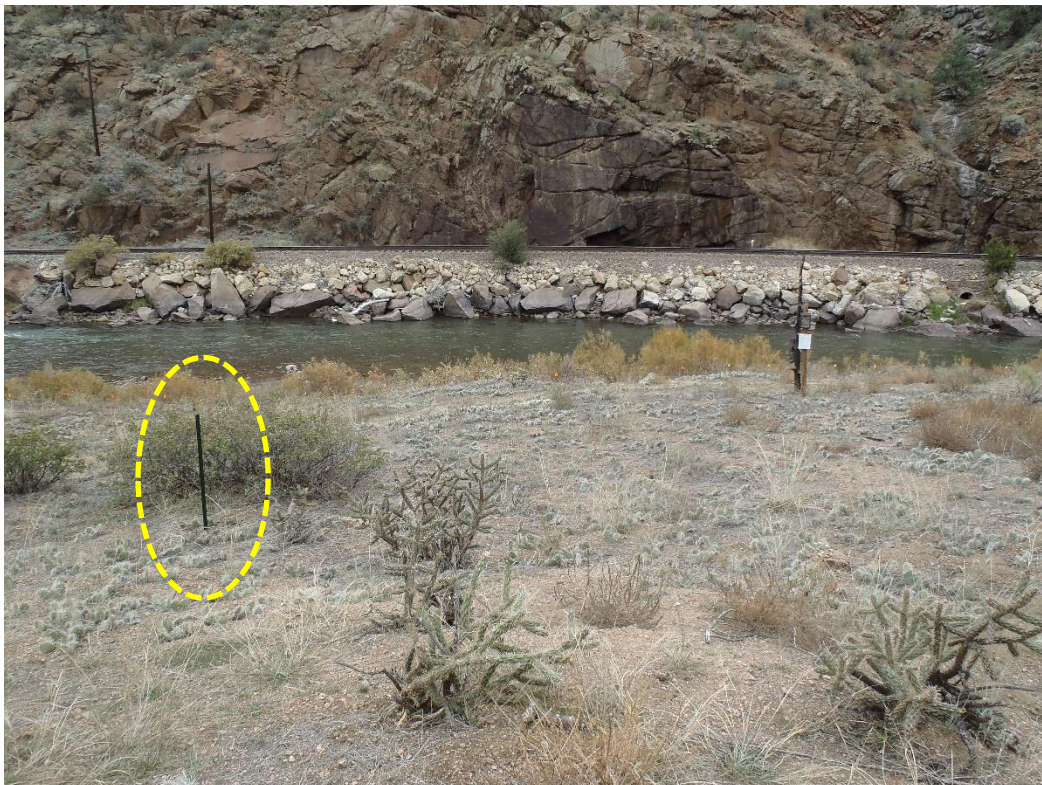
Photo 5. T-post marking permit boundary (north corner).

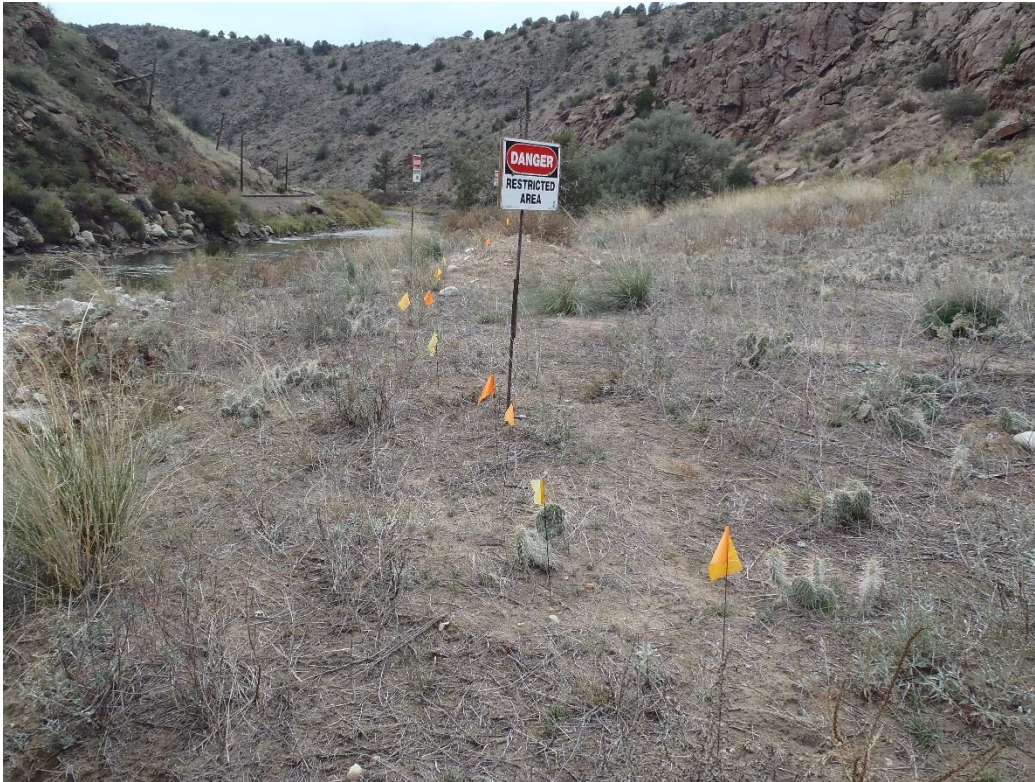
Photo 6. Marked permit boundary.
