**MINERALS PROGRAM INSPECTION REPORT**  
**PHONE: (303) 866-3567**

<b>MINE NAME:</b> Nahcolite Project	<b>MINE/PROSPECTING ID#:</b> M-1983-194	<b>MINERAL:</b> Carbonates	<b>COUNTY:</b> Rio Blanco
<b>INSPECTION TYPE:</b> Monitoring	<b>INSPECTOR(S):</b> Amy C. Yeldell	<b>INSP. DATE:</b> January 31, 2019	<b>INSP. TIME:</b> 10:00
<b>OPERATOR:</b> Natural Soda LLC	<b>OPERATOR REPRESENTATIVE:</b> Kirk Daehling	<b>TYPE OF OPERATION:</b> 112d-3 - Designated Mining Operation	
<b>REASON FOR INSPECTION:</b> Normal I&E Program	<b>BOND CALCULATION TYPE:</b> None	<b>BOND AMOUNT:</b> \$4,158,340.68	
<b>DATE OF COMPLAINT:</b> NA	<b>POST INSP. CONTACTS:</b> None	<b>JOINT INSP. AGENCY:</b> None	
<b>WEATHER:</b> Clear	<b>INSPECTOR'S SIGNATURE:</b>

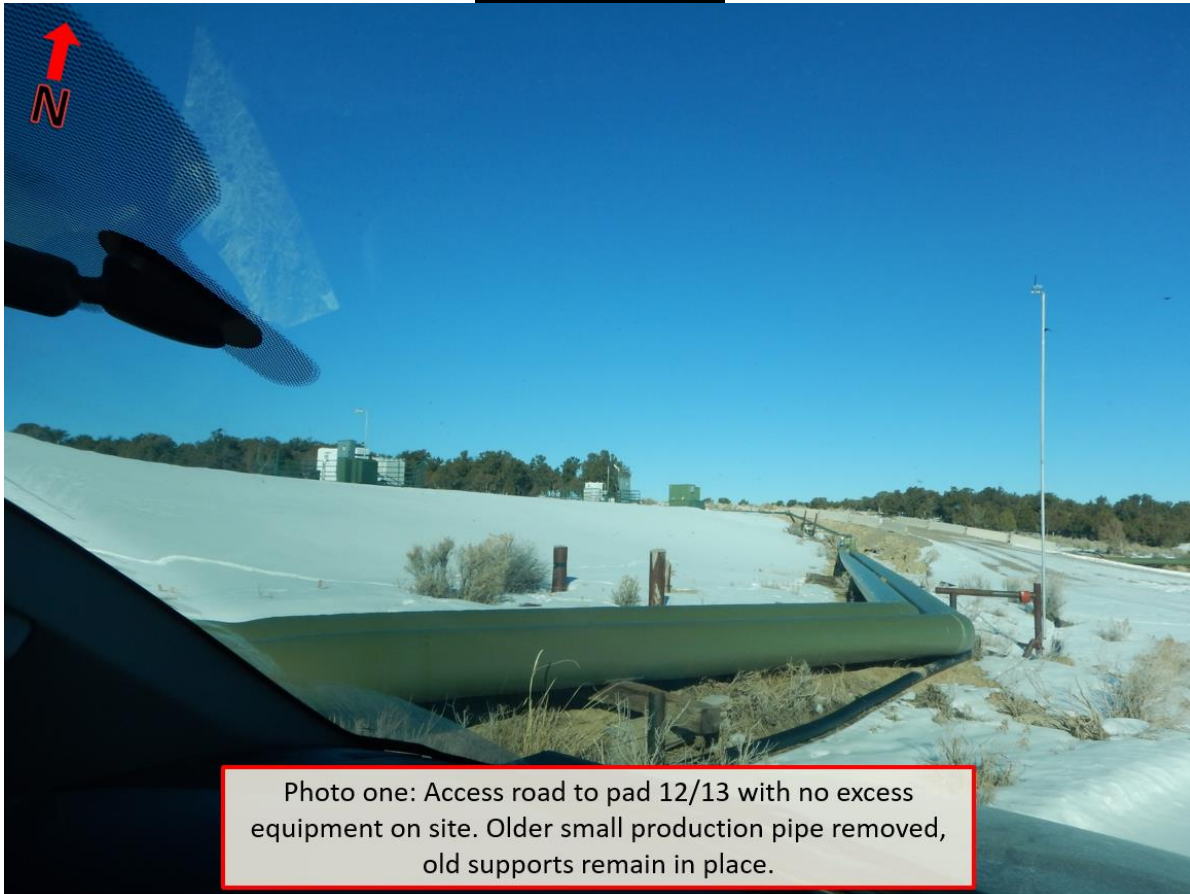
Since the last inspection drilling has been completed on the 12 and 13 pad, see photo one. All equipment has been removed and interim reclamation has begun. The pad has been reduced down to its operational size and was seeded in fall of 2018. The pit with drill cutting still remains in place and is expected to be reclaimed this summer.

The old production pipelines have been removed as shown in photo one. Only a few of the pipes support remain in place. Given the season and snow cover vegetation was not observed during this inspection. Everything appeared to be frozen and no signs of erosion were observed. Pads were clean and free of unnecessary debris.

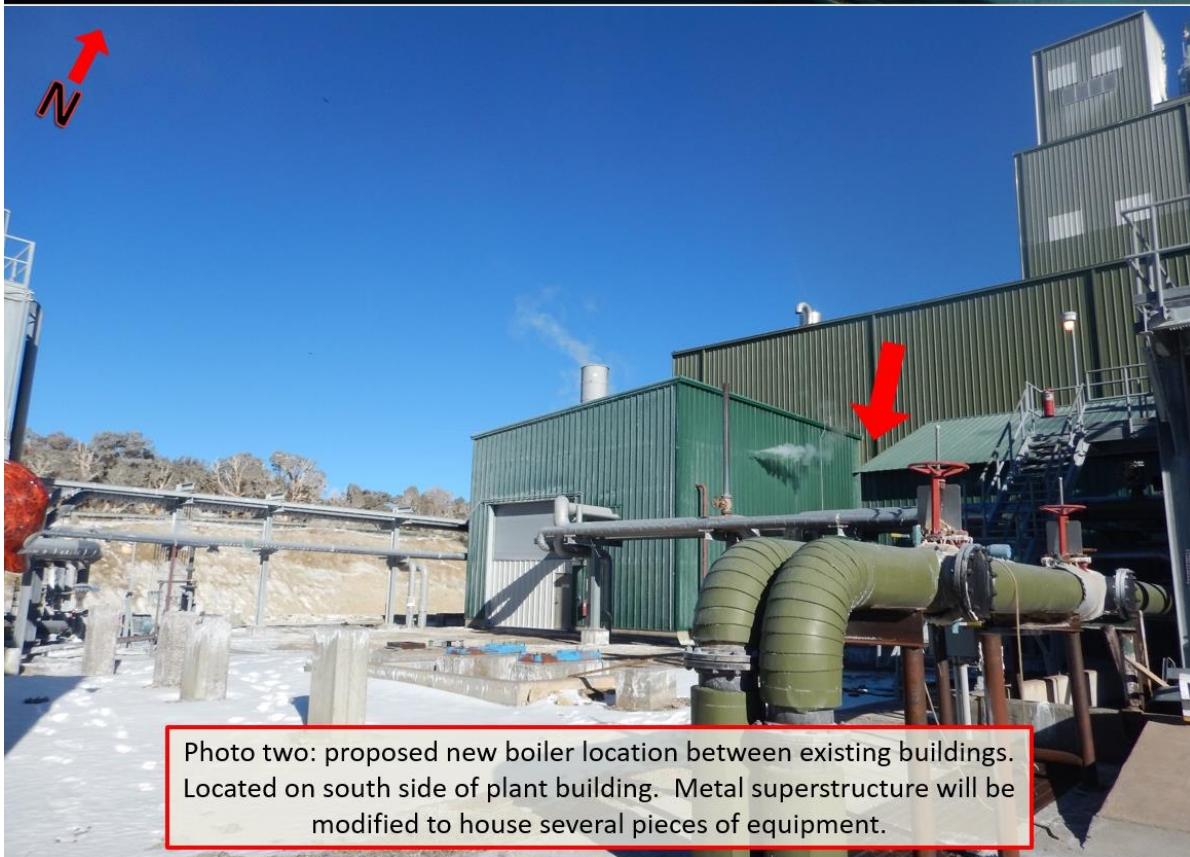
Future modifications to the production equipment was discussed. Staff was able to see where the proposed new boiler would go and how the housing structure will be modified to accommodate the new equipment, see photo two. The operator is currently working with engineering and their consultant to finalize plans. A technical revision is expected later this year with the intent of completing the project in 2019. The summer drilling program was also discussed. It is anticipated that several intercept wells will be completed as well as expansions and new well pad construction.
