**MINERALS PROGRAM INSPECTION REPORT**  
**PHONE: (303) 866-3567**

<b>MINE NAME:</b> Cresson Project	<b>MINE/PROSPECTING ID#:</b> M-1980-244	<b>MINERAL:</b> Gold	<b>COUNTY:</b> Teller
<b>INSPECTION TYPE:</b> Monitoring	<b>INSPECTOR(S):</b> Elliott R. Russell	<b>INSP. DATE:</b> December 20, 2018	<b>INSP. TIME:</b> 09:00
<b>OPERATOR:</b> Cripple Creek & Victor Gold Mining Company	<b>OPERATOR REPRESENTATIVE:</b> Justin Raglin and Erik Munroe	<b>TYPE OF OPERATION:</b> 112d-3 - Designated Mining Operation	
<b>REASON FOR INSPECTION:</b> Normal I&E Program	<b>BOND CALCULATION TYPE:</b> None	<b>BOND AMOUNT:</b> \$208,491,188.00	
<b>DATE OF COMPLAINT:</b> NA	<b>POST INSP. CONTACTS:</b> None	<b>JOINT INSP. AGENCY:</b> None	
<b>WEATHER:</b> Clear	<b>INSPECTOR'S SIGNATURE:</b>

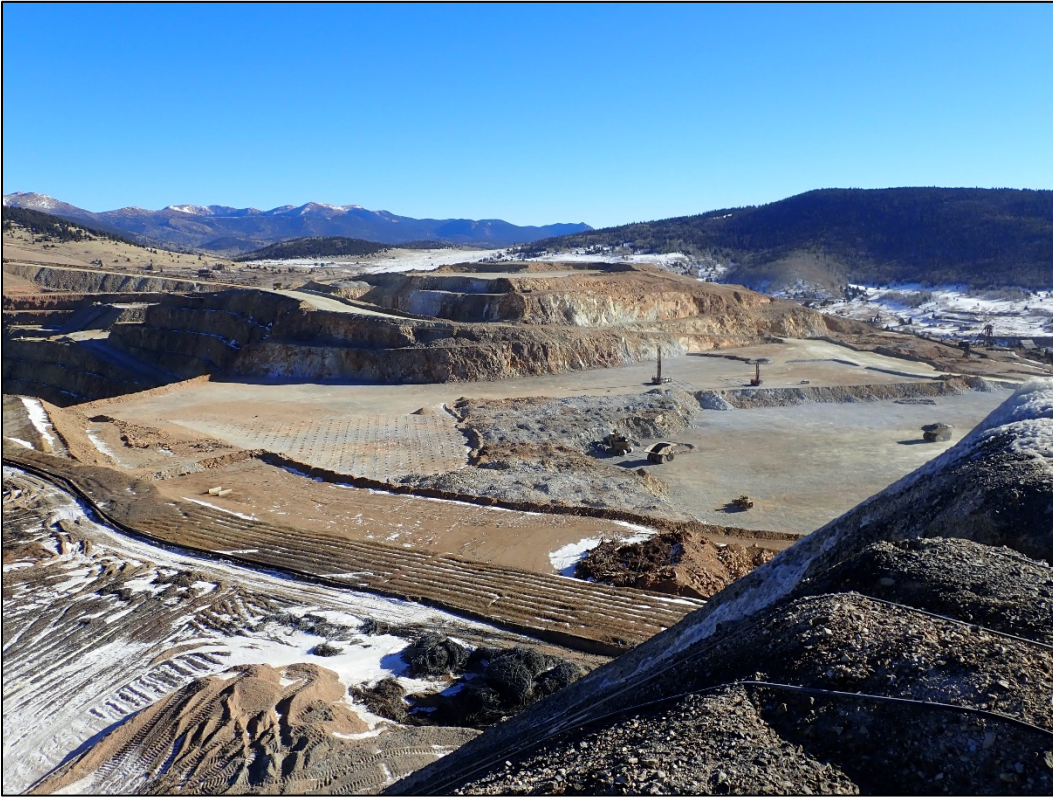
**Photo 13** Overview of the South Cresson mine; looking east..

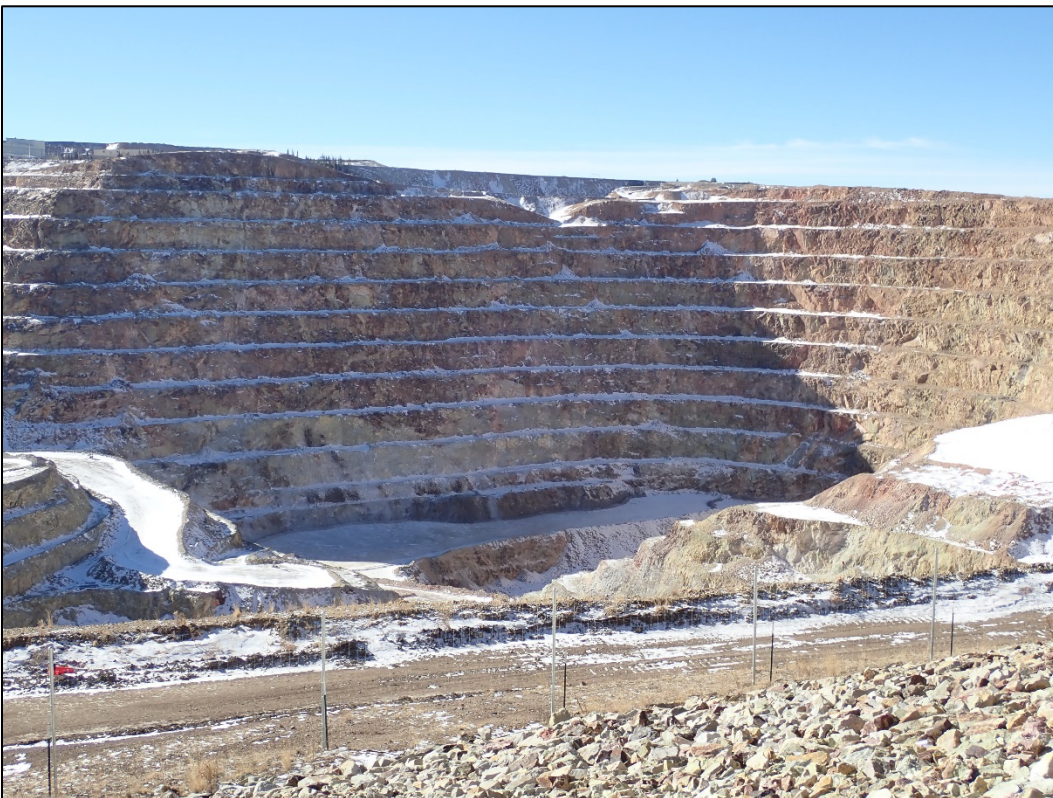
The East Cresson Mine includes the Wildhorse Extension (WHEX) Pit. The WHEX was observed from the Grassy Valley Mining Overlook along County Road 82 (**Photo 14**). Within the bottom of the WHEX, two mining areas have developed. These are known as Grassy Valley and Gold Bug. At the time of the inspection, the WHEX was at approximately 9,655'.

**Photo 14.** Overview of the WHEX; looking southwest.
