**COLORADO**Division of Reclamation,
Mining and Safety

MINERALS PROGRAM INSPECTION REPORT**PHONE: (303) 866-3567**

MINE NAME: Big R Pit	MINE/PROSPECTING ID#: M-1988-052	MINERAL: Sand and gravel	COUNTY: Elbert
INSPECTION TYPE: Monitoring	INSPECTOR(S): Patrick Lennberg and Michael Cunningham	INSP. DATE: January 25, 2019	INSP. TIME: 09:30
OPERATOR: Estate of Rick L Hunt	OPERATOR REPRESENTATIVE: None	TYPE OF OPERATION: 110c - Construction Limited Impact

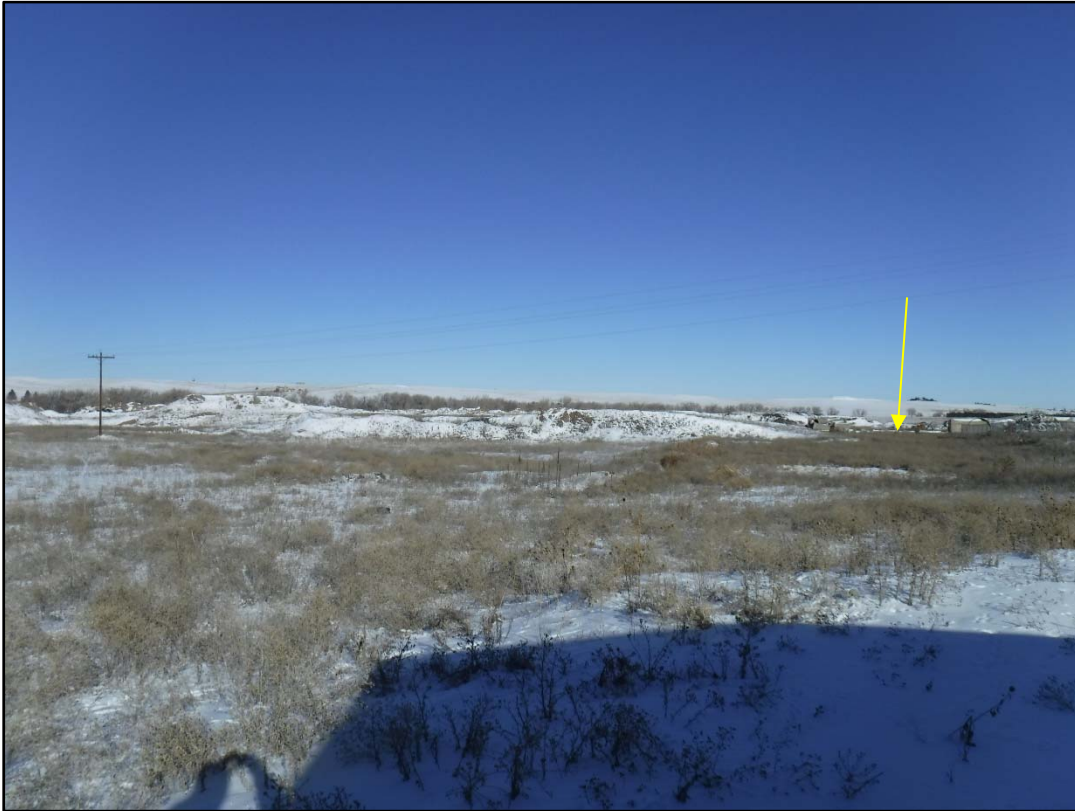
The approved reclamation plan calls for grading all highwalls to 3H:1V or flatter, ripping stockpiling areas and any temporary haul roads, replacing an average depth of 6 inches of topsoil across disturbed land, and revegetating the site for a post-mining land use of rangeland. In the 2016 inspection report it was documented that mining ceased in May 2015 and the deadline for final reclamation was May 2020. The 2017 inspection noted Diffuse Knapweed, a List B noxious weed listed on Colorado's Noxious Weed List, throughout the site with a large patch located in the northeast corner of the site and extending off site. The diffuse knapweed must be controlled and monitored prior to the start and during the reclamation process. The presence of the knapweed could prevent the establishment of reclamation grasses and delay the release of the permit by the Division.

Photo 1: Topsoil stockpile along the northern boundary of the permit, location of diffuse knapweed patch indicated by arrow

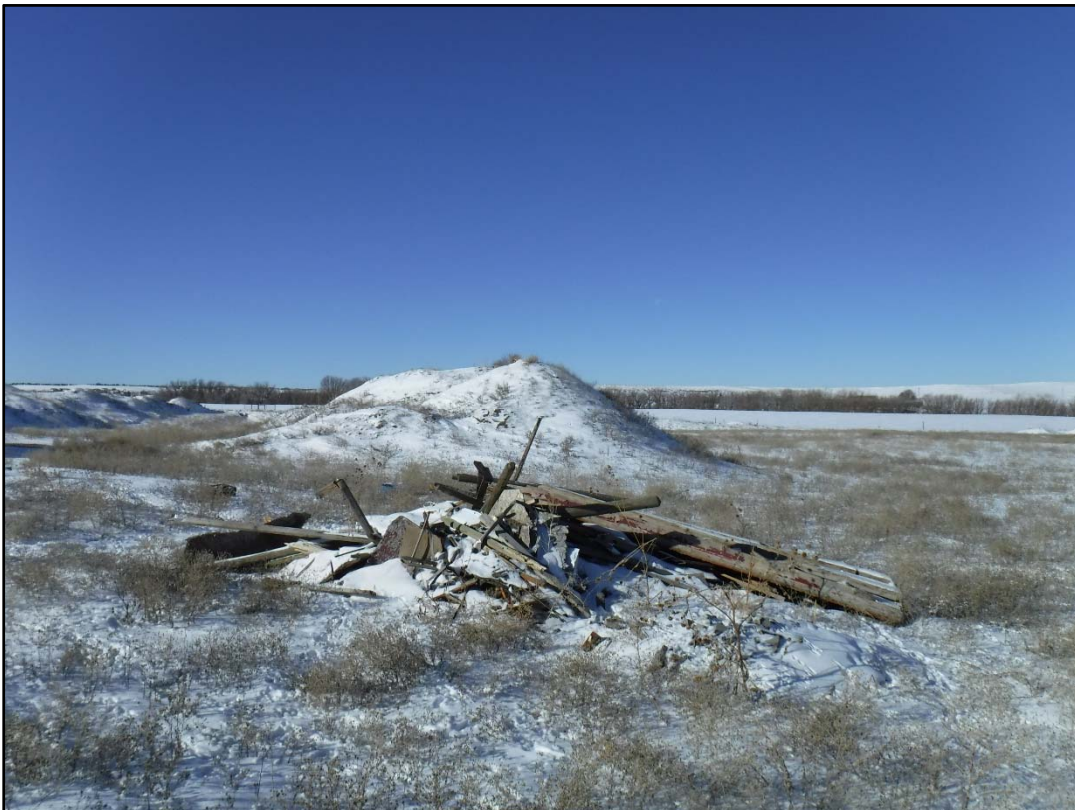
Photo 2: Topsoil stockpile behind a debris pile

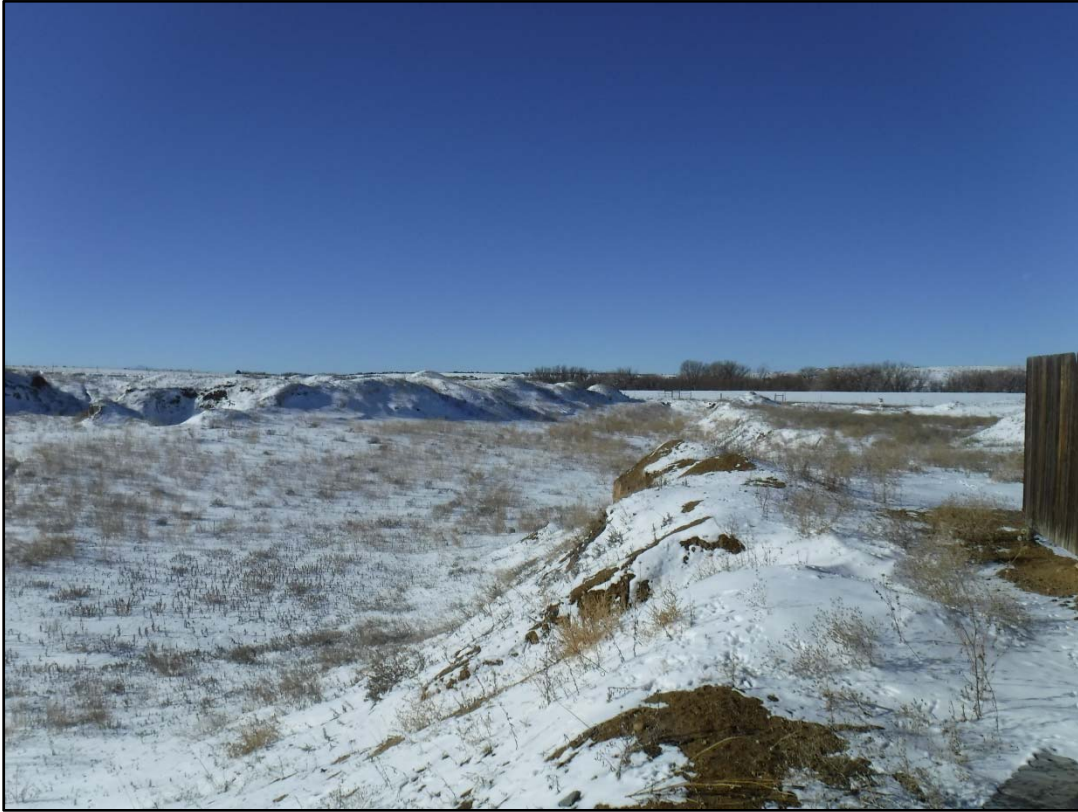
Photo 3: Mined out area south of the road that bisects site

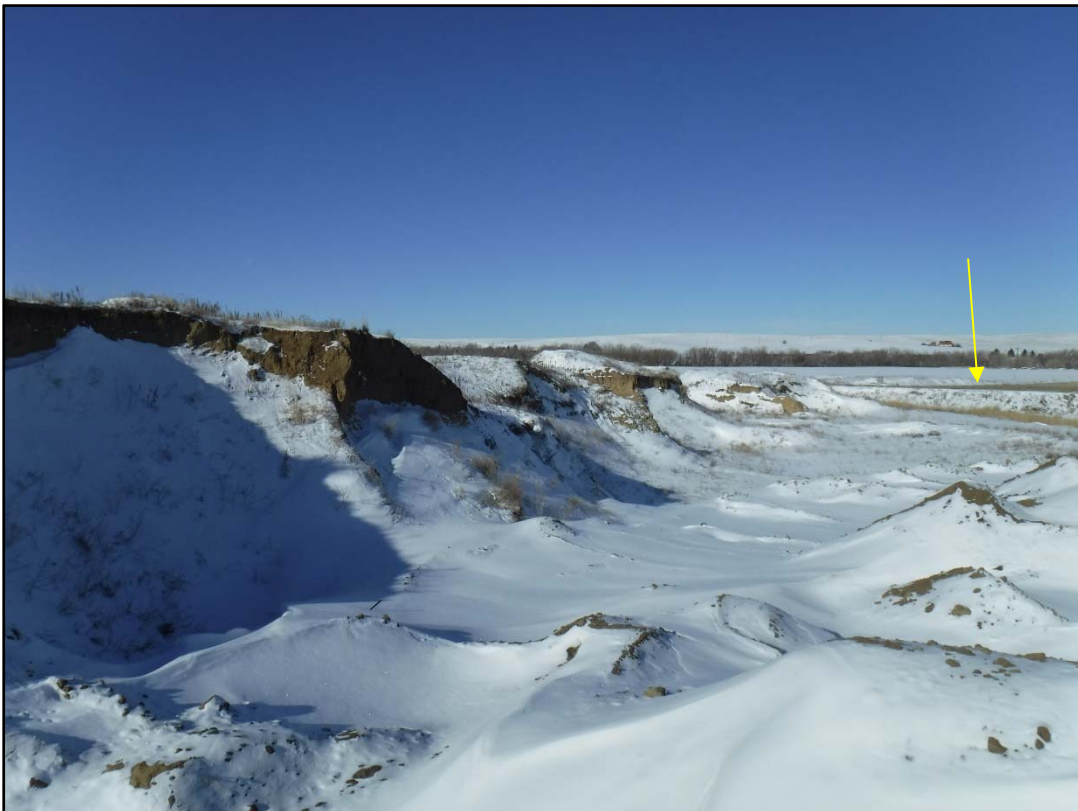
Photo 4: Southern pit highwall looking northwest road marked by yellow arrow

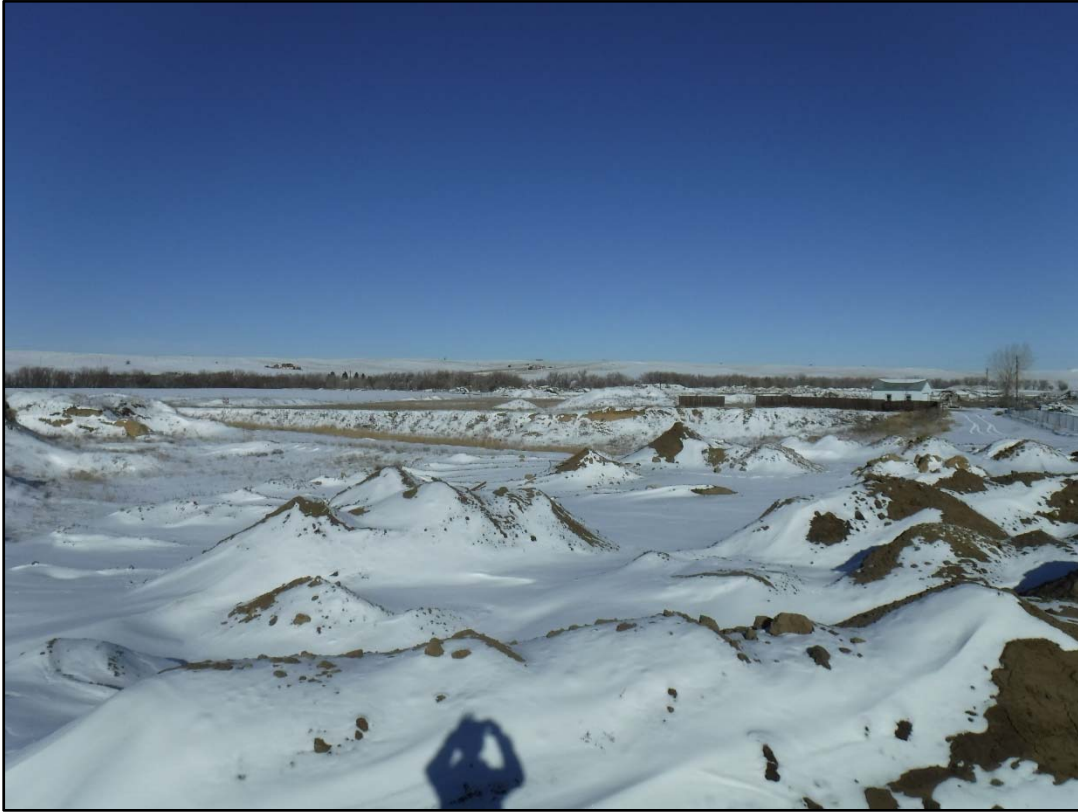
The Big R Pit is a 110c operation permitted for 9.9 acres to mine sand and gravel. A shop and office building originally used by Hunt Construction, now used by Colorado Farms, and its associated parking lot is located just east of the permit area. A garage is located between the eastern permit boundary and the shop and office building. There used to be a single-wide trailer located next to the garage but is now gone. The site is divided by an interior road into two pit areas, north and south. The north pit contains a large topsoil stockpile along the north boundary and a shallow, regraded excavation area in the remaining area. The south pit contains a mining area with 1H:1V highwall slopes of up to 15 feet in height. It was noted in the 2017 inspection there were two erosion features in the southwest highwall that were approaching the permit boundary. Due to snow cover these erosion features could not be verified. It does appear that the southern area is being used as a dump location for dirt being brought in from another area. It is unknown who is hauling in this material.

Photo 5: Looking north across southern pit area piles of dirt dumped by others not part of mining operation

While the permittee has kept up to date paying annual fees, it appears that little to no activity has taken place at the site for a period of time. Because it appears that the permit area is being used for purposes other than mining or reclamation the Division recommends the permittee begin active reclamation and work with current landowner to prevent unauthorized dumping into the permit boundary that would increase liability.

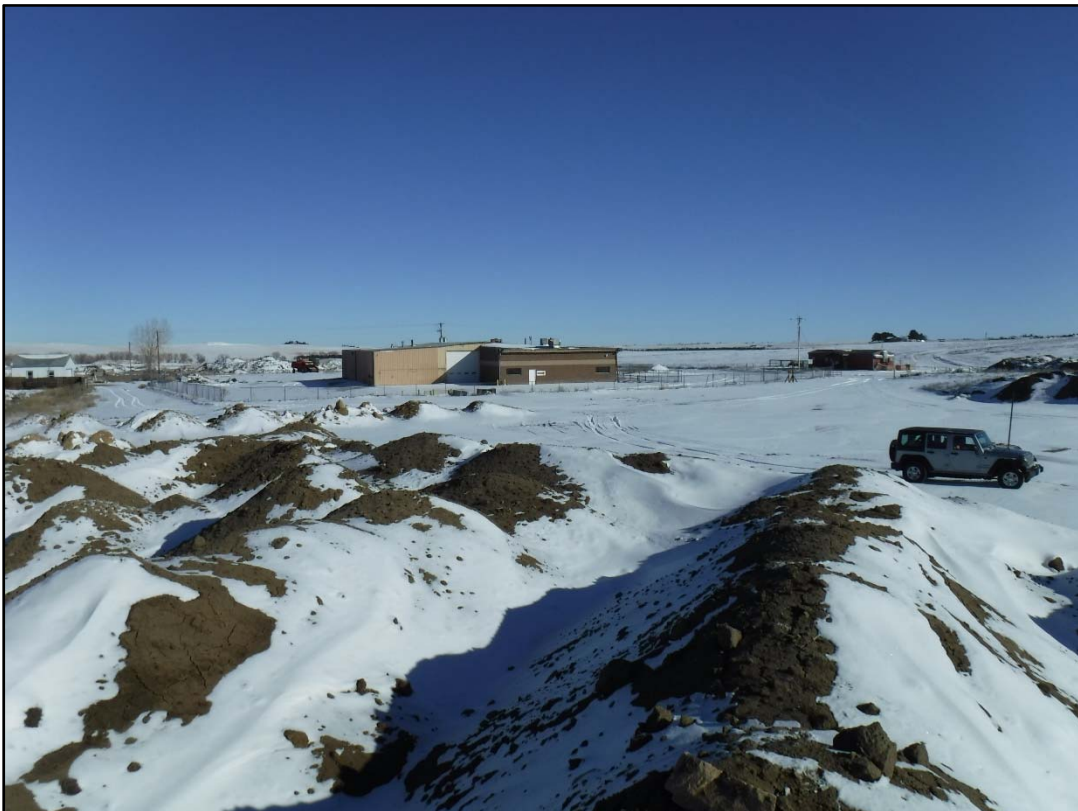
Photo 6: Looking northeast at pit entrance with dirt piles, not related to mining, in southern pit area

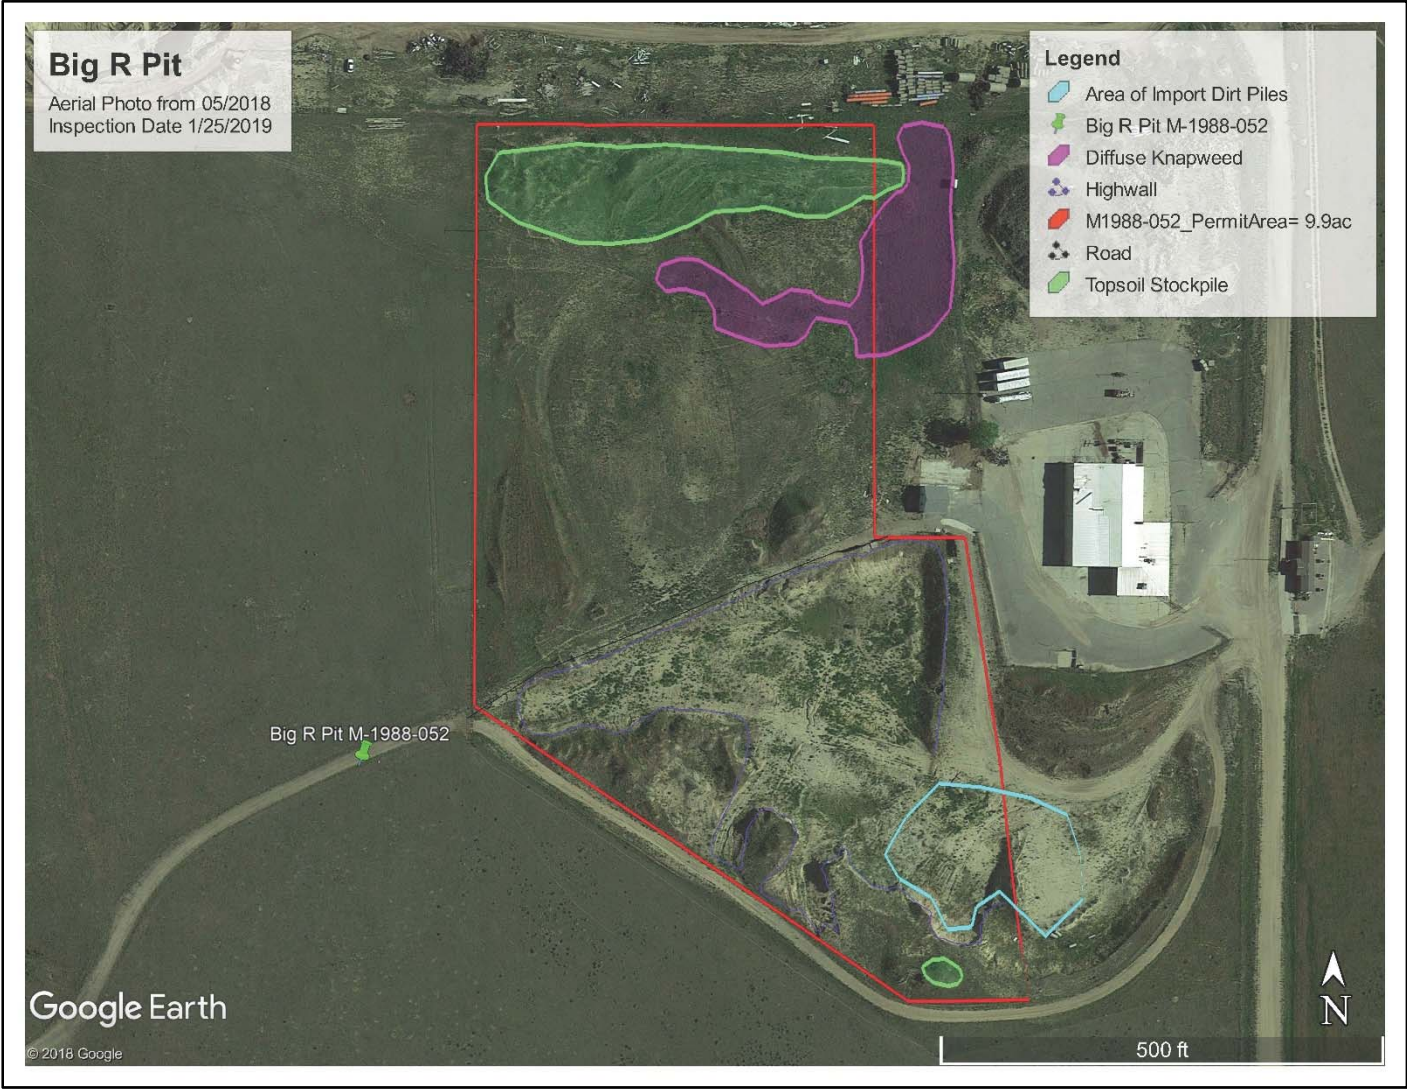
Figure 1: Google Earth Image of site noting major features
