MINERALS PROGRAM INSPECTION REPORT

MINE NAME: Pino Pit	MINE/PROSPECTING ID#: M-2000-118	MINERAL: Sand and gravel	COUNTY: Huerfano
INSPECTION TYPE: Monitoring	INSPECTOR(S): Patrick Lennberg and Michael Cunningham	INSP. DATE: January 25, 2019	INSP. TIME: 13:30
OPERATOR: APC Southern Construction Co., LLC	OPERATOR REPRESENTATIVE: Jim MacDonald and Rick Pounds	TYPE OF OPERATION: 112c - Construction Regular Operation

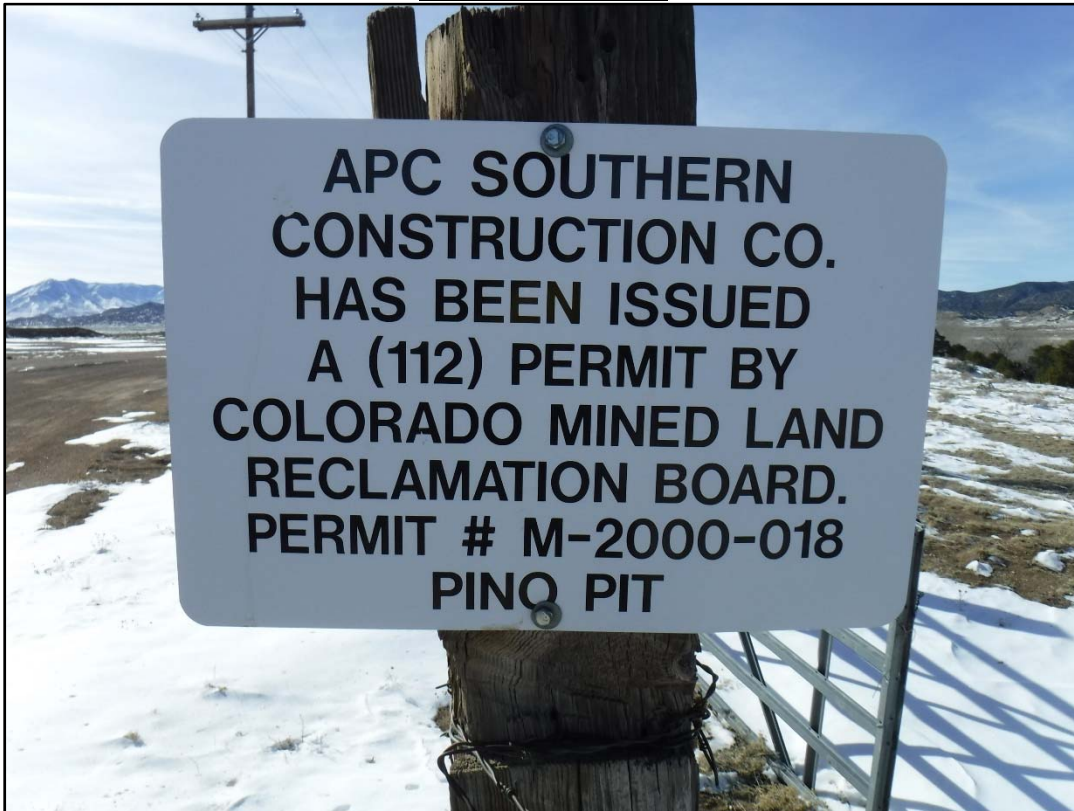
The Pino Pit is located 12 miles northwest of Walsenburg, CO. The pit is a 112c permitted for 80 acres with an approved maximum allowed disturbance of 35 acres. The approved post-mining land use is rangeland. A mine sign was observed as required by Rule 3.1.12.

Photo 1: Mine sign at entrance

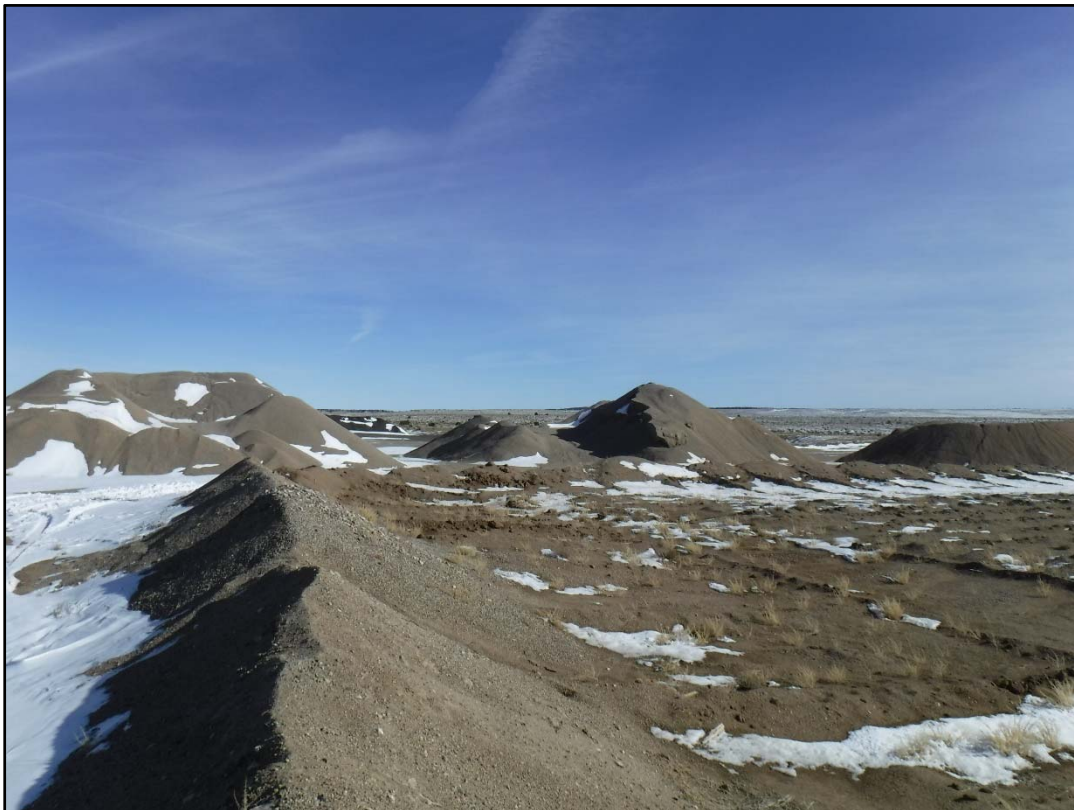
Photo 2: Product stockpiles, recycled asphalt stockpile in background

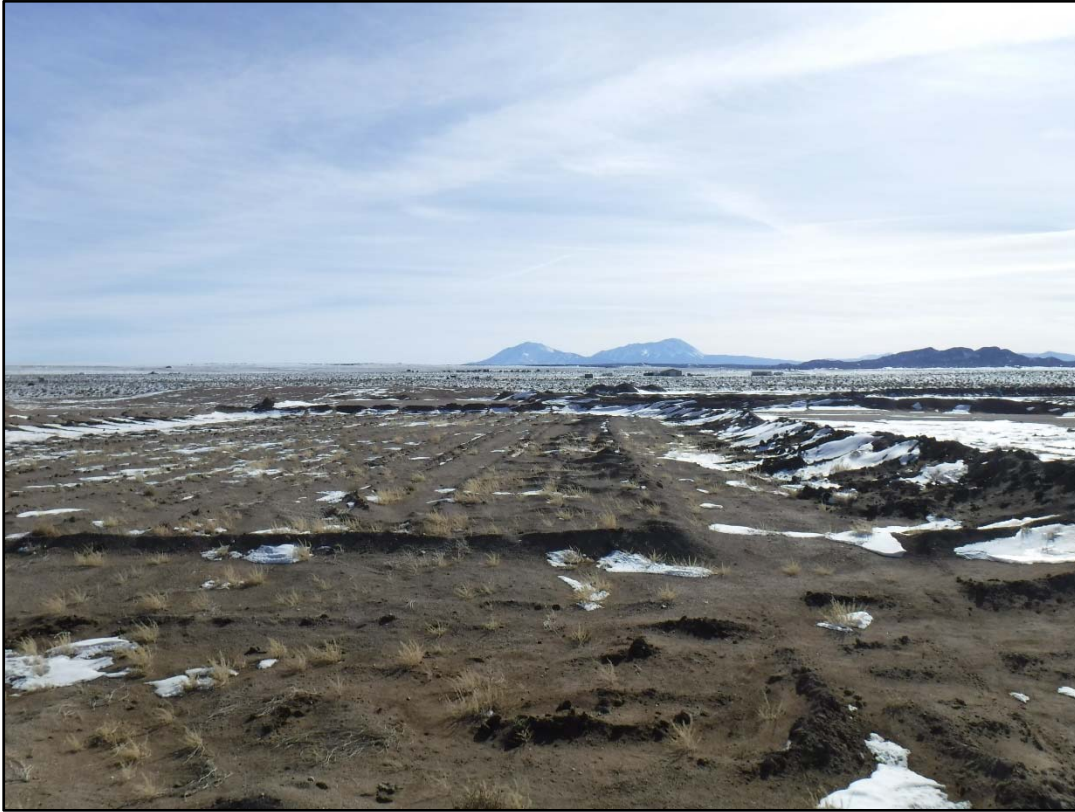
Photo 3: Looking south, topsoil stockpiles in background

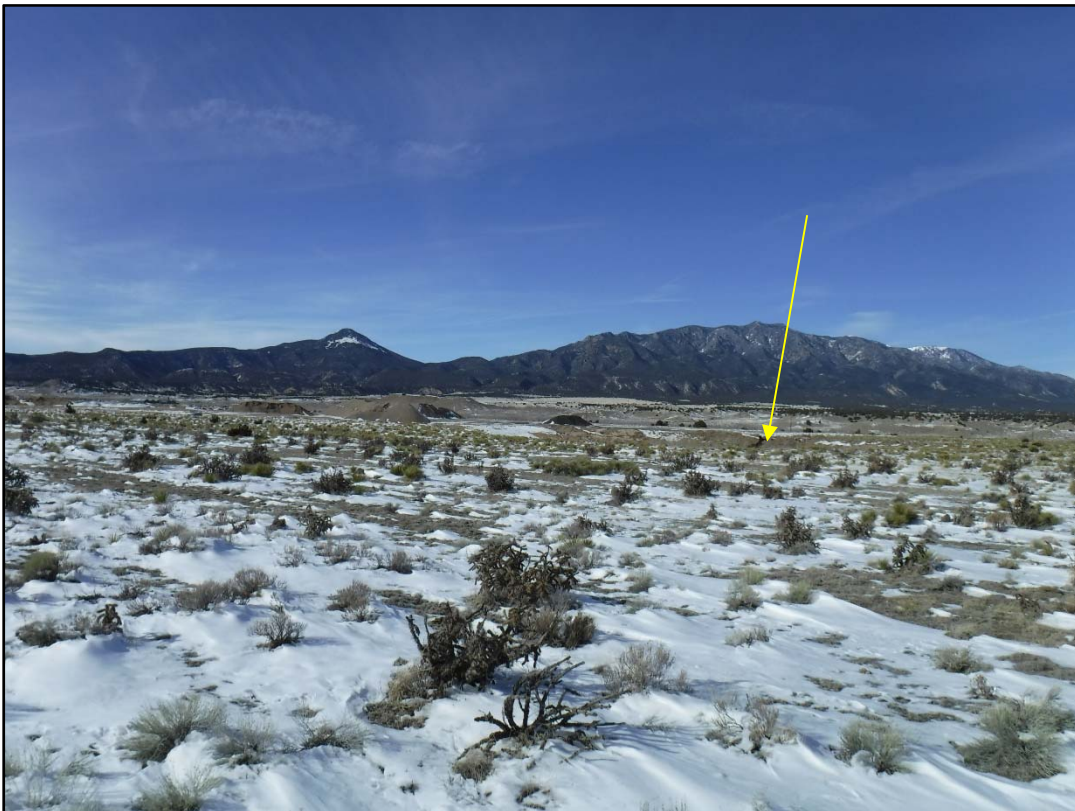
The site is being mined from east to west with the most recent mining activities occurring in the western portion. The western pit has been temporarily graded to get rid of any highwalls and minimize erosion. The eastern pit has not been active since the last inspection which stated that the pit walls had been graded to approximately 2H:1V and some reclamation has taken place. The slopes of both pits showed some rilling but all sediment is contained within the pits which are 30 to 40 feet deep. All slopes will need to be graded to a minimum of 3H:1V, erosion gullies repaired and stabilized once final reclamation begins.

Photo 4: Looking northwest from the southeastern corner of permit area, arrow indicates east pit location

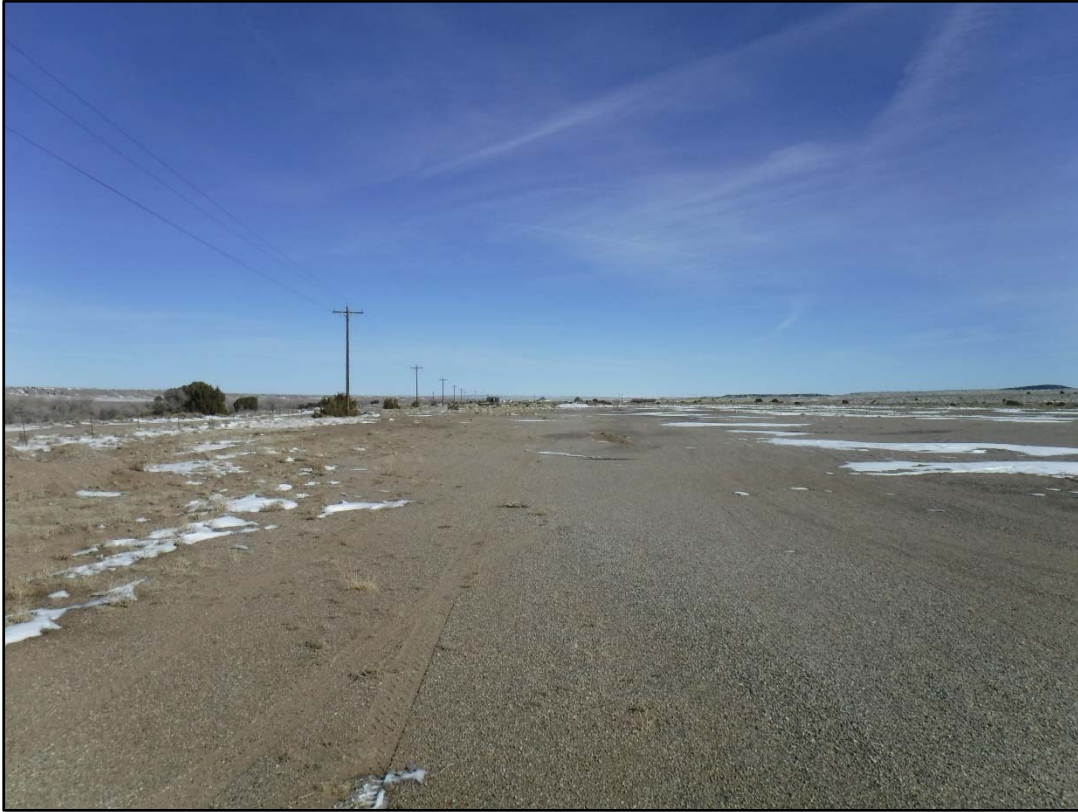
Photo 5: Pit entrance area

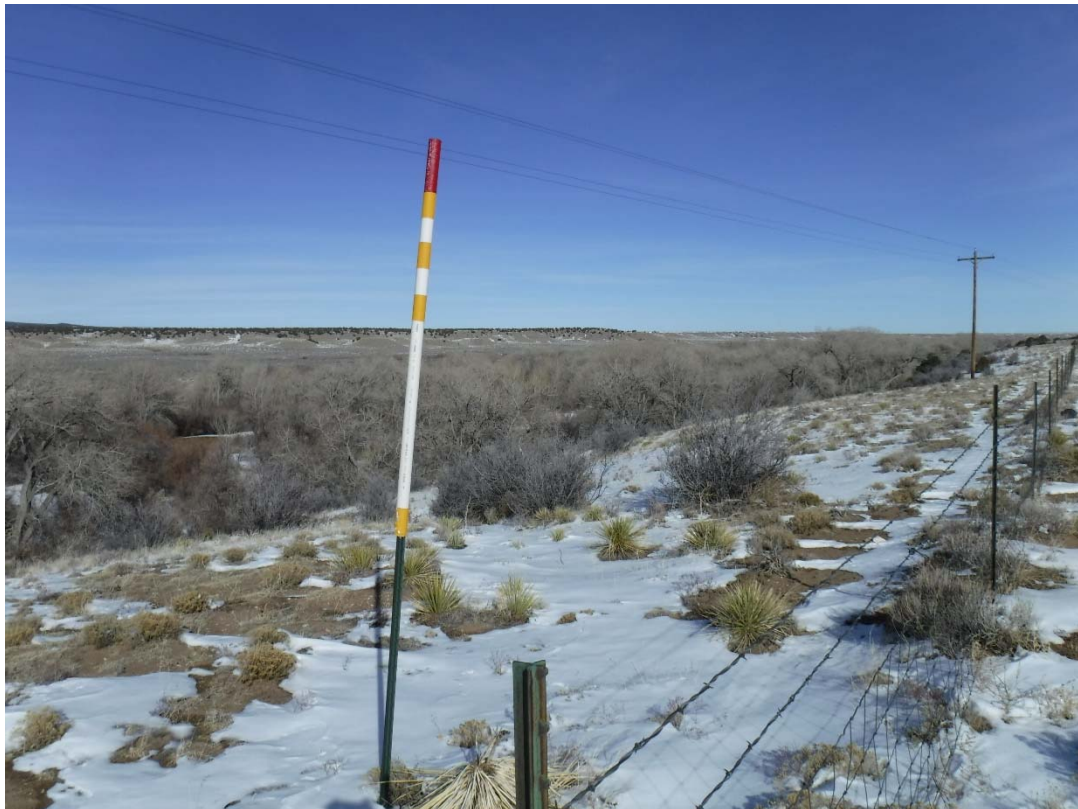
COMPLIANCE PROBLEM: The permit boundary markers are incorrectly placed. This is a problem for failure to maintain boundary markers around the affected area as required by Rule 3.1.12(2).

During the inspection the operator took the Division on a tour to the permit boundary markers. The location of these markers were marked by the Division using a handheld GPS unit (Garmin 64 ST). Reviewing these locations in the office it appears that the western boundary markers are in the incorrect location and is being cited as a problem in this report. The operator will have to conduct a survey to correctly place the boundary markers. The mining activities appear to be within the 35 acre maximum disturbance allowed.

Photo 6: Incorrectly placed boundary marker in the northwestern corner of permit area

CORRECTIVE ACTIONS: The operator shall conduct a survey and replace the boundary markers in the correct location(s). The operator shall provide photographic proof and the GPS coordinates of the replaced markers to the Division that this has been done by the corrective action date.

CORRECTIVE ACTION DUE DATE: 3/22/19
