MINERALS PROGRAM INSPECTION REPORT
PHONE: (303) 866-3567

MINE NAME: Velarde Pit	MINE/PROSPECTING ID#: M-2002-118	MINERAL: Sand and gravel	COUNTY: Huerfano
INSPECTION TYPE: Monitoring	INSPECTOR(S): Patrick Lennberg and Michael Cunningham	INSP. DATE: January 25, 2019	INSP. TIME: 12:50
OPERATOR: APC Southern Construction Co., LLC	OPERATOR REPRESENTATIVE: Jim MacDonald and Rick Pounds	TYPE OF OPERATION: 112c - Construction Regular Operation	
REASON FOR INSPECTION: Normal I&E Program	BOND CALCULATION TYPE: Complete Bond	BOND AMOUNT: \$114,200.00	
DATE OF COMPLAINT: NA	POST INSP. CONTACTS: None	JOINT INSP. AGENCY: None	
WEATHER: Clear	INSPECTOR'S SIGNATURE:

SIGNATURE DATE: February 13, 2019

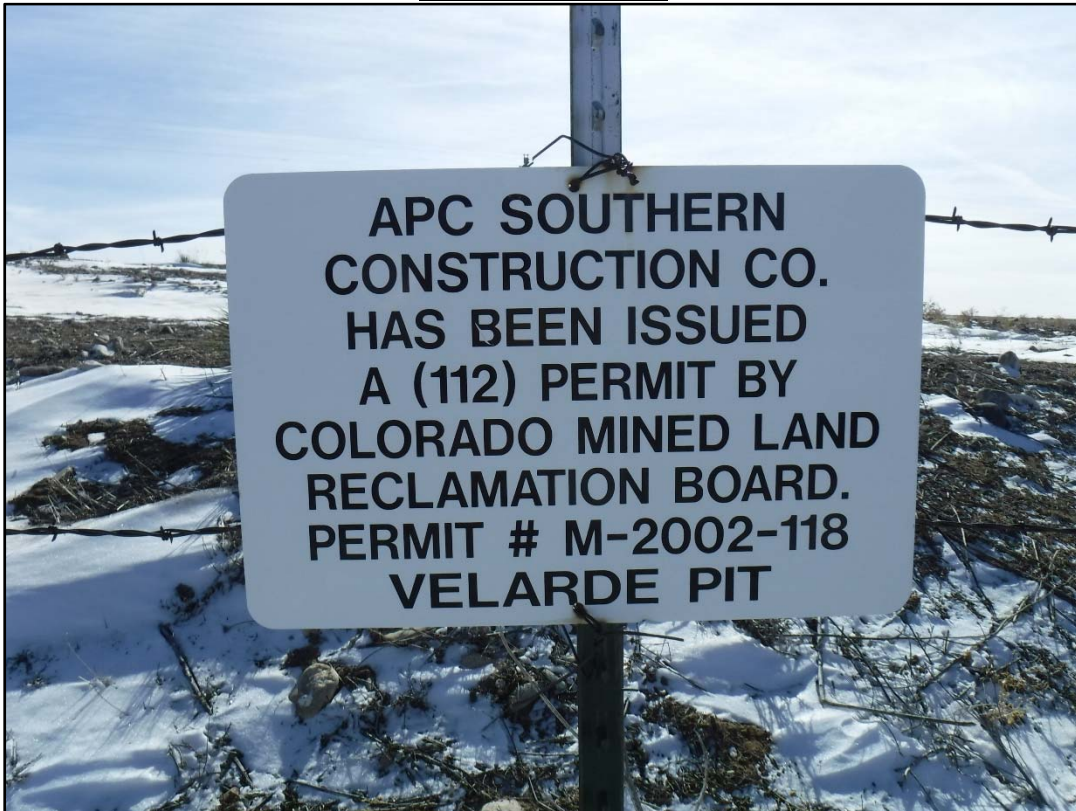
The Velarde Pit is located approximately 12.5 miles north of Walsenburg, Colorado. The site is 112c permitted for 300 total acres with 30 acres maximum allowed disturbance divided into three phases. It has an approved affected area of 149 acres at one time. The approved post-mining land use is rangeland. A mine sign was observed as required by Rule 3.1.12.

Photo 1: Mine sign at entrance

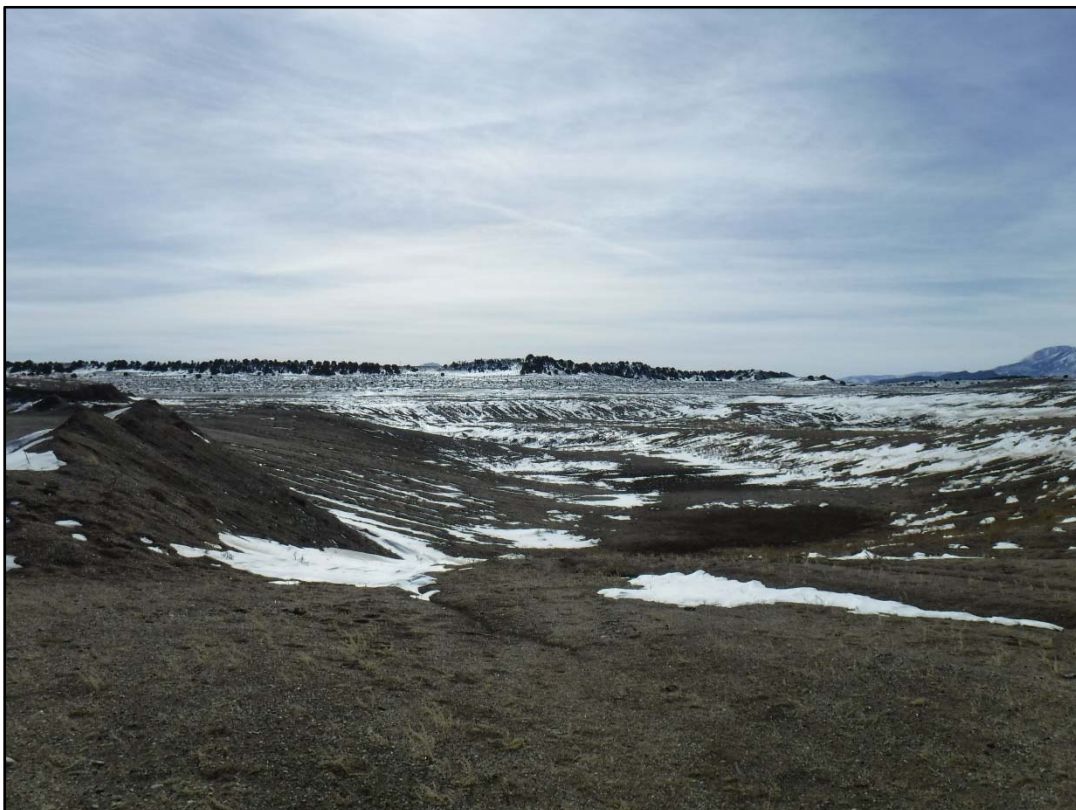
All current mining activity is contained within Phase 1 of the site and is progressing from the east to west. No processing facilities were observed but there were processed material stockpiles and recycled asphalt stockpiles located in the northeastern quadrant of Phase 1. Topsoil stockpile appears stable with some vegetation growing. The pit appeared to have highwalls and other portions of the pit graded between 2H:1V to 3H:1V. Some rilling of the side slopes was observed but everything is contained within the pit. As mining proceeds from east to west the mined out areas are backfilled and graded. At this time it does not appear that any topsoil has been placed on the reclaimed areas. No groundwater was observed during the inspection.

Photo 2: Current pit area

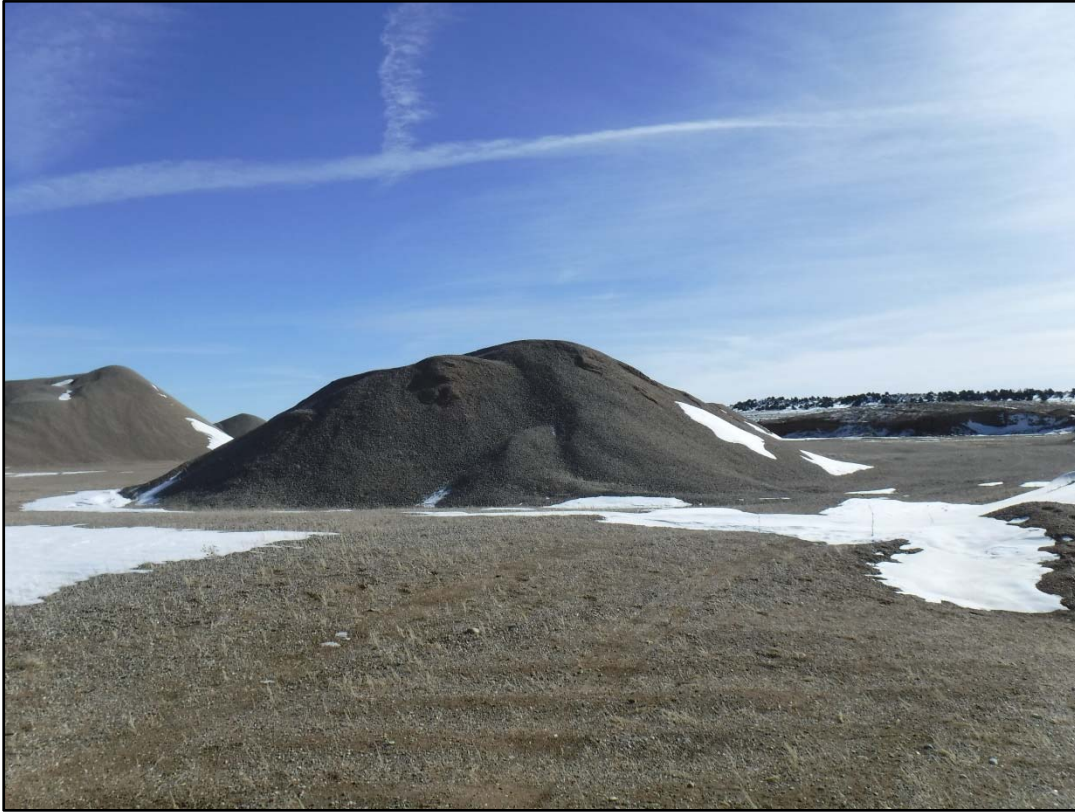
Photo 4: Stockpile of recycled asphalt, product stockpile to the left, and topsoil stockpile to right

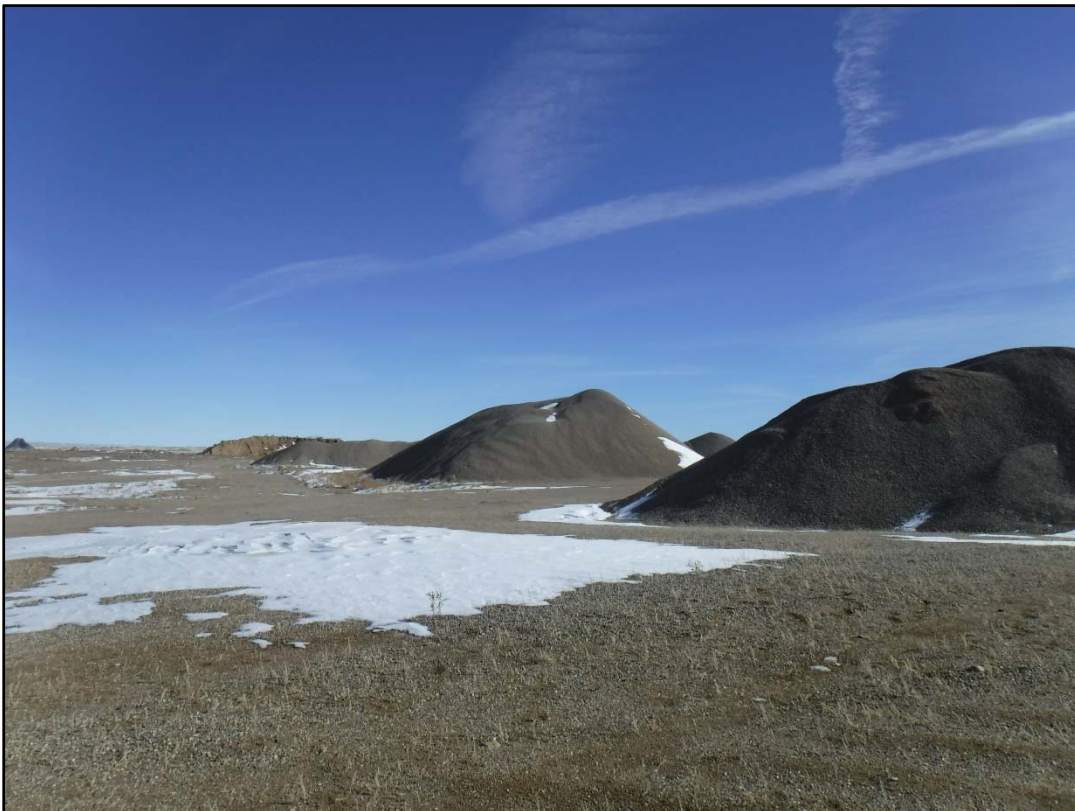
Photo 5: Product stockpiles, note the pile in the background is on an adjacent mine property

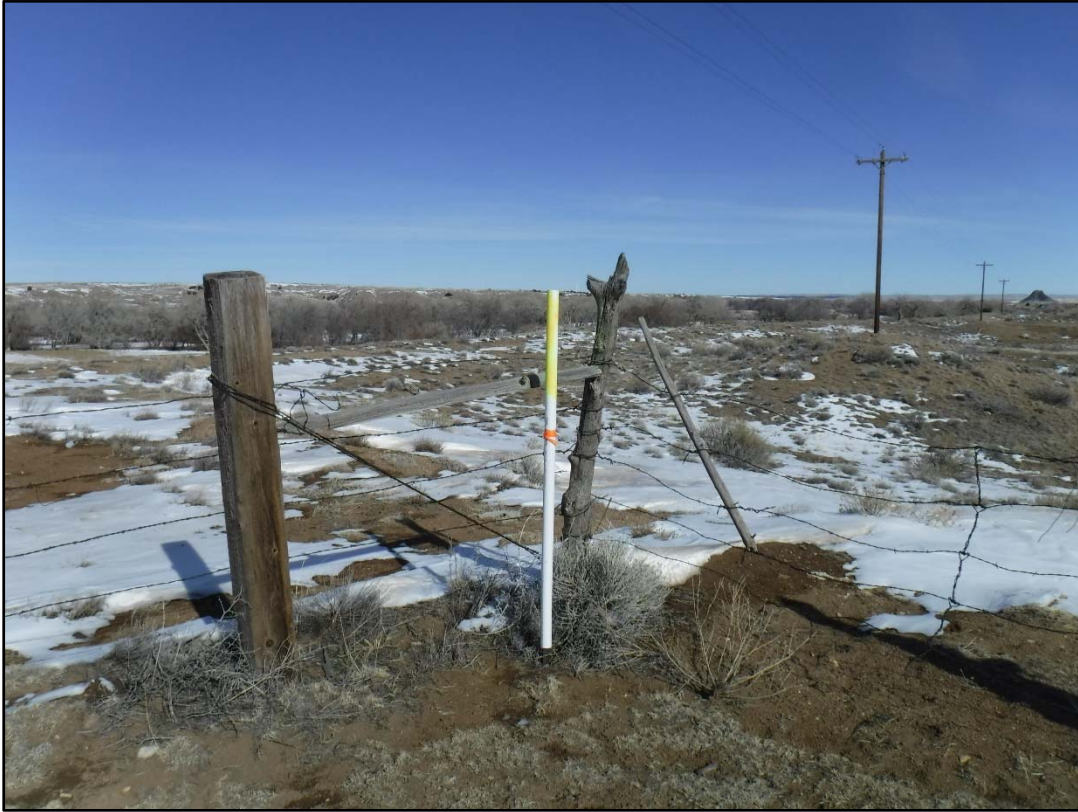
Photo 5: Boundary marker

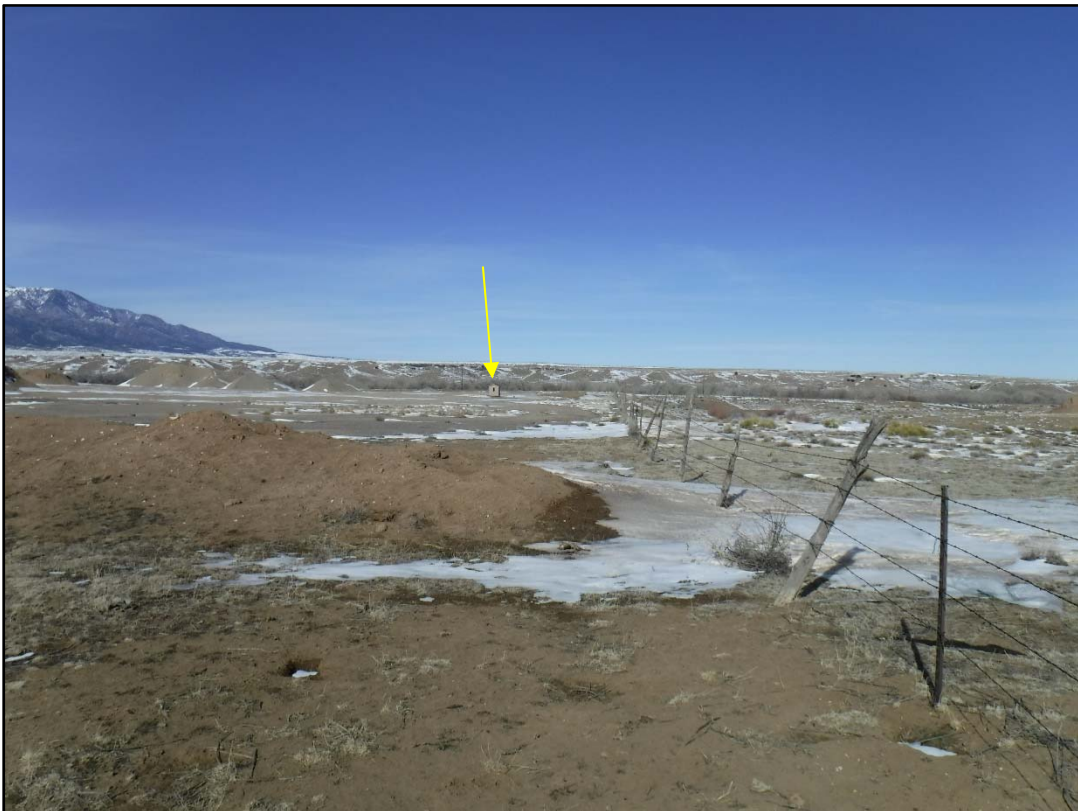
The site was not active at the time of inspection. The Operator is reminded, pursuant to Rule 1.13.5, if the site does not operate more than 180 days a year then the Operator must file a Notice of Temporary Cessation by submitting a Technical Revision. A scale house facility was noted to have been installed since the last inspection along the western portion of site. The affected area appears to be near the 30 acres maximum allowed.

Photo 6: Looking north from southeast corner of Phase 1 along fenceline, arrow indicates scale house

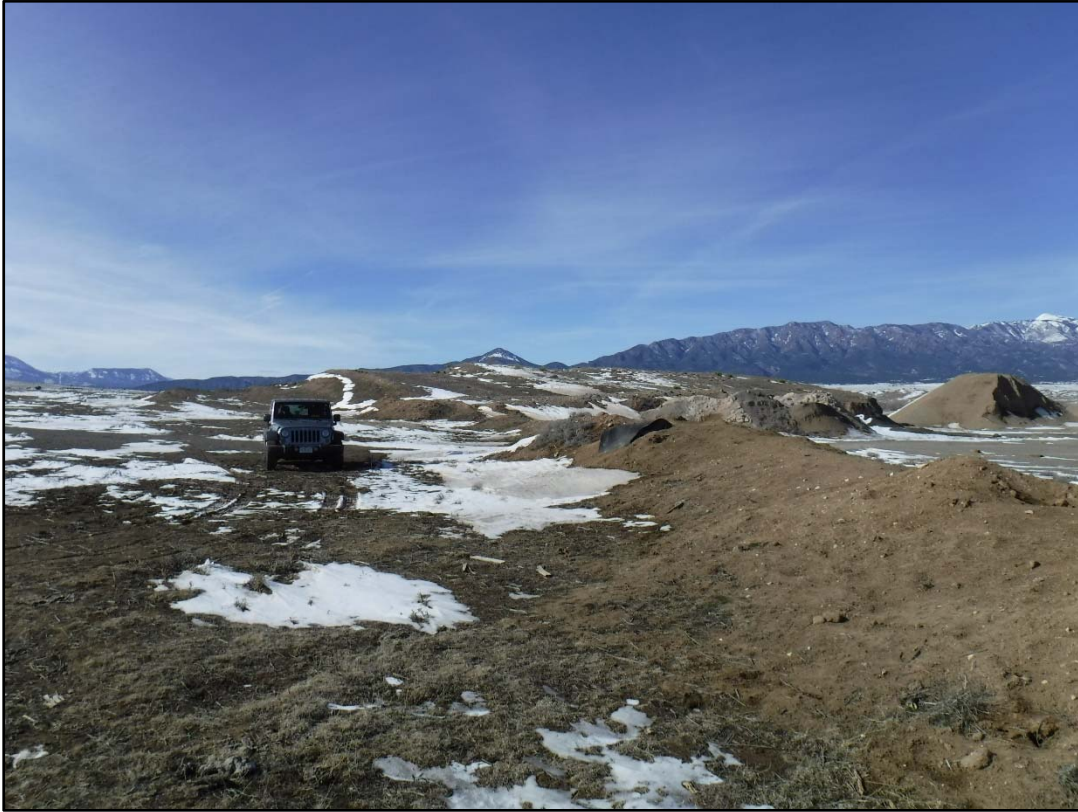
Photo 7: Overburden and topsoil stockpiles

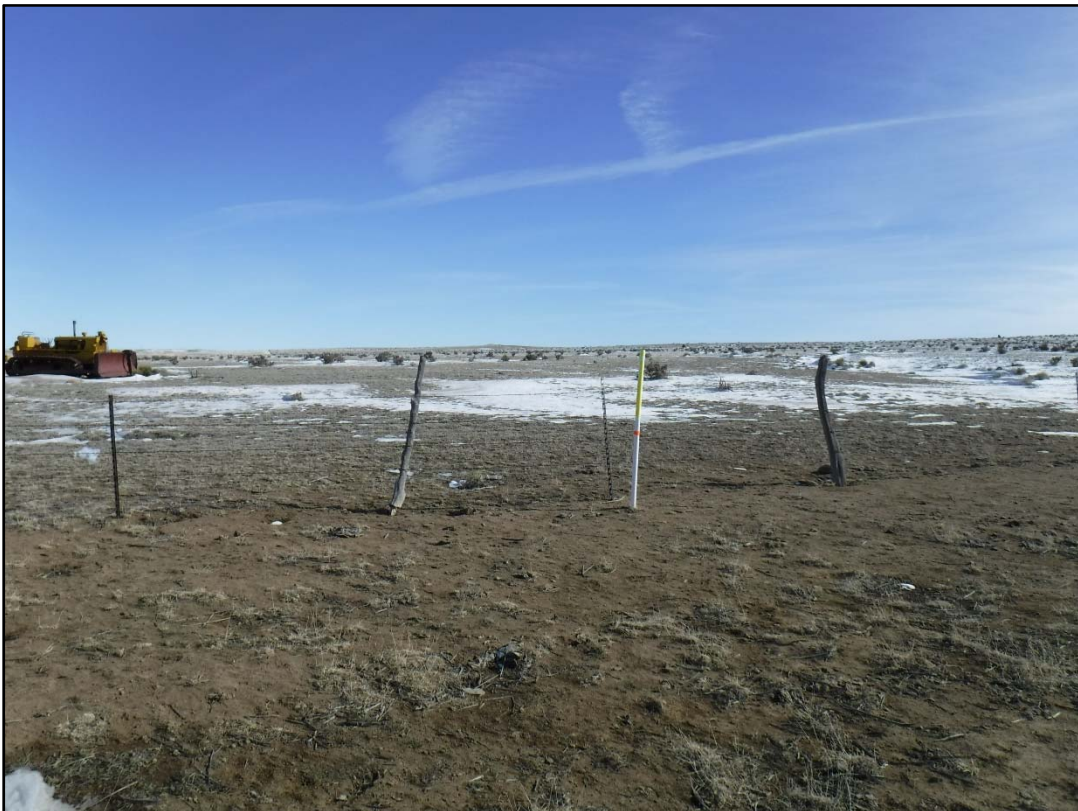
Photo 8: Southeastern boundary marker with relic bulldozer on adjacent property in background
