MINERALS PROGRAM INSPECTION REPORT
PHONE: (303) 866-3567

MINE NAME: Franciscotti Pit #2	MINE/PROSPECTING ID#: M-2018-058	MINERAL: Sand and gravel	COUNTY: Huerfano
INSPECTION TYPE: Preoperation Inspection	INSPECTOR(S): Patrick Lennberg and Michael Cunningham	INSP. DATE: January 25, 2019	INSP. TIME: 12:15
OPERATOR: APC Southern Construction Co., LLC	OPERATOR REPRESENTATIVE: Jim MacDonald and Rick Pounds	TYPE OF OPERATION: 112c - Construction Regular Operation	
REASON FOR INSPECTION: Preoperation Inspection	BOND CALCULATION TYPE: None	BOND AMOUNT: No Bond Held	
DATE OF COMPLAINT: NA	POST INSP. CONTACTS: None	JOINT INSP. AGENCY: None	
WEATHER: Clear	INSPECTOR'S SIGNATURE:

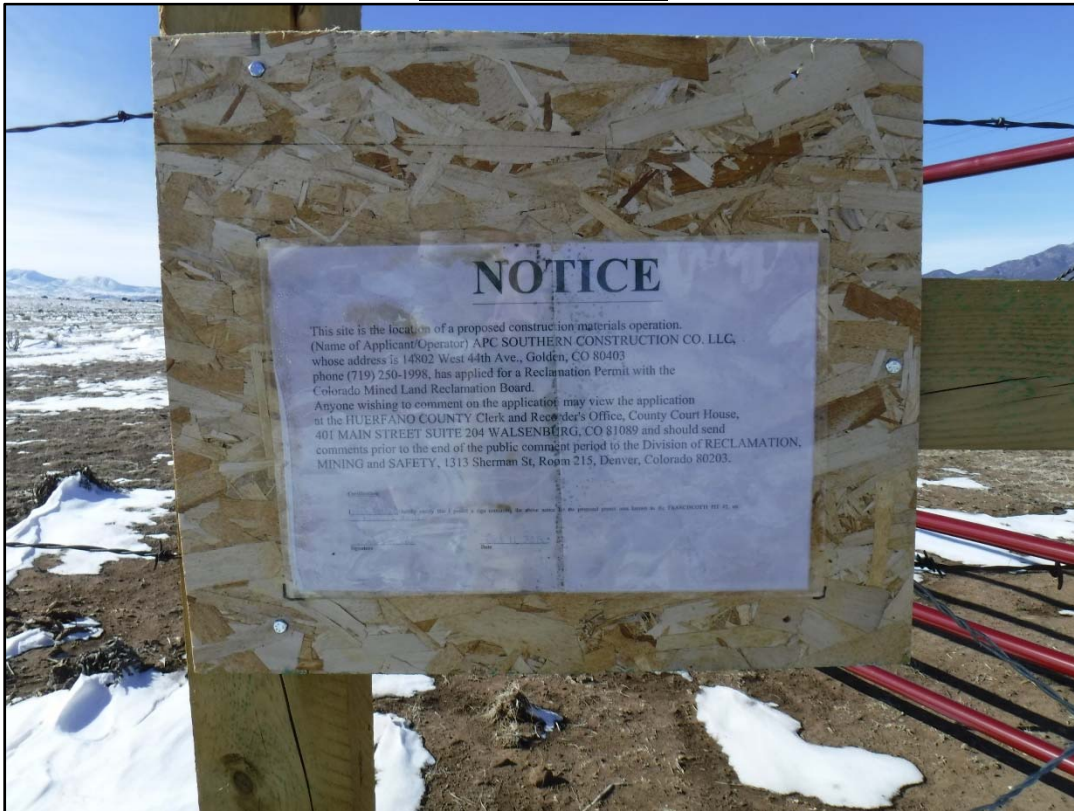
The permit notice was clearly posted at the mine entrance along County Road 613 and the proposed permit boundary was marked with 2-inch PVC casing painted yellow with orange flagging. The permit area is currently rangeland that is characterized by native grasses and cacti with some yucca. There are power poles that transect the permit area, a family cemetery (active), and an unlined ditch that is owned and operated by the land owner. All structures observed during the inspection were accurately depicted on the maps within the permit application. To the north of the permit area is the Huerfano River and Colorado Parks and Wildlife expressed a desire to have a raptor survey performed to determine if any nests are located near the proposed mine. A second adequacy letter was sent to the operator requesting a commitment to perform a survey prior to beginning mining operations.

Photo 1: Posted notice sign at mine entrance

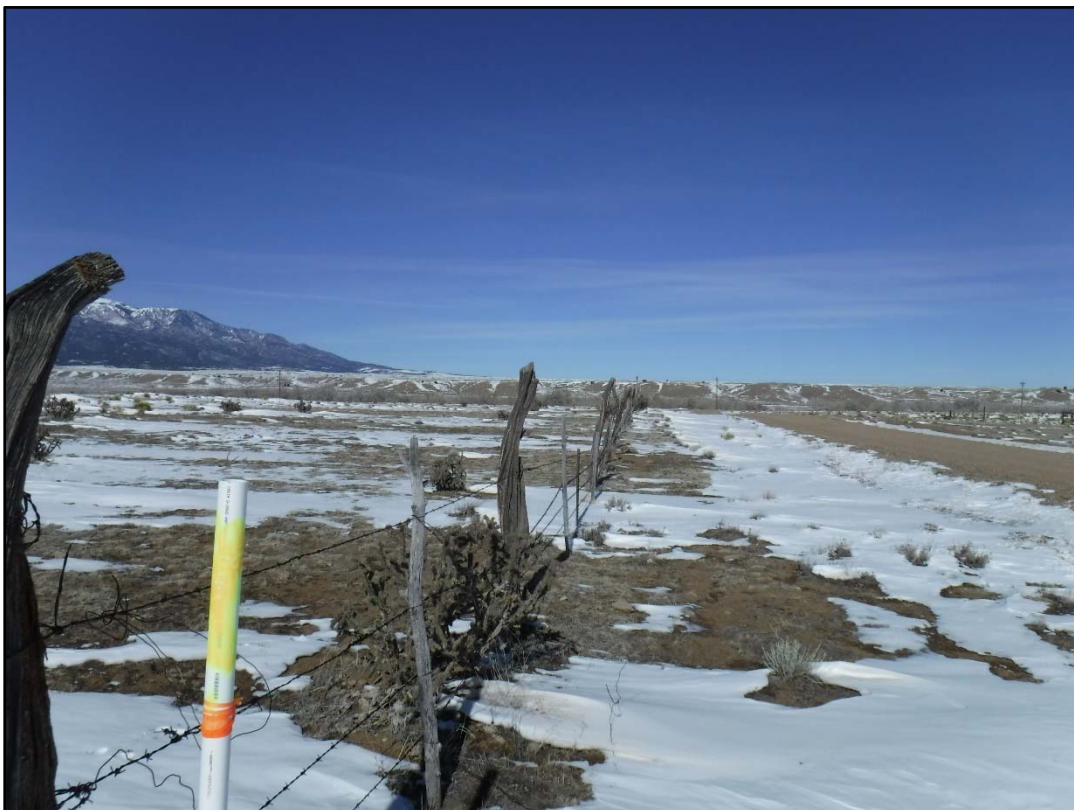
Photo 2: Boundary marker located at the southeastern corner

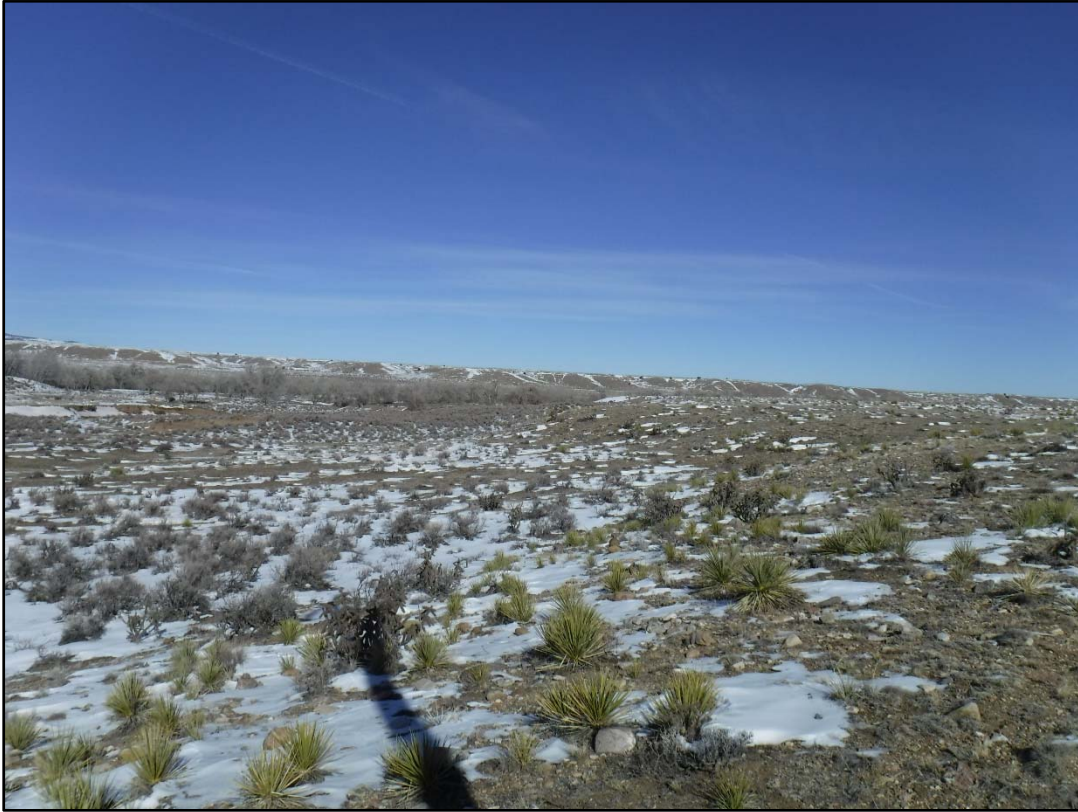
Photo 3: Typical vegetation occurring at the site

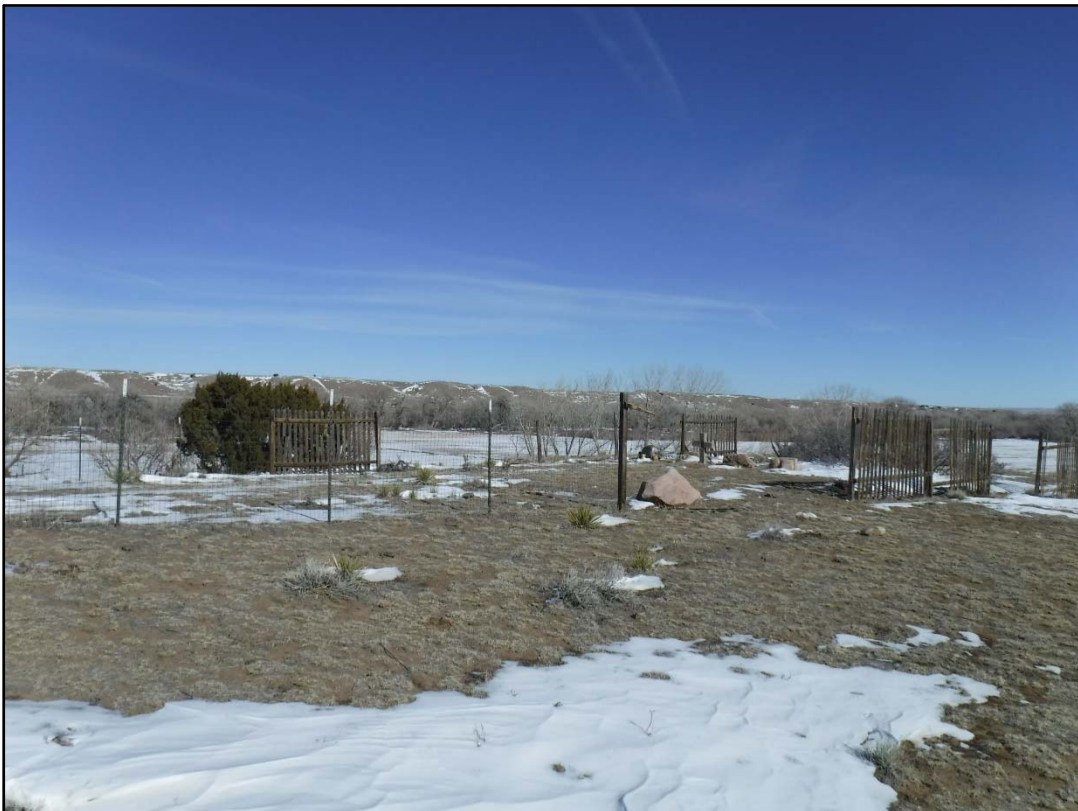
Photo 4: Active family cemetery

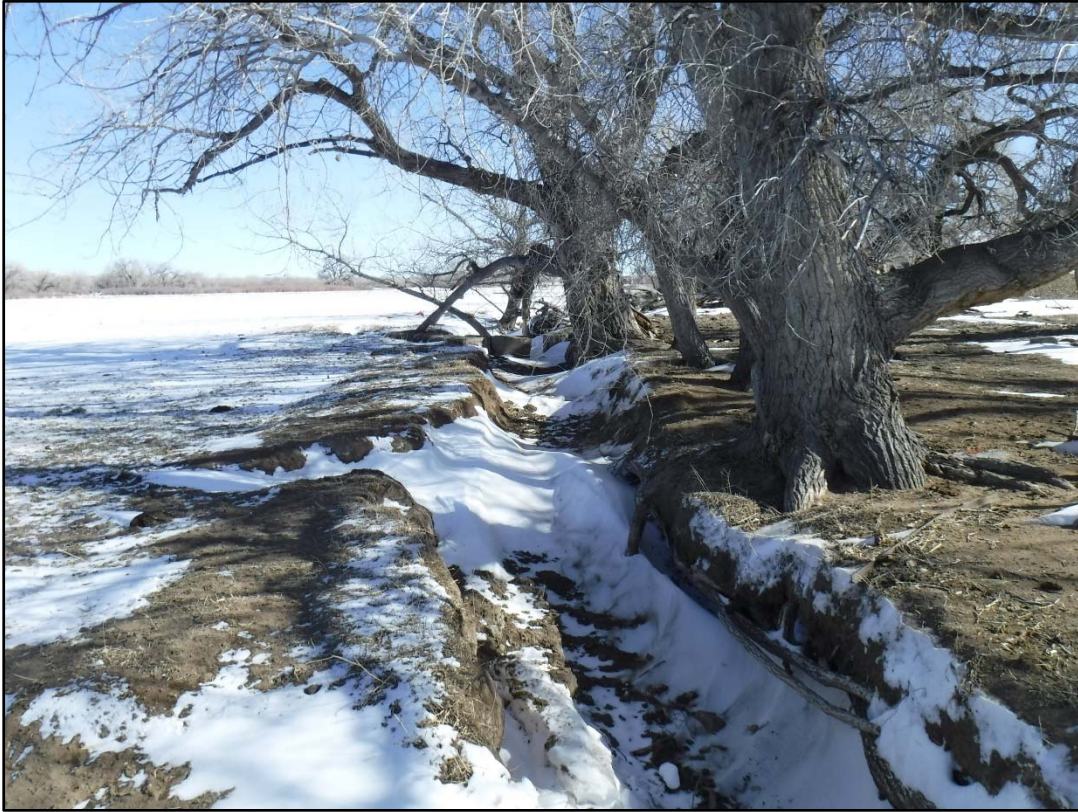
Photo 5: The Dan Mahan Ditch

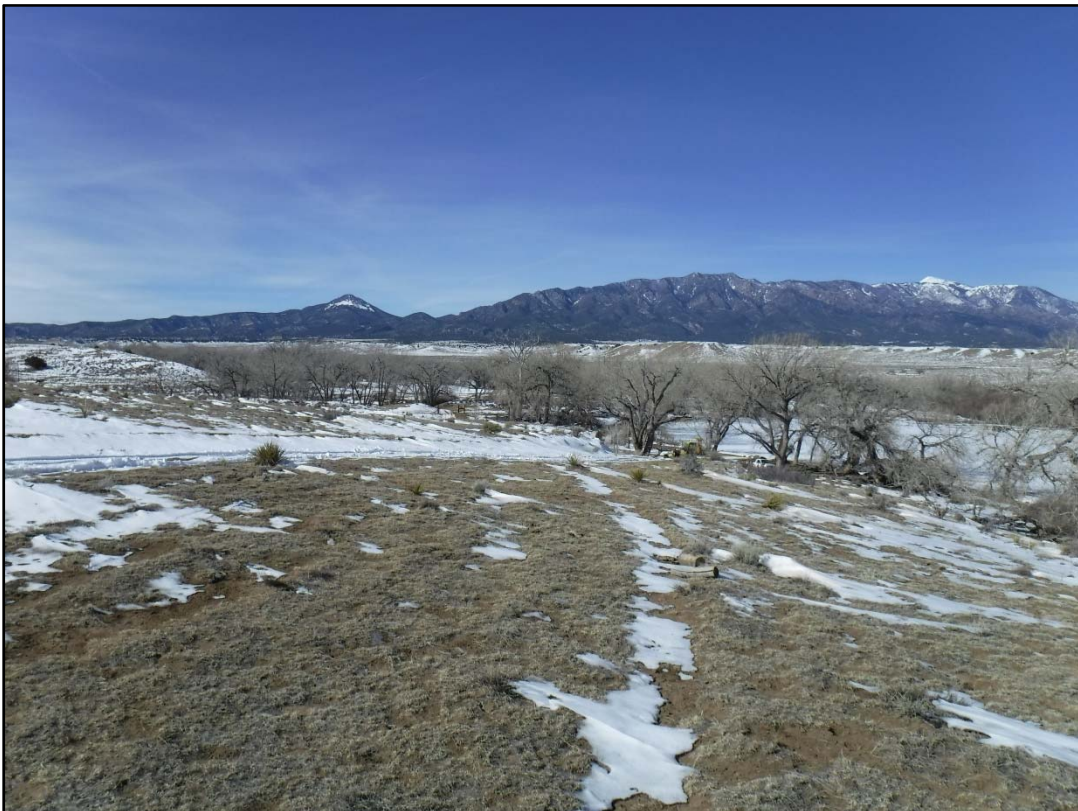
Photo 6: Looking northwest from the northern permit boundary towards Huerfano River
