Re: December 20, 2018 Inspection Report (Revised), Cresson Project, Permit No. M-1980-244

REVISED MINERALS PROGRAM INSPECTION REPORT
PHONE: (303) 866-3567

MINE NAME: Cresson Project	MINE/PROSPECTING ID#: M-1980-244	MINERAL: Gold	COUNTY: Teller
INSPECTION TYPE: Monitoring	INSPECTOR(S): Elliott R. Russell	INSP. DATE: December 20, 2018	INSP. TIME: 09:00
OPERATOR: Cripple Creek & Victor Gold Mining Company	OPERATOR REPRESENTATIVE: Justin Raglin and Erik Munroe	TYPE OF OPERATION: 112d-3 - Designated Mining Operation	
REASON FOR INSPECTION: Normal I&E Program	BOND CALCULATION TYPE: None	BOND AMOUNT: \$208,491,188.00	
DATE OF COMPLAINT: NA	POST INSP. CONTACTS: None	JOINT INSP. AGENCY: None	
WEATHER: Clear	INSPECTOR'S SIGNATURE:

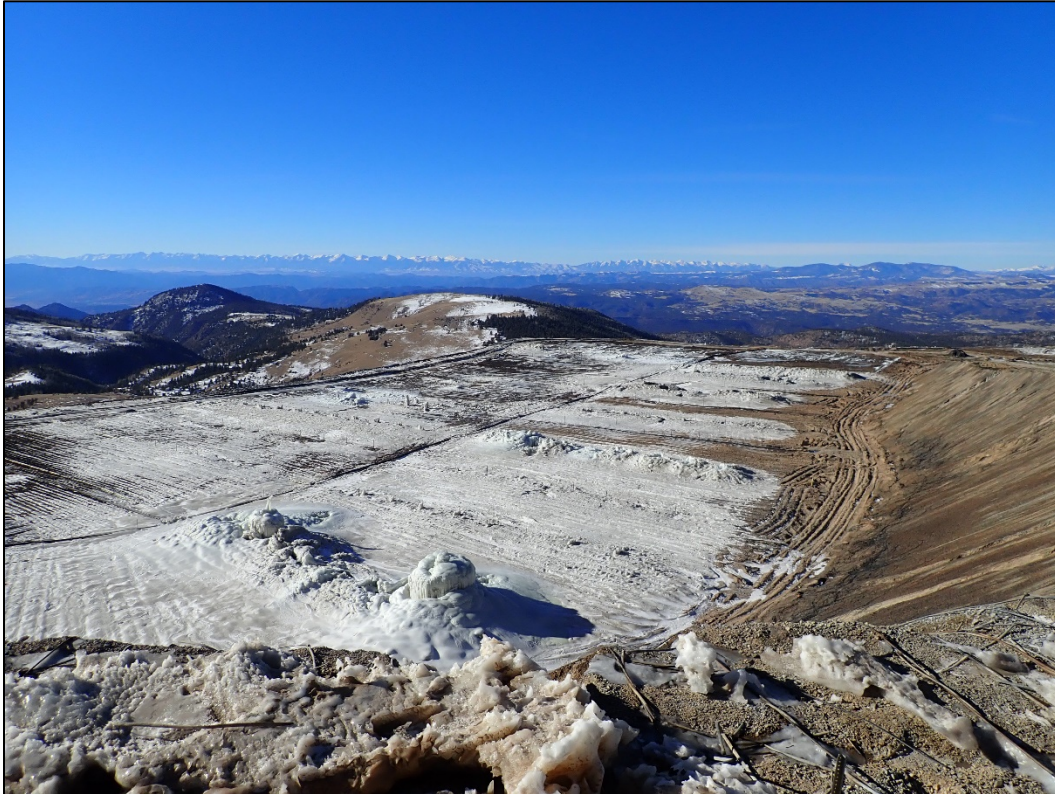
The Division observed the active leaching operations occurring on the top of the AGVLF (**Photos 1 and 2**). No ponded solution nor issues were observed. The Division also observed the southwest face of the AGVLF from State Highway 67 (**Photo 3**).

Photo 1. Southern portion of the top of the AGVLF; looking southwest.

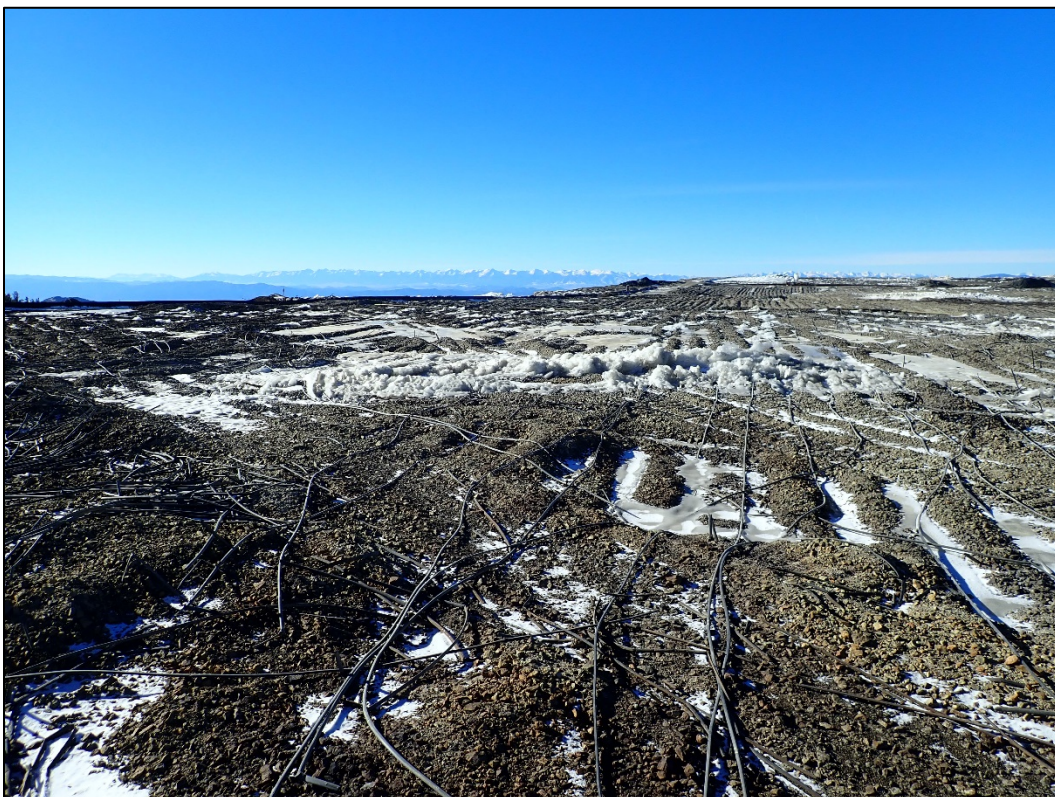
Photo 2. Southwest portion of the top of the AGVLF; looking southwest.

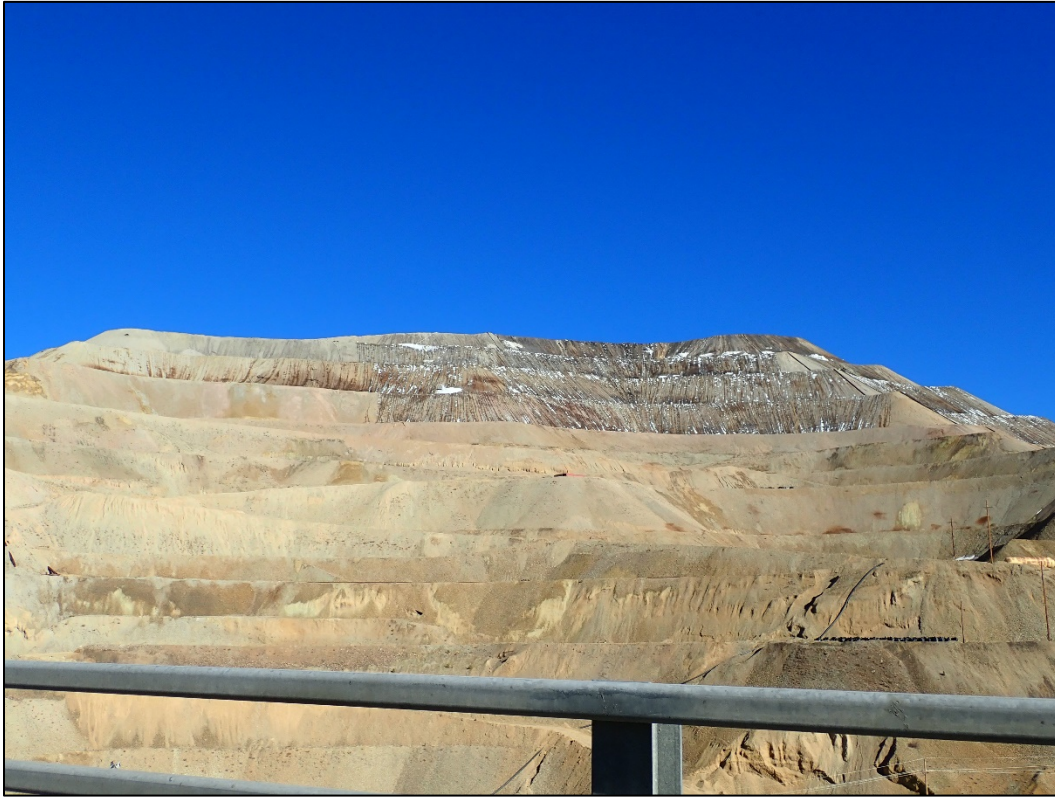
Photo 3. Southwest face of the AGVLF; looking northeast from State Highway 67.

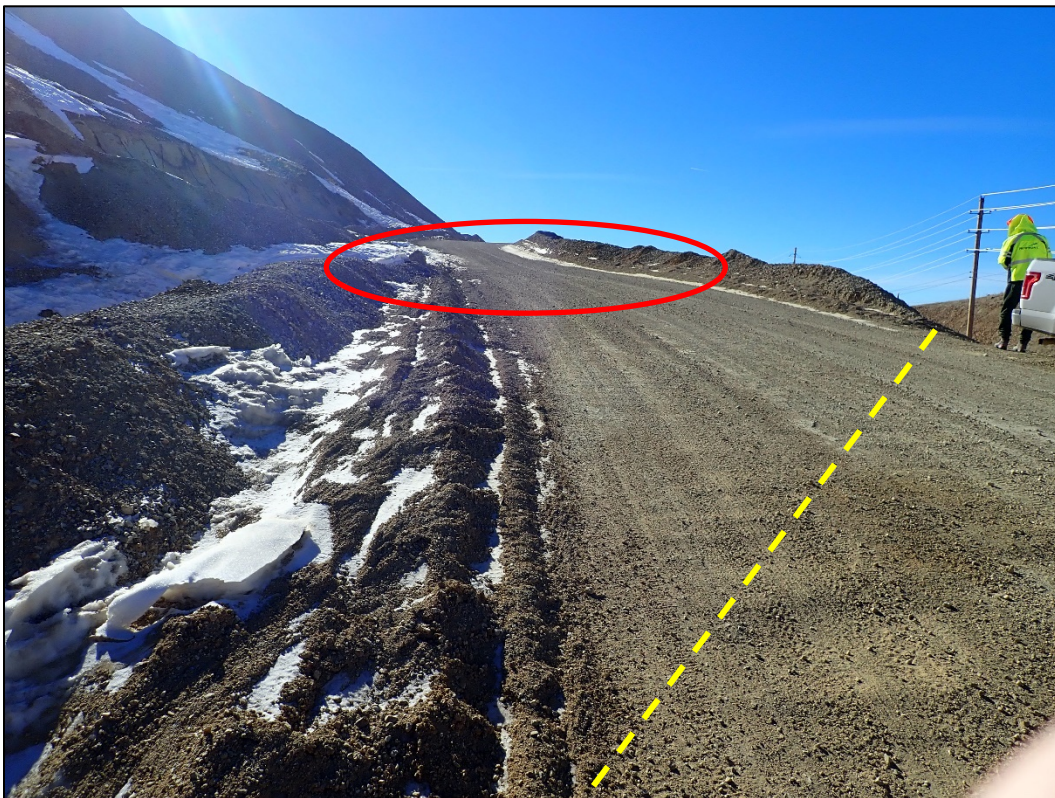
The Division inspected an access road which leads off of the northwest side of the AGVLF. This area poses a potential for storm water from AGVLF to leave the lined area. The Operator has previously installed an adequate swale in the access road to keep storm water on the liner and behind the edge of liner berm, however with time this swale has been reduced and appears in need of reworking (**Photo 4**). The Division also recommends the Operator establish edge of liner signage on either side of the access road to alert those using the access road the location of the edge of liner.

Photo 4. Access road in northwest portion of the AGVLF, edge of liner approximated by the dashed yellow line, area where storm water swale needs some work circled in red; looking south.

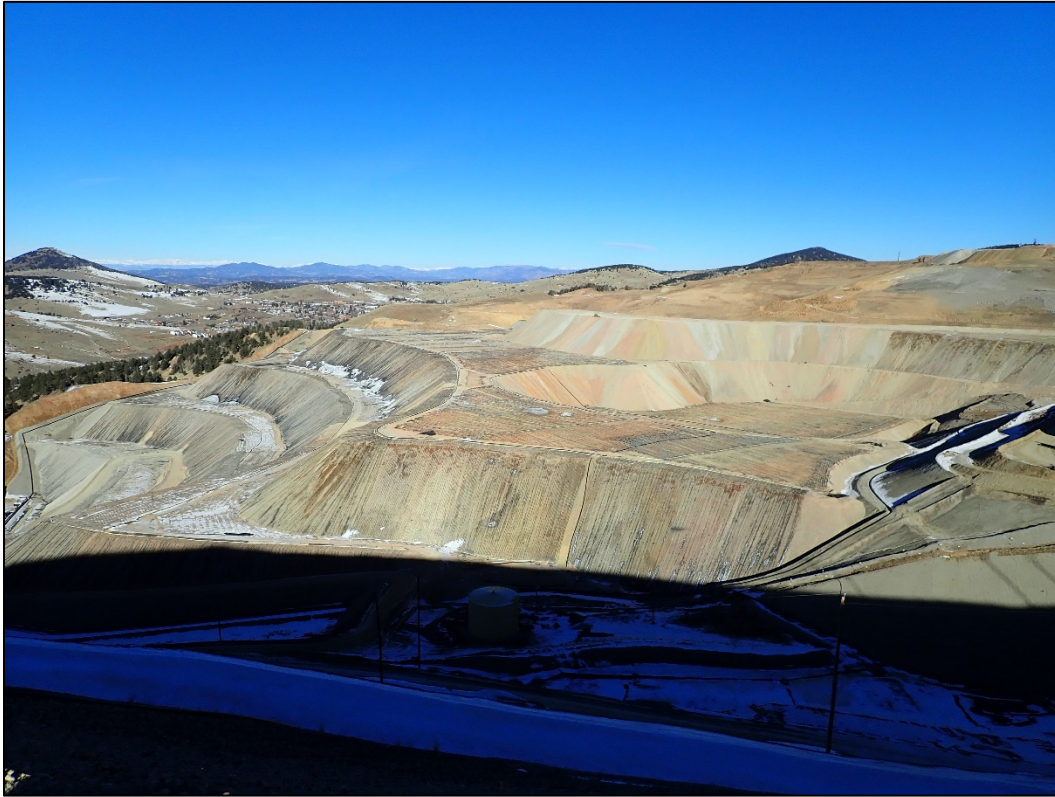
The Division observed the SGVLF from a lookout point on the north side of the AGVLF (**Photos 5 and 6**).

Photo 5. Overview of the SGVLF; looking northwest.

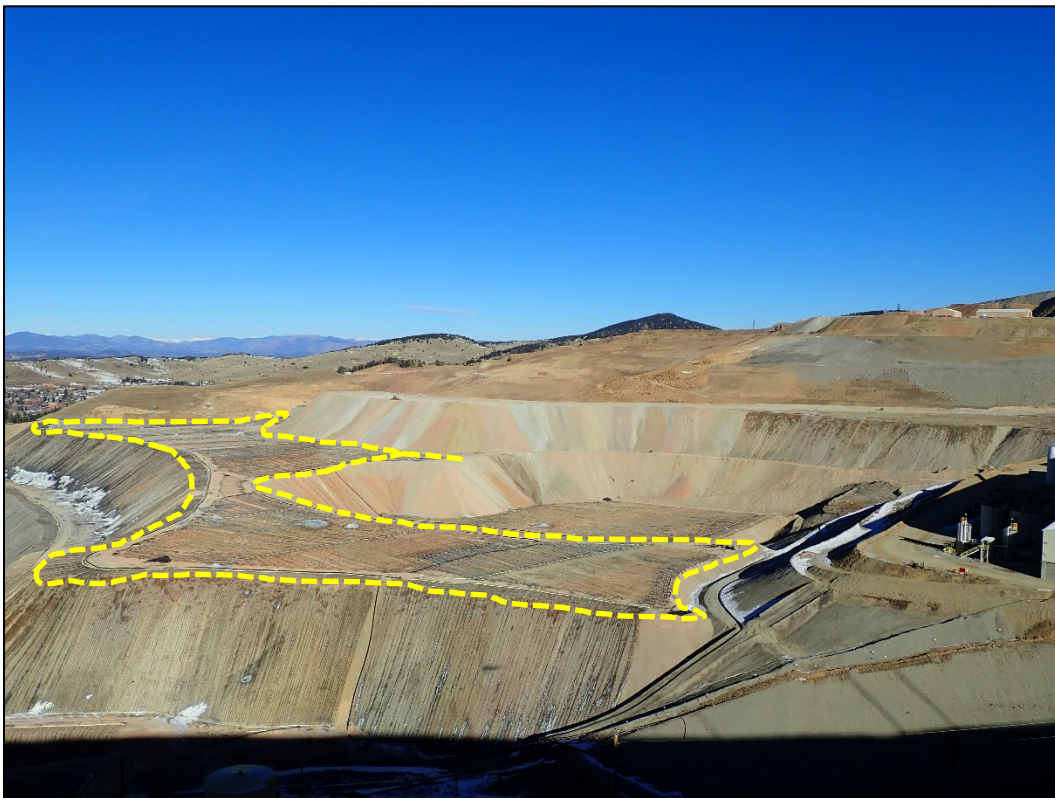
Photo 6. Overview of the SGVLF, top of 9,850 lift outlined in dashed yellow; looking north.

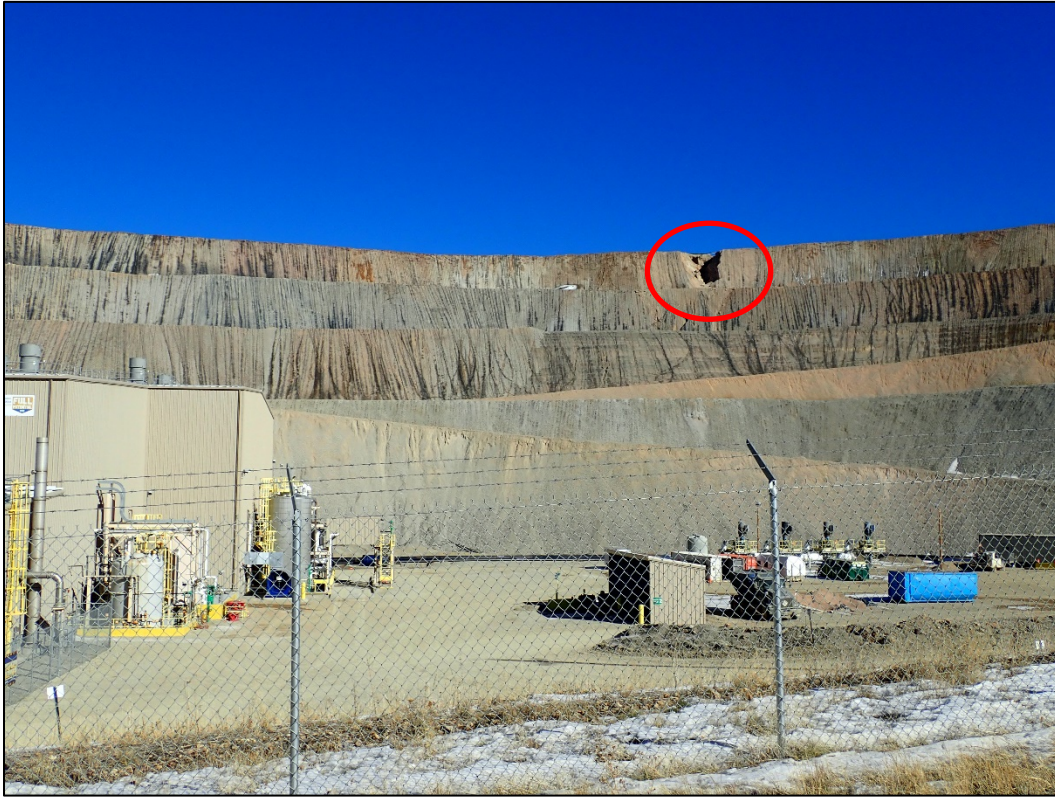
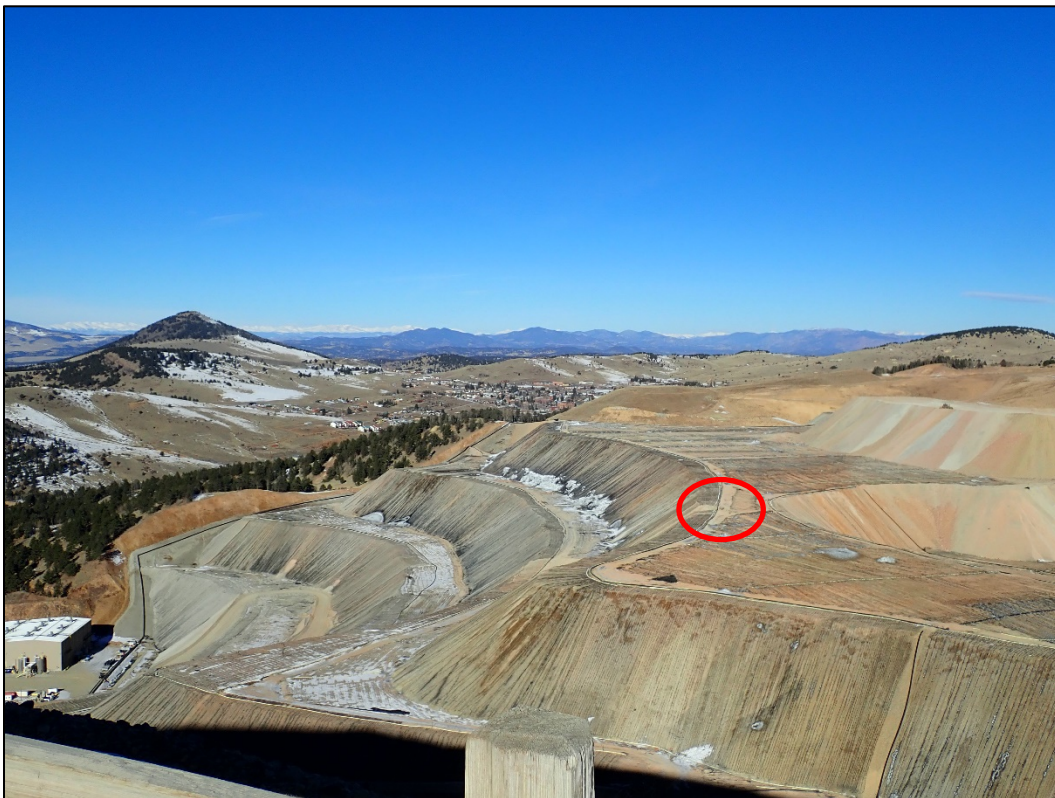
On November 5, 2018, CC&V informed the Division of a washout which occurred on the 9,850' lift of the SGVLF. The Operator stated at approximately 7:30am on November 4, 2018, a 4 inch feeder line broke on the south side of the 9,850' bench and caused a washout. All solution and displaced material remained within the SGVLF. The Division observed the washout (**Photos 7 and 8**) which the Operator stated would be backfilled when the remaining portion of the 9,750' lift is being backfilled. The Operator anticipated this would occur sometime in February.

Photo 7. Washout on the 9,850' bench of the SGVLF bench circled in red; looking northeast from State Highway 67.

Photo 8. Washout on the 9,850' bench of the SGVLF bench circled in red; looking northwest.

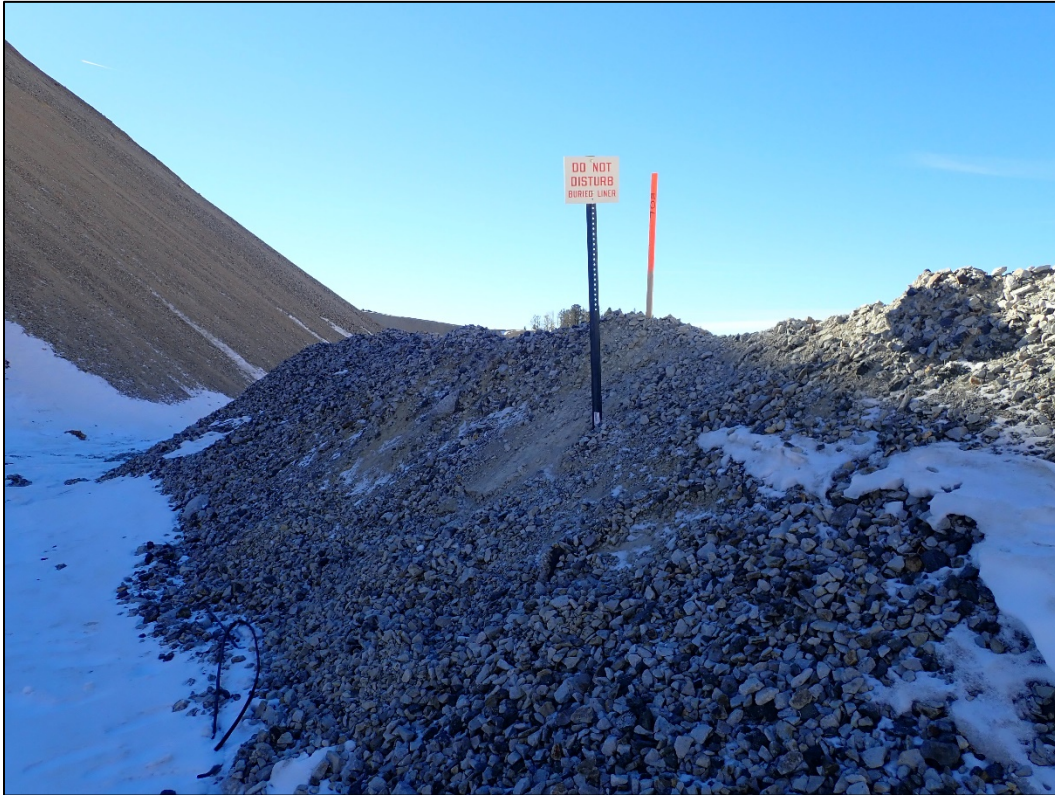
The Division observed the northwest portion of the SGVLF where, during the normal monitoring inspection on November 29, 2018, the Division had identified the need for edge of liner signs. The edge of liner had been surveyed and adequate signage was posted (**Photo 9**). This observation resolved the compliance problem cited in the November 29, 2018 inspection report.

Photo 9. Recently installed Edge of Liner signs in the northwest portion of SGVLF; looking southwest.

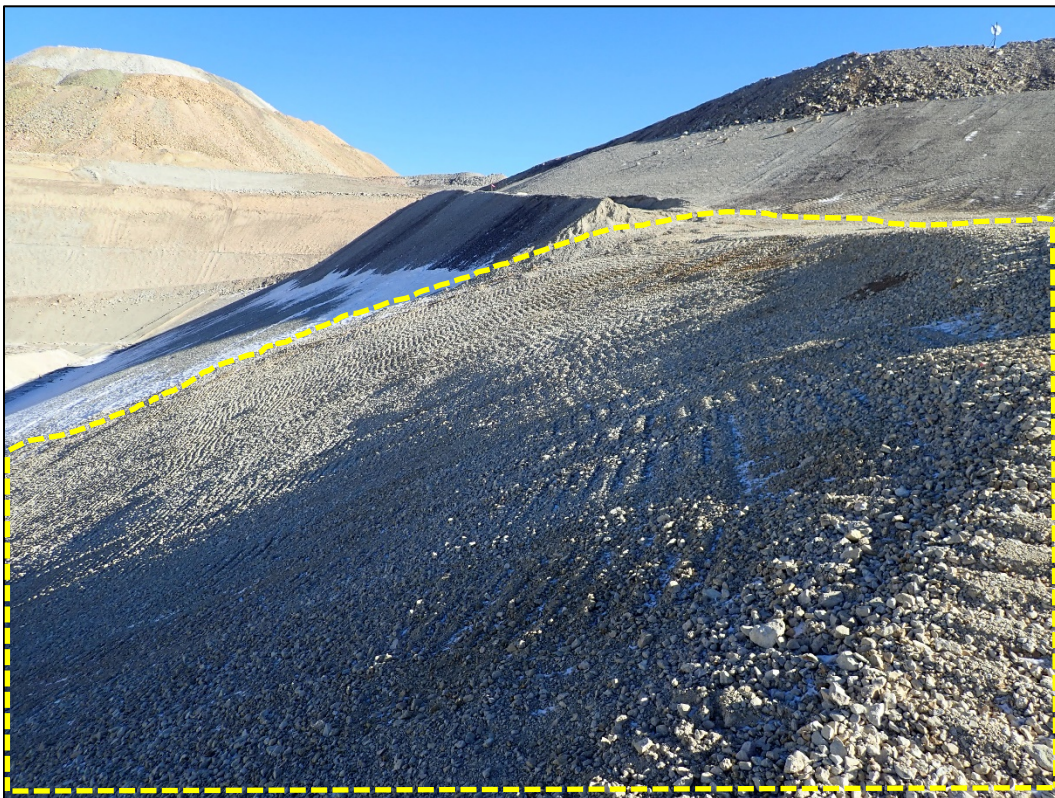
The Division observed the reject pile area north of the HGM where the liner integrity investigation proposed under TR-100 had recently concluded (**Photo 10**). On December 26, 2018, the Operator submitted the Record of Construction Report VLF2- Removal of the Crushed Ore Stockpile & Liner Integrity Verification Project.

Photo 10. Reject Pile Area where TR-100 liner integrity investigation was conducted; looking northeast.

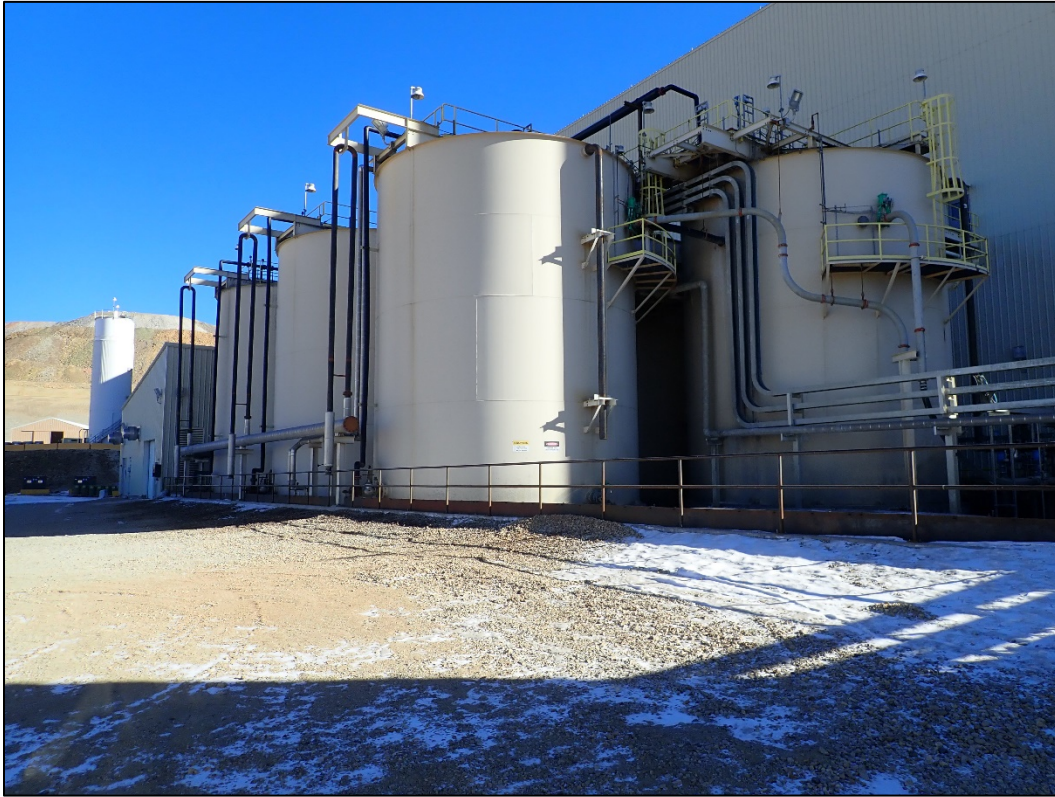
The Division inspected the HGM. Through TR-109, CC&V has been approved to utilize the empty vat-leach tanks for surge capacity of neutral pH solution (**Photo 11**). No problems or issues were noted during the HGM inspection.

Photo 11.HGM vat leach tanks; looking northeast.

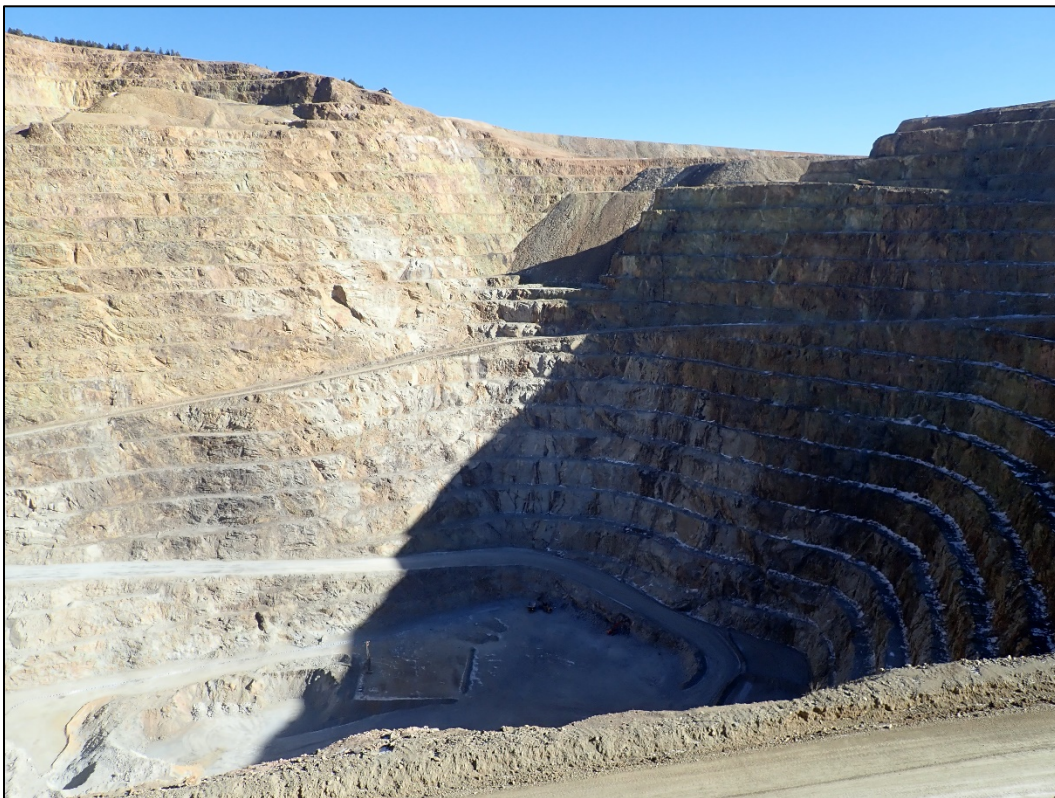
The Main Cresson Mine is divided into two mining areas known as the Main Cresson and the South Cresson. The Main Cresson was observed from the top of the Main Cresson's eastern highwall (**Photo 12**). At the time of the inspection, the Main Cresson's pit floor was at approximately 8,955'. The South Cresson was observed from the top of the Phase V area of the AGVLF (**Photo 13**). At the time of the inspection, the South Cresson's pit floor was at approximately 10,095'.

Photo 12. Overview of the Main Cresson mine; looking east

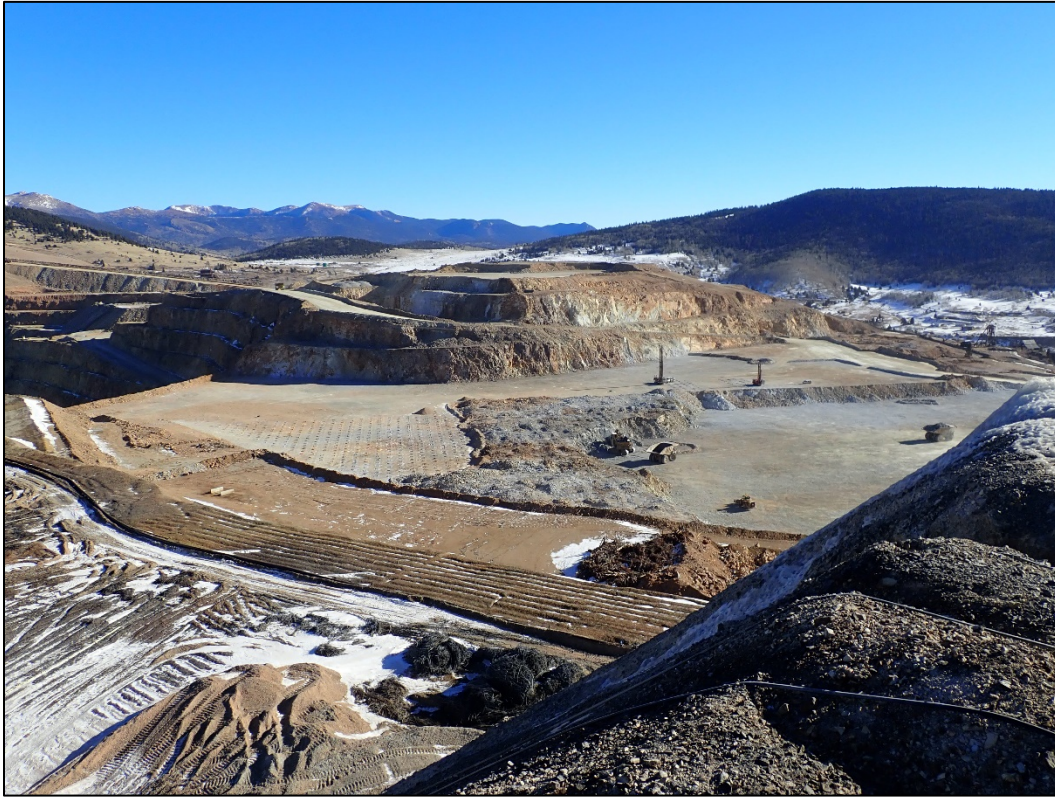
Photo 13 Overview of the South Cresson mine; looking east..

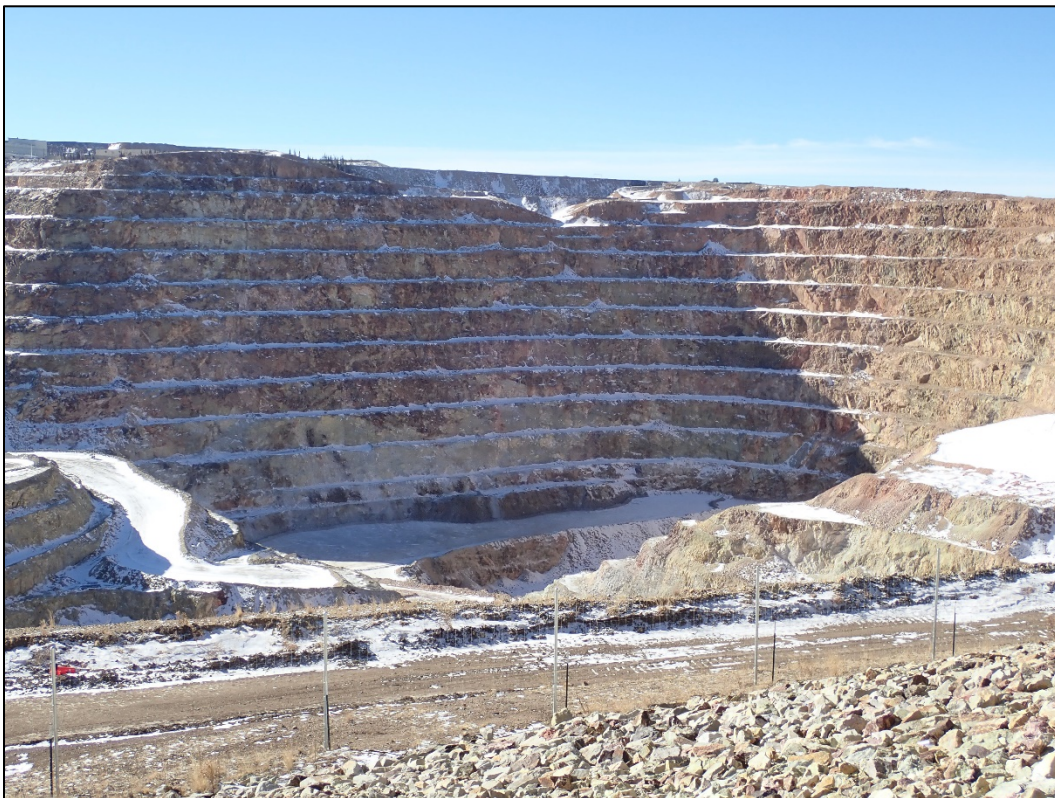
The East Cresson Mine includes the Wildhorse Extension (WHEX) Pit. The WHEX was observed from the Grassy Valley Mining Overlook along County Road 82 (**Photo 14**). Within the bottom of the WHEX, two mining areas have developed. These are known as Grassy Valley and Gold Bug. At the time of the inspection, the WHEX was at approximately 9,655'.

Photo 14. Overview of the WHEX; looking southwest.

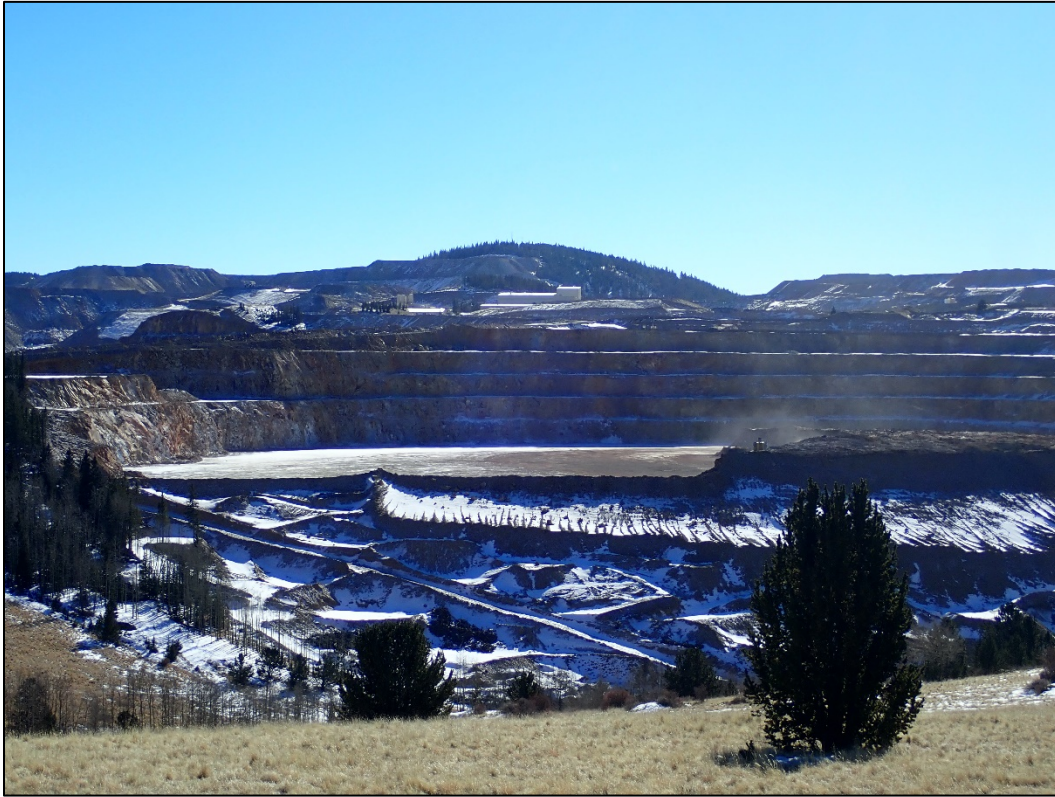
The North Cresson Mine is divided into two mining areas known as Gold Hill and Schist Island. Gold Hill was observed from County Road 82, east of the Mollie Kathleen (**Photo 15**). At the time of the inspection, Gold Hill's pit floor was at approximately 10,215'. Operations within the Schist Island area had just recently commenced. At the time of the inspection, Schist Island area was at approximately 10,180' (**Photos 16**).

Photo 15. Overview of the Gold Hill mine; looking southeast.

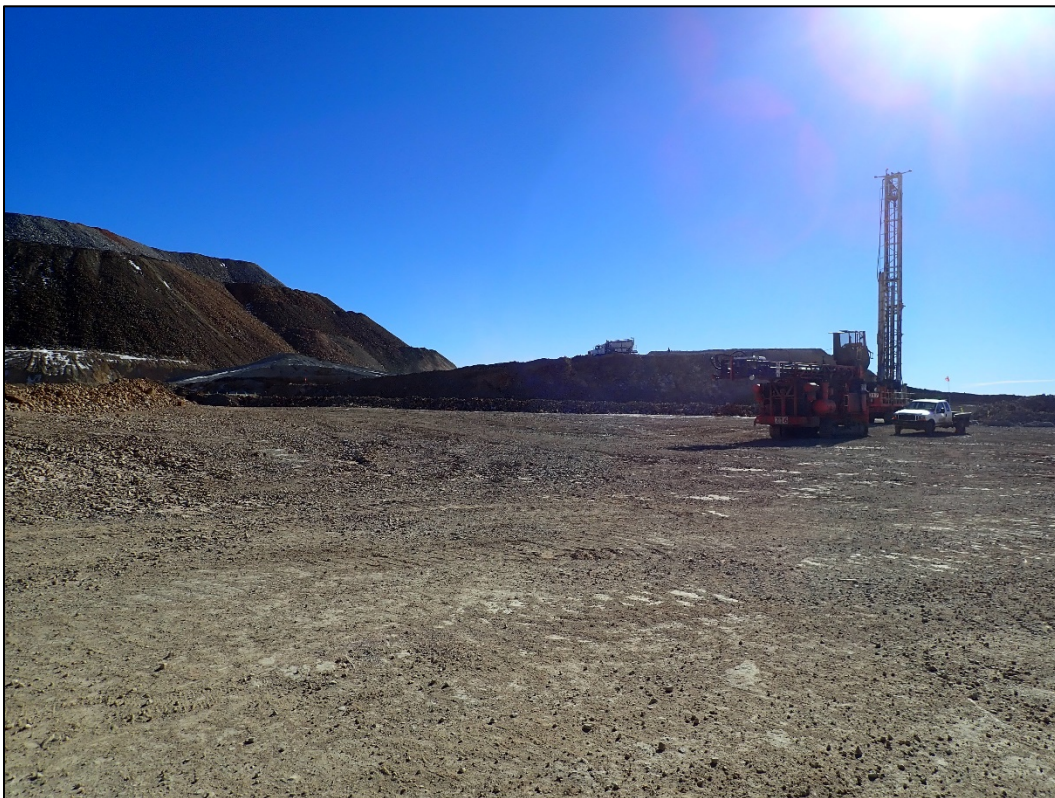
Photo 16. Development of the Schist Island mine; looking south.
