MINERALS PROGRAM INSPECTION REPORT

| MINE NAME: Cresson Project | MINE/PROSPECTING ID#: M-1980-244 | MINERAL: Gold | COUNTY: Teller |
| INSPECTION TYPE: Monitoring | INSPECTOR(S): Amy Eschberger, Patrick Lennberg | INSP. DATE: October 30, 2018 | INSP. TIME: 09:45 |

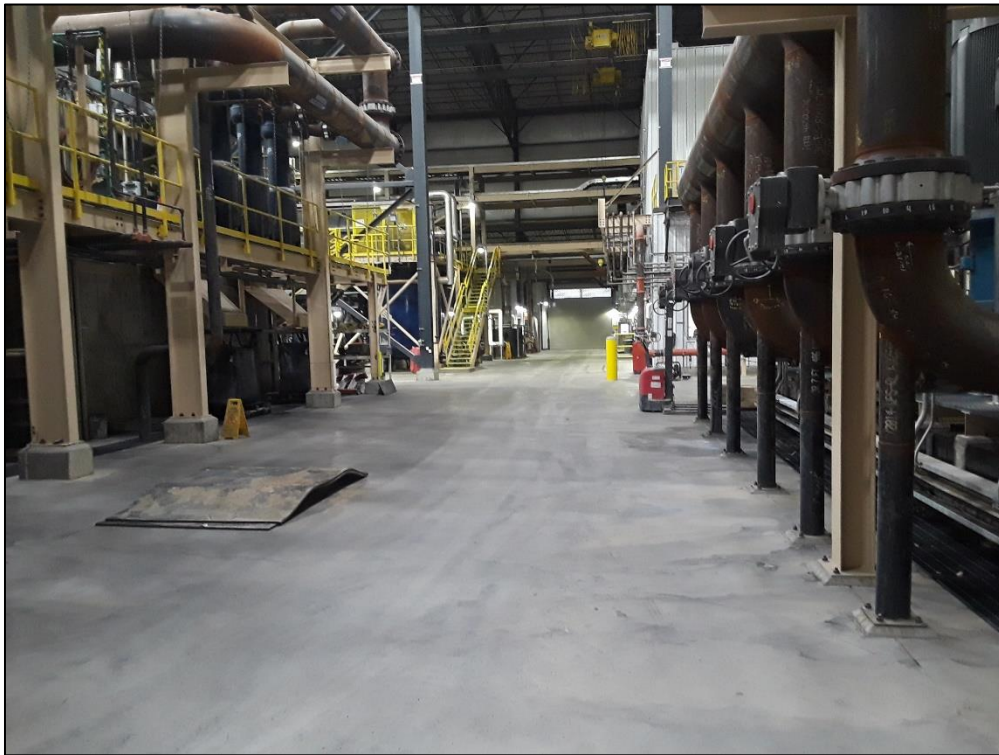
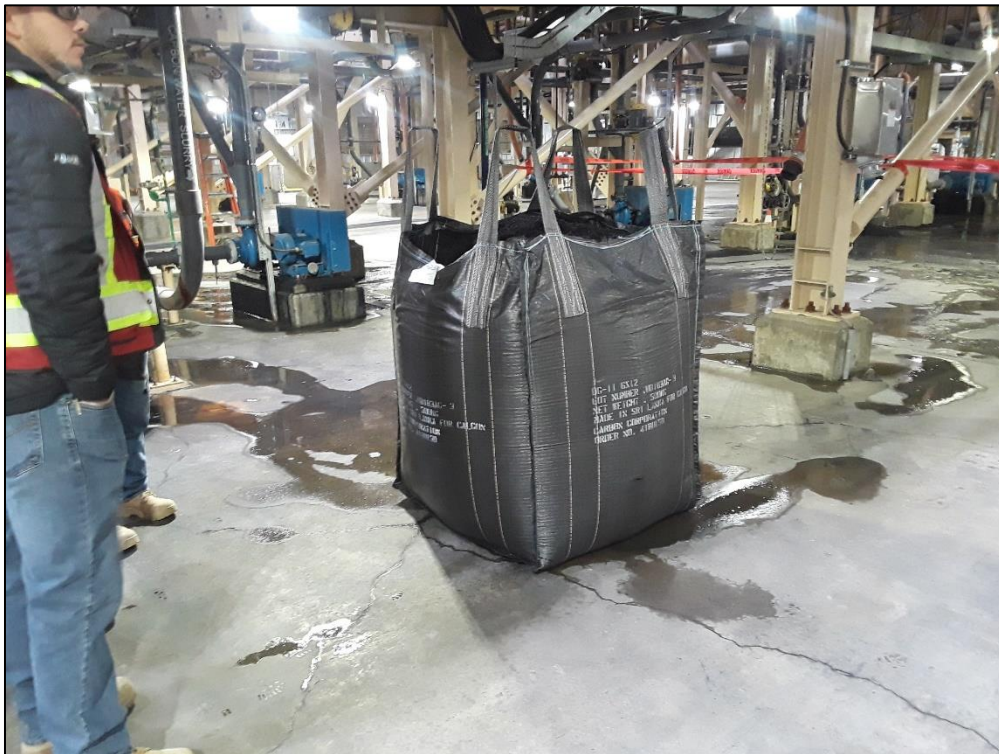
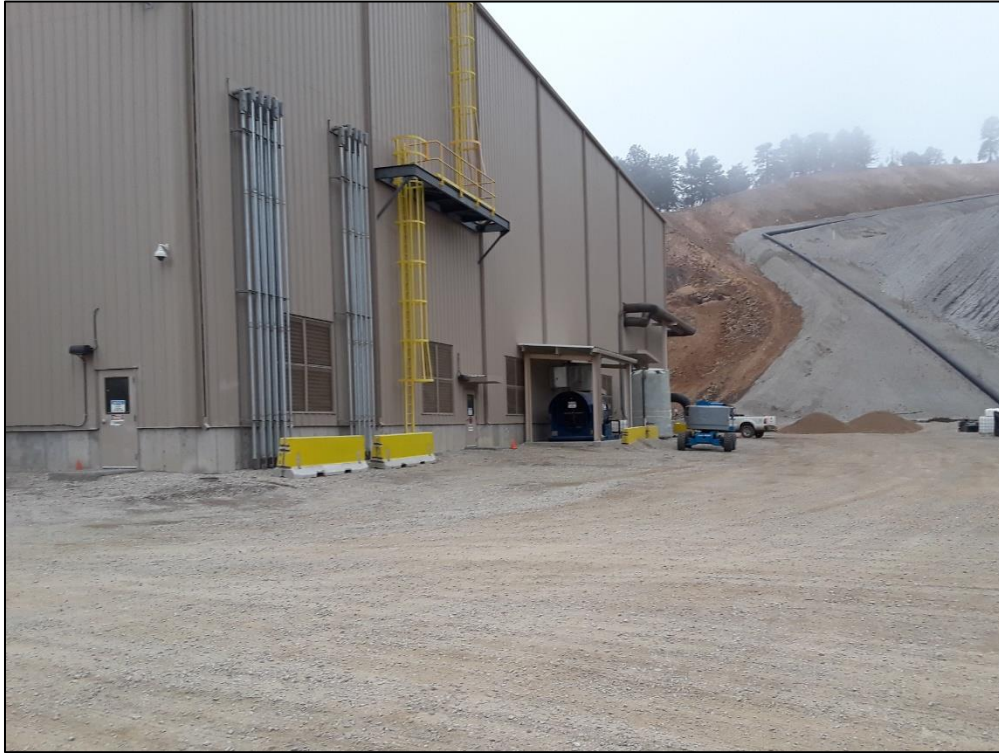
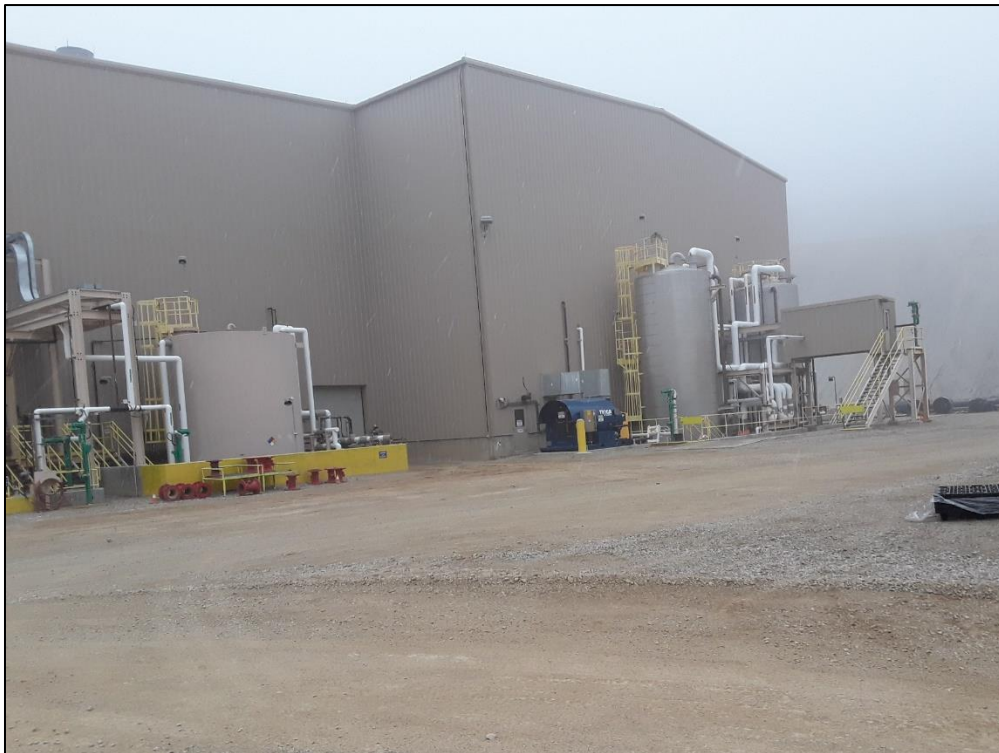
The Division inspected the interior and exterior of the ADR-2 plant (**Photos 1-4**) located in the Squaw Gulch Valley Leach Facility (SGVLF).

No problems were observed at the ADR-2 plant.

Photo 1. Interior view of Adsorption-Desorption Recovery Plant No. 2 (ADR-2) located in Squaw Gulch Valley Leach Facility.

Photo 2. Interior view of Adsorption-Desorption Recovery Plant No. 2 (ADR-2) located in Squaw Gulch Valley Leach Facility.

Photo 3. Exterior view of Adsorption-Desorption Recovery Plant No. 2 (ADR-2) located in Squaw Gulch Valley Leach Facility, showing northeast side of building.

Photo 4. Exterior view of Adsorption-Desorption Recovery Plant No. 2 (ADR-2) located in Squaw Gulch Valley Leach Facility, showing southeast side of building.

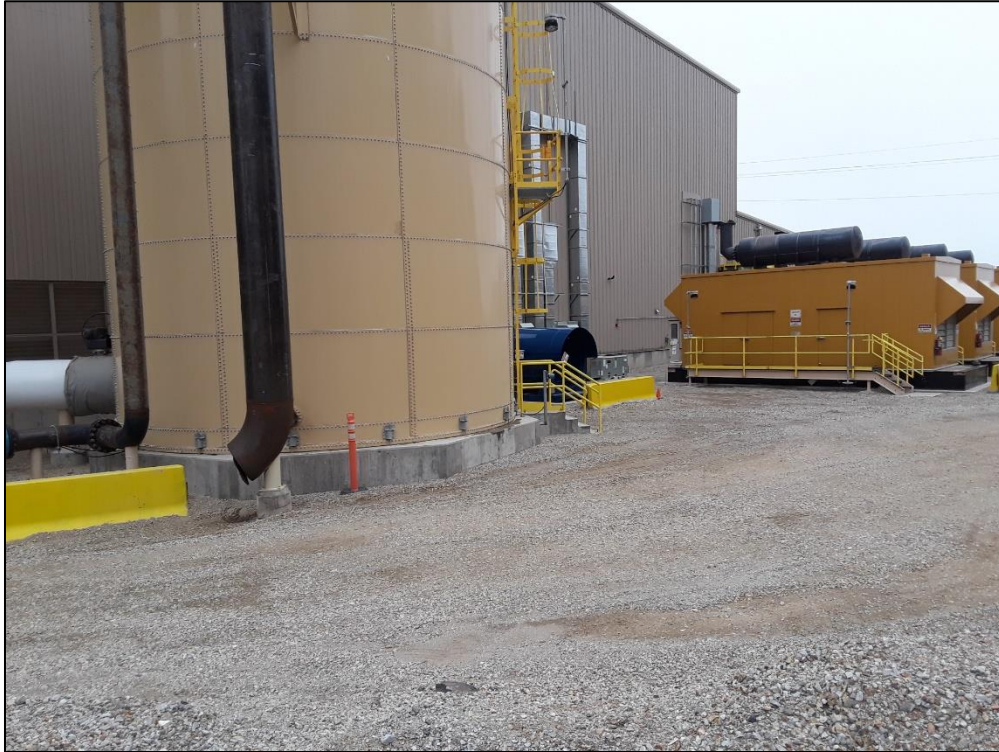
The Division inspected the area where a spill of approximately 4,000 gallons of barren solution occurred on September 29, 2018 from the barren solution tank located at the northwestern exterior edge of the plant (**Photo 5**). The spill occurred due to a valve malfunction which caused the pump at the barren solution tank to shutdown, causing the tank to overflow. The operator notified the Division of this spill on September 30, 2018. The spilled solution was fully contained over the SGVLF triple-lined Pregnant Solution Storage Area (PSSA). The material impacted by the spill was over-excavated and clean fill was brought in to eliminate the potential for tracking the impacted material to unlined areas.

Photo 5. Exterior view of Adsorption-Desorption Recovery Plant No. 2 (ADR-2) located in Squaw Gulch Valley Leach Facility, showing northwest side of building. Barren solution tank at left overflowed on 9/29/18 due to a valve malfunction. Material impacted by the spill was removed and replaced with clean fill material.

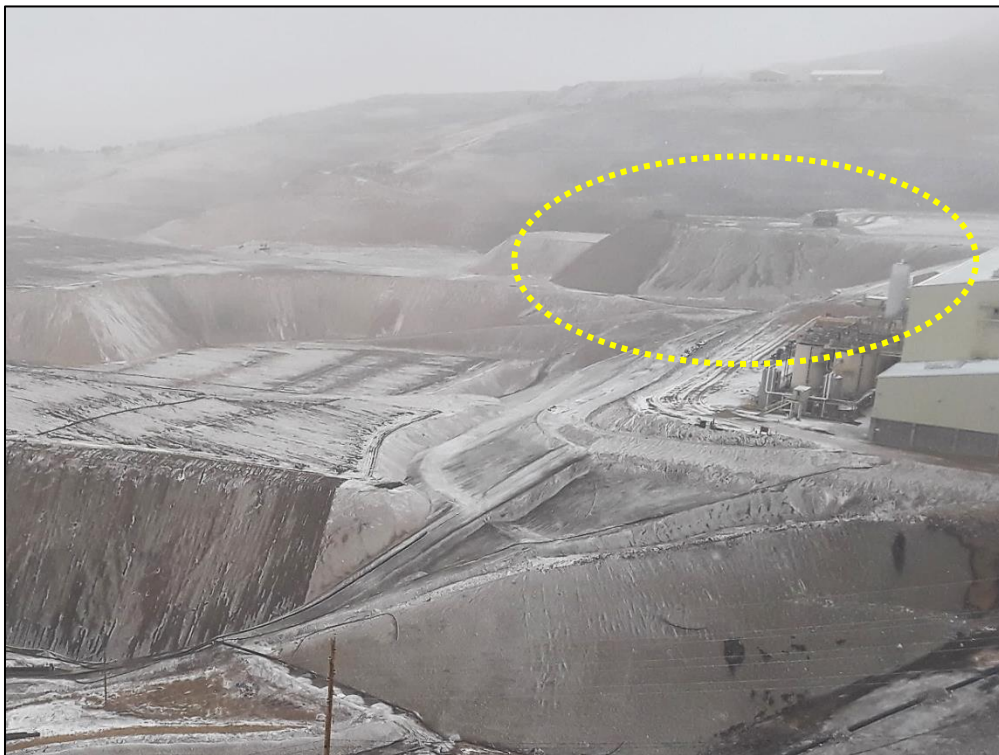
The operation is currently advancing the 5th (100 foot) ore lift in the SGVLF, at an elevation of 9,950 feet (**Photo 6**). The Division inspected active leaching surfaces on the SGVLF (**Photos 7 and 8**). The operation is required to minimize ponding of leaching solution to less than 3 feet by 3 feet in area. This is to prevent the ponds from being a wildlife attractant. Active leaching areas were well-ripped to minimize ponding. No significant ponding was observed.

Photo 6. View looking north across Squaw Gulch Valley Leach Facility, showing operation advancing 5th (100 foot) ore lift at an elevation of 9,950 feet (circled).

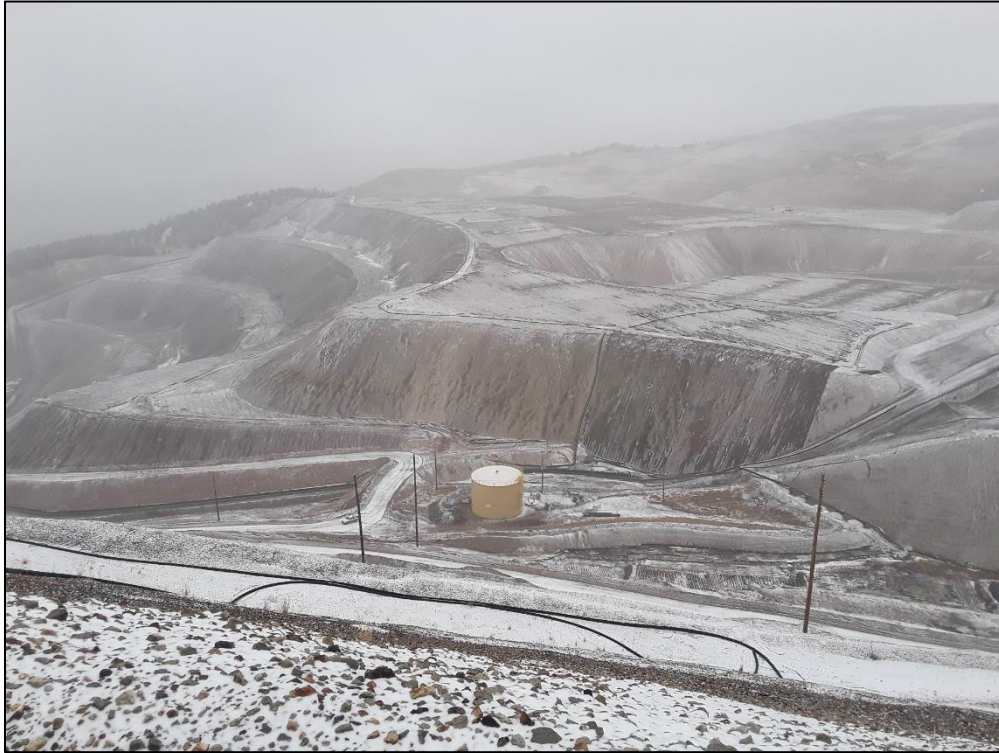
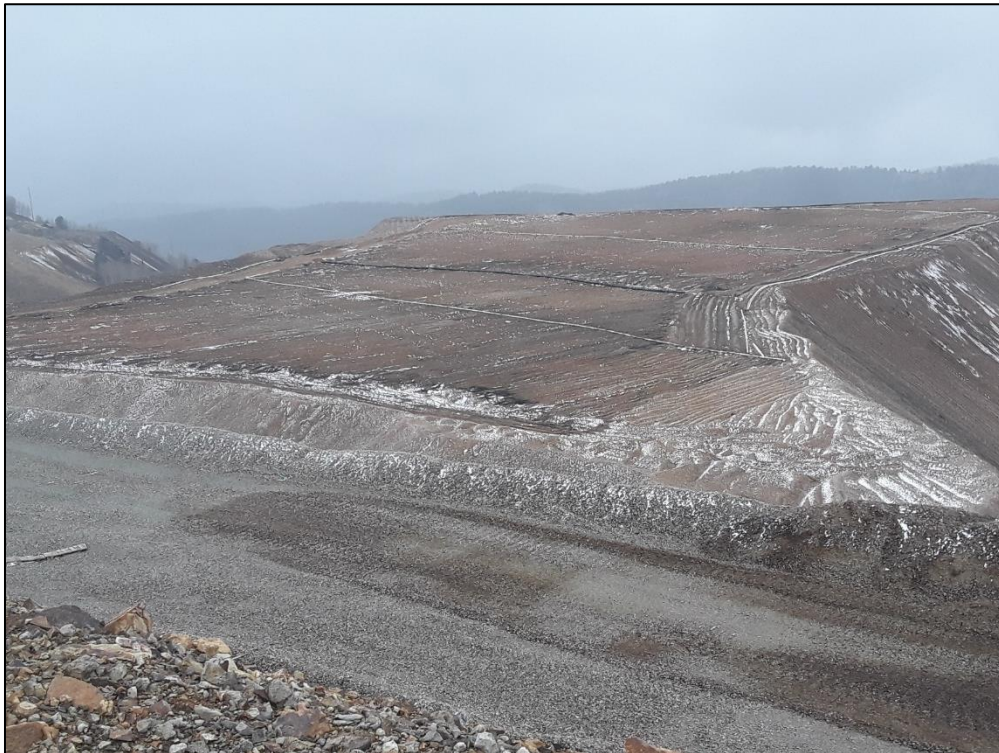
Photo 7. View looking west across Squaw Gulch Valley Leach Facility. No significant ponding was observed on leaching surfaces.

Photo 8. View looking west from HGM area across Squaw Gulch Valley Leach Facility. No significant ponding was observed on leaching surfaces.

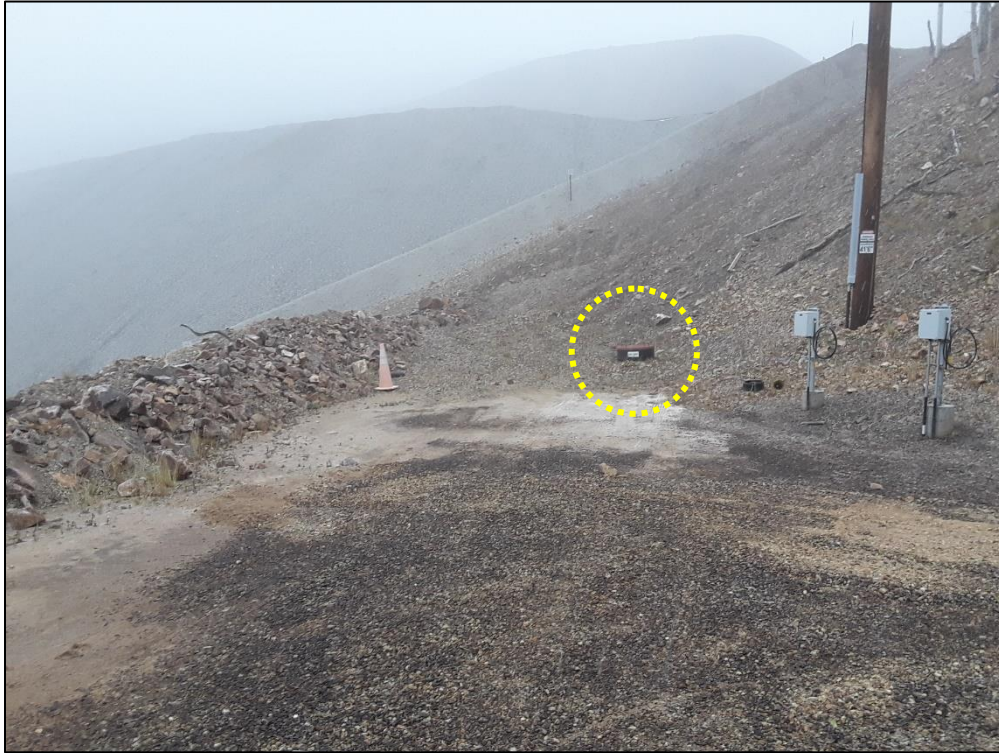
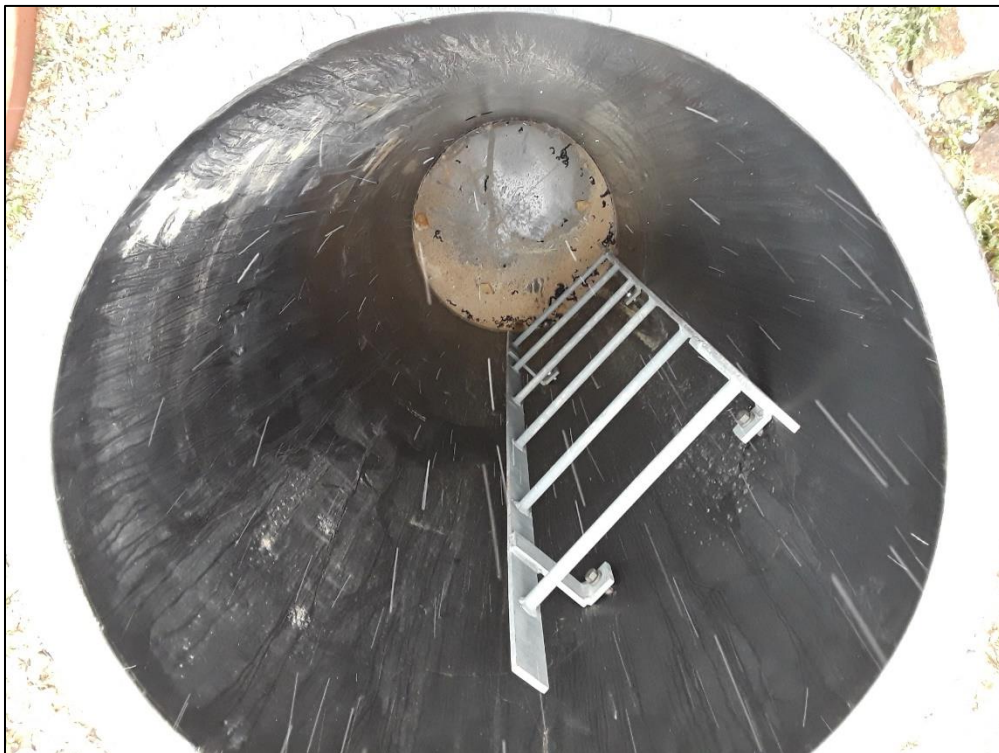
Photo 9. View of SG-LDS-1 sump (circled) located at southern edge of SGVLF.

Photo 10. View looking inside of SG-LDS-1 sump located at southern edge of SGVLF, showing sump dry during inspection.

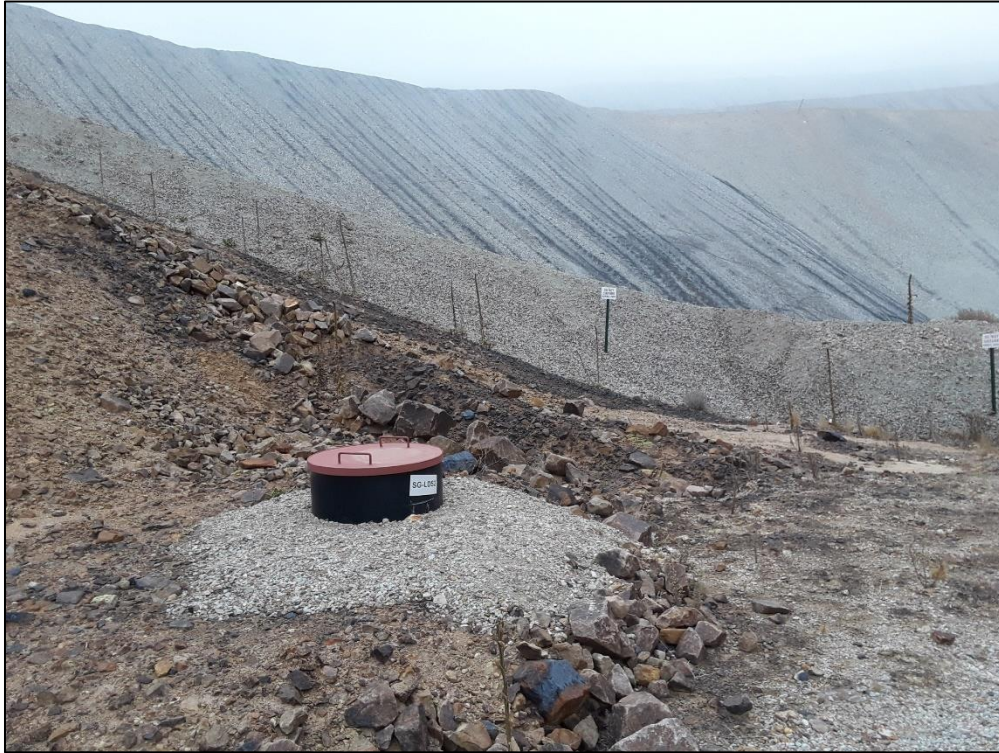
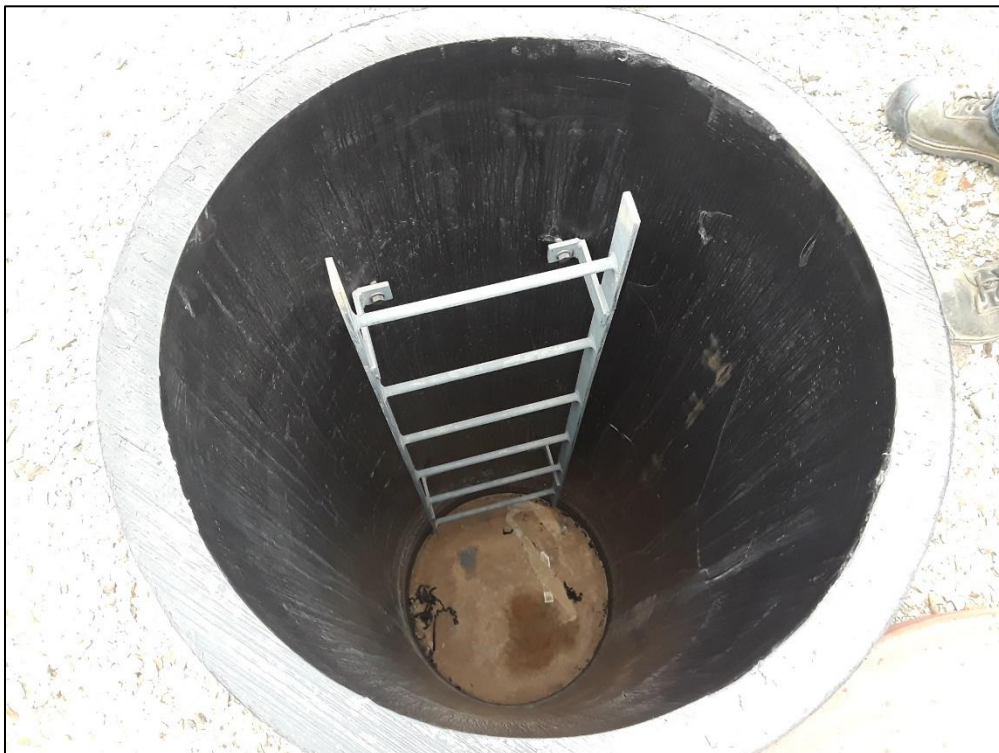
Photo 11. View of SG-LDS-2 sump located at southwestern edge of SGVLF.

Photo 12. View looking inside of SG-LDS-2 sump located at southwestern edge of SGVLF, showing sump dry during inspection.

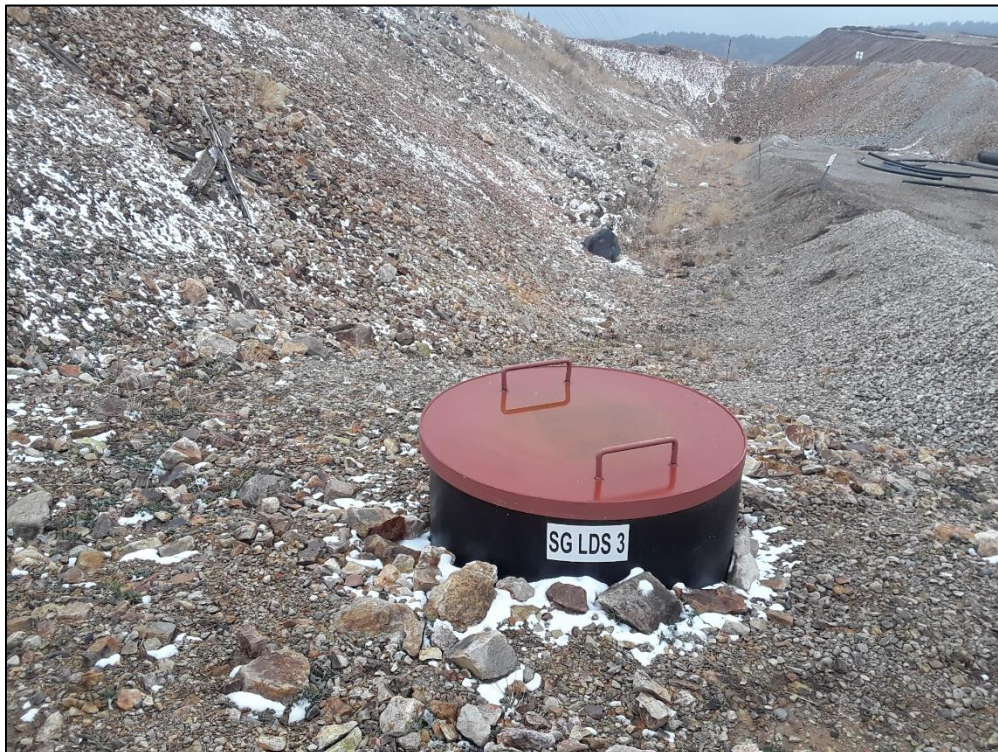
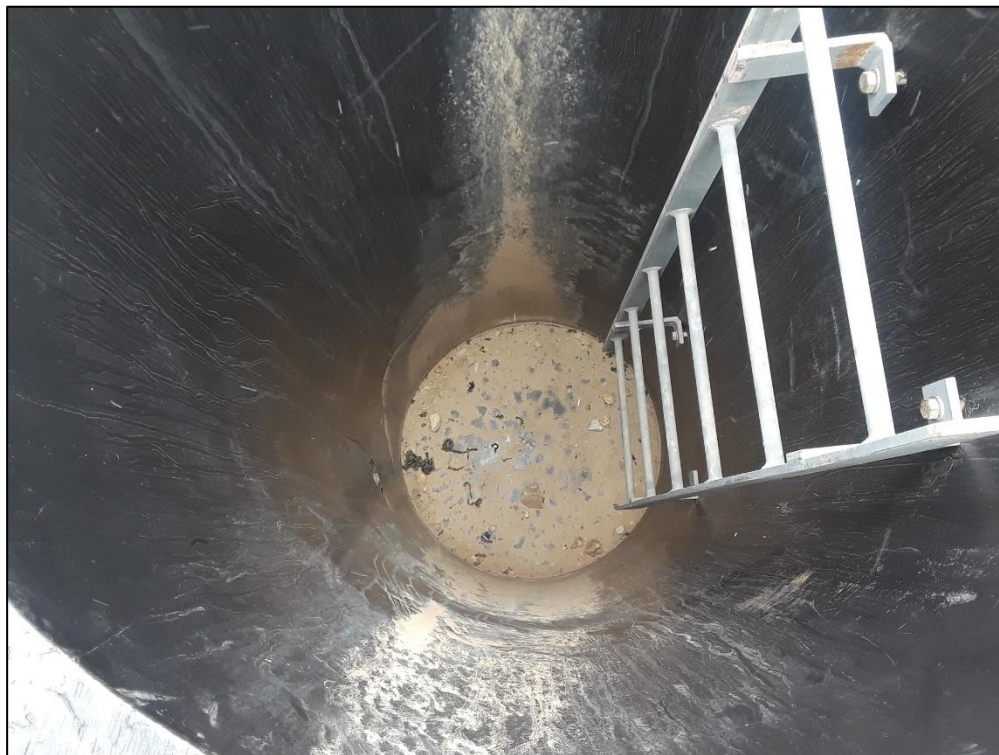
Photo 13. View of SG-LDS-3 sump located at eastern edge of SGVLF.

Photo 14. View looking inside of SG-LDS-3 sump located at eastern edge of SGVLF, showing sump dry during inspection.

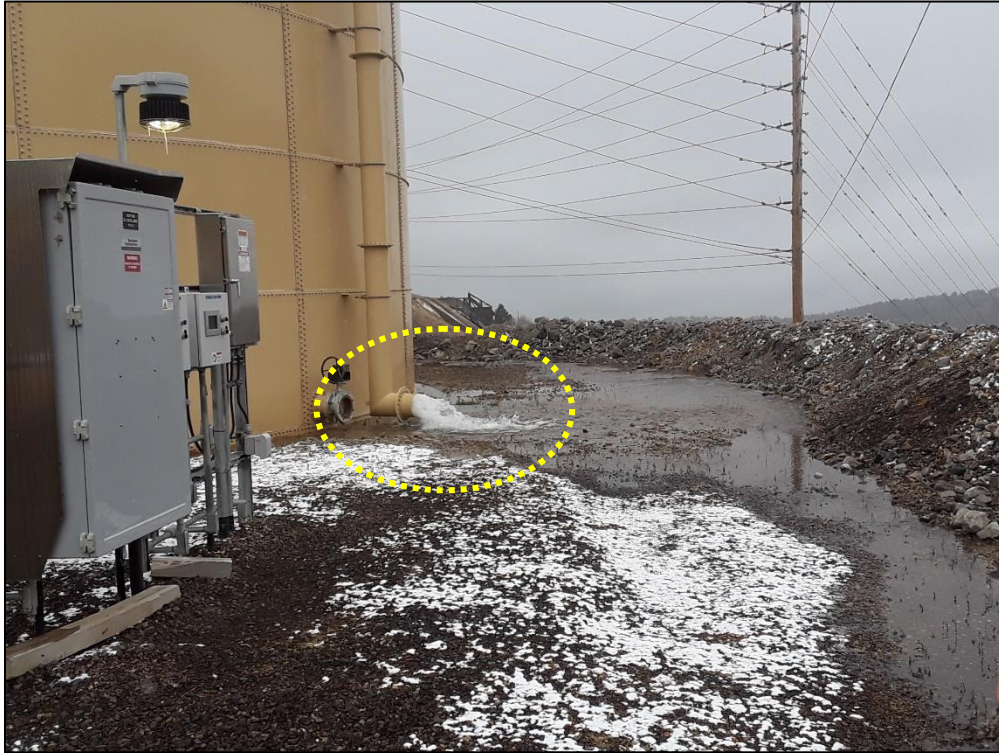
It should be noted, while inspecting the SG-LDS-3 sump, the Division observed water flowing from the overflow pipe of the freshwater tank (**Photo 15**) located just southwest of the High Grade Mill Facility (HGM) facility. The overflow water was contained by a berm constructed around the edge of the water tank area. According to the operator, overflow from this tank is rare, and the particular event observed during the inspection was caused by a fault in the tank level indicator. The indicator was repaired and the issue has not reoccurred since the inspection (according to email correspondence from the operator received on February 11, 2019). This is not considered an event that requires notification of the Division pursuant to Rule 8.

Photo 15. View looking west, showing water flowing from overflow pipe (circled) of freshwater tank located just southwest of HGM facility. The water was contained by a berm constructed around the edge of the water tank area.

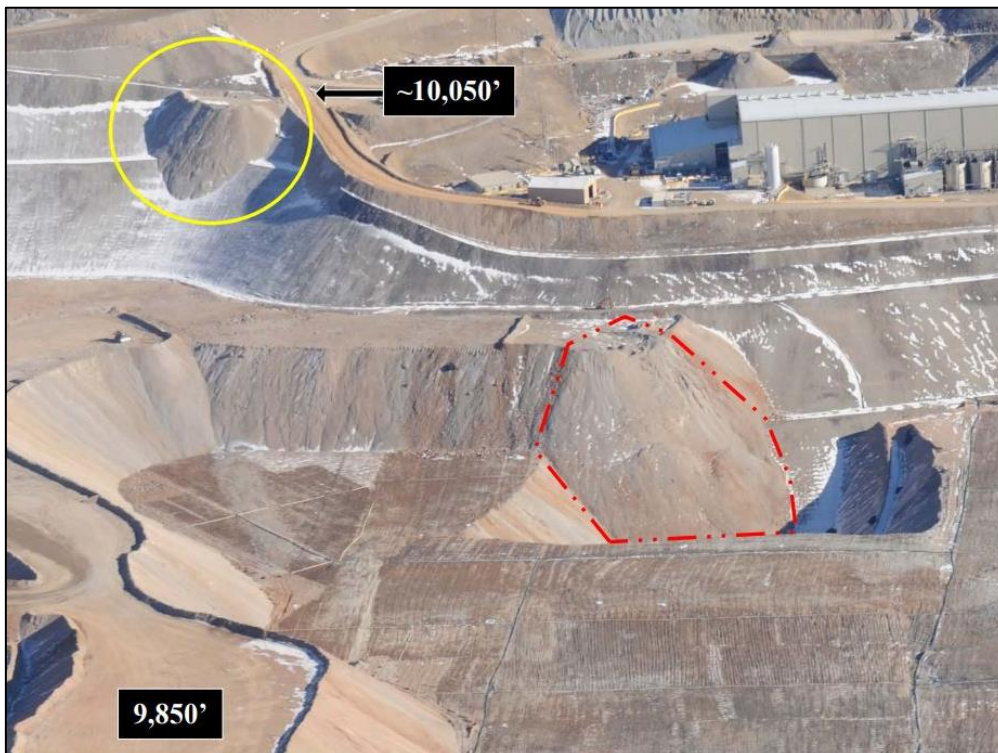
The Division inspected the reject pile area located at the 10,050 foot elevation level in the SGVLF, just north of the High Grade Mill Facility (**Photo 16**). Placement of this pile was not approved in the permit, thus, the Division cited a problem for this activity in its inspection report for February 27, 2018. The operator submitted Technical Revision No. 100 (TR-100) to address this matter, including plans for temporarily buttressing the reject material until it can be removed down to the DCF, and the liner beneath the pile inspected to ensure it was not damaged by this activity. At the time of the current inspection, the reject pile had been temporarily buttressed by ramping up the 9,950 foot ore lift (**Photo 17**).

Photo 16. View looking southeast, showing approximate 10,050 foot lift (circled in yellow) placed in northeastern portion of SGVLF, just north of HGM facility. This photo was taken from the Division's 2/27/18 inspection report.

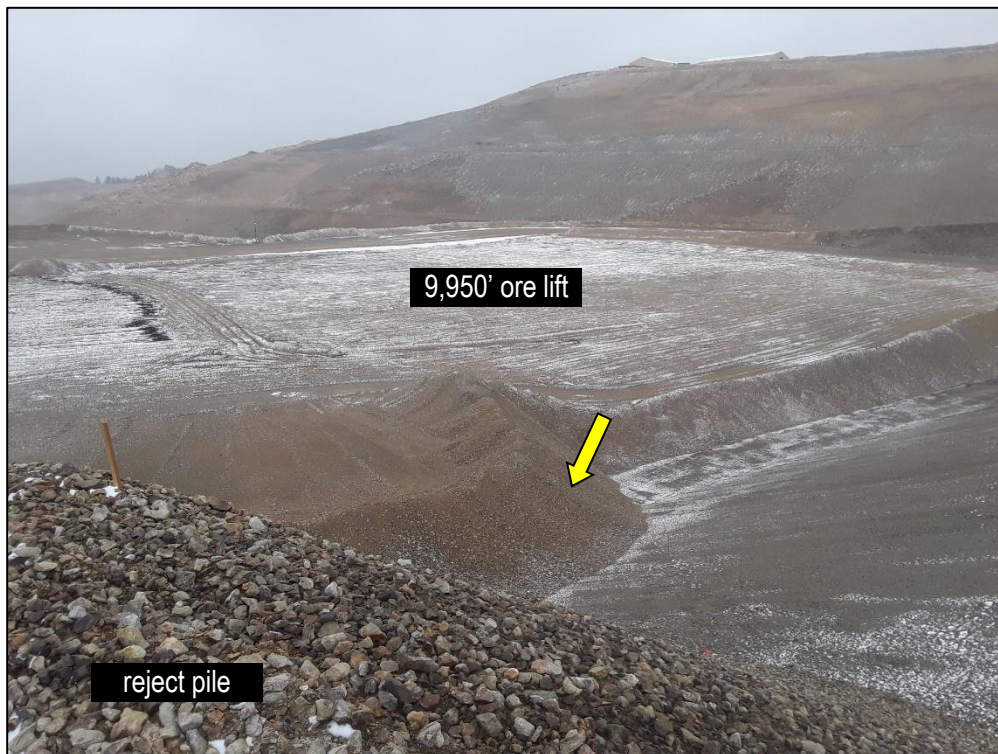
Photo 17. View looking northwest from edge of reject pile at 10,040 foot elevation (shown in Photo 16), showing pile temporarily buttressed by ramp from 9,950 foot ore lift (indicated with arrow).

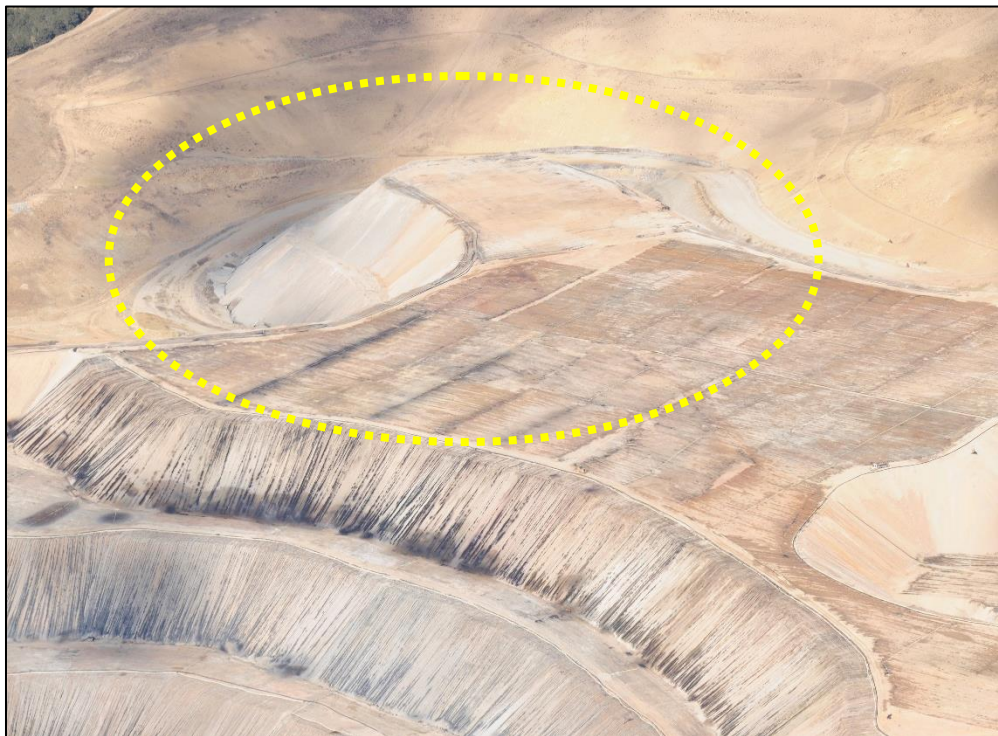
During the inspection, the Division inquired about the northern edge of the SGVLF where the operation has completed two 100-foot lifts above the haul road (**Photo 18**). Particularly, the Division wanted to know how the operation plans to continue building out the 9,750 foot and 9,850 foot ore lifts in this portion of the facility, given the liner has only been approved to the 9,650 foot elevation on that side of the facility, and the operation is not approved to dump ore from greater than 100 feet. The Division asked how the ore-stacking plan, as approved in Technical Revision No. 103 (TR-103) will be adhered to in this particular area. The operator emailed a formal response to this question on November 27, 2018. This response stated that once the Phase 2 liner is constructed, a haul road will be ramped down to the bottom of the existing lift. This will allow build-out to be advanced from the bottom up in alignment with the commitments made in TR-103, avoiding dumping from greater than 100 feet. The area will not be built out until the Phase 2 liner has been constructed and its certification reviewed and approved by the Division. The Division had some additional notes on this matter in its inspection report for November 29, 2018, emphasizing this activity will require frequent and detailed coordination between mine planners and equipment operators in order to avoid damage to the liner during the transition to loading the Phase 2 liner.

Photo 18. View looking across northwestern portion of SGVLF where operation has completed two 100-foot lifts (at 9,750 feet and 9,850 feet) above the haul road. The Division inquired how the ore-stacking plan approved in TR-103 will be adhered to in this particular area (circled).

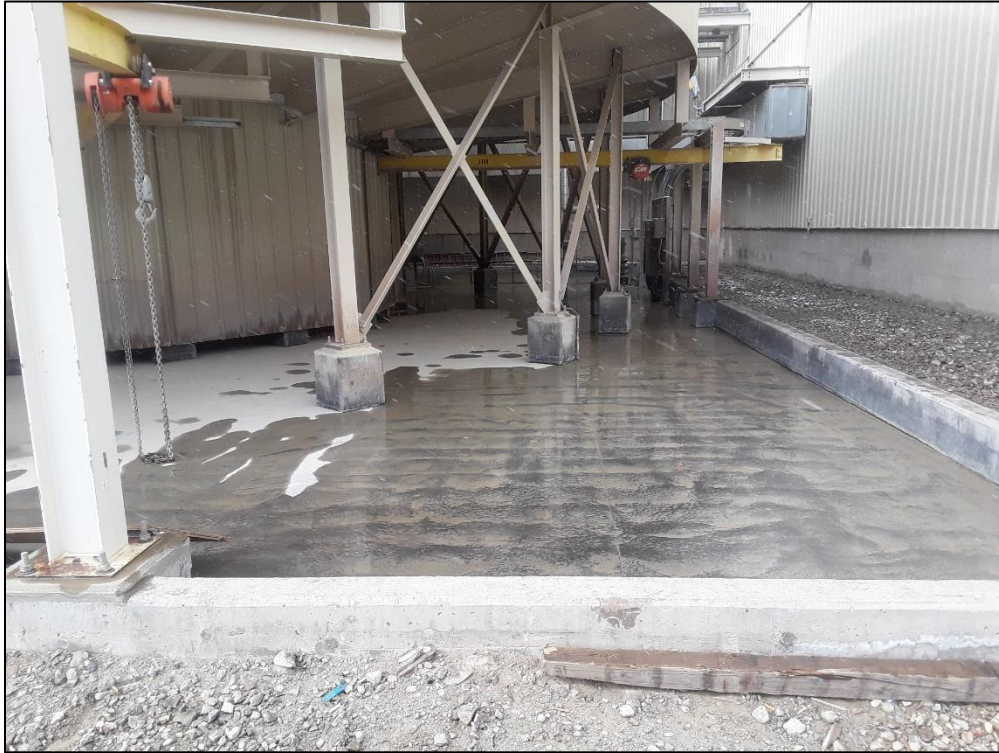
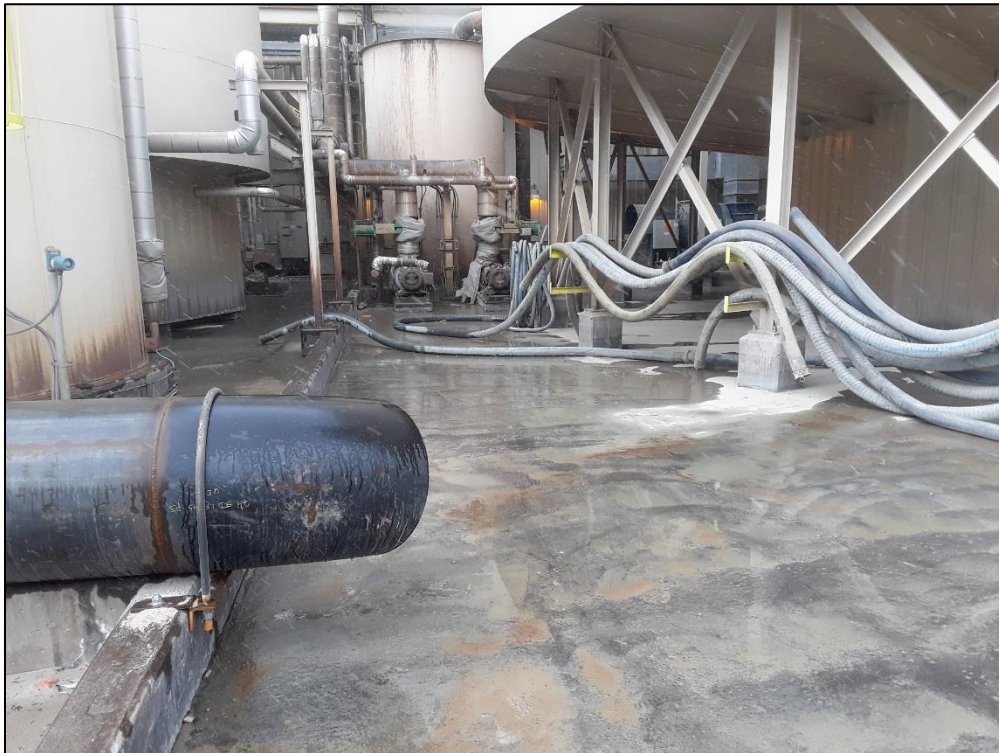
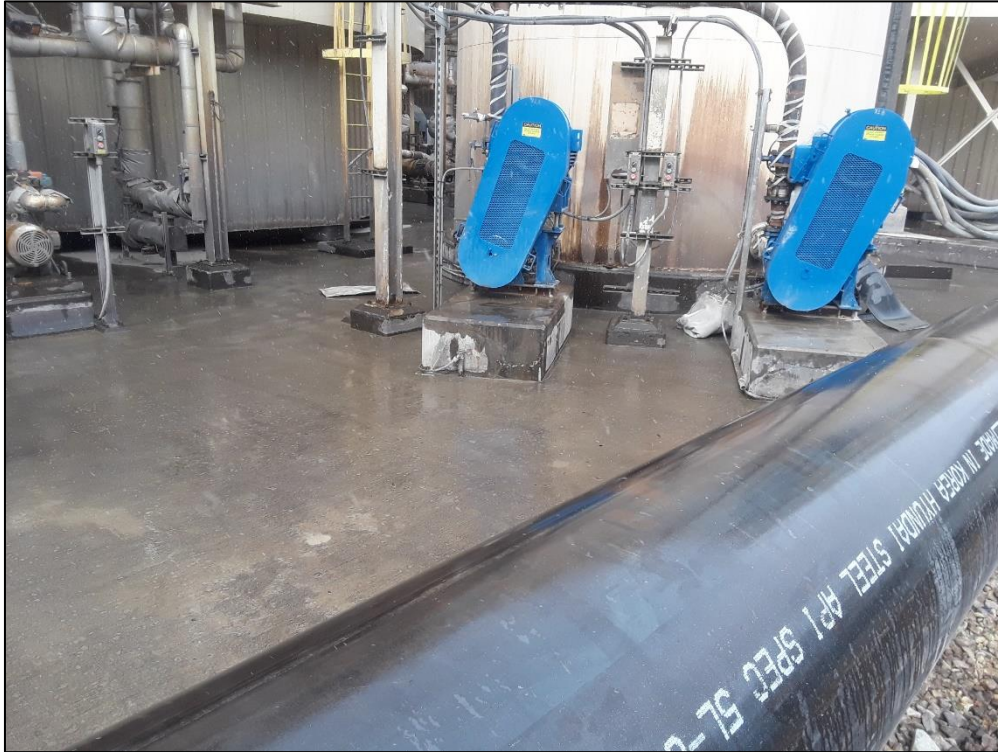
The Division walked around the exterior of the HGM facility to inspect for leaks, spills, and secondary containment issues (**Photos 19-21**). The secondary containment structures had no significant reduction in storage. The Division also inspected the area around the concentrate storage facility (Con Barn) located at the southern edge of the HGM (**Photo 22**). The vat leach circuit on the west side of the HGM continues to be offline (since February of 2018). However, Technical Revision No. 109 (TR-109), approved after the current inspection (on February 5, 2019), allows the existing vat leach tanks to be utilized for surge capacity of neutral pH process solution.

Photo 19. Exterior view of High Grade Mill facility, showing east side of building. Note secondary containment structure has no significant reduction in storage.

Photo 20. Exterior view of High Grade Mill facility, showing east side of building. Note secondary containment structures have no significant reduction in storage.

Photo 21. Exterior view of High Grade Mill facility, showing east side of building. Note secondary containment structure has no significant reduction in storage.

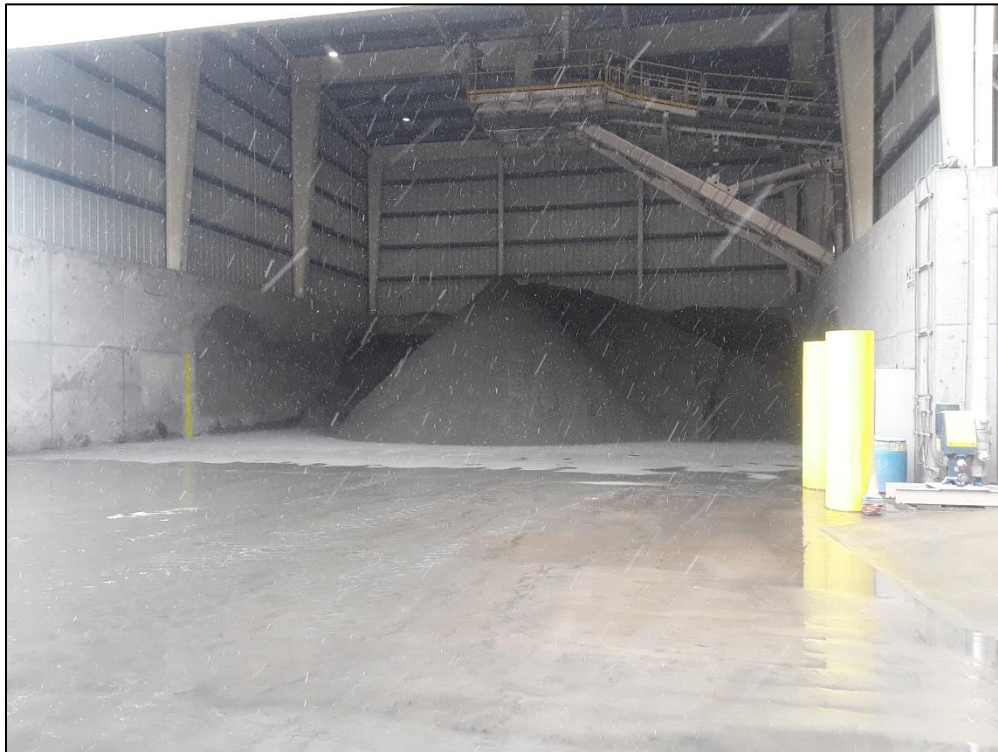
Photo 22. View of concentrate storage facility (Con Barn) located at southern edge of High Grade Mill facility.

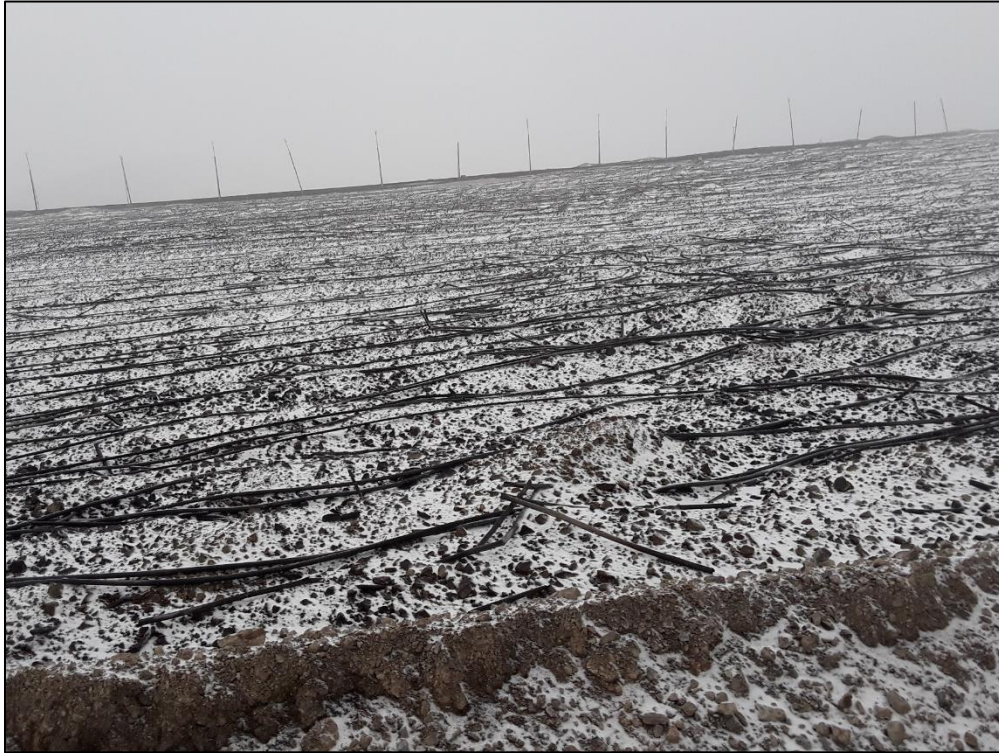
Photo 23. View looking across top of Arequa Gulch Valley Leach Facility. No significant ponding was observed on leaching surfaces.

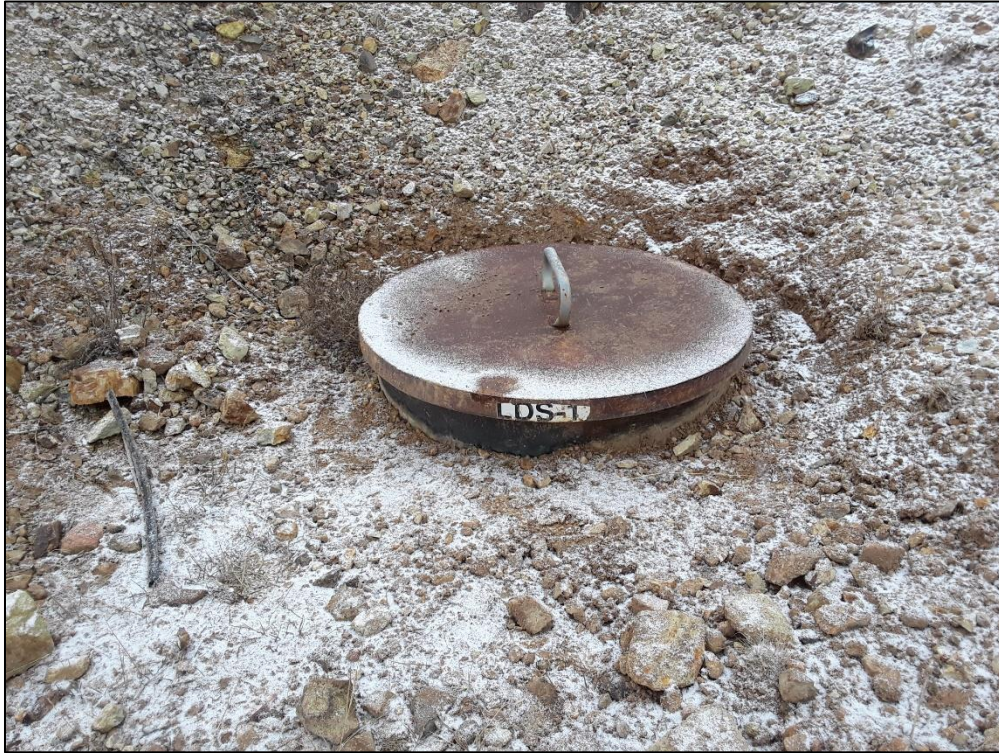
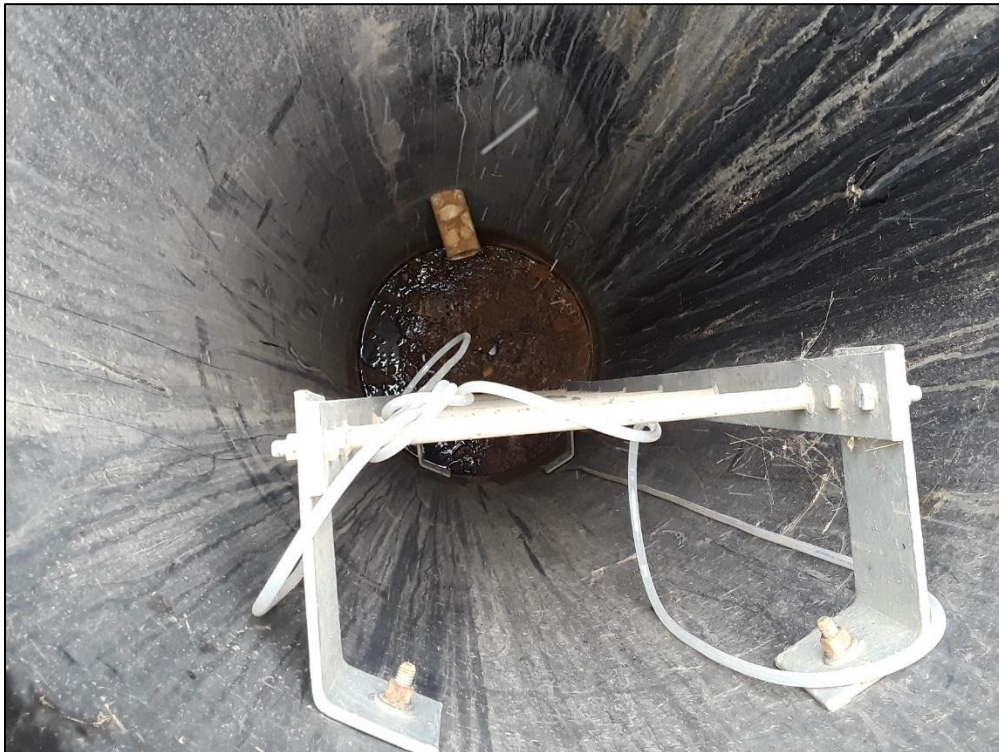
Photo 25. View of AG-LDS-1 sump located near ADR-1 plant in Phase I of AGVLF.

Photo 26. View looking inside of AG-LDS-1 sump located near ADR-1 plant in Phase I of AGVLF, showing sump contained some sediment and water.

A total of 15 Leak Detection System (LDS) sumps exist in the AGVLF. The Division inspected six of these LDS sumps, including AG-LDS-1 (**Photos 25 and 26**) and AG-LDS-9 (**Photos 27 and 28**; located near the ADR-1 plant in Phase I), AG-LDS-2 (**Photos 29 and 30**; located near the External Storage Pond in Phase I), AG-LDS-3 (**Photos 31 and 32**; located just west of AG-LDS-2 in Phase II), and AG-LDS-12 (**Photos 33 and 34**) and AG-LDS-13 (**Photos 35 and 36**; located at the northern edge of the crusher area, in Phase IV). AG-LDS-1, AG-LDS-2 and AG-LDS-12 had some sediment and a minor amount of water (< 2 inches). AG-LDS-3 had a minor amount of water. The other sumps inspected were dry. The operator indicated the sumps with water had been recently sampled. The Division recommends the operator clean out any sediment and/or water from the sumps that have been sampled as soon as possible.

In its inspection report sent on September 27, 2018, the Division recommended a raise or barrier for some of the LDS sumps where the ground surface was close to the top of the sump. The Division specified this should be done for AG-LDS-1 and AG-LDS-13. During the current inspection, the Division observed the ground surface had been excavated around these sumps, per the Division's recommendations. This should help minimize debris deposition and surface runoff into the sumps. Keeping sediment and snow away from the immediate area of the tops of the sumps will require consistent attention and maintenance by the operation.
