MINERALS PROGRAM INSPECTION REPORT

| MINE NAME: Cresson Project | MINE/PROSPECTING ID#: M-1980-244 | MINERAL: Gold | COUNTY: Teller |
| INSPECTION TYPE: Monitoring | INSPECTOR(S): Amy Eschberger, Patrick Lennberg | INSP. DATE: October 30, 2018 | INSP. TIME: 09:45 |

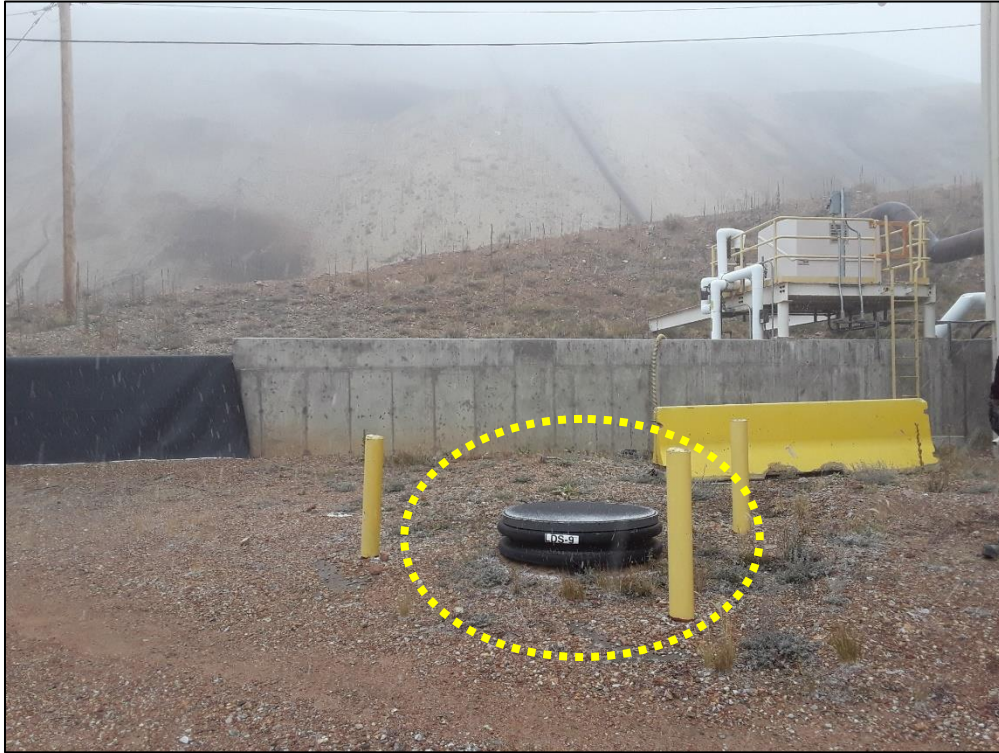
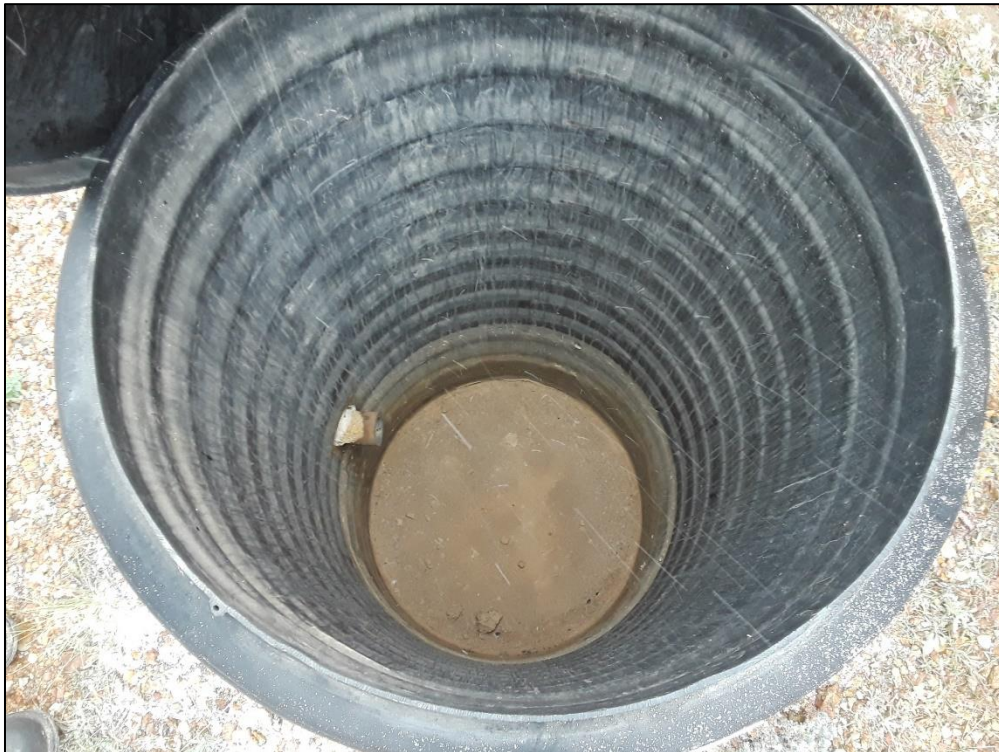
Photo 27. View of AG-LDS-9 sump (circled) located near ADR-1 plant in Phase I of AGVLF.

Photo 28. View looking inside of AG-LDS-9 sump located near ADR-1 plant in Phase I of AGVLF, showing sump dry during inspection.

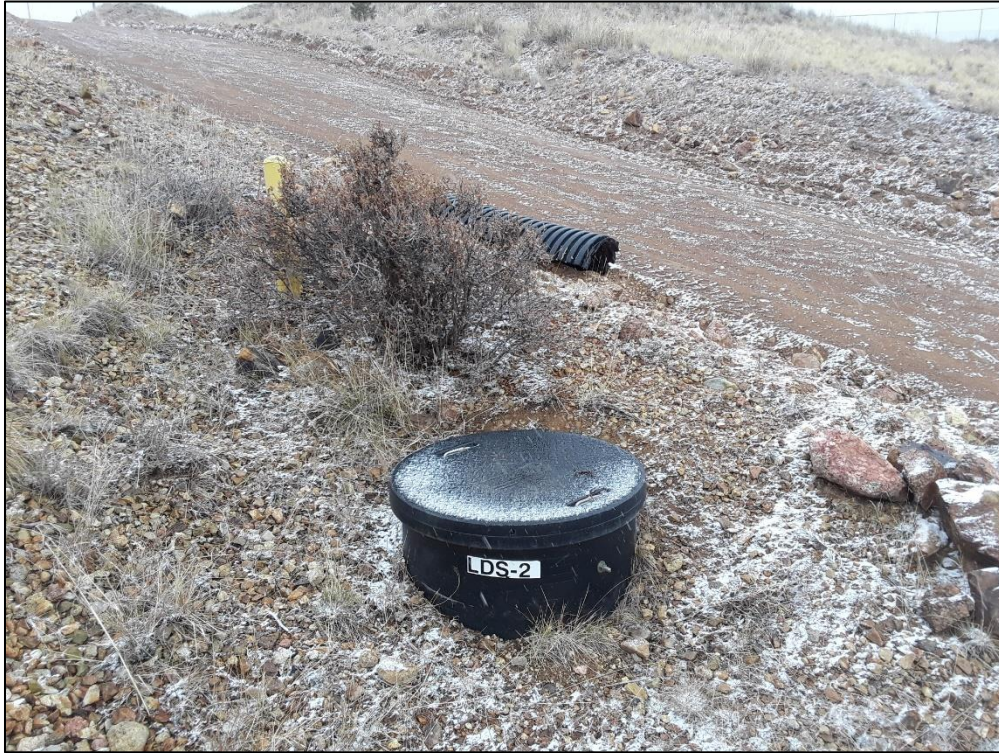
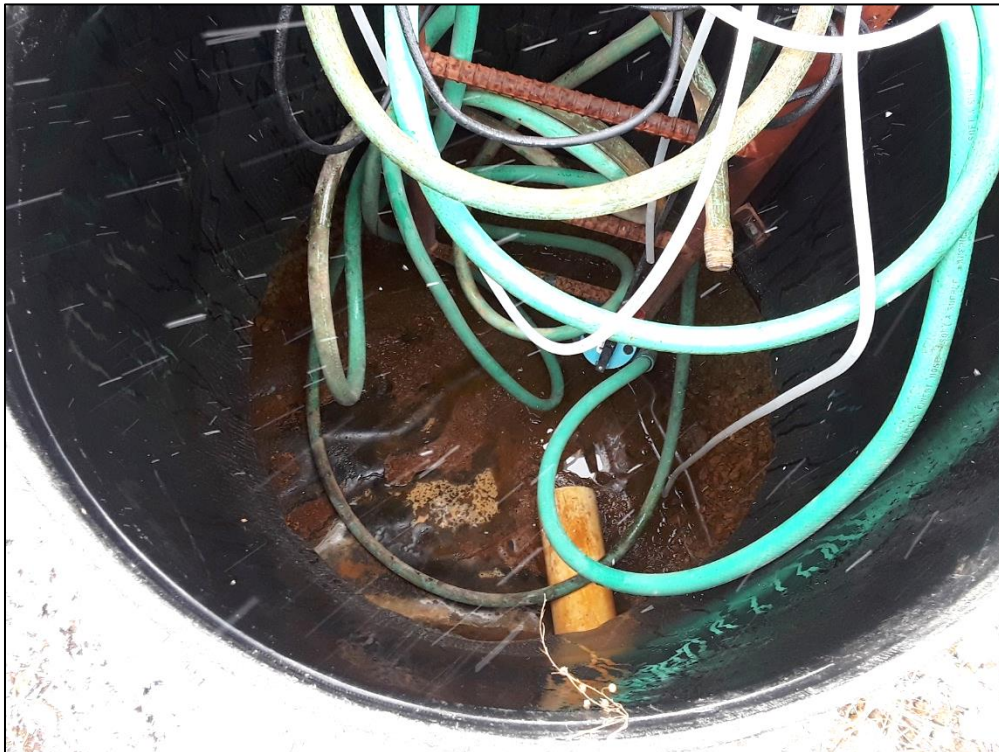
Photo 29. View of AG-LDS-2 sump located near External Storage Pond in Phase II of AGVLF.

Photo 30. View inside of AG-LDS-2 sump located near External Storage Pond in Phase II of AGVLF, showing sump contained some sediment and water.

A total of 15 Leak Detection System (LDS) sumps exist in the AGVLF. The Division inspected six of these LDS sumps, including AG-LDS-1 (**Photos 25 and 26**) and AG-LDS-9 (**Photos 27 and 28**; located near the ADR-1 plant in Phase I), AG-LDS-2 (**Photos 29 and 30**; located near the External Storage Pond in Phase I), AG-LDS-3 (**Photos 31 and 32**; located just west of AG-LDS-2 in Phase II), and AG-LDS-12 (**Photos 33 and 34**) and AG-LDS-13 (**Photos 35 and 36**; located at the northern edge of the crusher area, in Phase IV). AG-LDS-1, AG-LDS-2 and AG-LDS-12 had some sediment and a minor amount of water (< 2 inches). AG-LDS-3 had a minor amount of water. The other sumps inspected were dry. The operator indicated the sumps with water had been recently sampled. The Division recommends the operator clean out any sediment and/or water from the sumps that have been sampled as soon as possible.

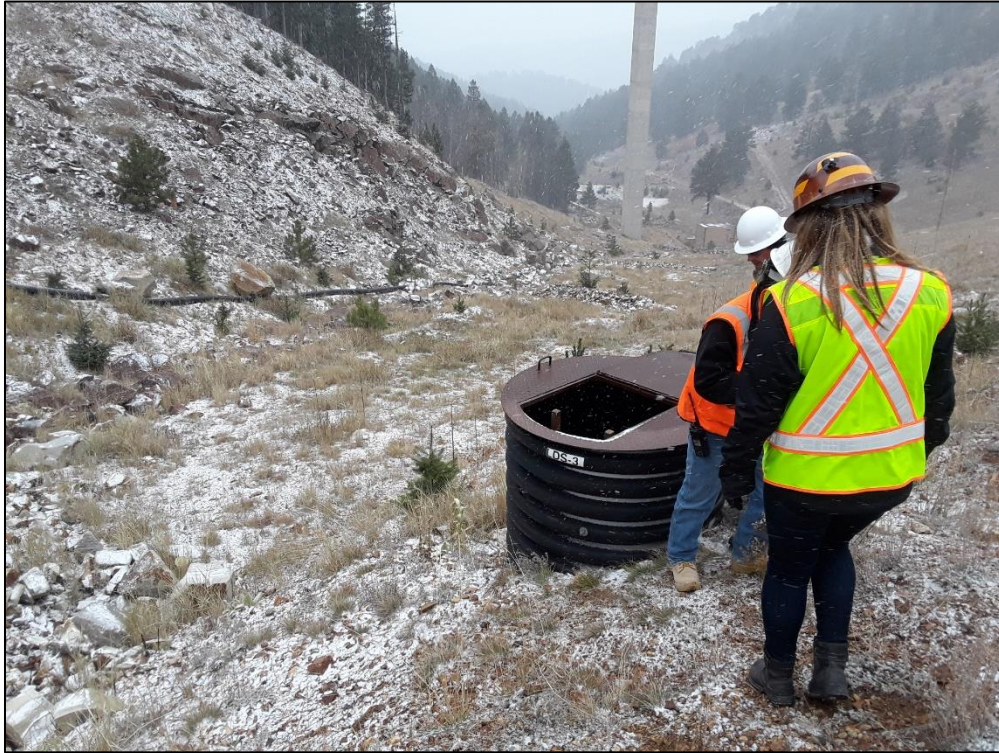
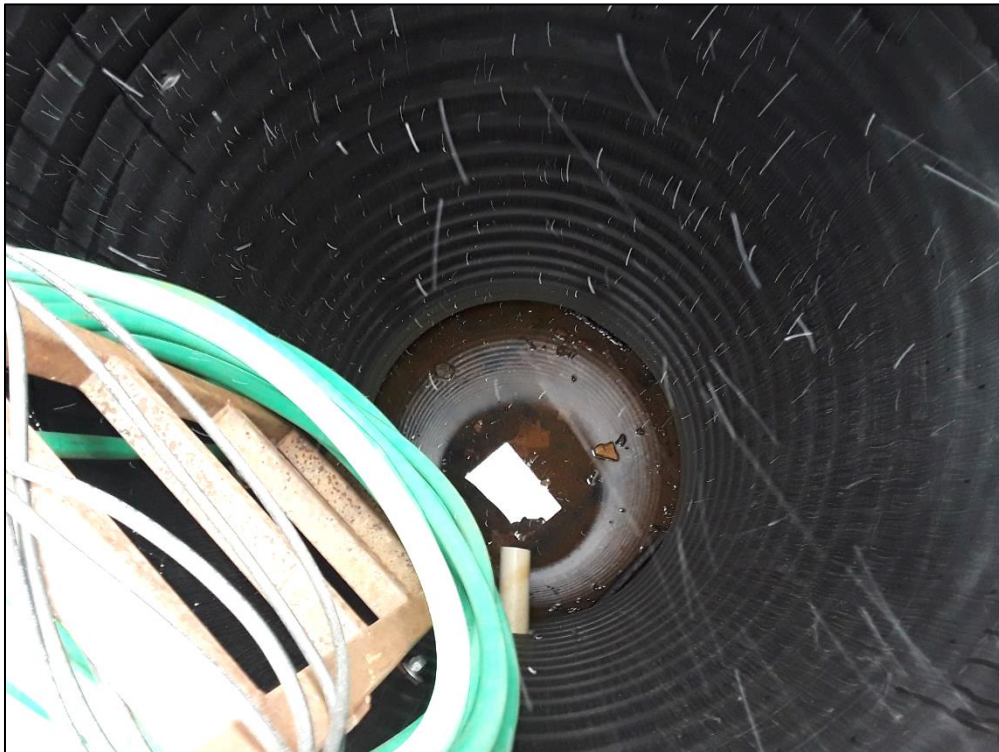
Photo 31. View of AG-LDS-3 sump located just west of AG-LDS-2 sump in Phase II of AGVLF.

Photo 32. View looking inside of AG-LDS-3 sump located just west of AG-LDS-2 sump in Phase II of AGVLF, showing sump had some water during inspection.

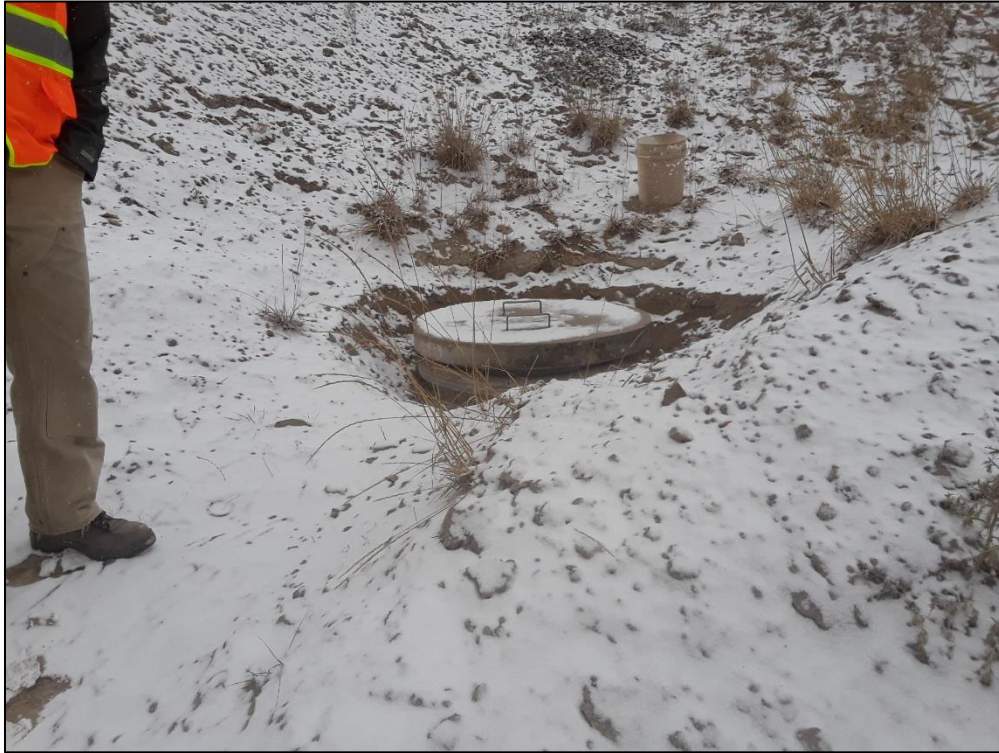
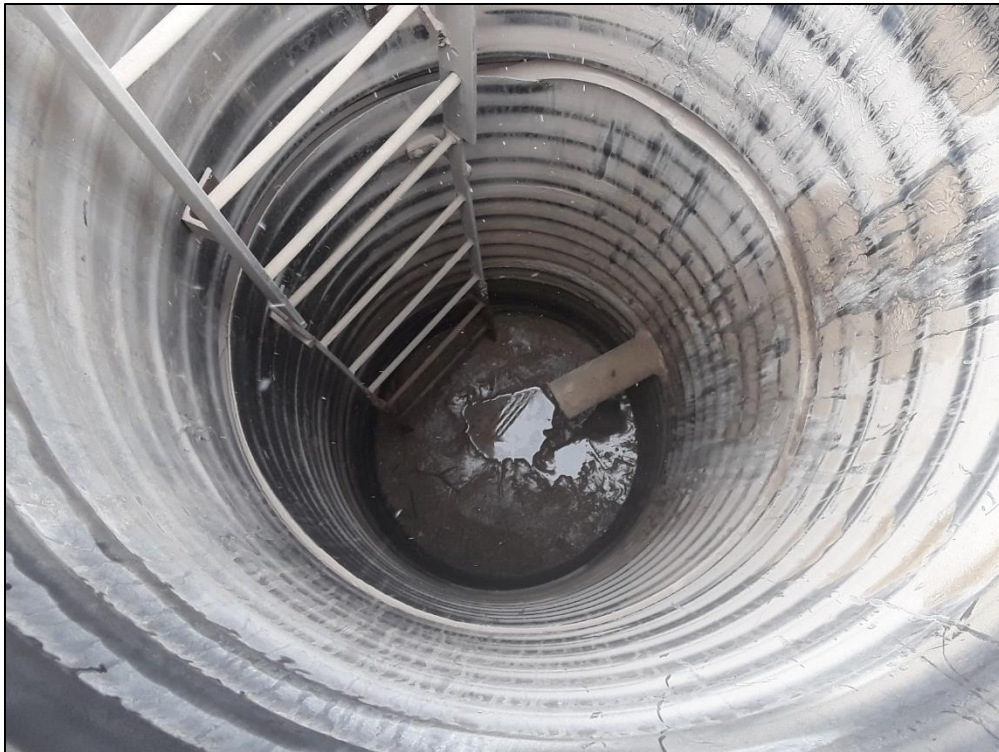
Photo 33. View of AG-LDS-12 sump located at northern edge of crusher area in Phase IV of AGVLF.

Photo 34. View looking inside of AG-LDS-12 sump located at northern edge of crusher area in Phase IV of AGVLF, showing sump had some sediment and water during inspection.

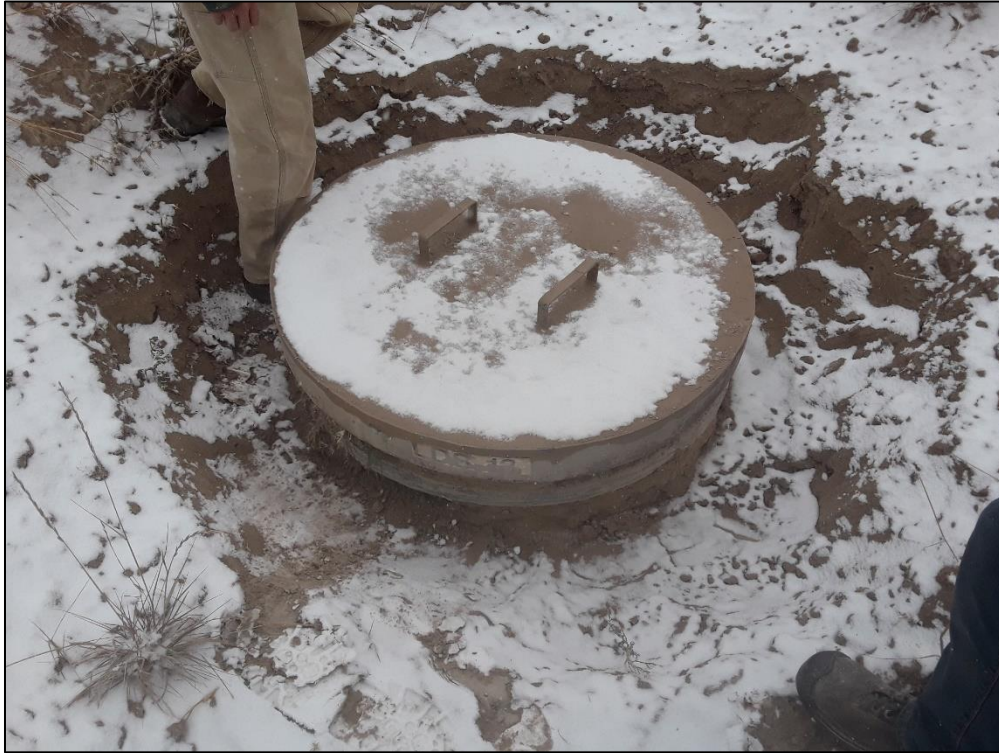
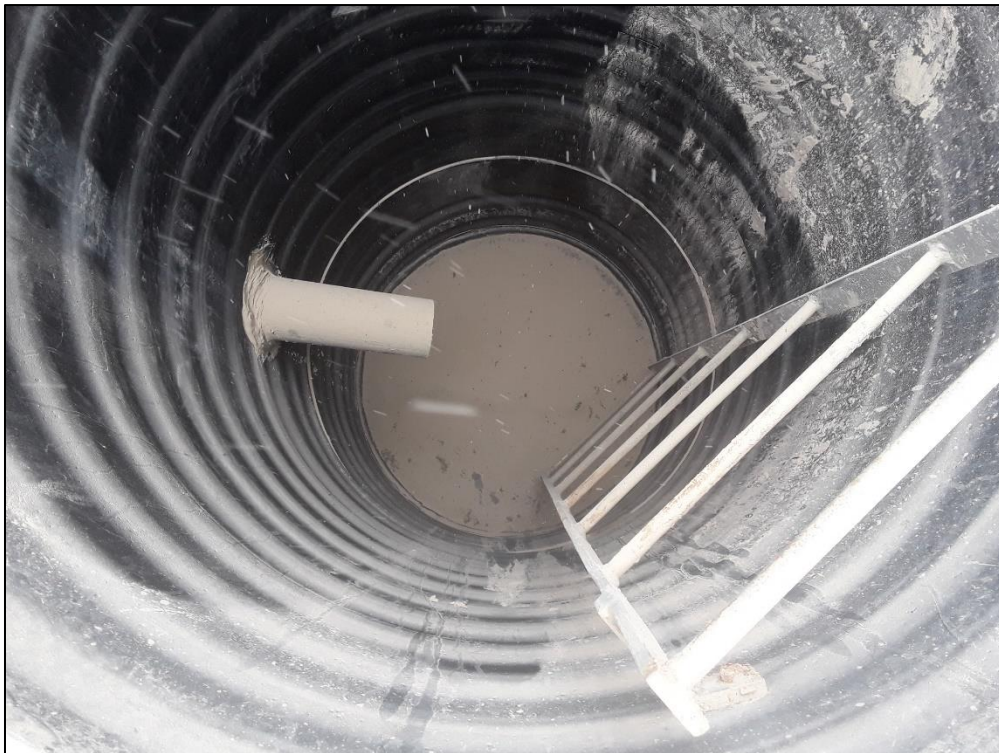
Photo 35. View of AG-LDS-13 sump located at northern edge of crusher area in Phase IV of AGVLF.

Photo 36. View looking inside of AG-LDS-13 sump located at northern edge of crusher area in Phase IV of AGVLF, showing sump dry during inspection.

In its inspection report sent on September 27, 2018, the Division recommended a raise or barrier for some of the LDS sumps where the ground surface was close to the top of the sump. The Division specified this should be done for AG-LDS-1 and AG-LDS-13. During the current inspection, the Division observed the ground surface had been excavated around these sumps, per the Division's recommendations. This should help minimize debris deposition and surface runoff into the sumps. Keeping sediment and snow away from the immediate area of the tops of the sumps will require consistent attention and maintenance by the operation.

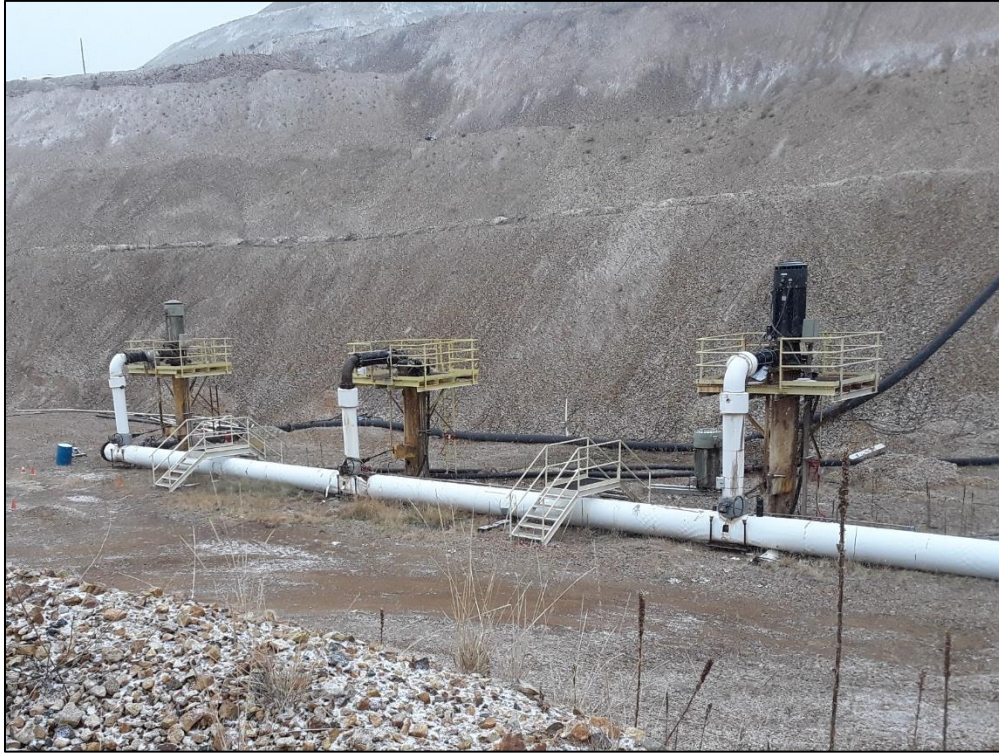
The Division recorded water level readings from transducers for the AGVLF high volume solution collection system (HVSCS; **Photo 37**), pond piezometers, and low volume solution collection system (LVSCS) for Phases I, II/III, IV, and V. Readings were also recorded from the transducers for the SGVLF HVSCS (**Photo 38**; pond piezometer, and LVSCS. The values recorded during this inspection are presented on the enclosed **Attachment A**. All recorded values were below their respective reporting limits.

Photo 37. View looking northeast, showing AGVLF Phase II/III HVSCS pumps from which PSSA water level readings are recorded.

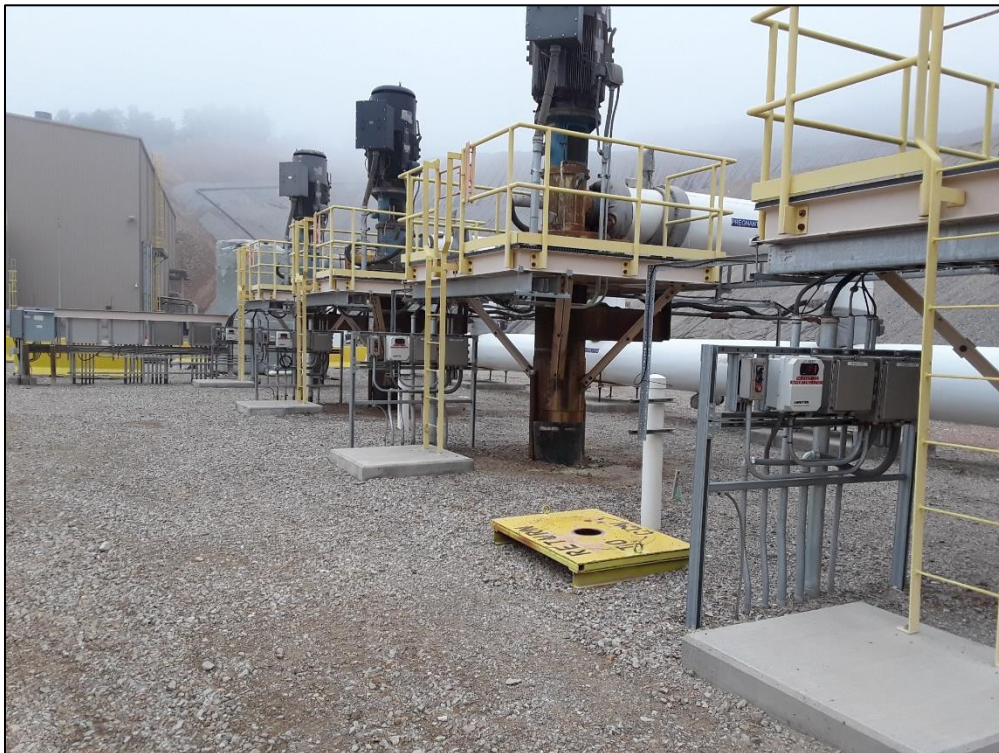
Photo 38. View looking northwest, showing SGVLF HVSCS pumps from which PSSA water level readings are recorded.
