**MINERALS PROGRAM INSPECTION REPORT**  
**PHONE: (303) 866-3567**

<b>MINE NAME:</b> Colorado Red Rose Stone Resource	<b>MINE/PROSPECTING ID#:</b> M-2013-068	<b>MINERAL:</b> Granite, granite gneiss	<b>COUNTY:</b> Larimer
<b>INSPECTION TYPE:</b> Monitoring	<b>INSPECTOR(S):</b> Jared L. Ebert	<b>INSP. DATE:</b> January 31, 2019	<b>INSP. TIME:</b> 11:30
<b>OPERATOR:</b> Colorado Rose Red Inc.	<b>OPERATOR REPRESENTATIVE:</b> Caleb Liesveld	<b>TYPE OF OPERATION:</b> 111 - Construction by Government Agency	
<b>REASON FOR INSPECTION:</b> Normal I&E Program	<b>BOND CALCULATION TYPE:</b> Partial Bond	<b>BOND AMOUNT:</b> \$7,500.00	
<b>DATE OF COMPLAINT:</b> NA	<b>POST INSP. CONTACTS:</b> None	<b>JOINT INSP. AGENCY:</b> None	
<b>WEATHER:</b> Clear	<b>INSPECTOR'S SIGNATURE:</b>

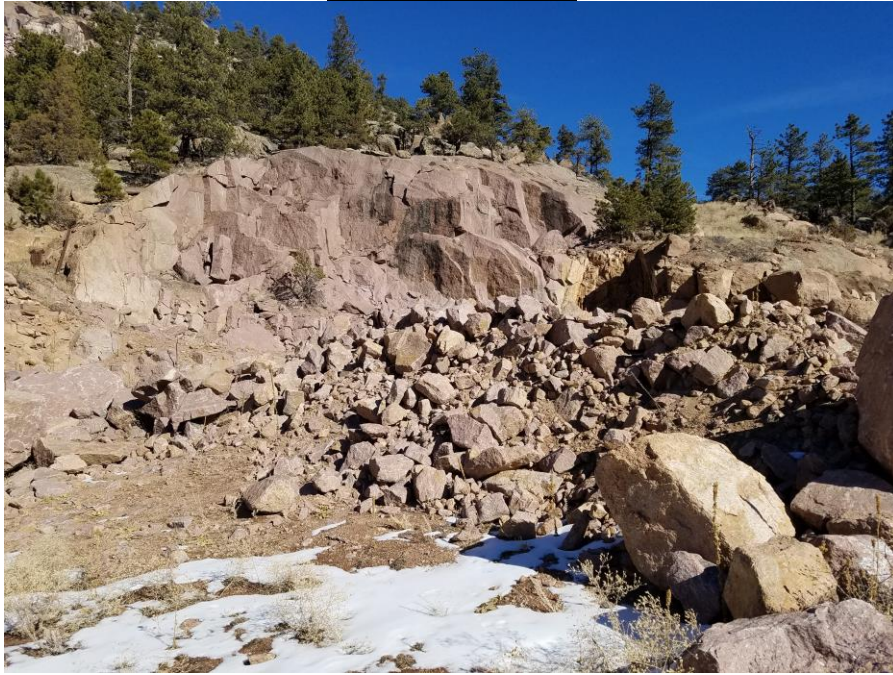
A small highwall about 12 feet in height exists at the site with a small pit depression at the base of the highwall. Rocks and boulders are at various locations surrounding the small excavation.

**Figure 1. From the southeast side of the excavation looking at the highwall.**

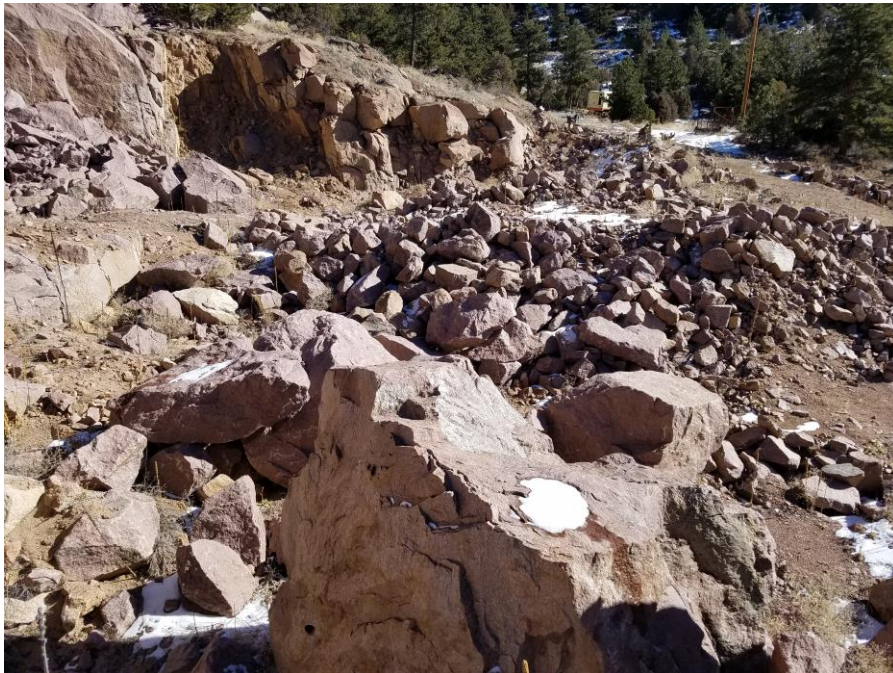
**Figure 2. From the west side of the excavation looking east.**
